FLOODING AND FLOOD-RELATED DAMAGES REPORT

SAN FRANCISQUITO CREEK SANTA CLARA COUNTY DECEMBER 21-23, 2012

# FLOODING AND FLOOD RELATED DAMAGES REPORT IN SANTA CLARA COUNTY SAN FRANCISQUITO CREEK DECEMBER 21-23, 2012

# SAN FRANCISQUITO CREEK EVENT INSPECTION 12/27/2012

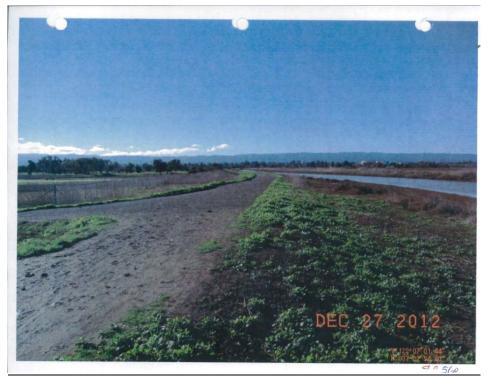
Typical levee (SCVWD 560) - 12/27/2012

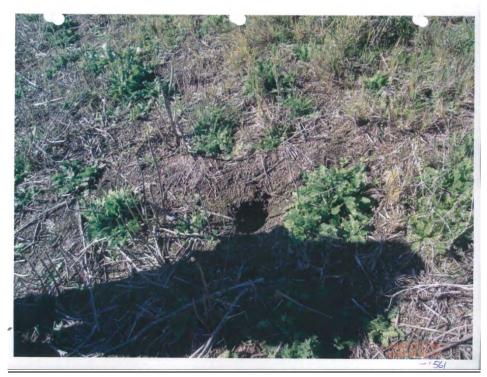
Rodent hole (SCVWD 561) – 12/27/2012

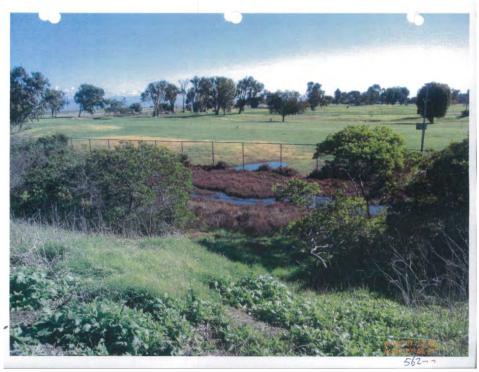
Standing water (SCVWD 562) – 12/27/2012

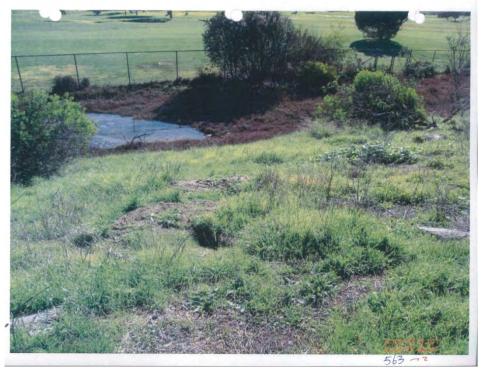
Rodent hole (Foreground) Standing water (Background) (SCVWD 563) – 12/27/2012

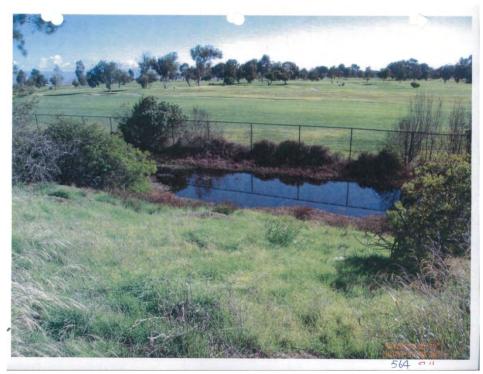
Standing water (SCVWD 564) – 12/27/2012

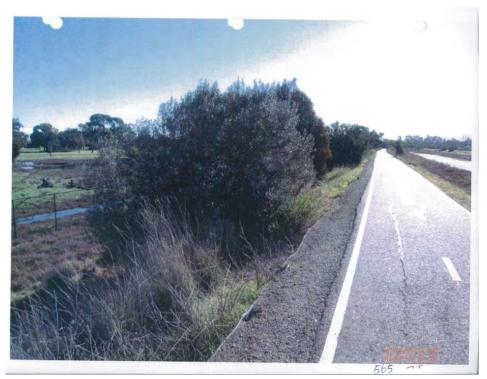
Woody growth – "no visual of levee" (SCVWD 565) – 12/27/2012

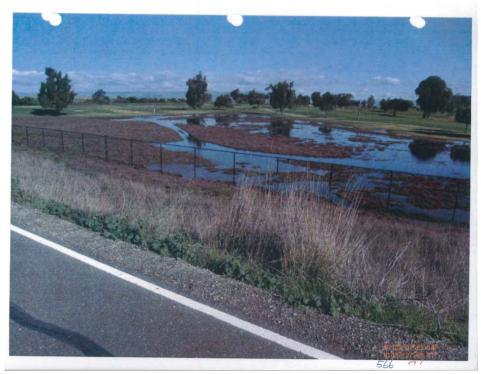
Standing water (SCVWD 566) – 12/27/2012

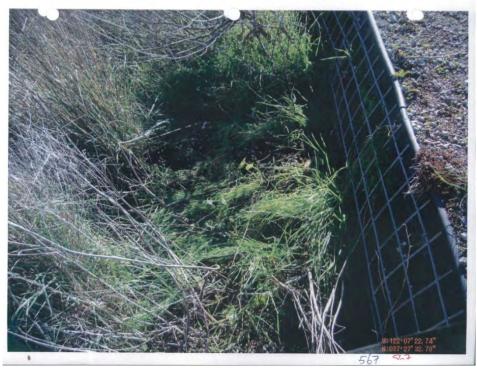
Minor void / seepage through lift (SCVWD 567) – 12/27/2012

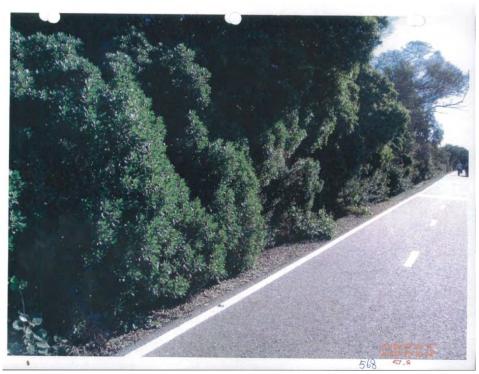
Woody growth on levee – no visual inspection (SCVWD 568) – 12/27/2012

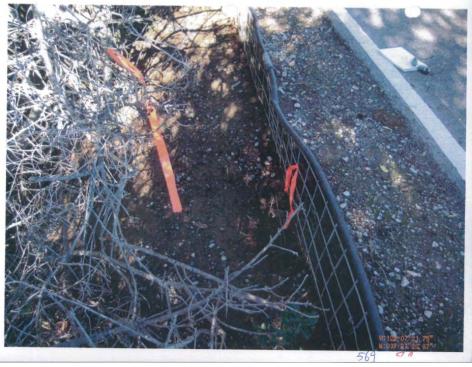
Rodent hole at lift – noted "seepage?" (SCVWD 569) – 12/27/2012

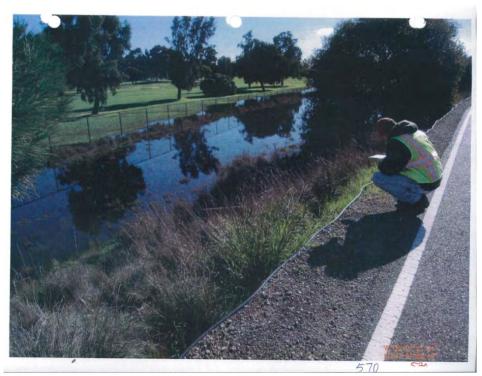
Standing water (SCVWD 570) – 12/27/2012

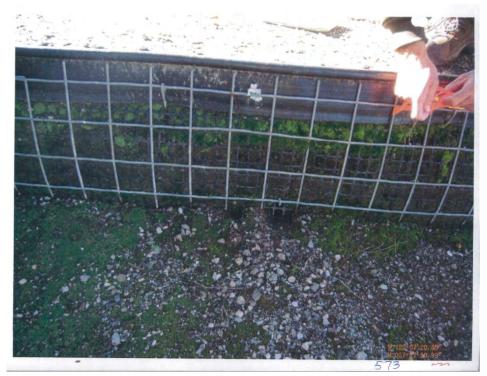
Hole with seepage at lift (SCVWD 573) – 12/27/2012

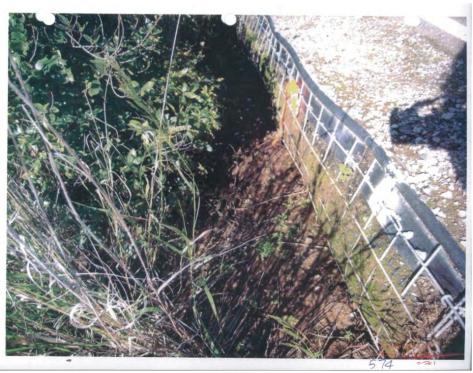
Hole with seepage at lift (SCVWD 574) – 12/27/2012

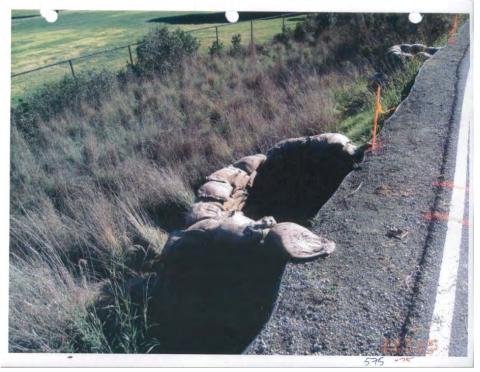
Boil Berms (SCVWD 575) – 12/27/2012

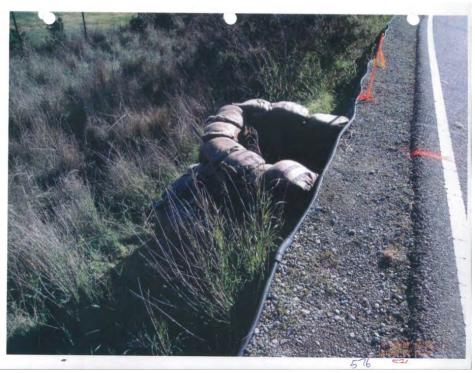
Boil Berm (SCVWD 576) – 12/27/2012

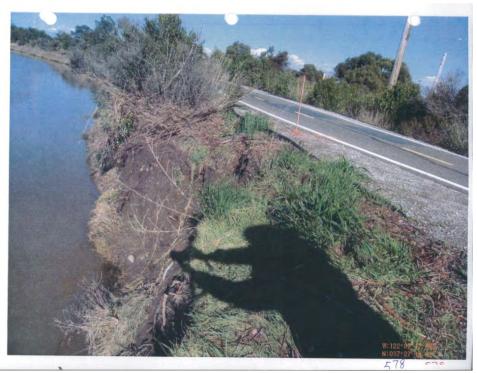
New sloughing inboard (SCVWD 578) – 12/27/2012

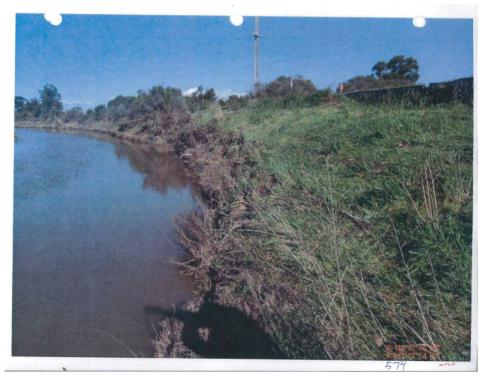
New sloughing inboard (SCVWD 579) – 12/27/2012

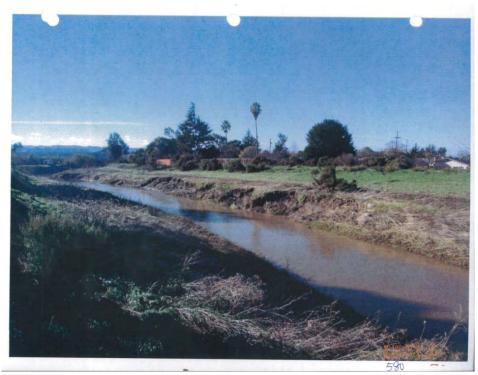
New sloughing on opposite bank (SCVWD 580) – 12/27/2012

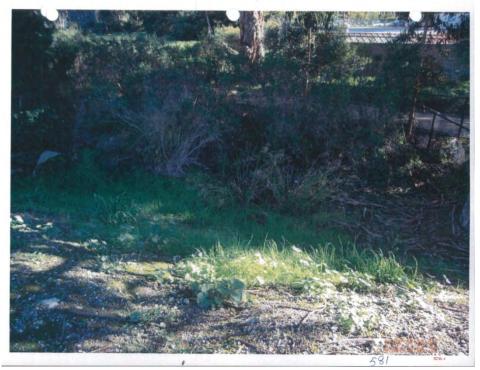
Standing water located near East Palo Alto Post Office (SCVWD 581) – 12/27/2012

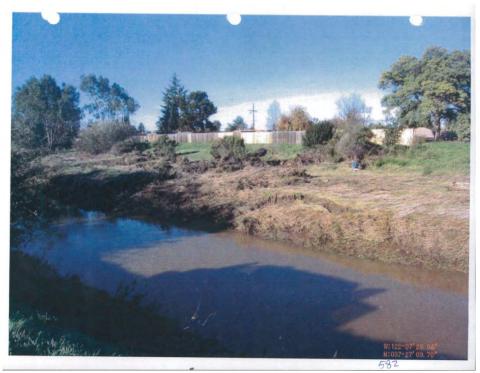
New sloughing located on the opposite bank (SCVWD 582) – 12/27/2012

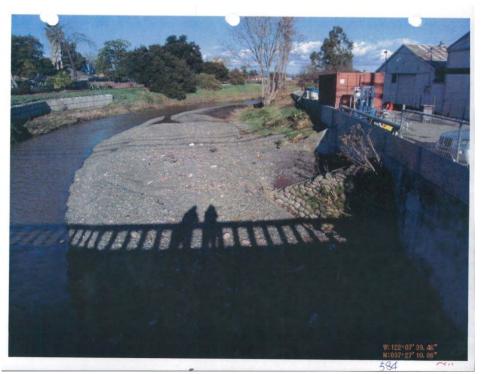
Sediment downstream of Bayshore Road (SCVWD 584) -12/27/2012

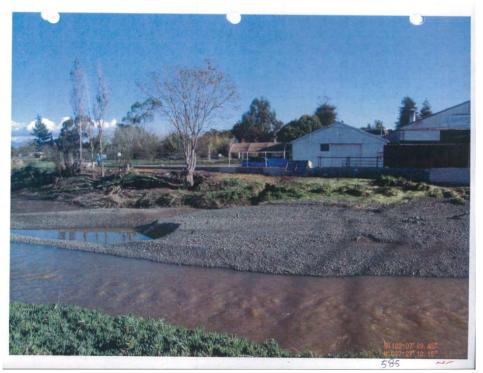
Sediment buildup downstream of Bayshore Road (SCVWD 585) – 12/27/2012

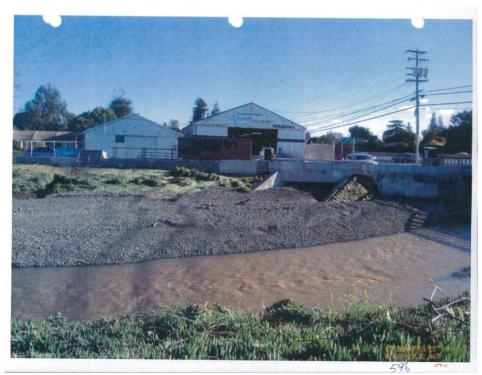
Sediment buildup downstream of Bayshore Road (SCVWD 586) – 12/27/2012

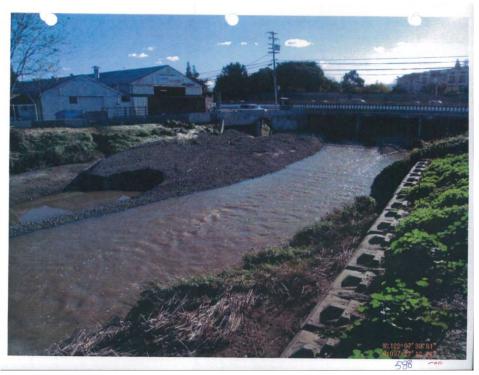
Sediment buildup downstream of Bayshore Road (SCVWD 588) – 12/27/2012

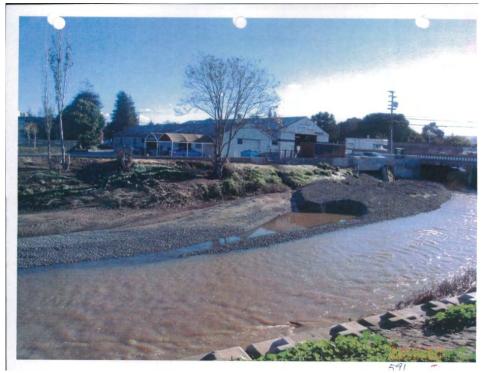
Sediment buildup downstream of Bayshore Road (SCVWD 591) – 12/27/2012

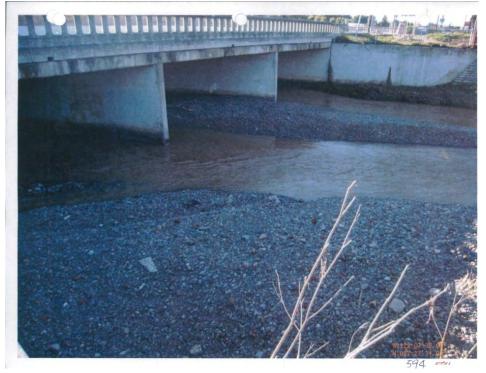
Sediment under (upstream) of Bayshore Road (SCVWD 594) – 12/27/2012

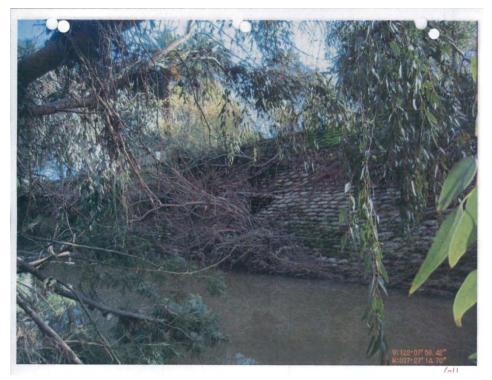
Willows on Rip Rap (SCVWD 611) – 12/31/2012

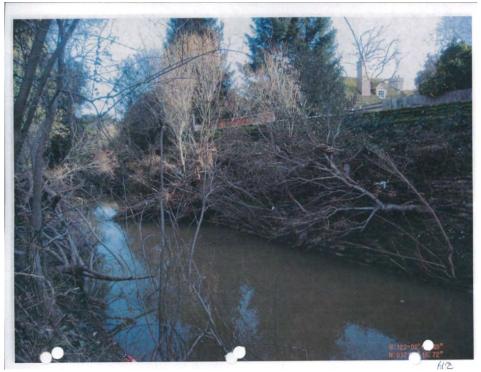
Willows on Rip Rap (SCVWD 612) – 12/31/2012

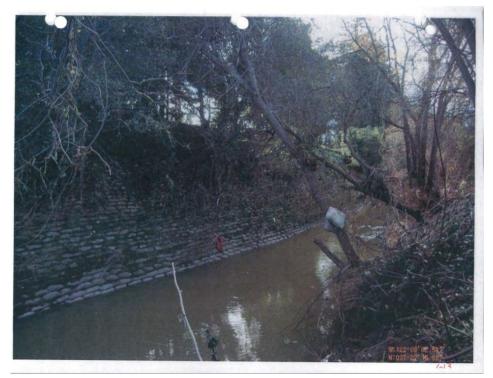
Willows on Rip Rap (SCVWD 613) – 12/31/2012

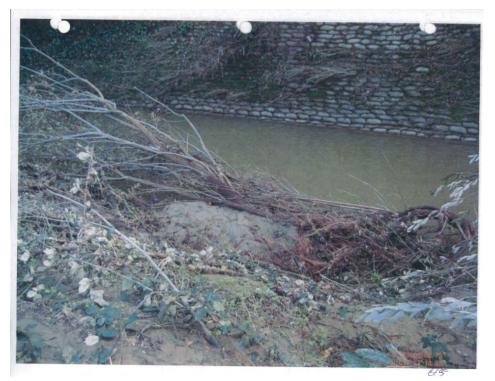
Tree down East Palo Alto side (SCVWD 615) – 12/31/2012

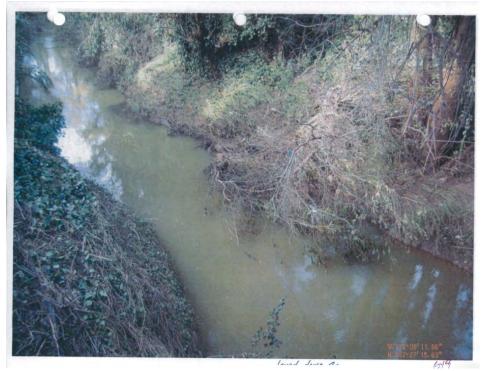
Down tree East Palo Alto side – Joe Teresi sent picture (SCVWD 619) – 12/31/2012

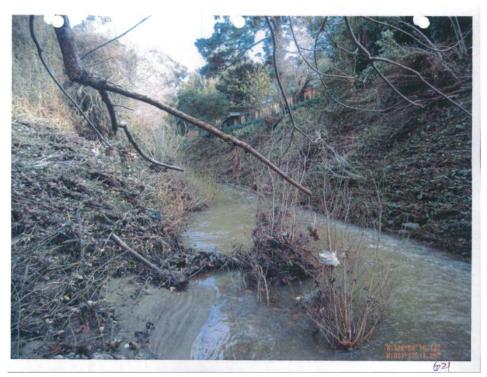
Narrowed channel due to sediment and vegetation (SCVWD 621) – 12/31/2012

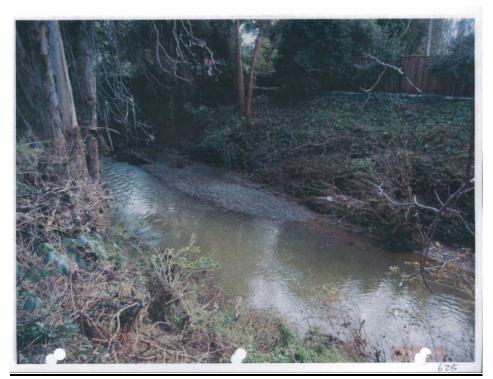
Willows in channel (SCVWD 625) – 12/31/2012

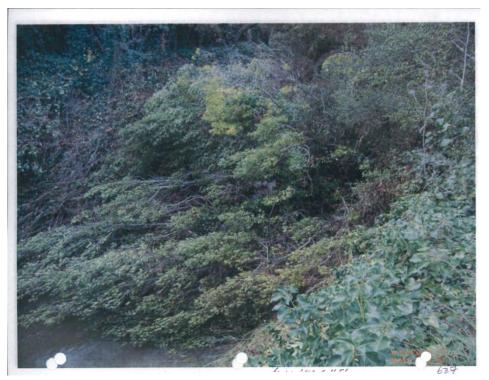
Downed tree in channel from East Palo Alto side engulfing channel (SCVWD 627) – 12/31/2012

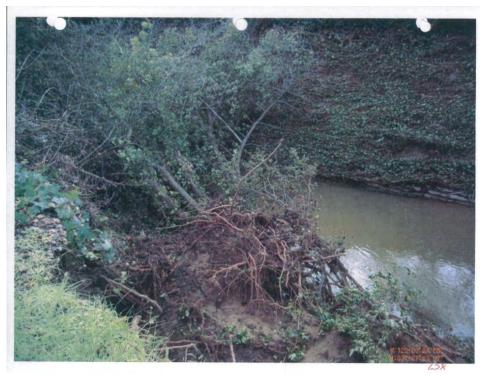
Down tree in channel from East Palo Alto side engulfing channel (SCVWD 628) – 12/31/2012

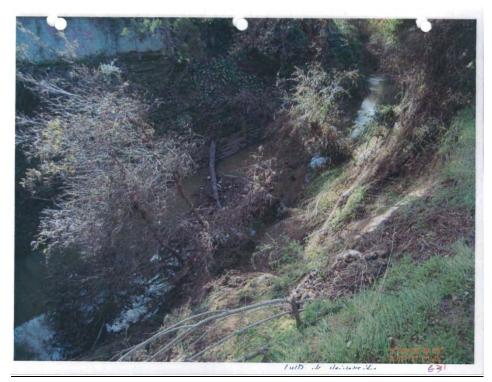
Minor blockage across from 1523 Woodland Avenue (SCVWD 631) – 12/31/2012

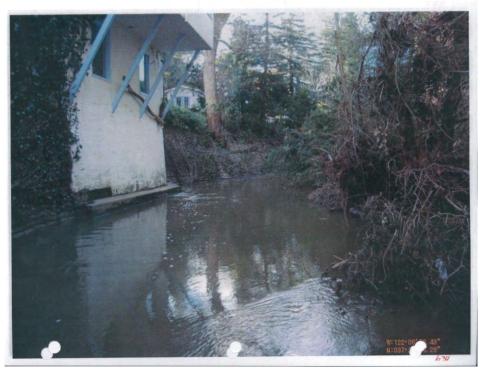
Cantilever house on Lincoln Avenue (SCVWD 634) – 12/31/2012
