Appendix G

Geotechnical Engineering

GEOTECHNICAL APPENDIX
South San Francisco Bay Shoreline Study (SSFBS)

Attachment E – Geotechnical field assessment of the San Francisco South Bay Dike system

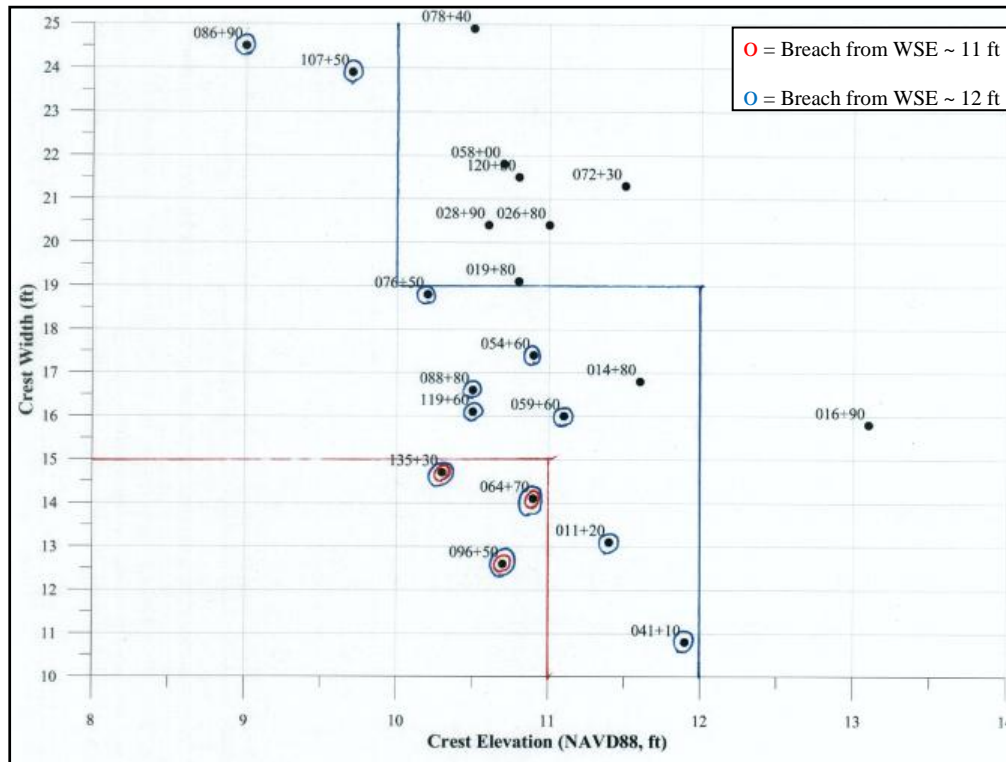
threshold (i.e. overtopping duration vs. crest width) to which overtopping breaches are likely to occur. Of the 21 cross sections evaluated, three locations are at risk of an overtopping breach for a peak WSE of 11 ft. The number of potential overtopping breaches increases to 12 for a peak WSE of 12 ft.

Figure 4-4: Potential overtopping breach locations for given peak WSE (Geomatrix, 2006).

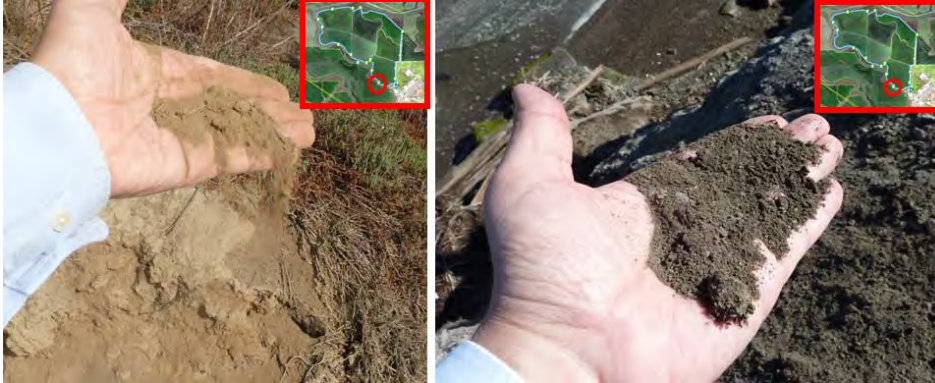
During the field assessment most of the dike length had an observed crest soil composition ranging from loose silt behavior with high organic fiber content (termed moon dust in the field) to loose soil mixtures as shown in Figure 4. The left photo shows a silt behavior soil and the right photo shows darker high organic fiber content silt. This loose silt like behaving soil has a thickness of at least a foot in several locations (see Figure 5). These silt behaving soils have secondary influences, unfortunately generating an optimum condition for rodents to dig holes but allowing specific vegetation types to grow.

Figure 4 - Crest loose silt behavior with some to high organic fiber content

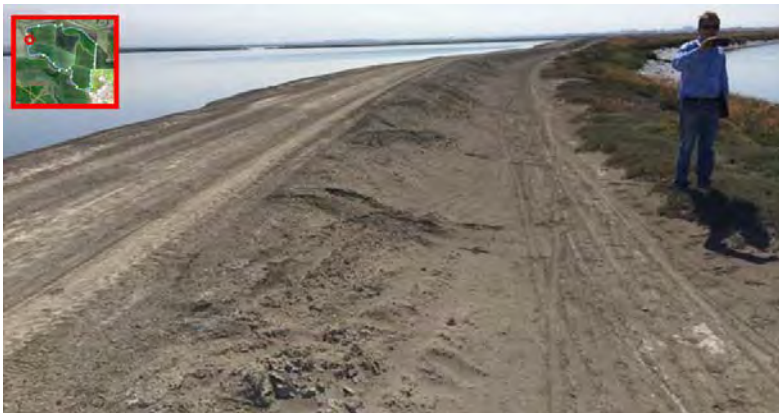
Figure 5 - Loose silt like behavior on dike crest

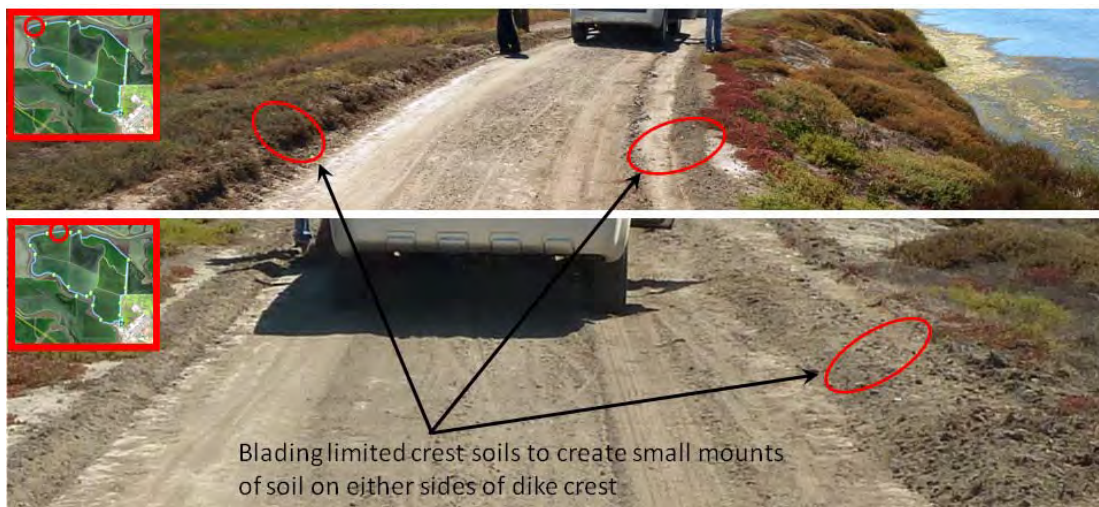
During the field inspection there is evidence that Cargel field operations would scarify or blade crest soil to the bay side of the crest as shown in Figure 6. The apparent purpose of blading was to generate a small temporary raised crest section as illustrated in Figure 7.

Figure 6 – Blading and scarifying dike crest silt to either side of the crest – to create limited crest elevation rise.

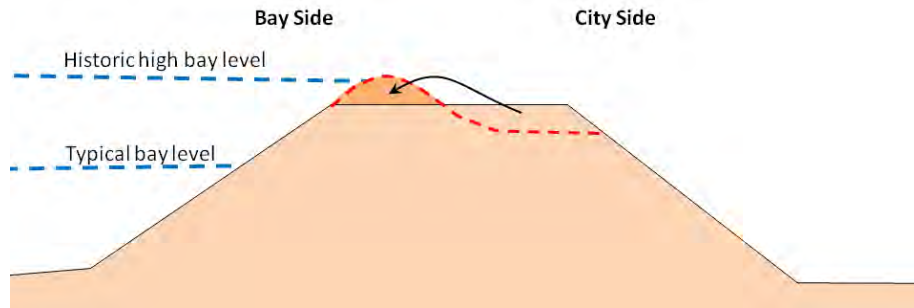
Figure 7 – Blading to create small localized mounds on the side of the crest to temporary raise the effective crest height

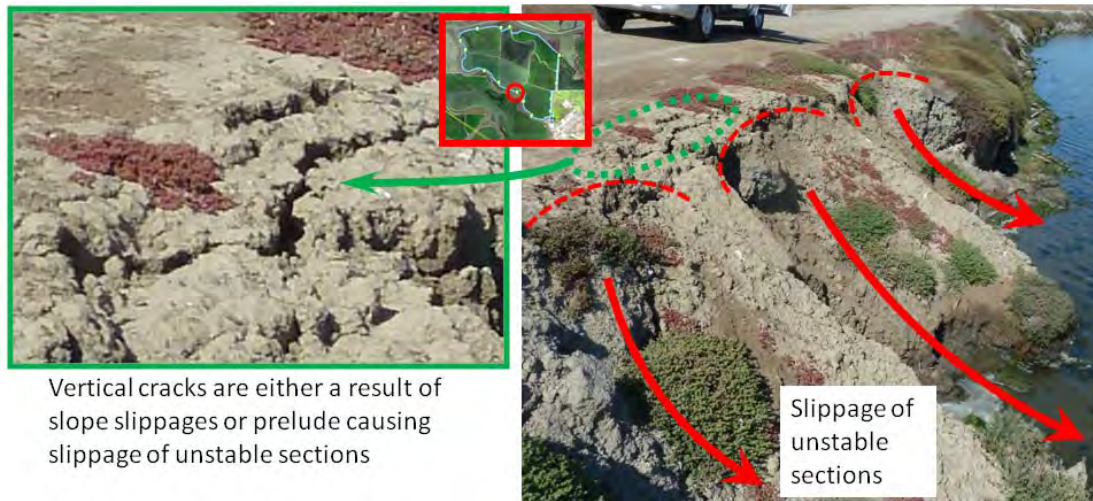
On the South segment of this dike system, when the dike height is high, the exposed soils on the slopes become dry and brittle. Erosion due to wave action erodes away the dike toe resulting in steeper slopes (see Figure 8). These steep sections slowly experience multipoint failures (as shown in Figure 9). The resulting debris flows into the ponds create a bench of flow material just beyond the dike toe, as illustrated in Figure 10.

Figure 8 - toe erosion resulting in near surface failure of dike dry material

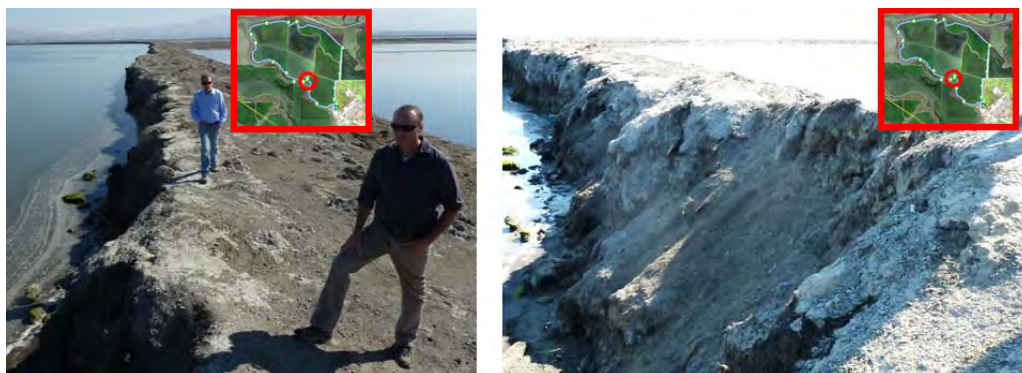
Figure 9 - Steepen dry silts and resulting sliding

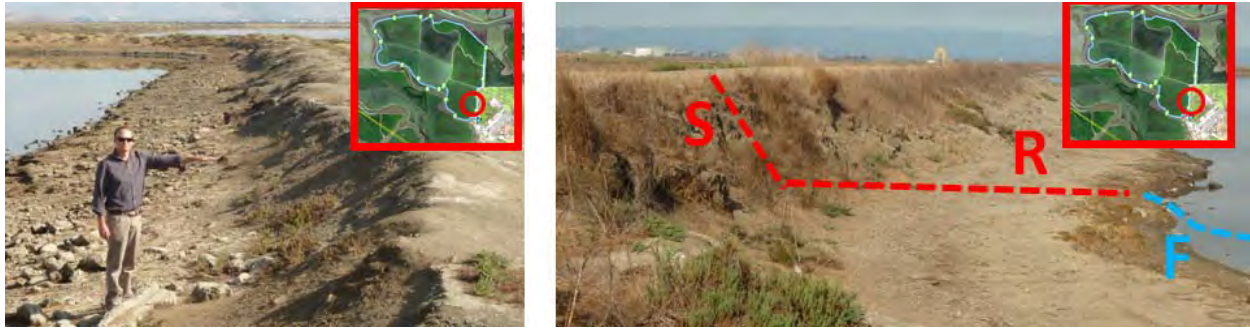
Figure 10 - runout of flow material just beyond the dike toe

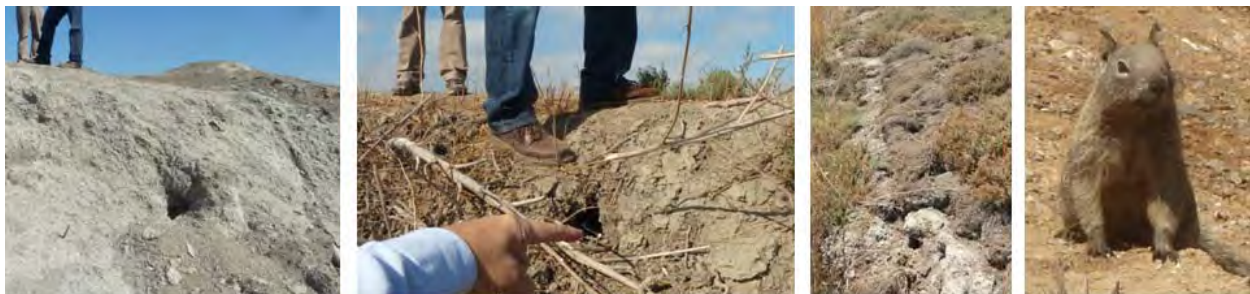
The combination of rodent holes and dry highly erodible silt soils together provide a dangerous condition because either or both in combination can cause erosion failure along an upper section of the dike (as illustrated in Figure 14).

Figure 11 - Rodent dug tunnels are throughout the dike system

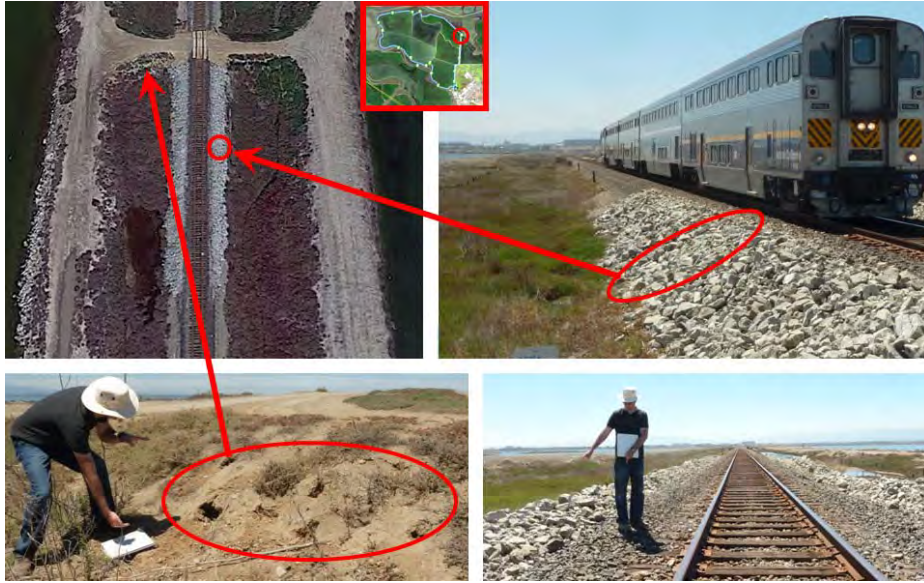
Figure 12 - Rodent dug holes next to railroad crossing

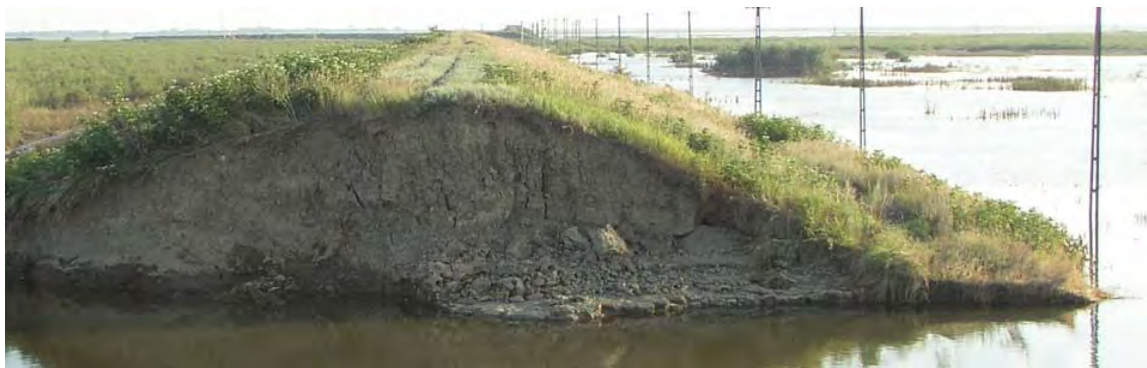
Figure 13 - Failed levee in Romania due to rodent tunneling holes

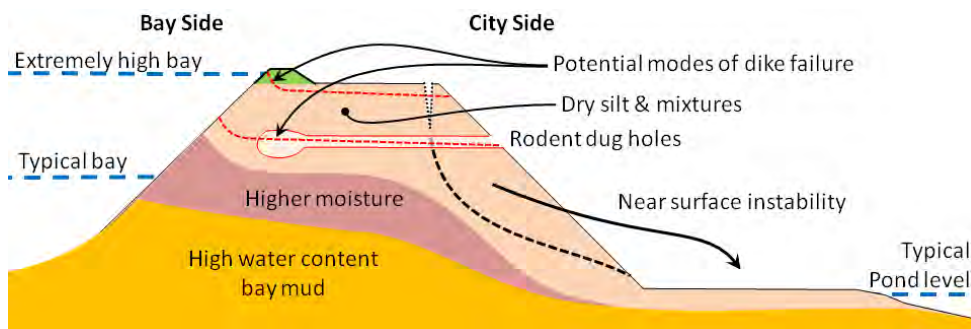
Figure 14 - Hypothetical section showing soil moisture contents, near surface instability, and rodent dug holes, and potential modes of failure.

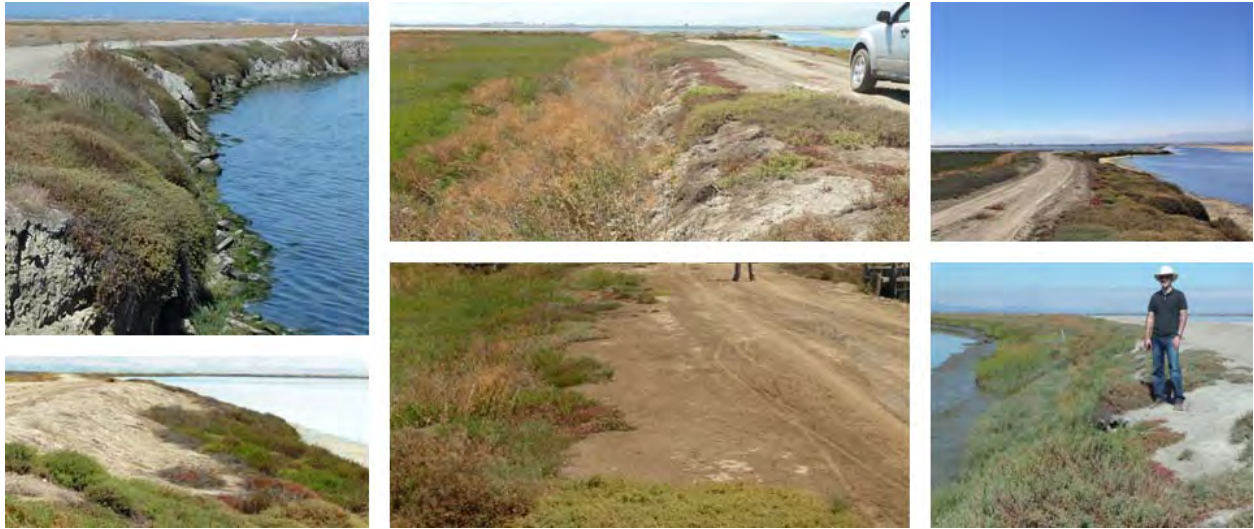
Much of this dike system is covered with various types of grass cover. While grass can resist water flow the problem is that the coverage for this dike is not 100% as shown in Figure 15, there is better coverage on the bay side of the dike. There are several elevation zones of vegetation along the face of the dike likely due to the availability of water and specific soil type (see left side of Figure 16). Pickle weed was identified along upper reaches of the dike near the crest (shown at the right of Figure 16). While vegetation can resist small wave action this resistance is not absolute as shown in the upper left of Figure 15.

Figure 15 - Vegetation is covering much but not all the dike slopes

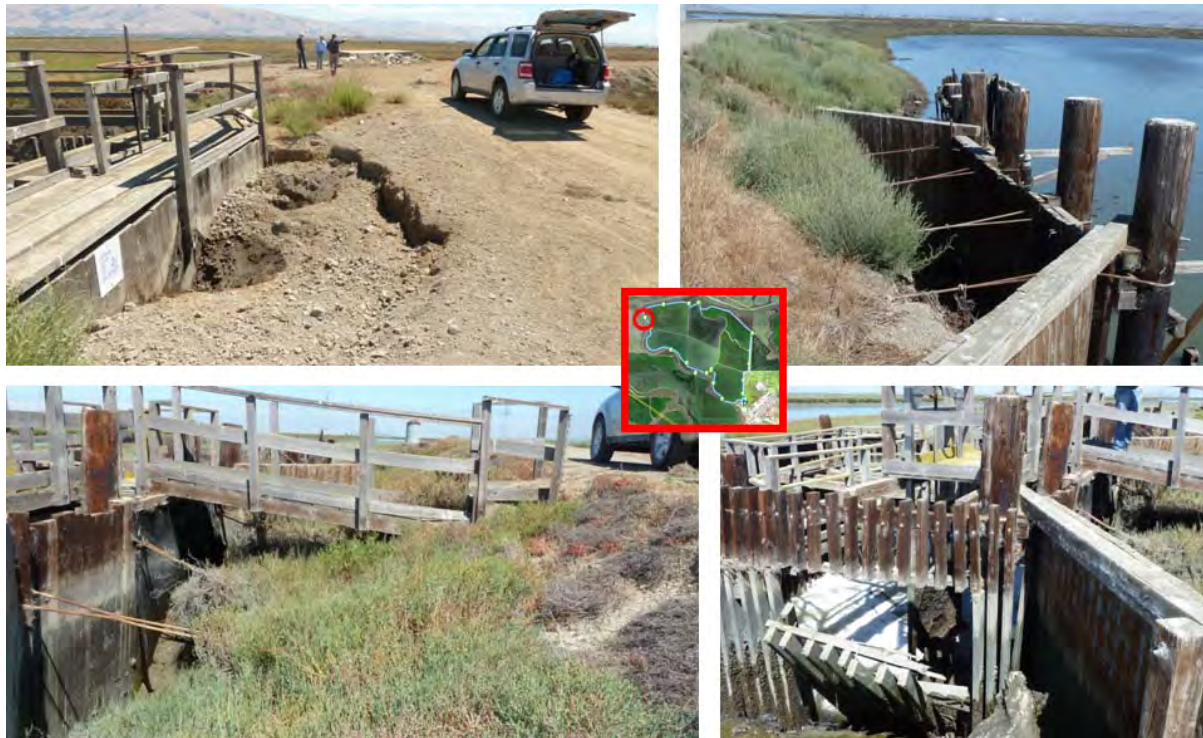
Figure 17 - Water Control structures are experiencing lose of soil issues

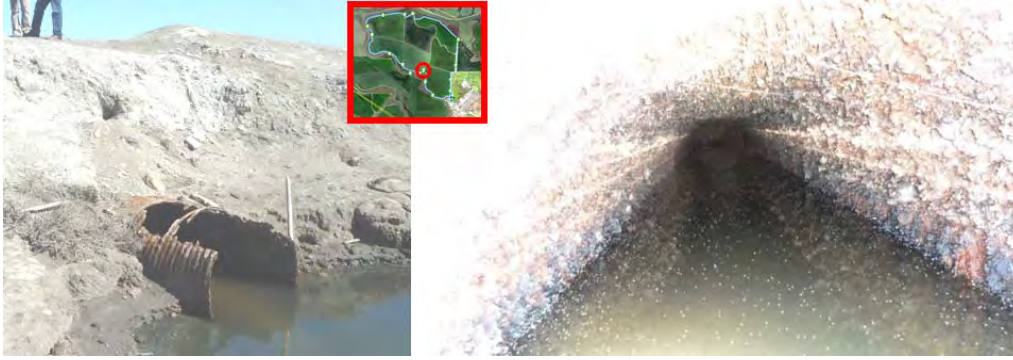
An isolated pipe through a dike section is shown Figure 18. The outside of this steel pipe has experienced severe rusting. The inside of the pipe (right side of Figure 18) shows rusting but the extent of rusting could not be observed.

Figure 18 - Pipes through the dike are likely having rusting issues

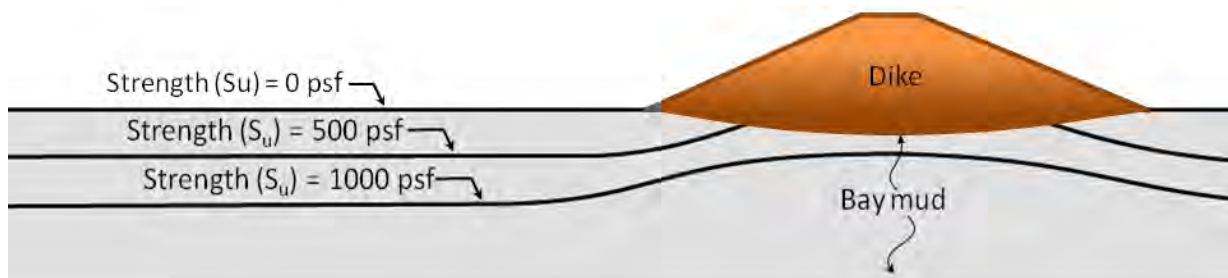
Figure 19 - Bay Mud strength beneath dike (due to consolidation and settlement) and beyond the dike

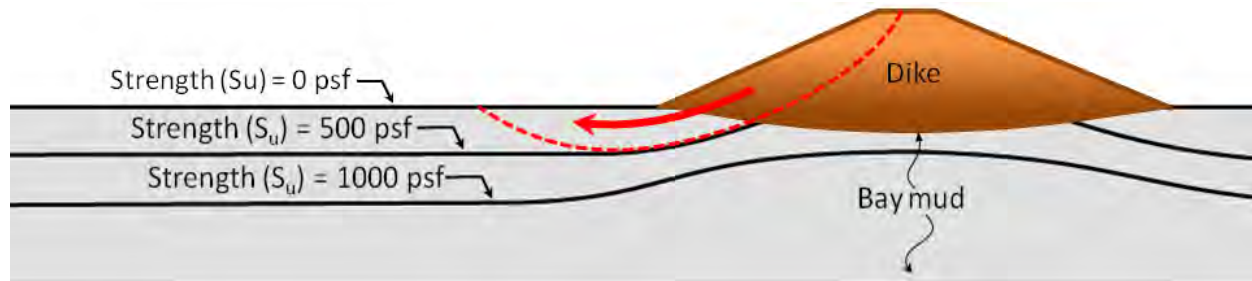
Figure 21 - Potential slip surface accounting for a realistic strength distribution around the dike
