#### SANTA CLARA COUNTY FLOOD CONTROL AND WATER DISTRICT

RECONNAISSANCE REPORT
ON
FLOODS
OF
JANUARY 21-24, 1967

January 1967

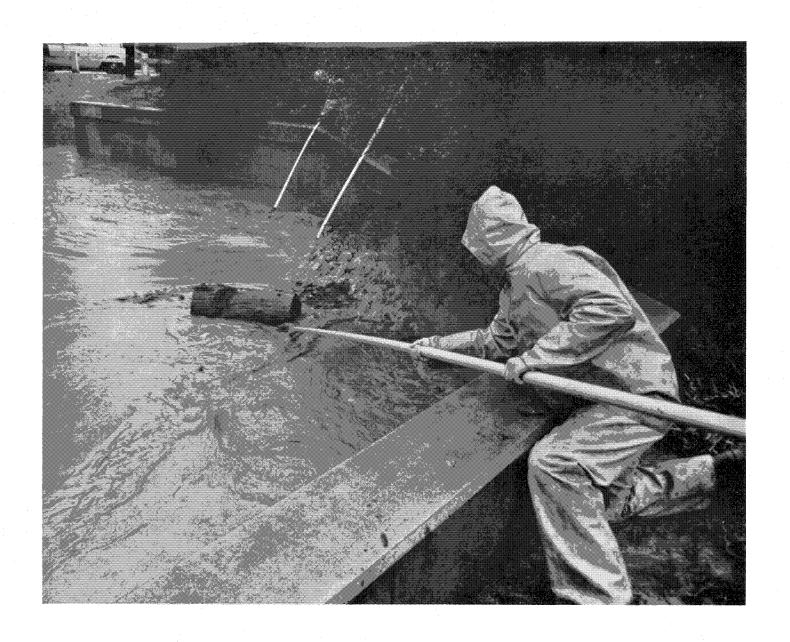
Surcharged culvert on San Francisquito Creek at Chaucer Street.

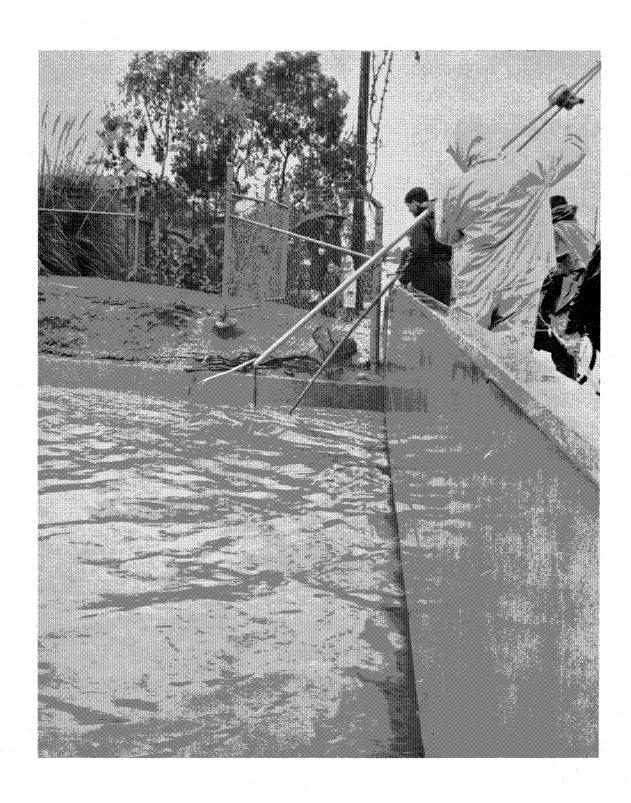
Flood flows in Matadero Creek caused surcharge of the Greer Road crossing about one-quarter mile upstream of Bayshore Freeway;

however, there was about one foot of freeboard in the lined channel. This high stage probably resulted from high tides and inadequate storage capacity in the Palo Alto Flood Basin. The lower reaches of Adobe and Barron Creeks handled the peak flood flows without difficulty, but the flows contributed significantly to the filling of the area reserved for the Palo Alto Flood Basin.

Matadero Creek at Greer Road. Note one foot of freeboard.

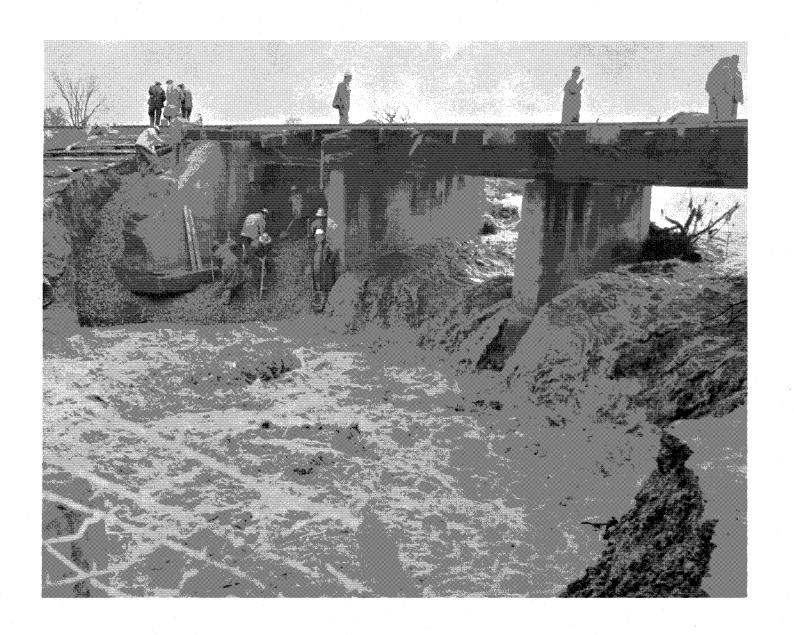
San Tomas Aquino Creek at Southern Pacific Company bridge. Note exposed abutment footings on downstream side.

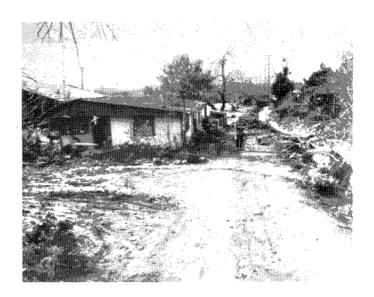
Los Coches Creek looking west -Sepulveda house on left - silt covering field down to fence.

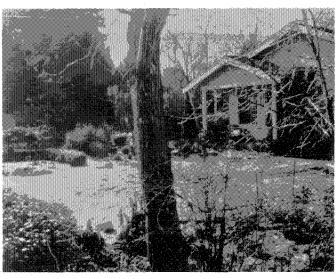
House on the westerly side of King Rd. and the northerly side of Penitencia Creek about 50 feet from the right bank of the Creek. Water which had passed through the culvert topped the right bank and went through this house at a depth of about 6 inches. Silt deposit in the front yard can be seen reflect-

ing the suns rays.

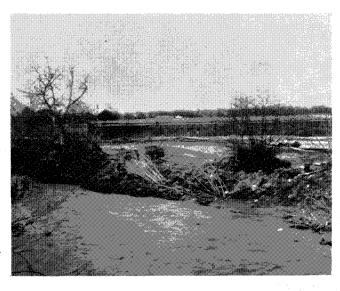
Looking northerly along Capitol Ave. at the upstream side of the Penitencia Creek Bridge showing debris deposited on the sidewalk when flow topped the bridge; water had been running over the sidewalk at a depth of 8 to 10 inches. There was no apparent blockage in the culvert but capacity has been greatly reduced by bed load deposit to a depth of several feet.

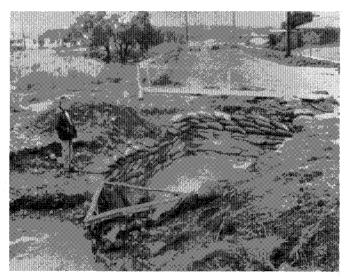
Right bank Penitencia Creek - major breakout about 500 feet east of King Rd. Chin Ah Gum property.

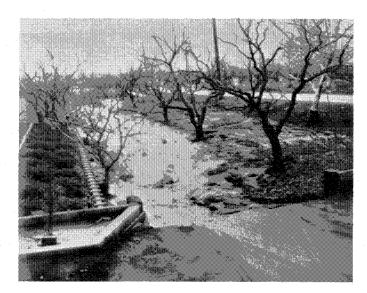
Crosley Ck intake after clamshell clean-out. Flow coming out of 1st manhole at car in distance.

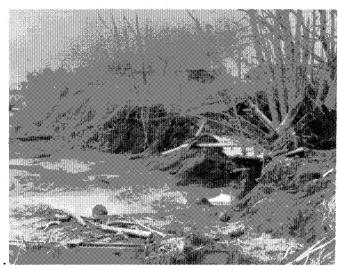
#22 Major breakout on Berryessa Creek left bank about 400 feet east of Morrill Rd.

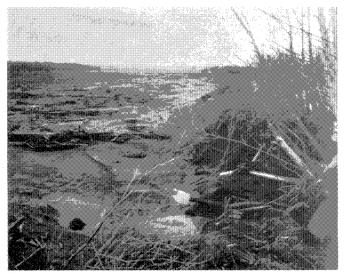
#23 Silt and debris deposits in field at major breakout in Berryessa left bank 400 feet east of Morrill Rd.

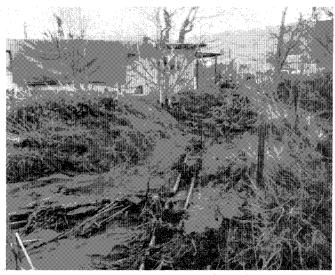
Breakout left bank Berryessa Ck. about 100 feet upstream of that shown in #22 and 23. Irrigation flume shown installed thru levee

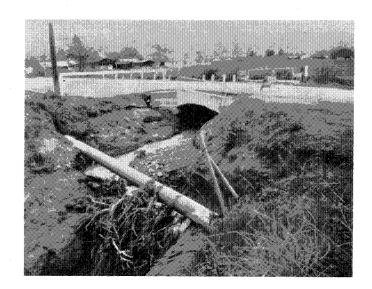
The Cropley Avenue culvert was inundated and the overflow seriously undermined one of the headwalls causing the downstream end to settle. The Berryessa Creek overflow crossed Cropley Road and entered Junewood Avenue, coursing down the street flooding adjacent streets, and leaving considerable debris and silt. The overflow continued on to Capewood Lane flooding front yards and crossing over Berryessa Creek on a temporary access fill to flood Sierrawood Drive and Trimble Road. Further downstream, the Landess Avenue culvert was partially obstructed with debris and sheet flow from Berryessa Creek topped Landess Avenue to a depth of

Looking upstream at the Cropley Rd. culvert over Berryessa Creek show-ing serious erosion under San Jose Water Works' main and collapse of the culvert extension on the northerly side of Cropley Road.

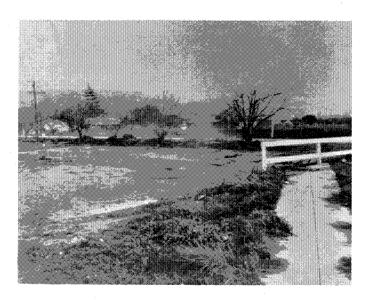
Cropley and Junewood Ave. - silt and debris from overtopping of Berryessa Creek along Cropley Rd.

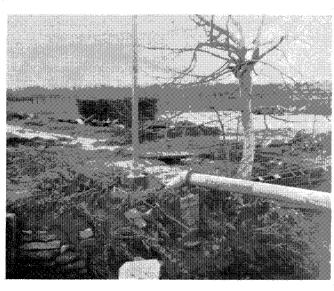
West of Morrill at Cropley Ave. - Silt and debris from Berryessa Ck. overflow

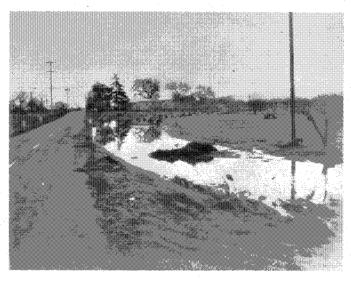
Sharp bend in Little Llagas Creek 3400 feet south of Middle Avenue next to Sycamore Avenue. Debris on road and in trees.

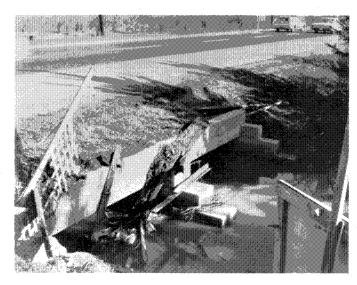
Little Llagas Creek at El Camino Real (U.S. 101) South of Morgan Hill. Note debris from overtopping.

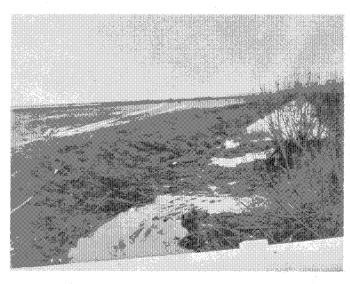
Llagas Creek from Bloomfield Rd. Large amount of debris in Creek. Flooded field at left.

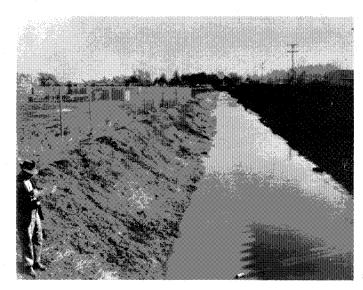
Miller Slough At Welburn Avenue looking south. High water mark can be seen at left.

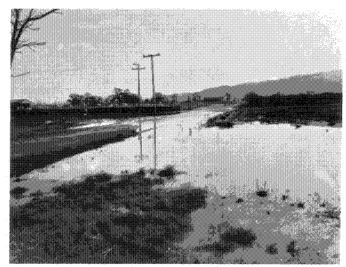
Looking southerly as sheet flow from North branch of Miller Slough in City of Gilroy crosses intersection of Ronan and Wren Avenues.

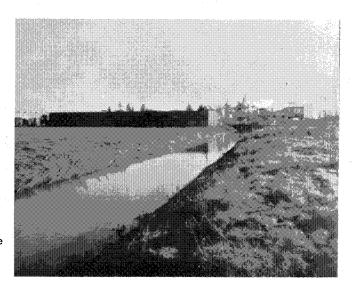
Miller Slough from 1.0.0.F Avenue looking south. High water at top of left bank.

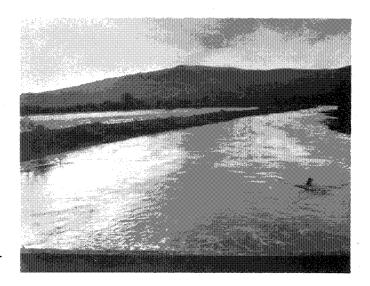
Carnadero Creek at farm bridge near Pajaro River. Note ponding outside of left levee.

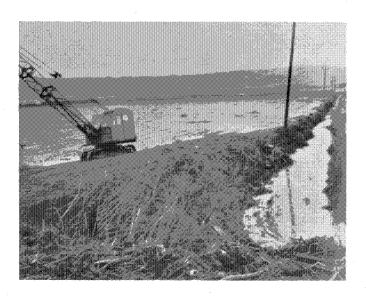
Alamias (Jones) Creek at confluence with Llagas Creek. Flooded fields at left.
