SEISMIC STABILITY EVALUATIONS OF CHESBRO, LENIHAN, STEVENS CREEK, AND UVAS DAMS (SSE2)

STEVENS CREEK DAM

COMPILATION REPORT (REPORT No. SSE2A-SC)

January 2013

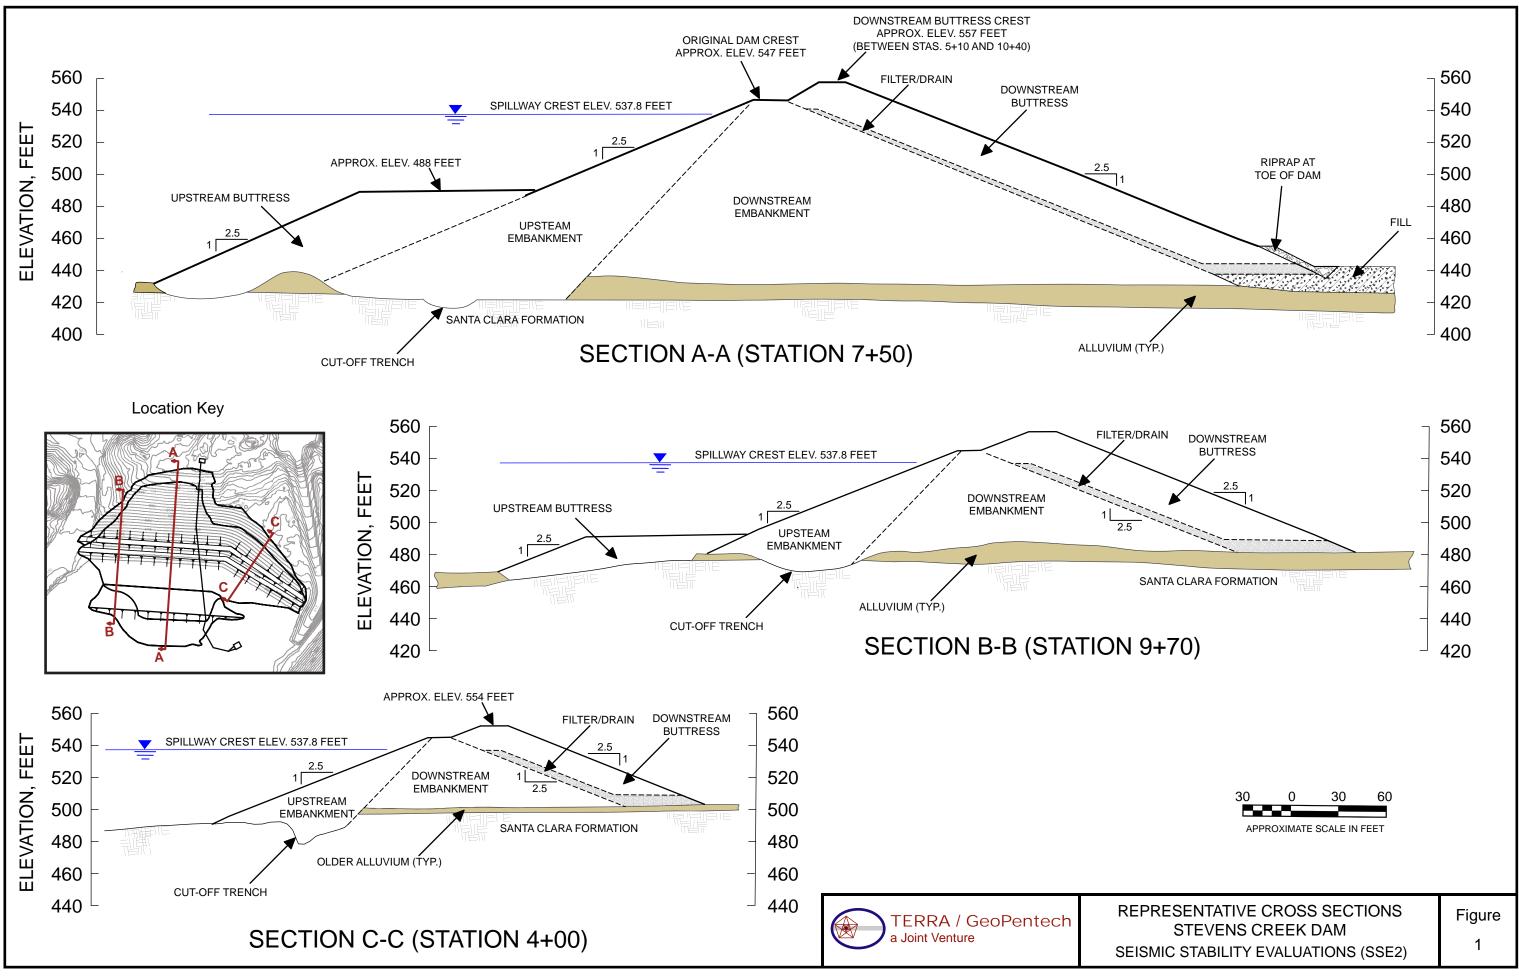
Figure 1 contains representative cross sections through the current configuration of the dam at the maximum section (Station 7+50) and at Stations 9+70 and 4+00 on the left and right sides of the dam, respectively. The locations of the three sections are shown on the insert in the lower portion of the figure. The original dam embankment was designed as a two-zone earthfill dam, with an "impervious" upstream zone and a "pervious" downstream zone. However, subsequent studies indicated that the dam may in fact be more like a homogenous embankment. Thus, the embankment zones are referred to as upstream embankment and downstream embankment. The original embankment has slopes of 2.5 horizontal to 1 vertical (2.5H : 1V) both upstream and downstream. Overburden soils were generally excavated beneath the upstream embankment and a cutoff trench was constructed at about the midpoint of the upstream embankment by excavating into the Santa Clara Formation. The Santa Clara Formation is a poorly indurated conglomerate with lesser interbeds of sandstone, siltstone and claystone - it is essentially a very dense clayey gravel.

Based on the estimated distribution and thickness of soils remaining beneath the embankment, the maximum section of the dam at Station 7+50 (Figure 1) was selected as the analysis section. While the section at Station 9+70 shown on Figure 1 also has some alluvium beneath the upstream and downstream portions of the dam, it was judged to be less critical than that at Station 7+50 because of the relative height of the section and the distribution of the materials.

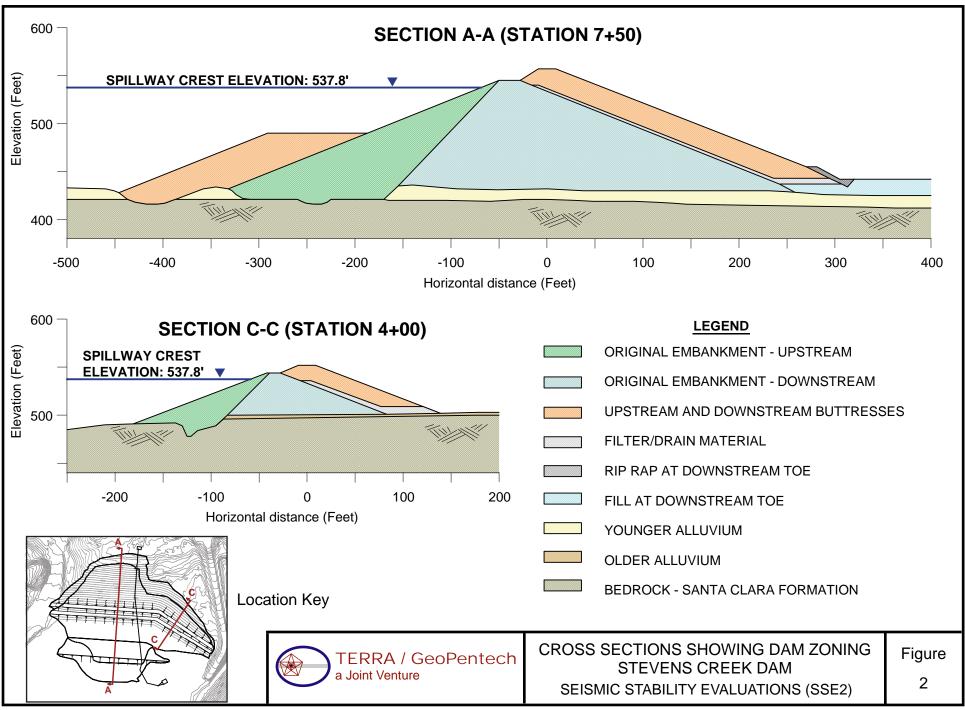
Figure 2 shows the generalized configuration of the dam and its foundation at the maximum section (Section A-A – Station 7+50) and at a section through the right abutment (Section C-C' – Station 4+00). The various material zones identified are: Original Embankment – Upstream and Downstream; Upstream and Downstream Buttresses; Filter/Drain; Rip Rap at Downstream Toe; Fill at Downstream Toe; Alluvium; and Bedrock – Santa Clara Formation. The alluvium is further divided into two zones: Younger Alluvium and Older Alluvium.
