# STEVENS CREEK FISH PASSAGE ANALYSIS

*Prepared for*

Valley Water  
5750 Almaden Expressway  
San Jose, CA 95118

June 2020

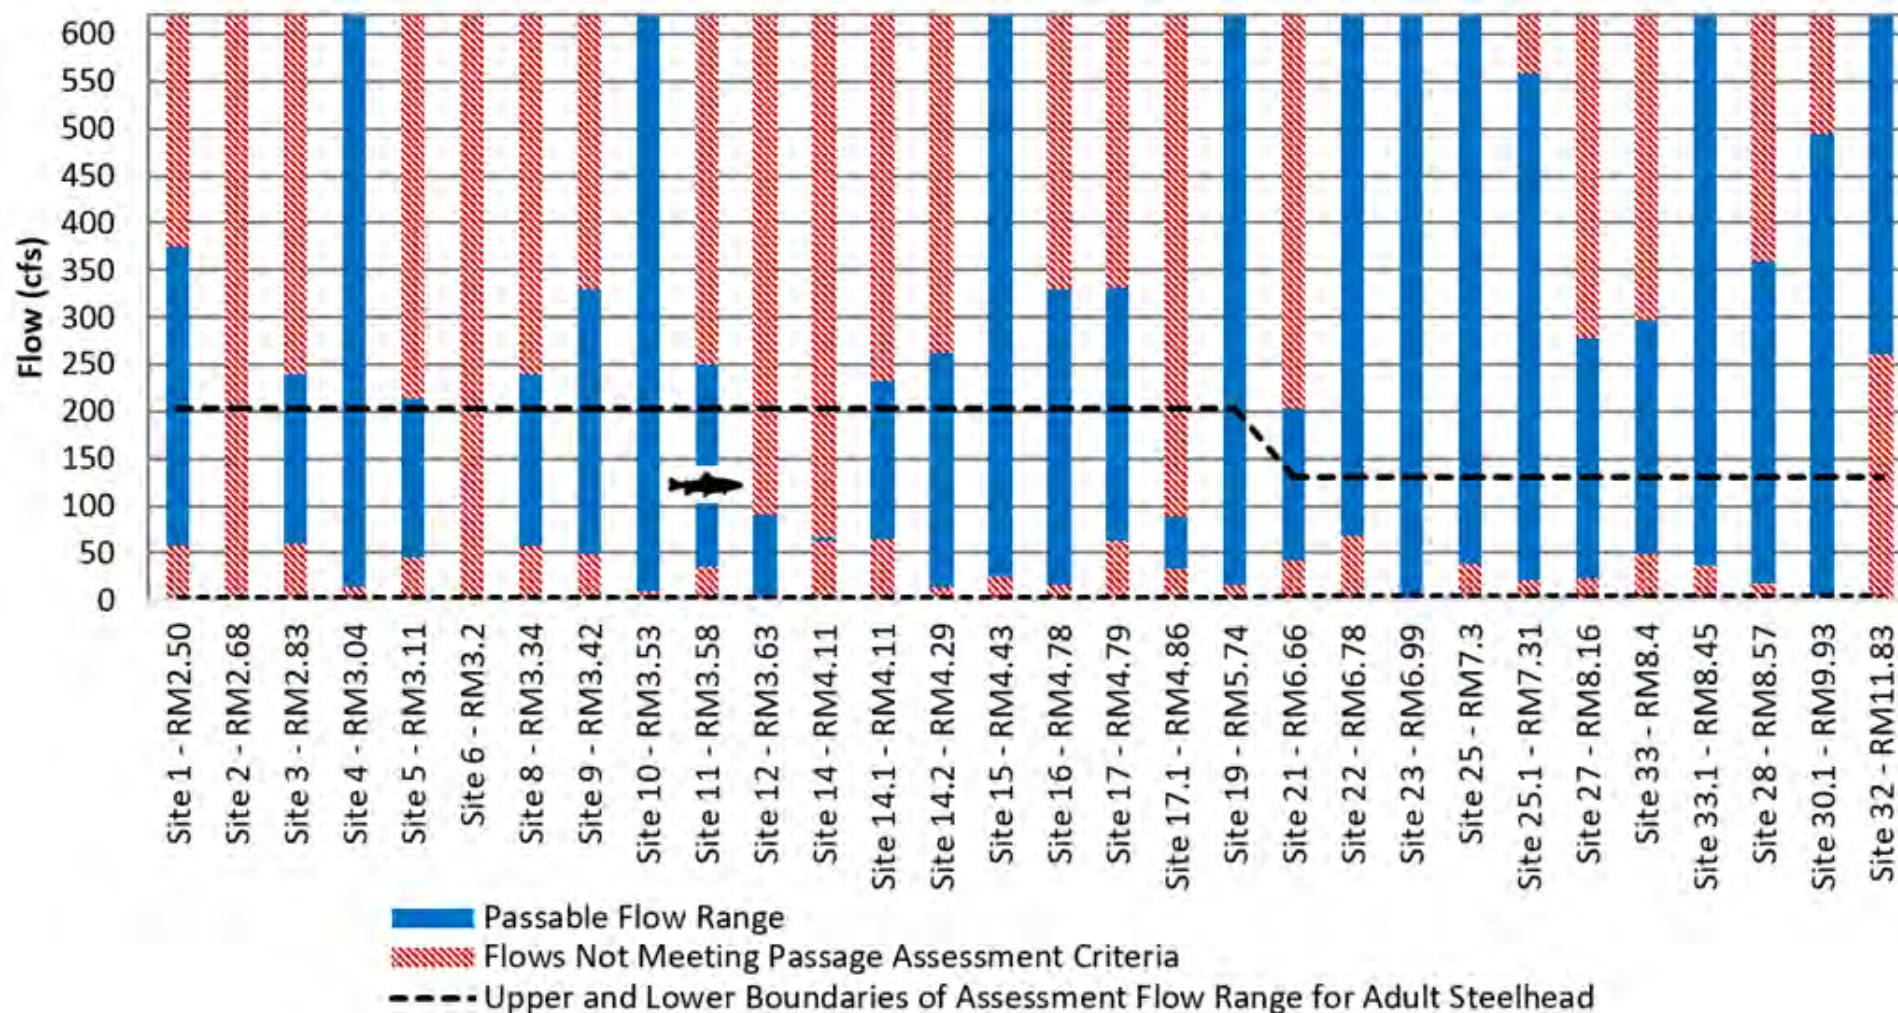
Figure 3. Flows Meeting Passage Assessment Criteria for Adult Steelhead at Each Assessment Site, from Zero to 619 cfs

Note: Sites are arranged from downstream to upstream, with the river mile (RM) indicated. The low and high fish passage assessment flows shown with horizontal dashed lines are 3 cfs and 203 cfs for sites 1 through 19 and 5 cfs and 130 cfs for sites 20 through 32.

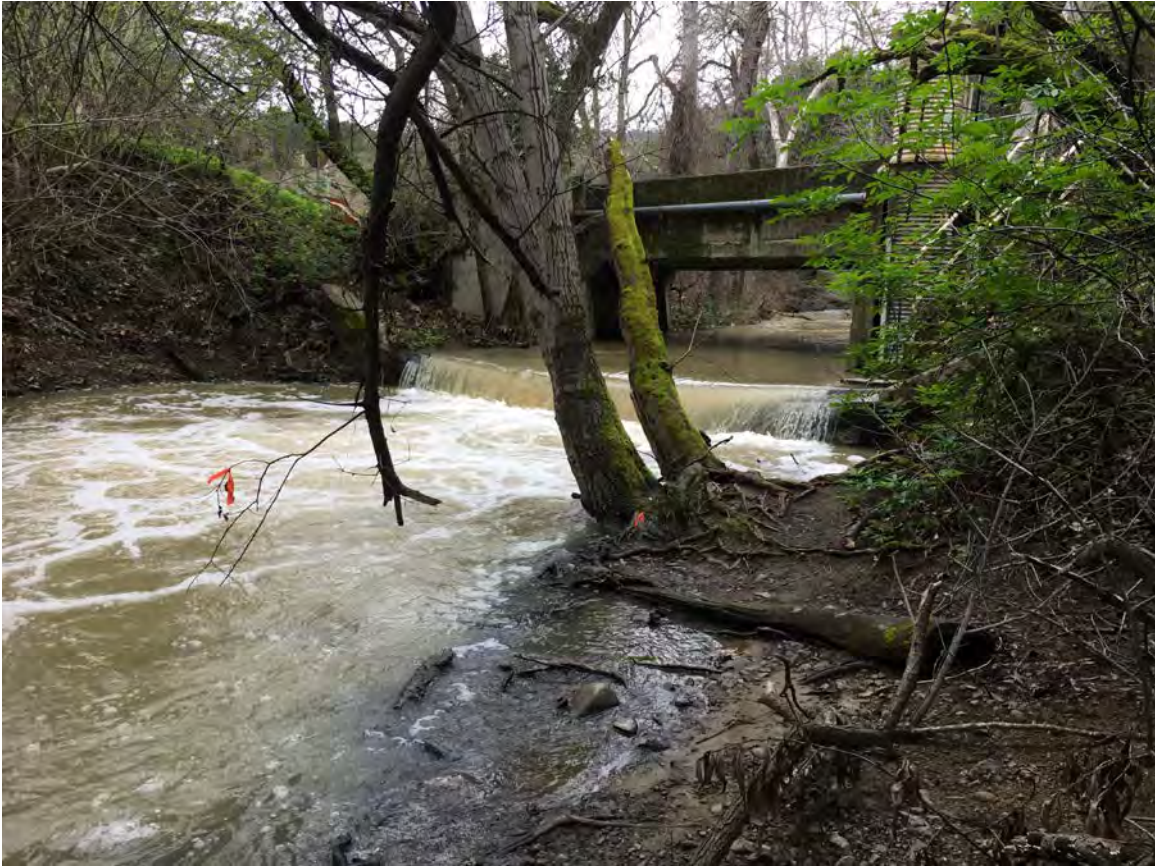
No new potential fish passage impediments were noted. The gauging weir at Stevens Creek Park (44), a previously identified potential impediment, is still present and was confirmed as a potential impediment (see photograph 1).

Photograph 1: Potential fish passage impediment at gauge weir at Stevens Creek Park

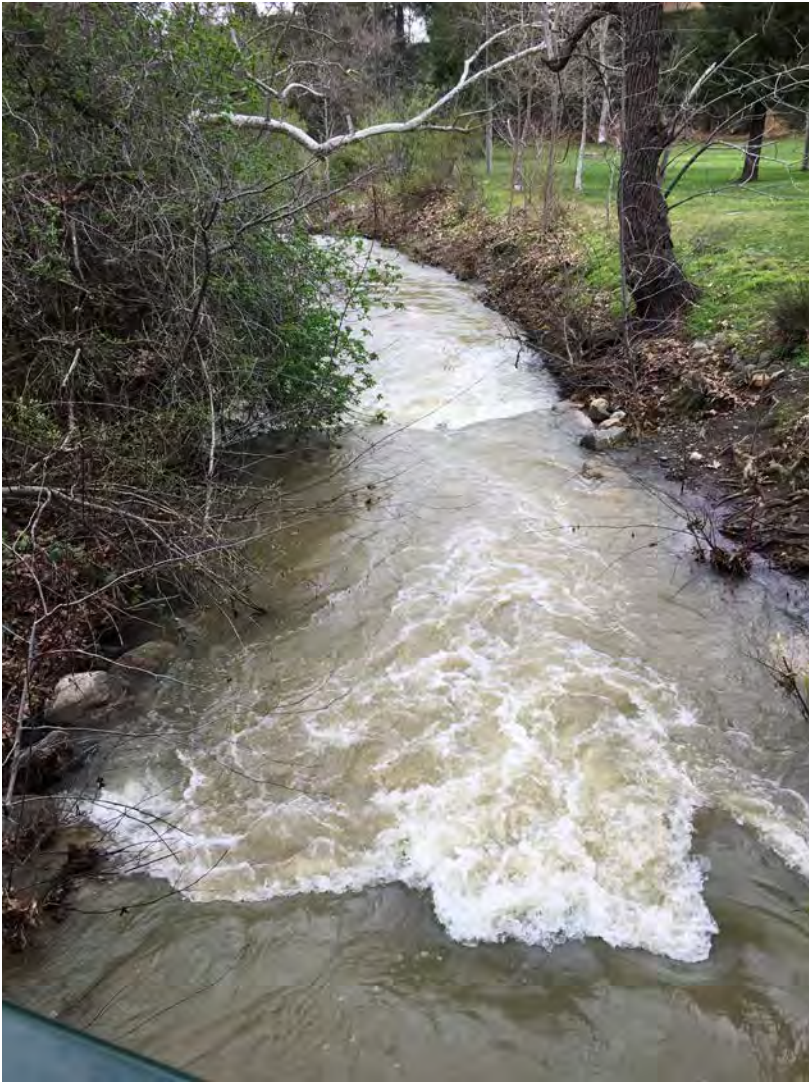
One potential fish passage impediment was noted. Water clarity (i.e. turbidity) made viewing the stream bed during the reconnaissance survey challenging therefore, it was difficult to ascertain what type of structure (i.e. concrete weir, bridge footings) was creating the turbulent condition noted in Photograph 2. The potential passage impediment is located directly downstream of a pedestrian bridge crossing on the creek and therefore it was presumed to be infrastructure related to the bridge crossing. The spatial coordinates for this suspected barrier are as follows; latitude 37.32, longitude -122.06.

Photograph 2. Potential fish passage impediment downstream of footbridge.

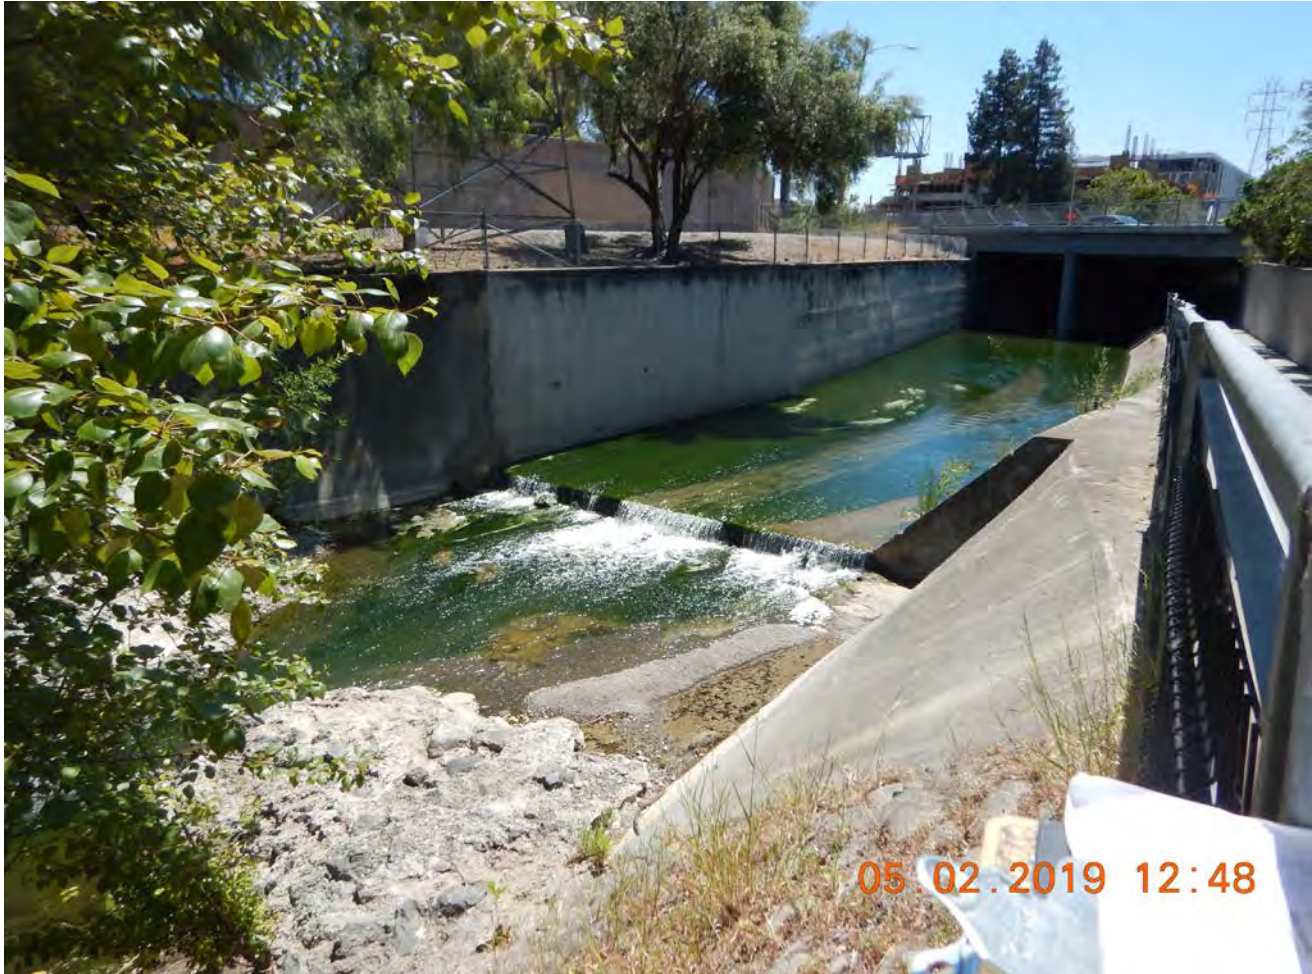
**Results:** Two previously recorded potential fish passage impediments were confirmed in Study Area 6: Highway 101 culvert (see Photograph 3) and chute and the grade control structure at Vernon Avenue (see Photograph 4). No other potential fish passage impediments were noted in Study Area 6.

Photograph 3: Highway 101 culvert and chute

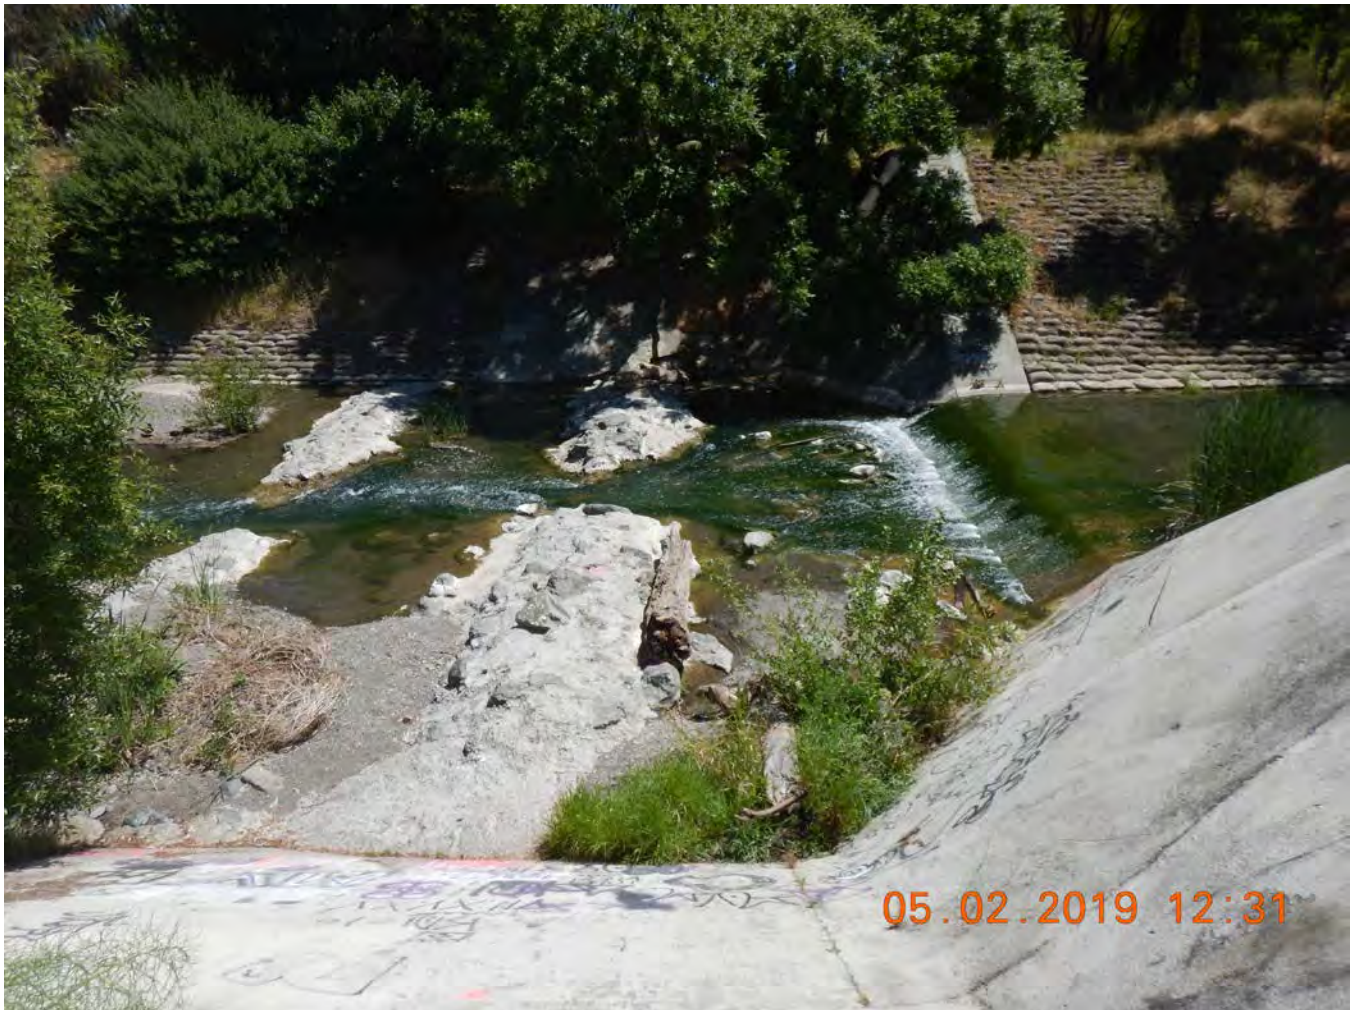
Photograph 4: Grade control structure at Vernon Avenue

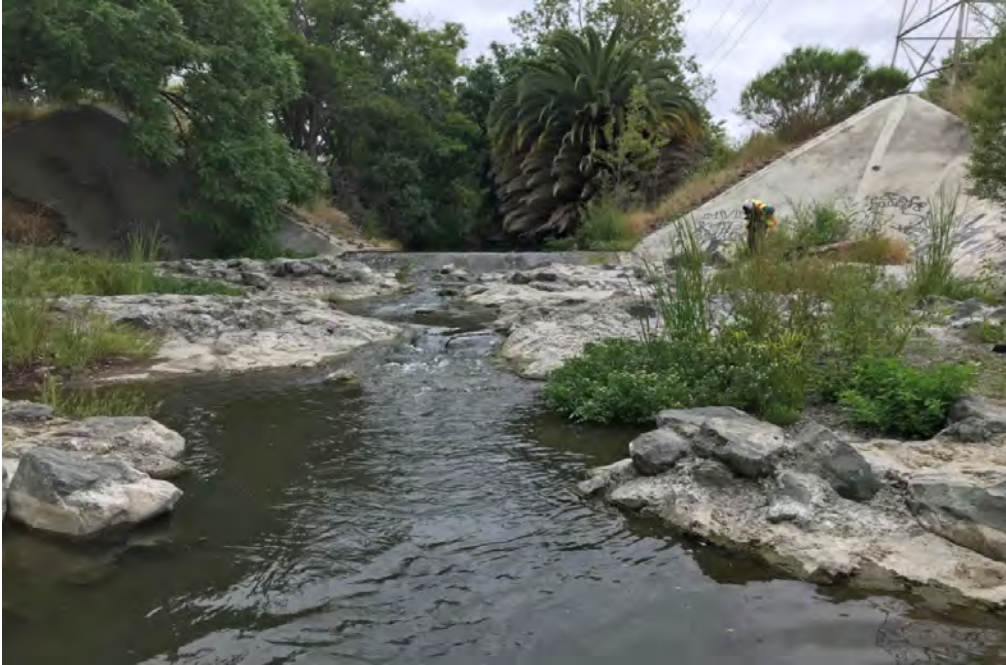
**View from downstream looking upstream at grouted rock veins and concrete drop structure**

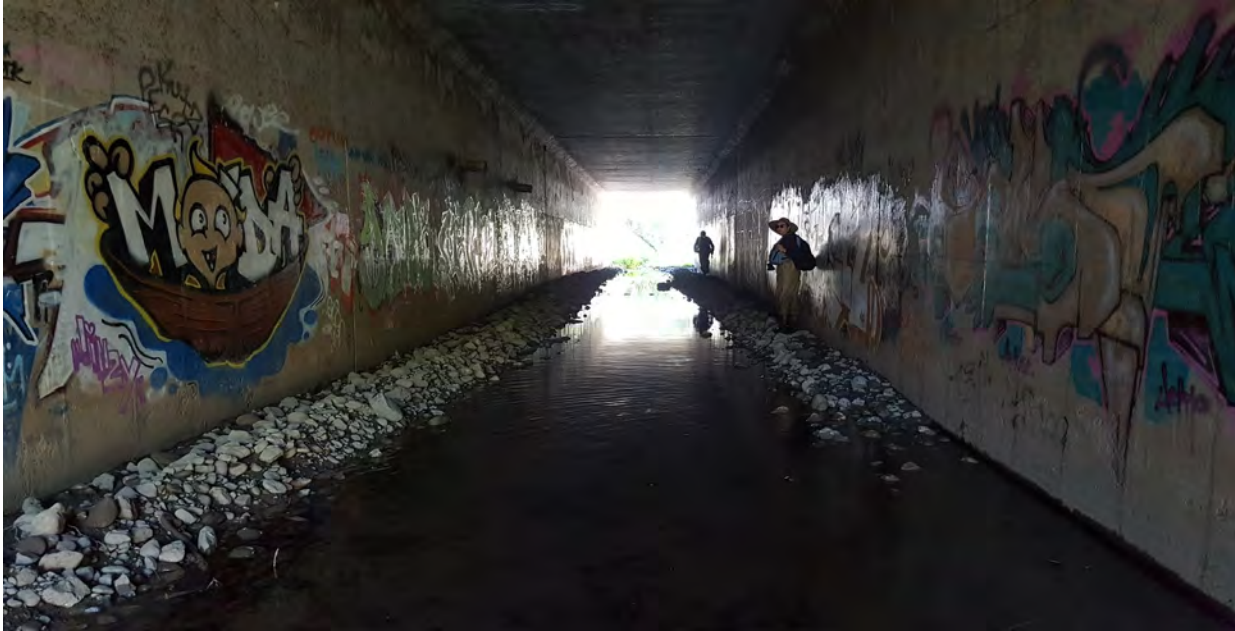
**Culvert 1: Primary passage culvert, looking downstream. Note low-flow channel shape provides suitable depth.**

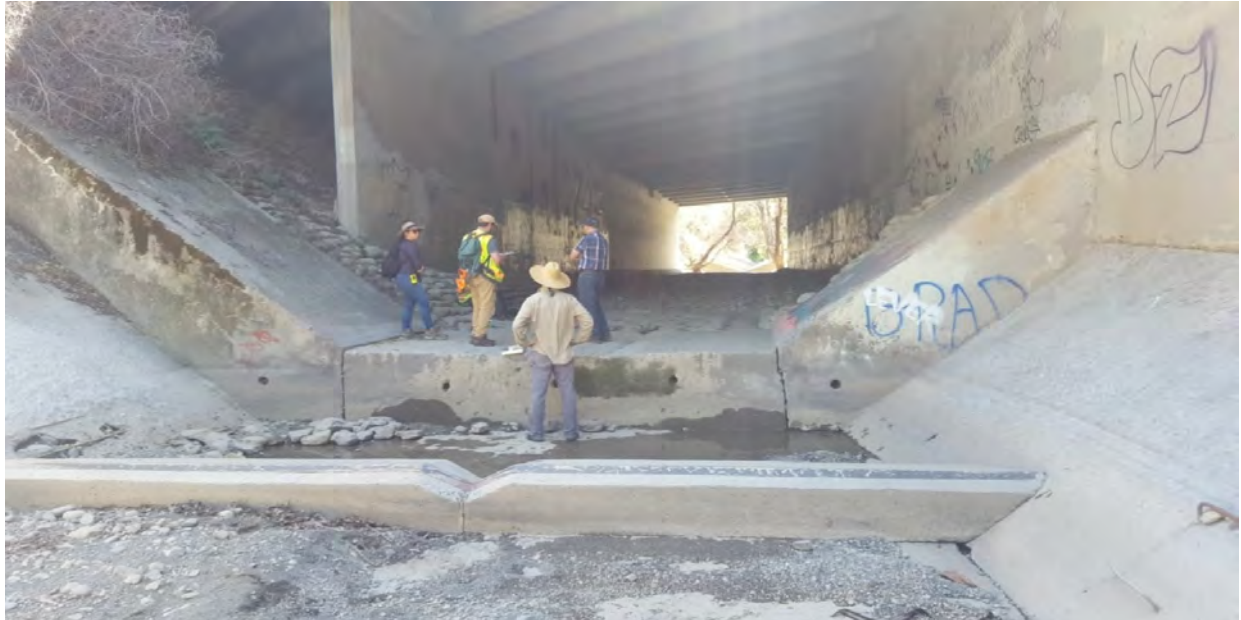
**Looking upstream to drop structure and bridge, with v-weir in foreground**

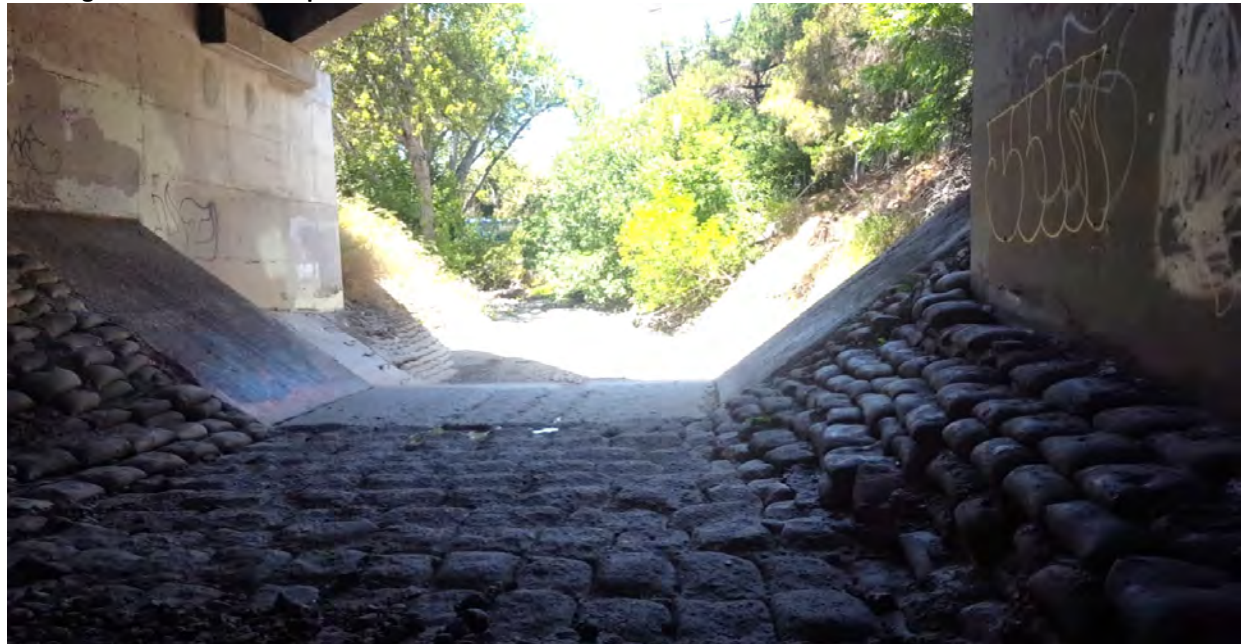
**Looking downstream to drop structure from within culvert with sacrete invert**

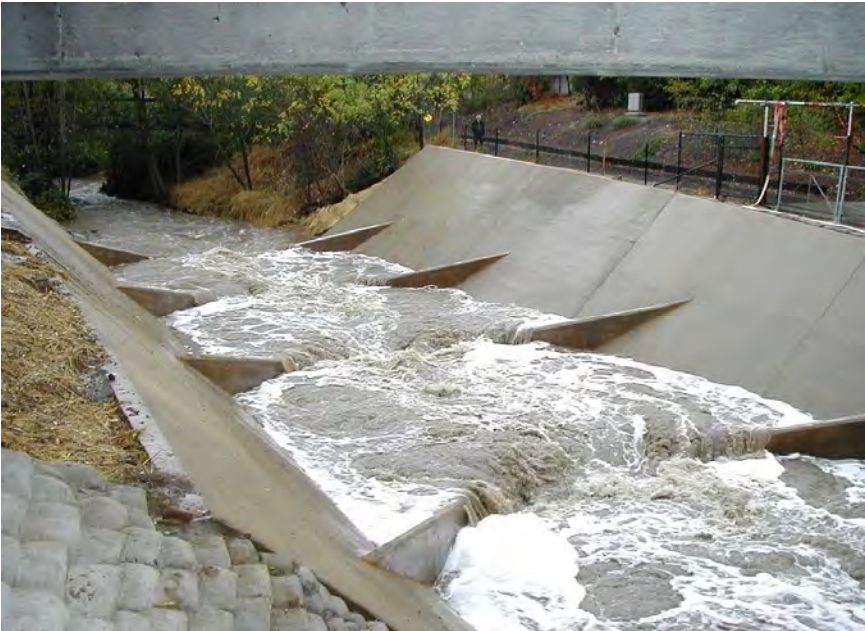
Looking upstream at fishway with entrance weir in foreground, and water surface drops increasing from upstream to downstream as a result of the low tailwater

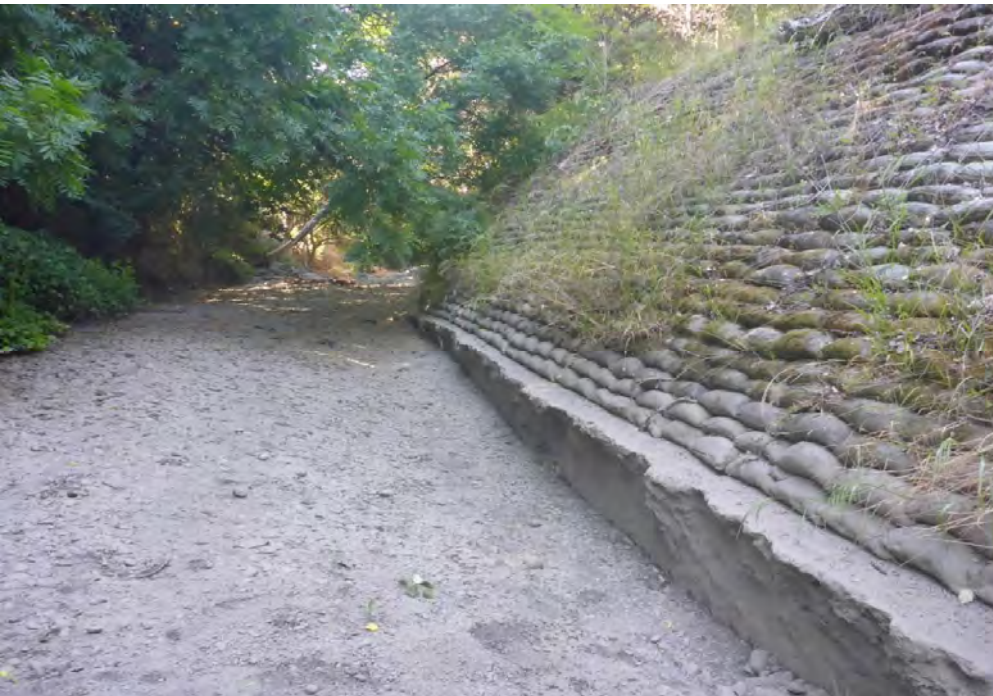
Right bank sacrete revetment with undermined toe, looking downstream from grouted boulders

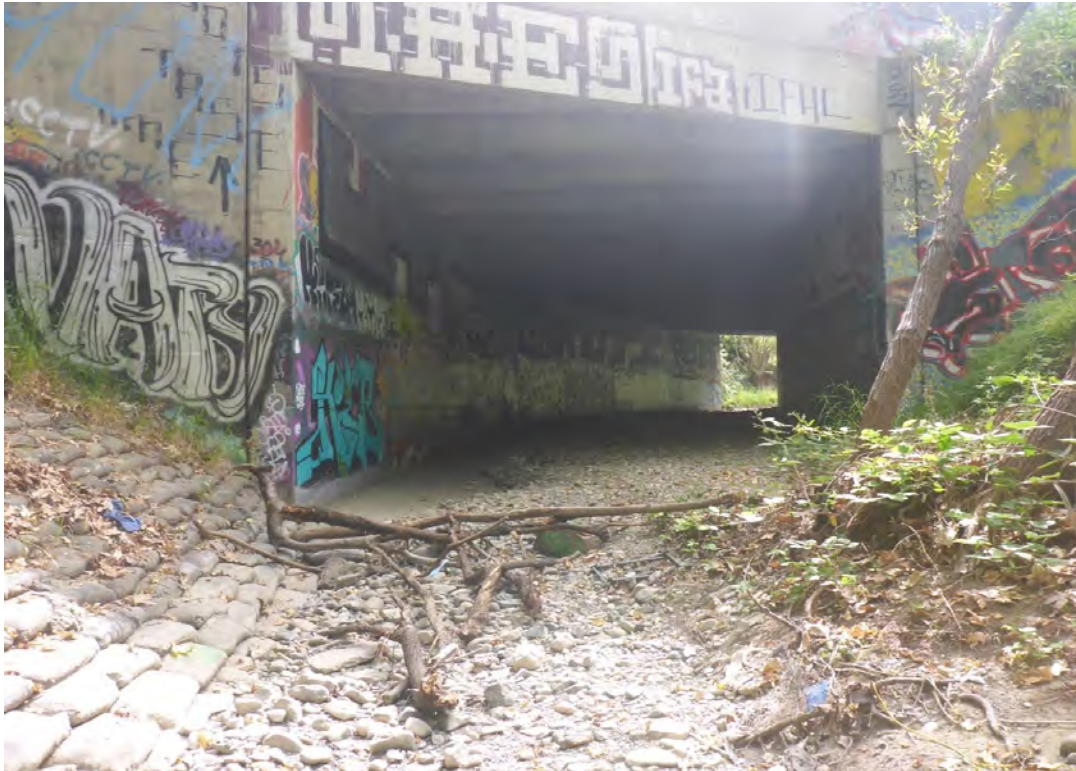
**Culvert outlet, looking upstream with some concrete exposure on outside of bend**

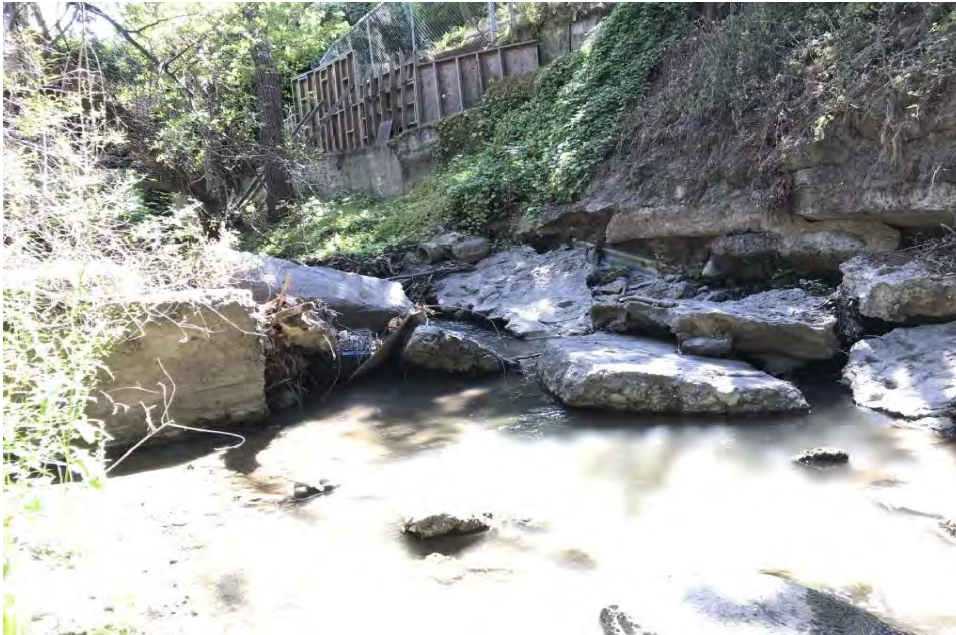
**Looking upstream at concrete rubble across channel located downstream of the crossing**
