Upper Llagas Creek Flood Protection Project Site Characterization Report

Site Characterization Report

June 2012

Cardno ENTRIX
2300 Clayton Road, Suite 200, Concord, CA 94520
Tel 925 935 9920 Fax 925 935 5368 Toll-free 800 368 7511
www.cardnoentrix.com

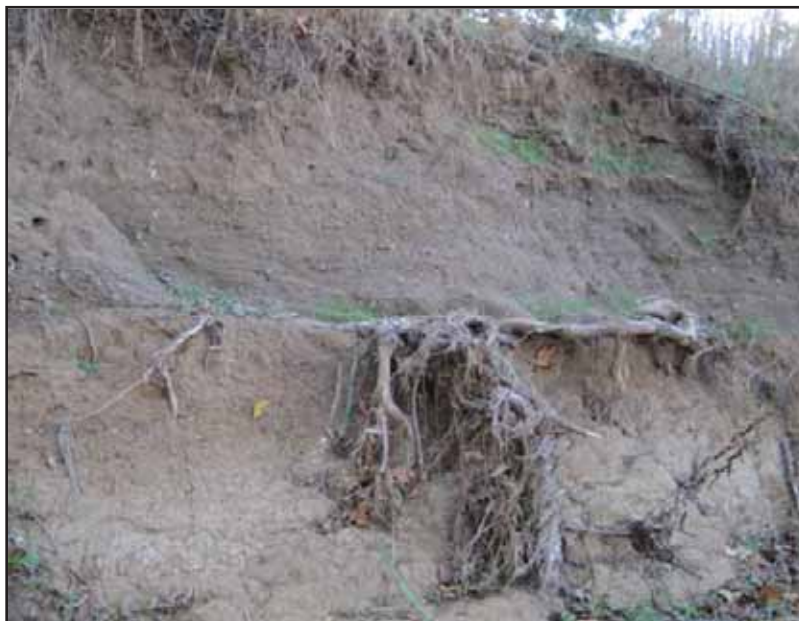
As previously mentioned, a gravelly, moderately cemented substratum and a finely textured lacustrine-deltaic deposit were observed (See Appendix D - Figures 4 and 23). When encountered as shallow contacts, these two subjacent geological units impose a strong influence on soil quality and mitigation suitability.

Both types of substratum were observed in sections of Reaches 4, 6 and 7a. Both types of substratum were observed to directly prevent the downward growth of roots, causing them to bend at 90 degrees at the point of contact (See Appendix D - Figures 4 and 23).

Figure 4: Stratigraphic column portraying a gravelly, massive substratum between Soil Profile Description and Sampling Locations 1.1 and 2.1 in Reach 4. Notice the abrupt textural (color) change associated with the contact boundary between the different depositional units. The subjacent densic unit prevents downward root penetration.

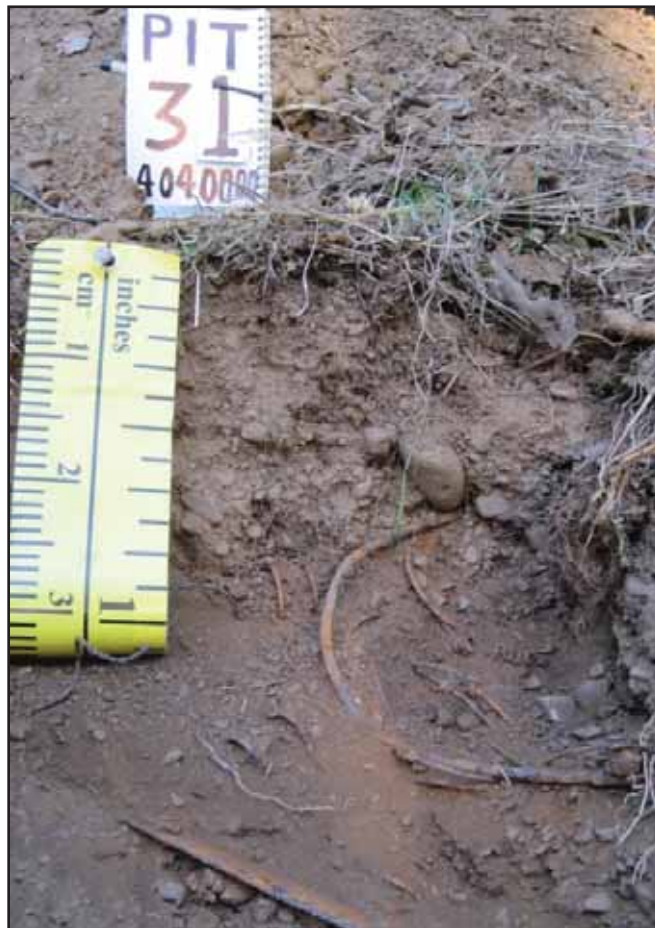
Figure 8: Soil Profile Description Location 3.1 in Reach 4 - A picture depicting the soil profile being comprised of manmade fill and debris, This soil classified as a Loamy-skeletal, mixed, thermic Typic Xerofluvent (Man-Modified).
(The soil profile was positioned on a mid-terrace flank located on the left side of the creek, looking downstream)

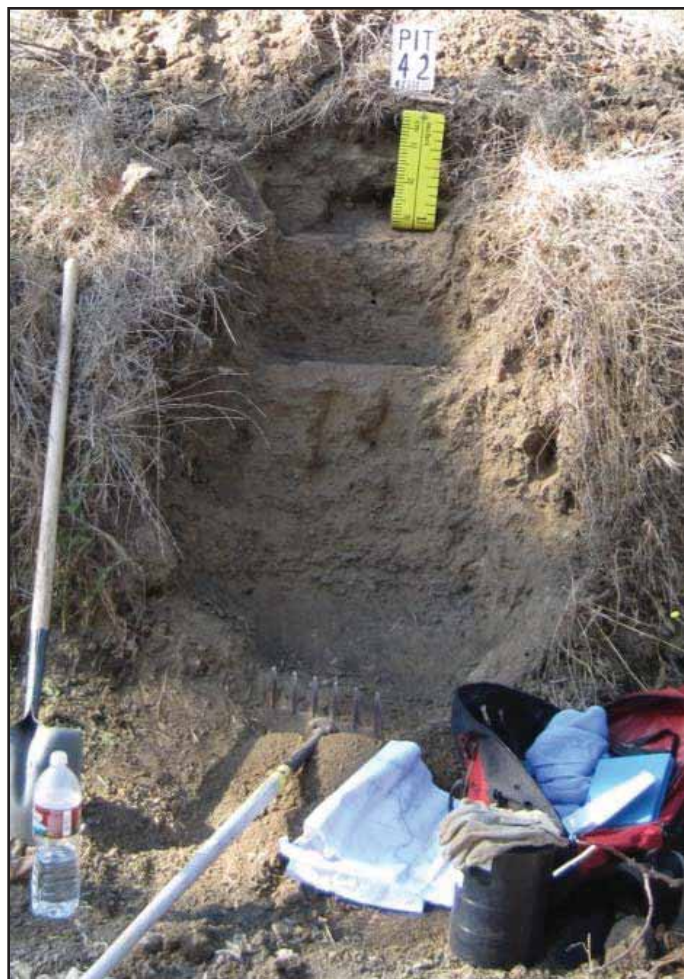
Figure 14: Soil Profile Description Location 4.2 in Reach 4 - A picture depicting the soil profile of a Coarse-loamy, mixed, thermic Typic Haploxeralf. The soil profile was positioned to examine the material that forms the terrace embankment down to the bottom of the channel invert. The profile was located on the right side of the creek, looking downstream.

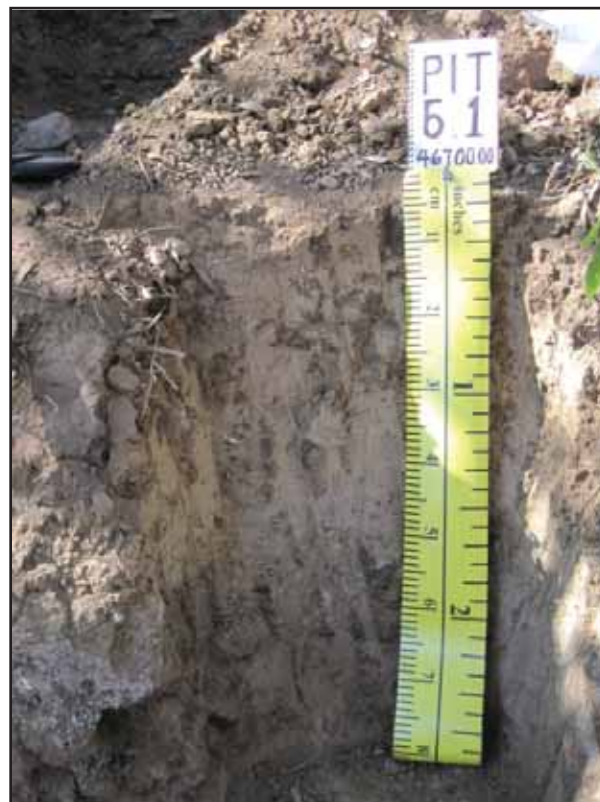
Figure 18: Soil Profile Description Location 6.1 in Reach 4. - A picture depicting the soil profile of a Coarse-loamy, mixed, thermic Typic Xerorthent.
The soil profile was positioned to examine the material that forms the terrace embankment down to the bottom of the channel invert. This soil profile was located on the right side of the creek, looking downstream.

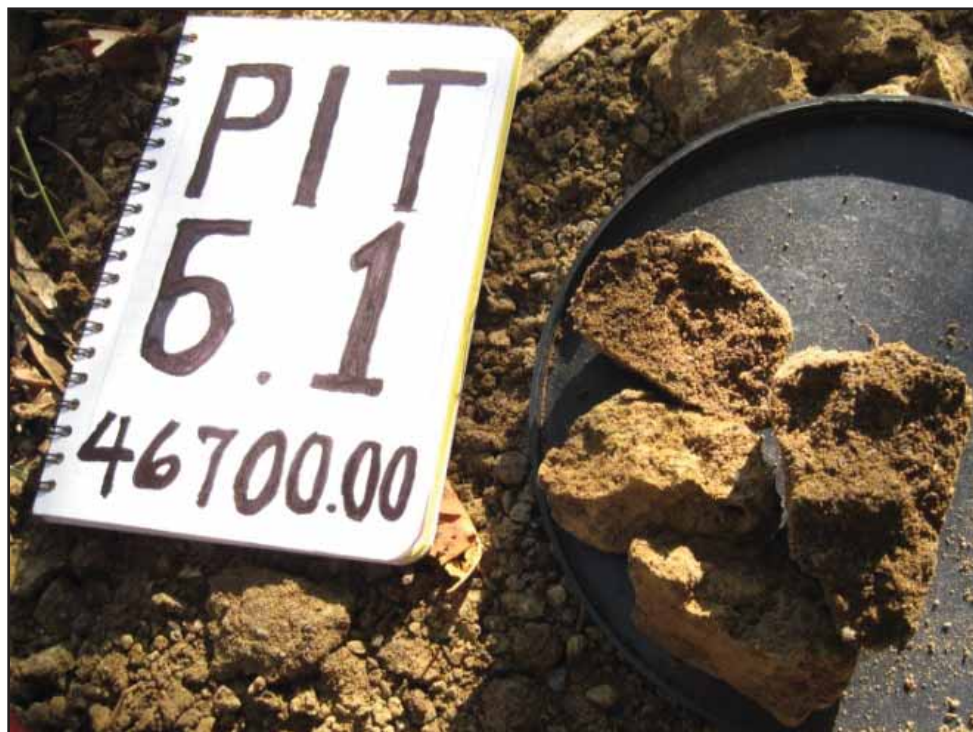
Figure 20: Soil Profile Description and Sampling Location 6.1 in Reach 4 - A picture depicting the medium to coarse subangular blocky structure and the interior ped face color. The soil was sampled from the top 20 inches of a profile that forms the right terrace embankment

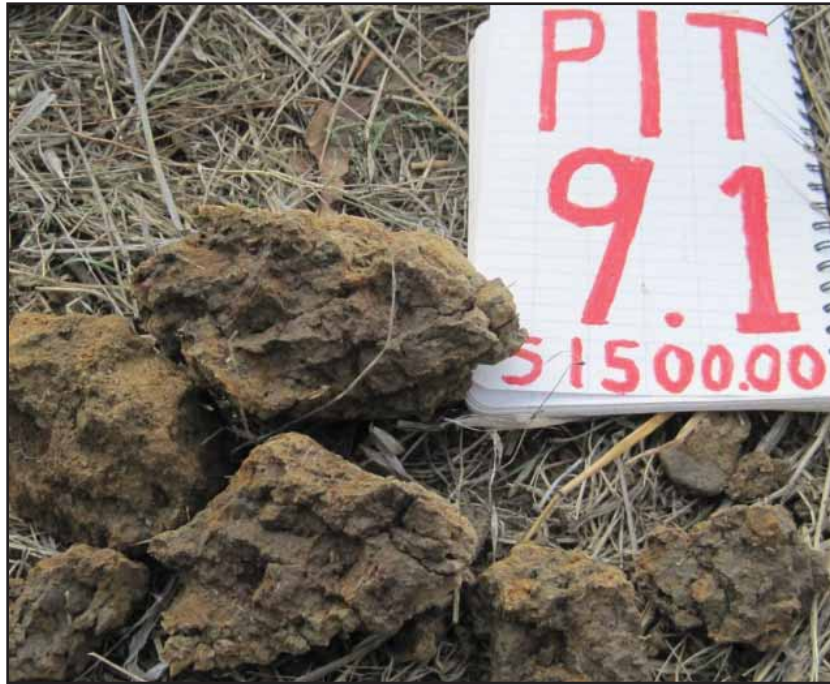
Figure 27: Soil Profile Description and Sampling Location 9.1 in Reach 4 - A picture portraying the medium to coarse subangular blocky structure. Note the interior ped face color illustrating Fe^{++} reduced matrix and redoximorphic features. The soil sample was retrieved from 35 inches below the ground surface, which was one foot above the channel invert. The profile was located on left lower terrace flank of the creek, looking downstream.

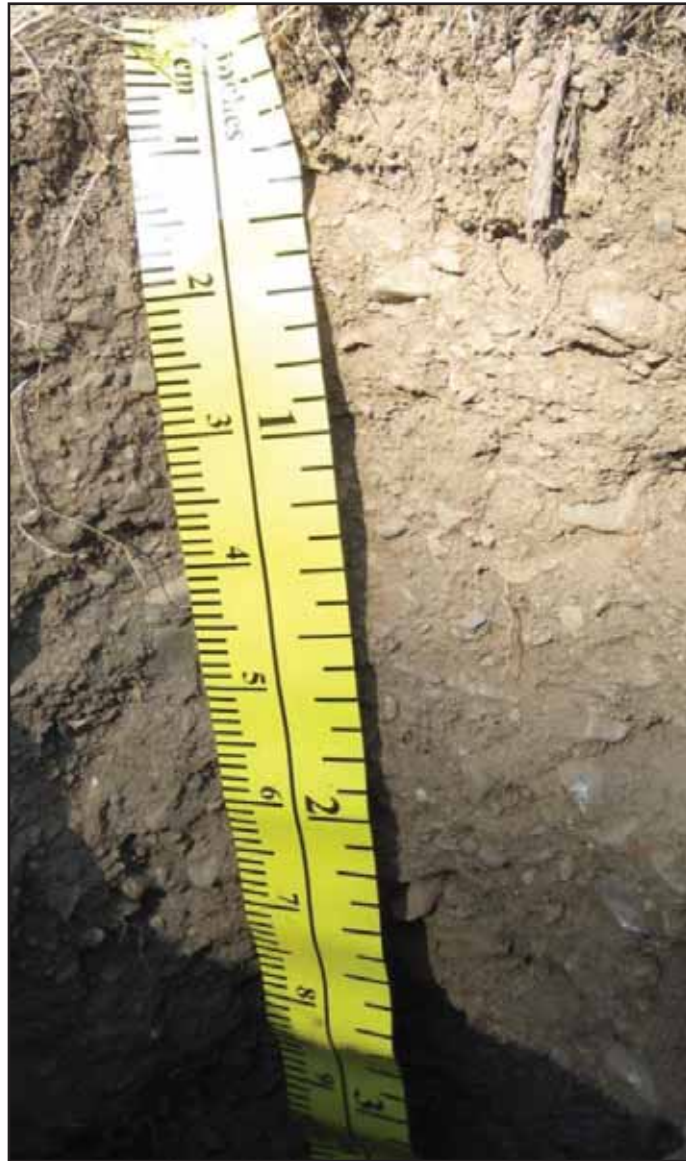
Figure 29: Soil Profile Description Location 10.1 in Reach 5 - A picture depicting the top soil profile of a Loamy-skeletal, mixed, thermic Typic Xerorthent. The soil profile was positioned on a mid-terrace flank located on the left side of the creek, looking downstream.

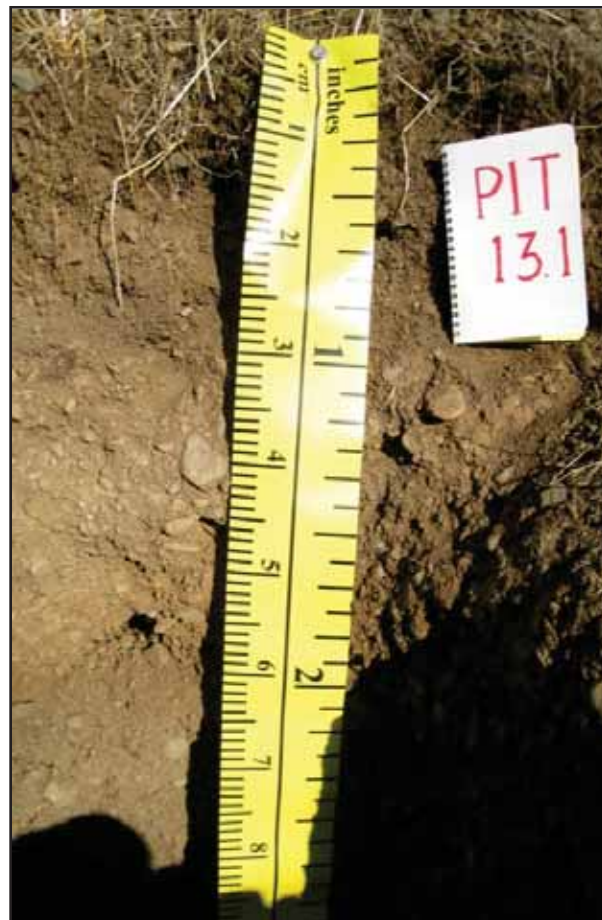
Figure 34: Soil Profile Description Location 13.1 in Reach 6b - A picture depicting the soil profile of a Loamy-skeletal, mixed, thermic Typic Xerorthent. The soil profile was positioned on a mid-terrace flank located on the left side of the creek, looking downstream.

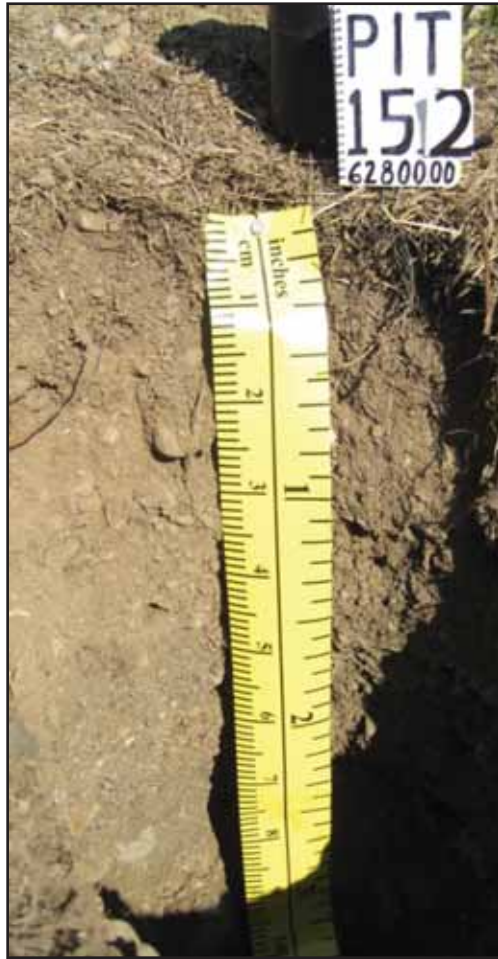
Figure 43: Soil Profile Description Location 15.2 in Reach 6b - A picture depicting the soil profile of a Loamy-skeletal, mixed, thermic Typic Xerorthent. The soil profile was positioned on the right side of the creek, looking downstream.

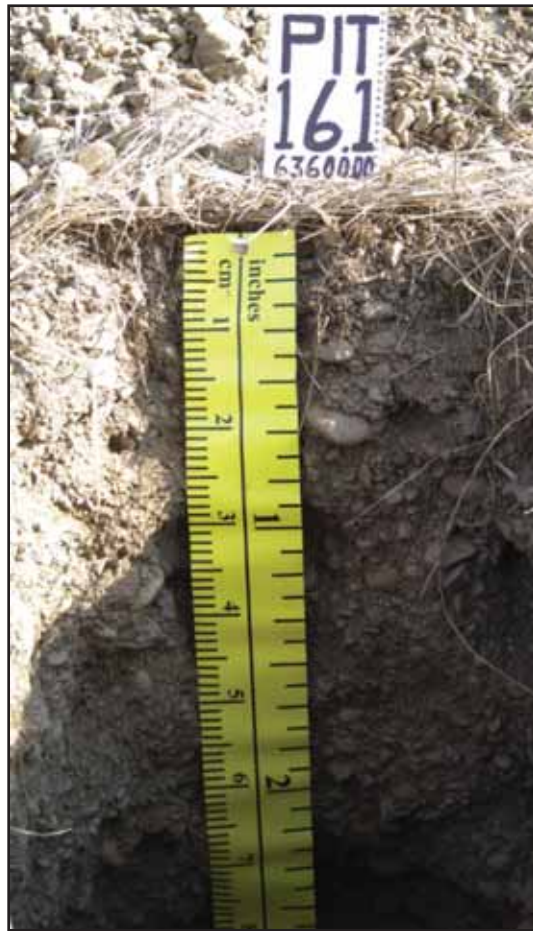
Figure 45: Soil Profile Description Location 16.1 in Reach 6b - A picture depicting the upper part of the soil profile of a Loamy-skeletal, mixed, Typic Xerofluvent. The soil profile was positioned on a mid-terrace flank located on the left side of the creek, looking downstream.

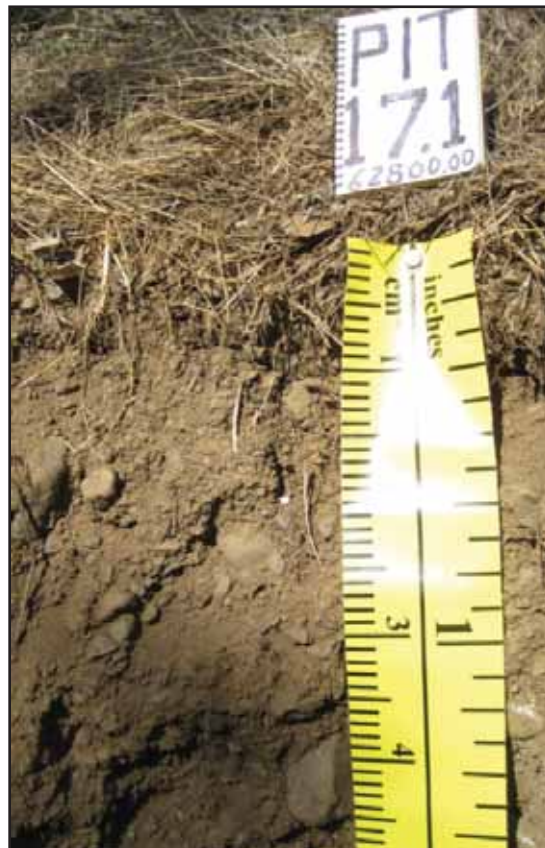
Figure 48: Soil Profile Description Location 17.1 in Reach 6b - A picture depicting the upper part of the soil profile of a Loamy-skeletal, mixed, thermic
Typic Xerorthent. The soil profile was positioned on a mid-terrace flank located on the left side of the creek, looking
downstream.

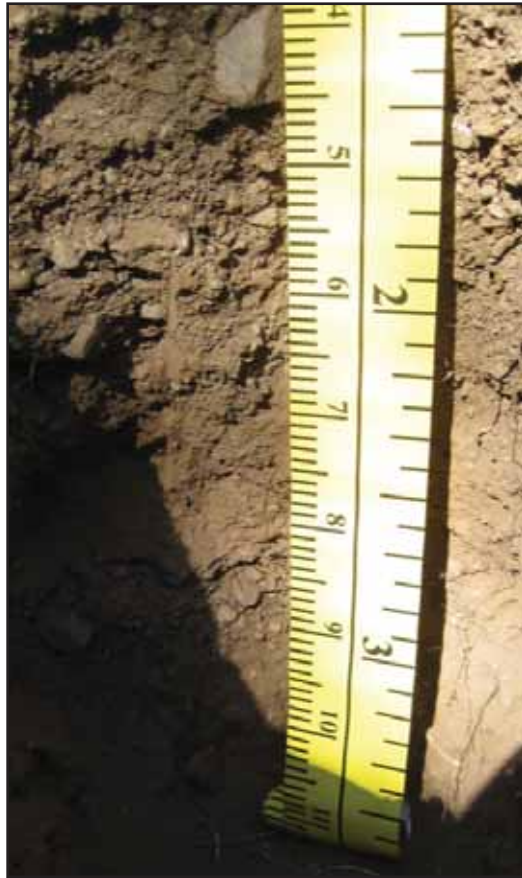
Figure 49: Soil Profile Description Location 17.1 in Reach 6b - A picture depicting the lower part of the soil profile of a Loamy-skeletal, mixed, thermic Typic Xerorthent. The soil profile was positioned on a mid-terrace flank located on the left side of the creek, looking downstream.

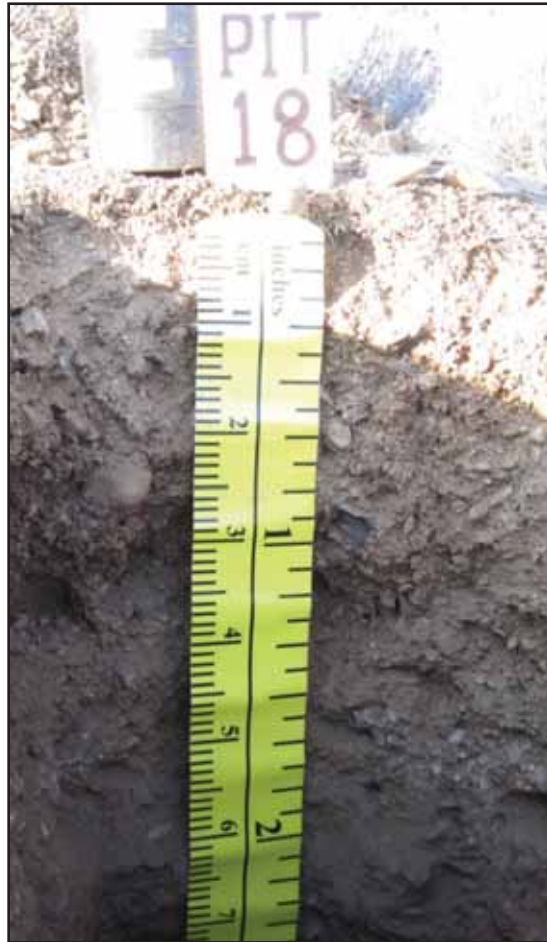
Figure 51: Soil Profile Description Location 18.1 in Reach 6a - A picture depicting the upper part of the soil profile of a Loamy-skeletal, mixed, thermic Typic Xerorthent. The soil profile was positioned on the east side of the county parcel (County Bowtie Property).

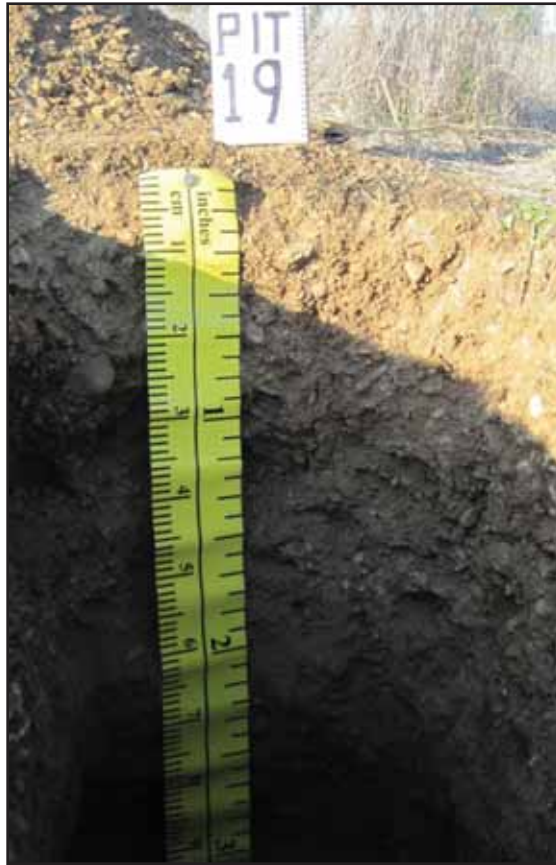
Figure 55: Soil Profile Description Location 19.1 in Reach 6a - A picture depicting the upper soil profile of a Loamy-skeletal, mixed, thermic Typic Xerorthent. The soil profile was positioned on the south central part of the county parcel (aka the Bowtie property).

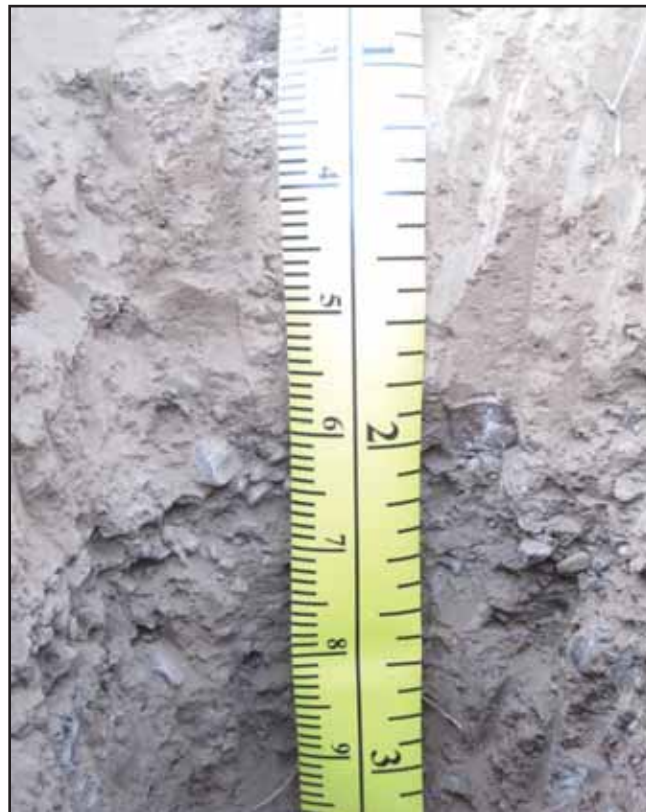
Figure 62: Soil Profile Description Location 22.1 in Reach 7a - A picture of the lower part of the soil profile depicting a Fine-loamy, mixed, thermic
Typic Haploxeralf.
