SANTA CLARA VALLEY WATER DISTRICT

Rancho Cañada de Pala Preserve Areas 1 & 2 Long-term Management Plan

SANTA CLARA VALLEY WATER DISTRICT
5750 Almaden Expressway
San Jose, CA 95118
March 2016

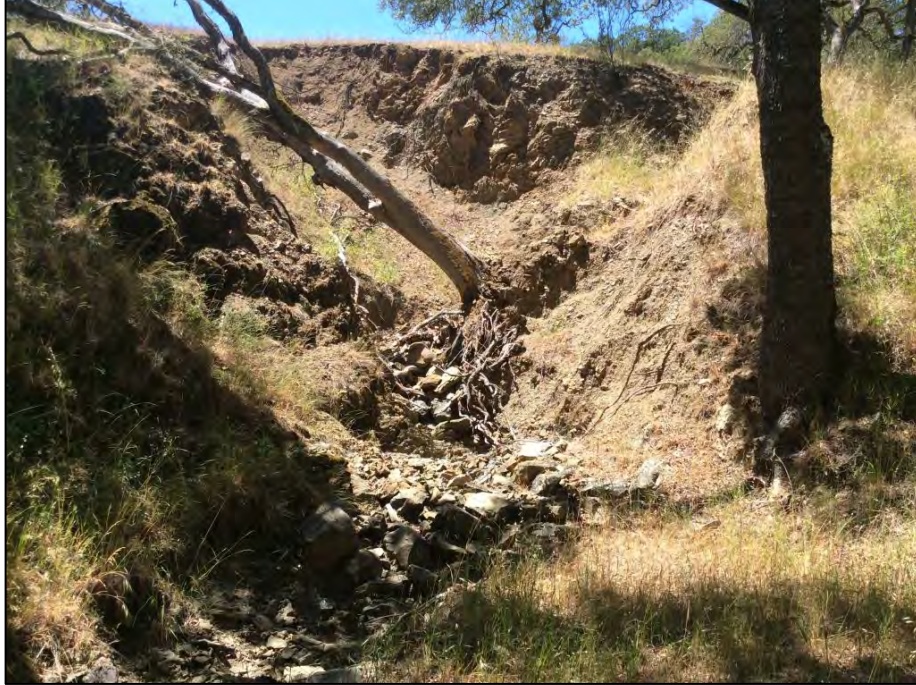
Photo 1. A large gully near stream crossing SC1, downstream of the road.

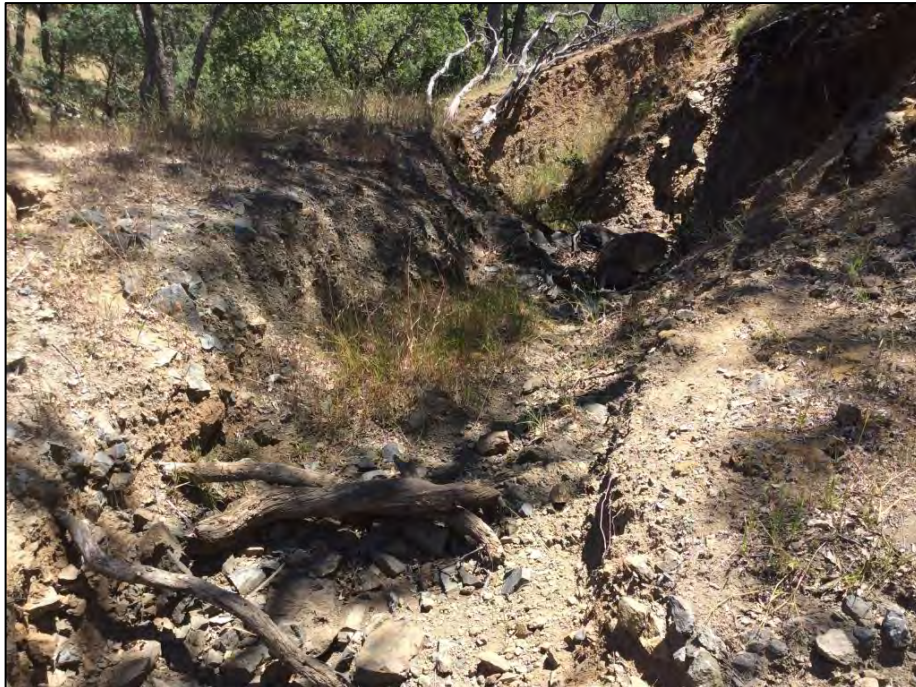
Photo 2. The upslope (top) end of the gully at SC1. The photo of the ephemeral drainage was taken facing downstream.

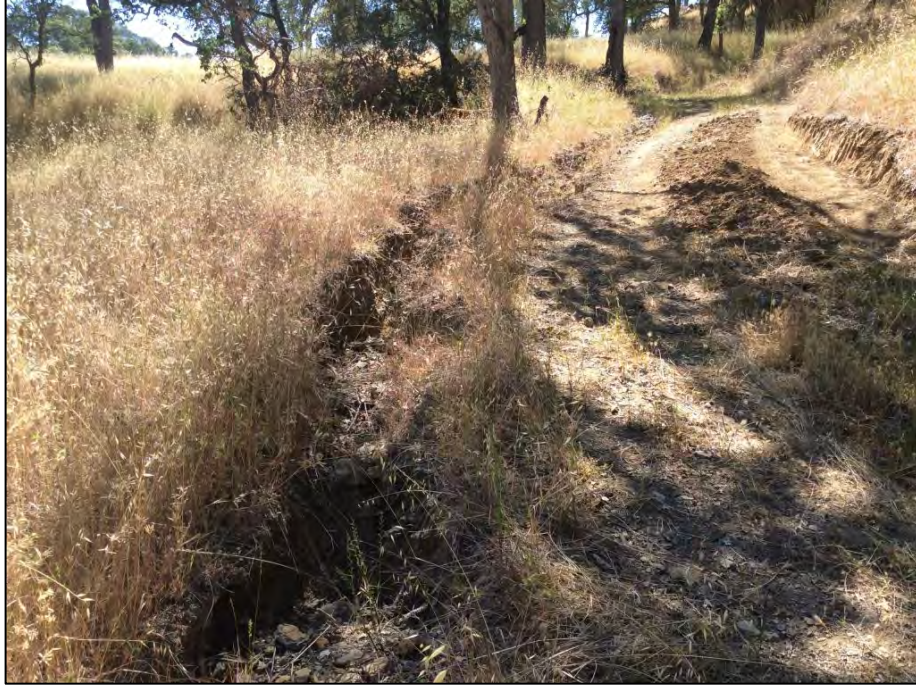
Photo 3. The upslope (top) end of the gully on the downstream side of SC2.

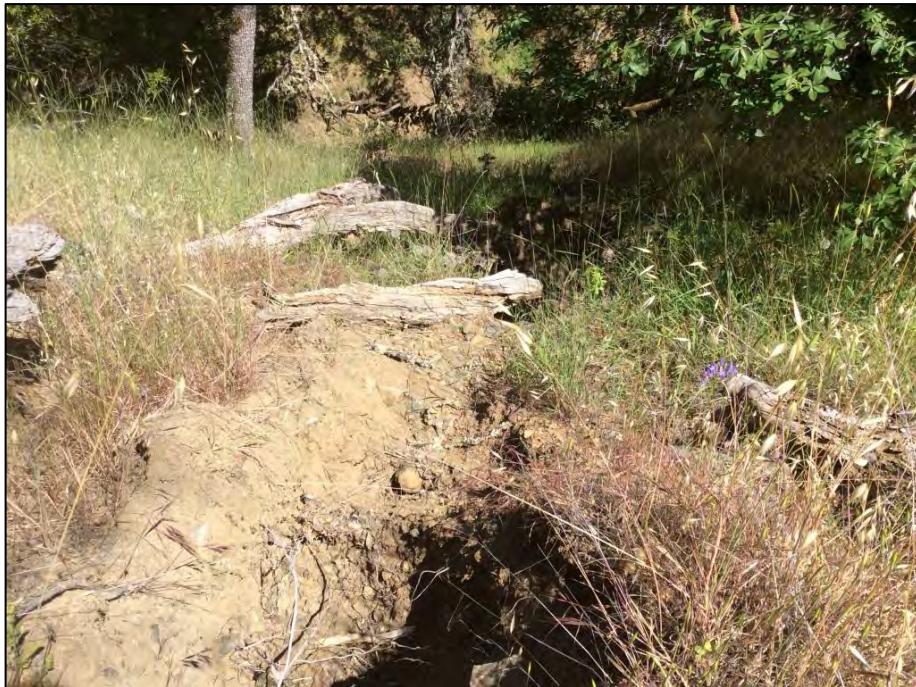
Photo 4. Photo of gully at SC2 taken from the road, facing downstream.

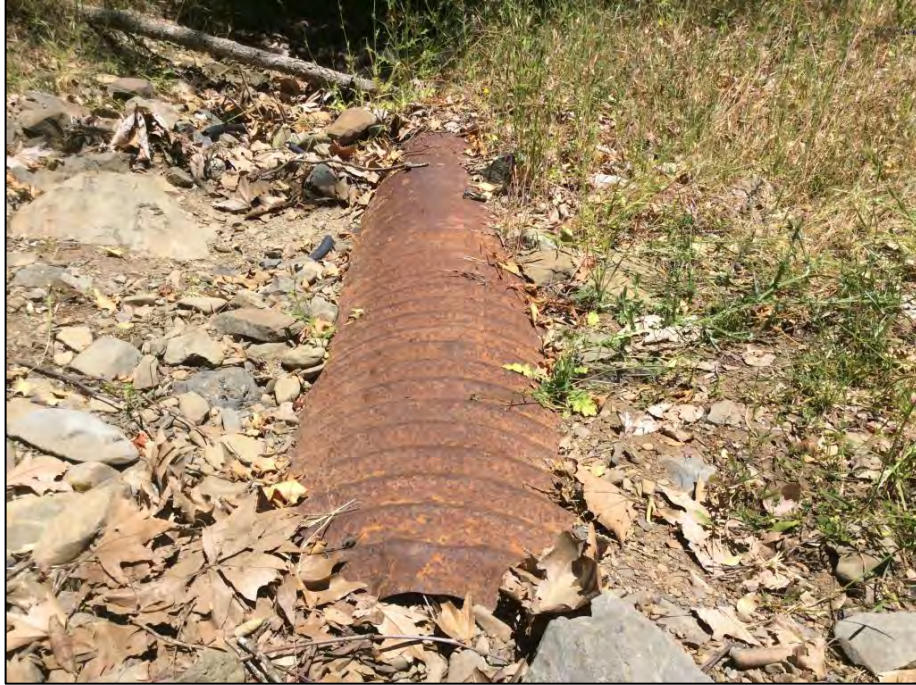
Photo 5. Nonfunctional culvert at SC3.

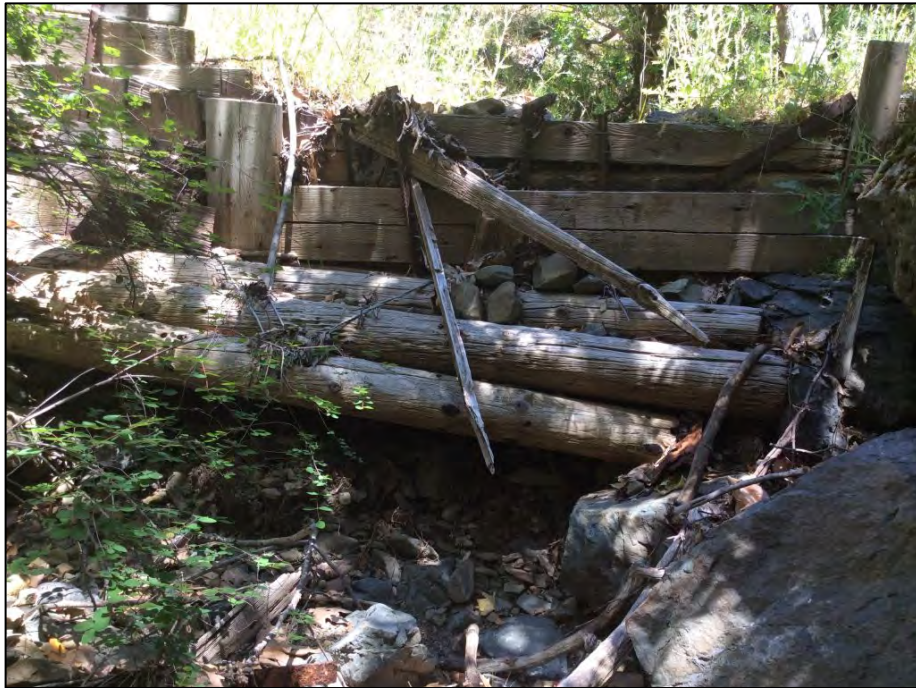
Photo 6. A wooden retaining wall stabilizing the downstream side of SC3.

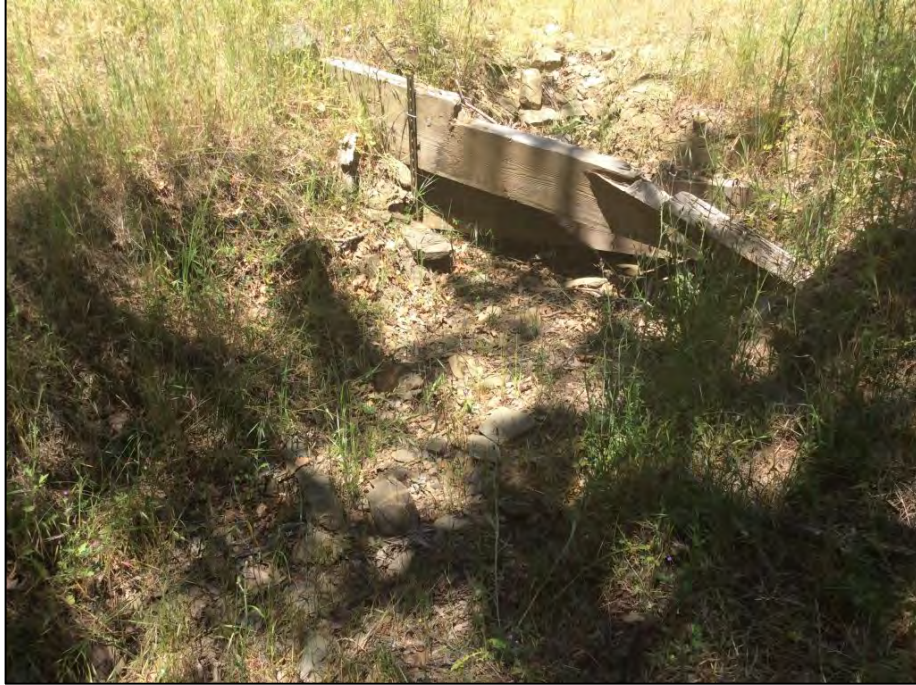
Photo 7. The road crossing over an intermittent section of Upper Penitencia Creek at SC6 that was dry at the time of the May and June field surveys. A small wooden retaining wall stabilizes the downstream side of the road.

SC 6	The road crosses over Upper Penitencia Creek. A small wooden retaining wall stabilizes the downstream side of the roadway, and has some visible (minor) damage from erosion (Photo 7, Appendix B).
SC 7	No infrastructure and/or erosional features are present.
SC 8	No infrastructure and/or erosional features are present.
SC 9	The road crosses over a seasonal wetland/seep at the headwaters of an ephemeral drainage. A culvert passes under the road (Photo 8, Appendix B).
SC 10	The road crosses over a seasonal wetland just upstream of Pond 7. A culvert passes under the road (Photo 9, Appendix B).
SC 11	No infrastructure and/or erosional features are present.
SC 12	No infrastructure and/or erosional features are present.
SC 13	A pig fence intersects the stream channel, just upstream of the road (Photo 10, Appendix B).
SC 14	No infrastructure and/or erosional features are present.
SC 15	No infrastructure and/or erosional features are present.

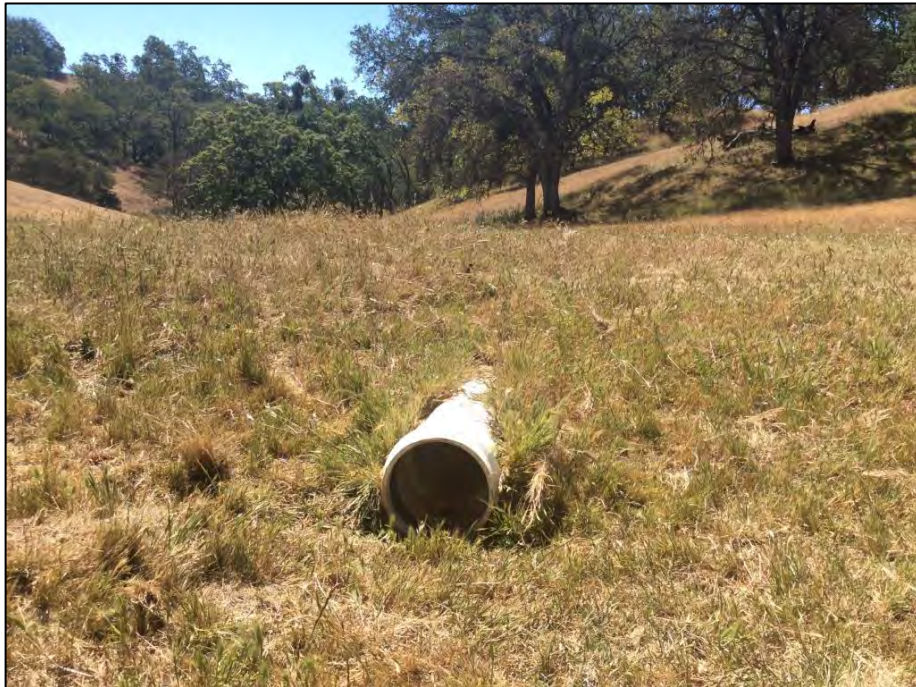
Photo 8. Culvert outlet at SC9.

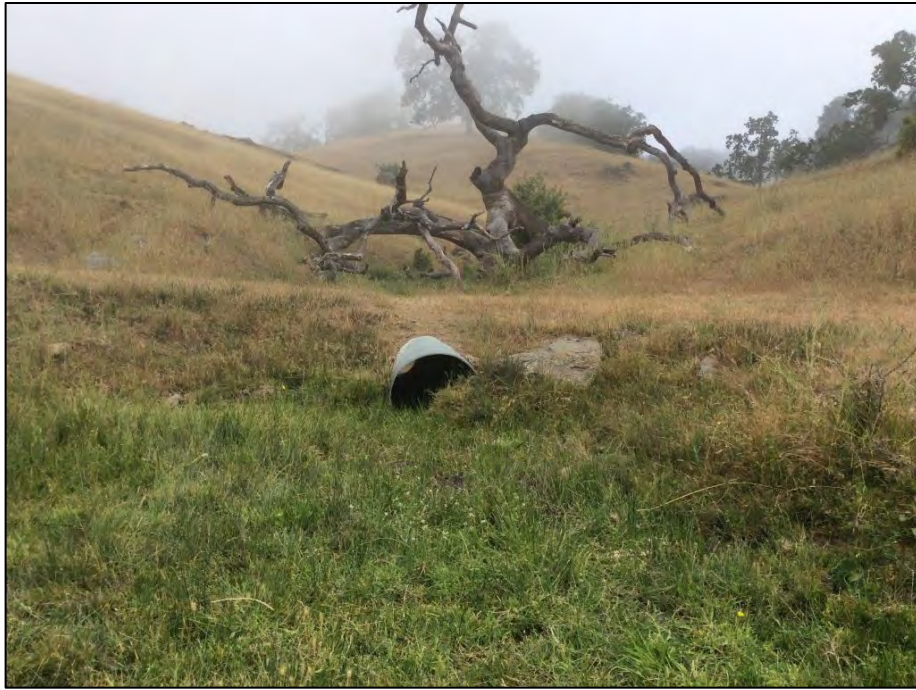
Photo 9. Culvert outlet at SC10.

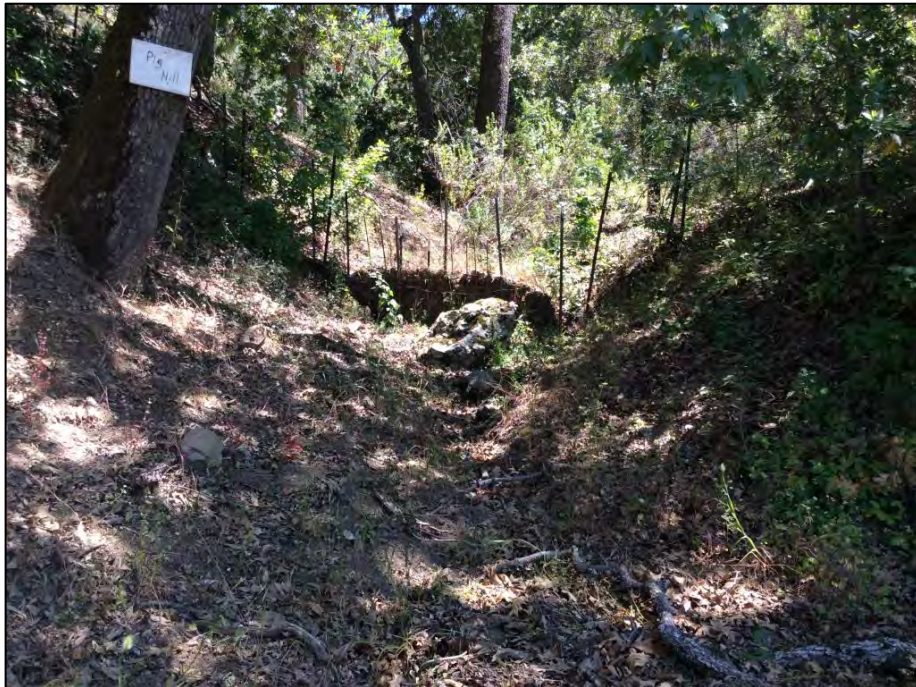
Photo 10. A pig fence crossing the ephemeral stream channel on the upstream side of SC13.

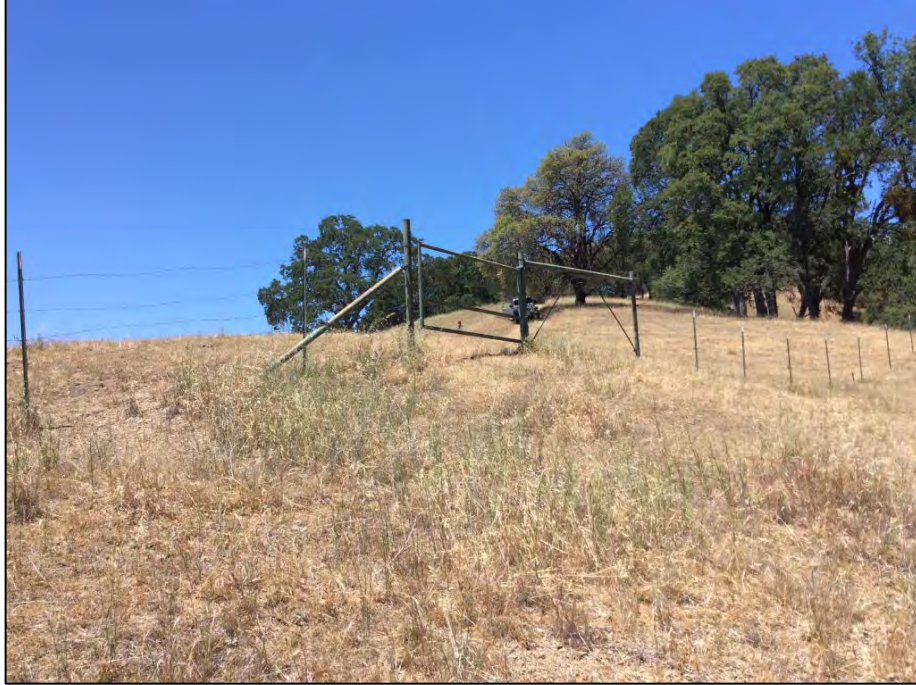
Photo 11. Barbed wire fence and gate to exclude cattle from Pond 4.

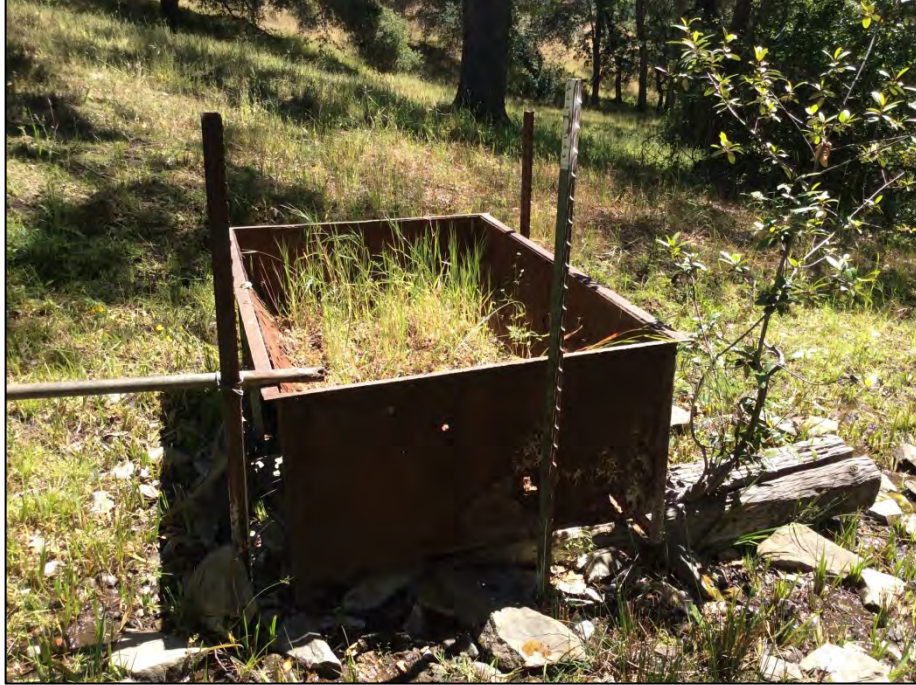
Photo 15. Trough to the northwest of SC14.

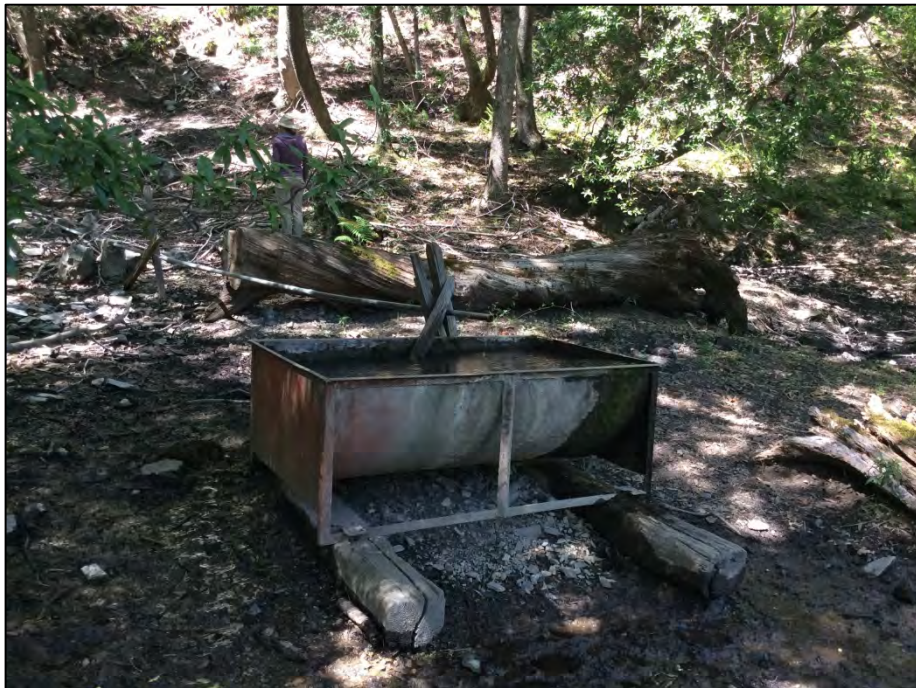
Photo 16. Trough near SC16 is located in Area 1 near the border of Area 3.

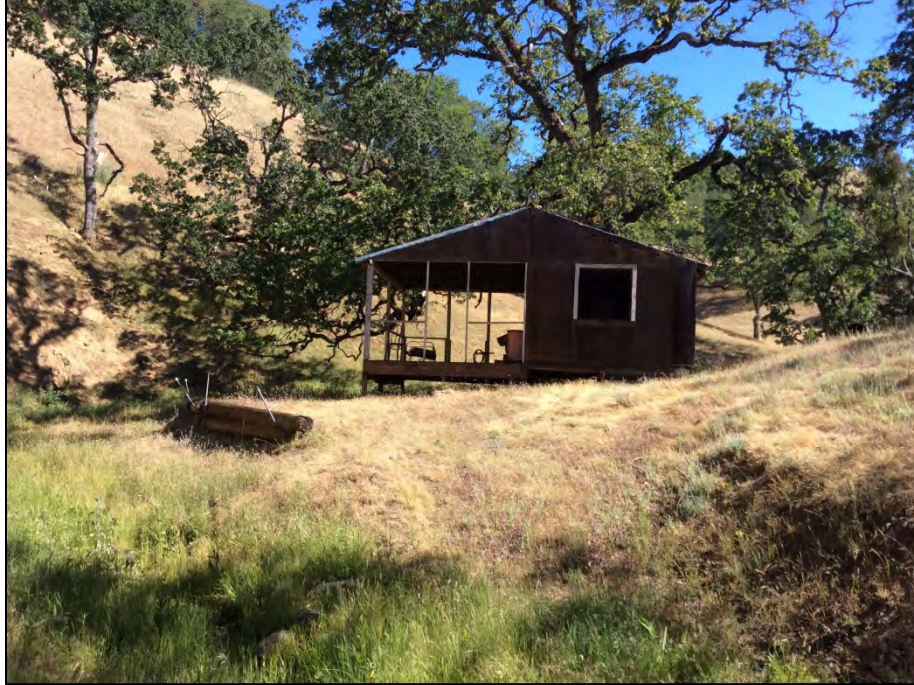
Photo 17. Old one-room ranch house and adjacent retaining wall.

A small ranch house is present in Area 2 (Figure 5). This small house has only one room and was historically used for overnight stays on the Preserve by the Kammerers and their guests (Photo 17, Appendix B). This house has not been used recently. A retaining wall is present between the house and the nearby stream, but no erosional features were observed at this location. A minimal outhouse is located adjacent to the ranch house.

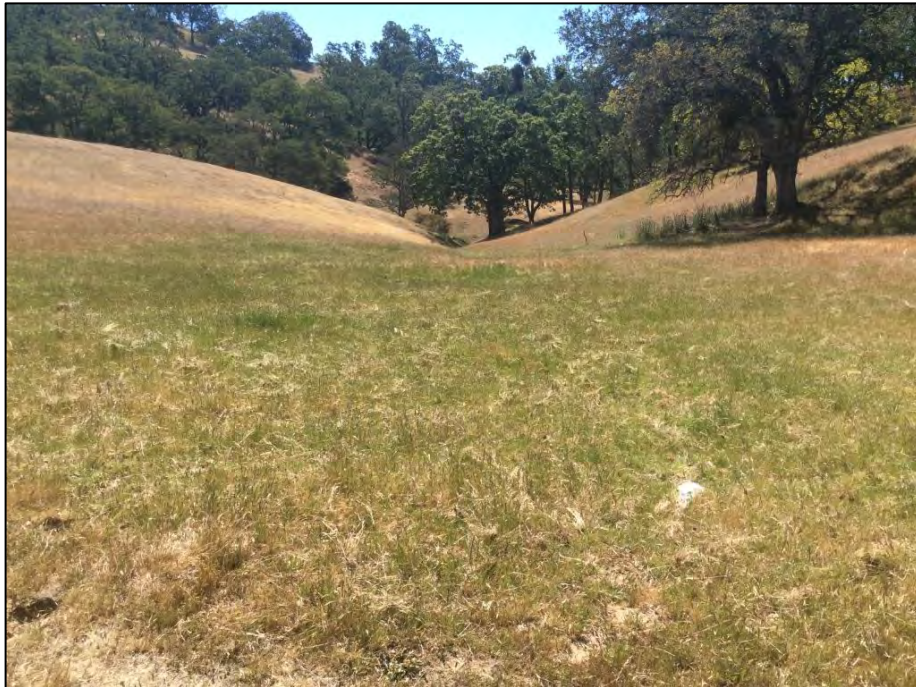
Photo 38. Photo of a seep at the headwaters of the stream near SC9.

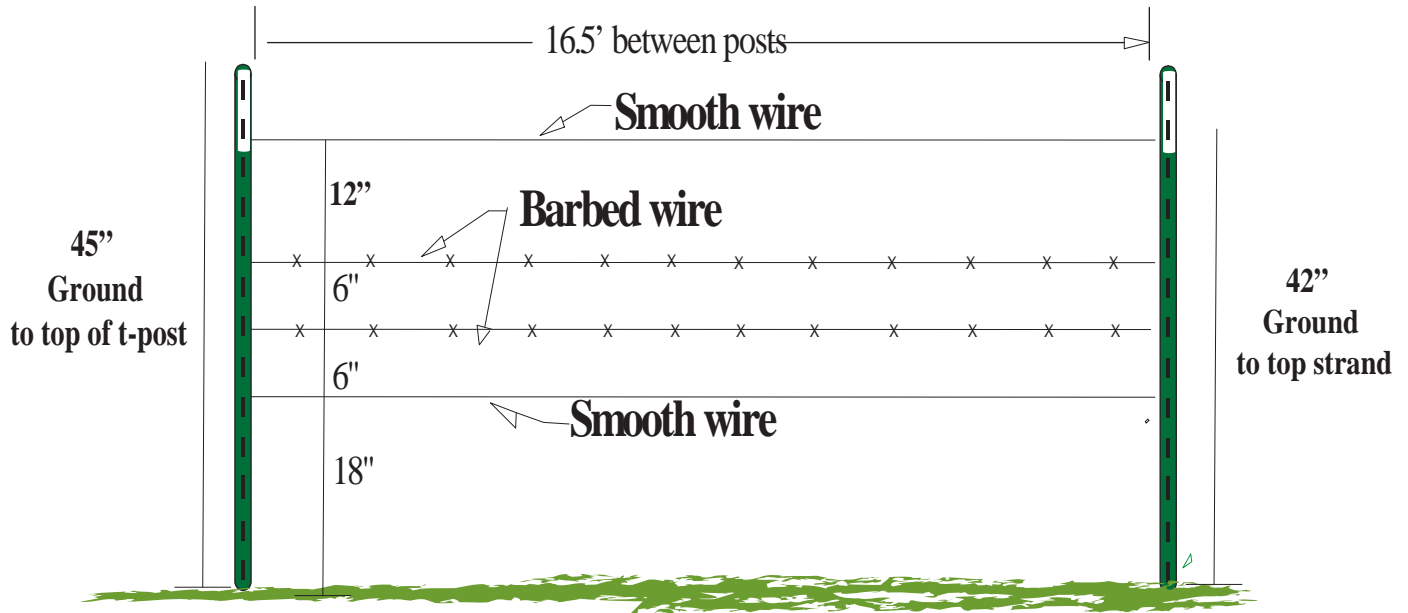
Road Side - Use 66" (5.5') t-posts

Roadside t-post length is 66" (5.5')

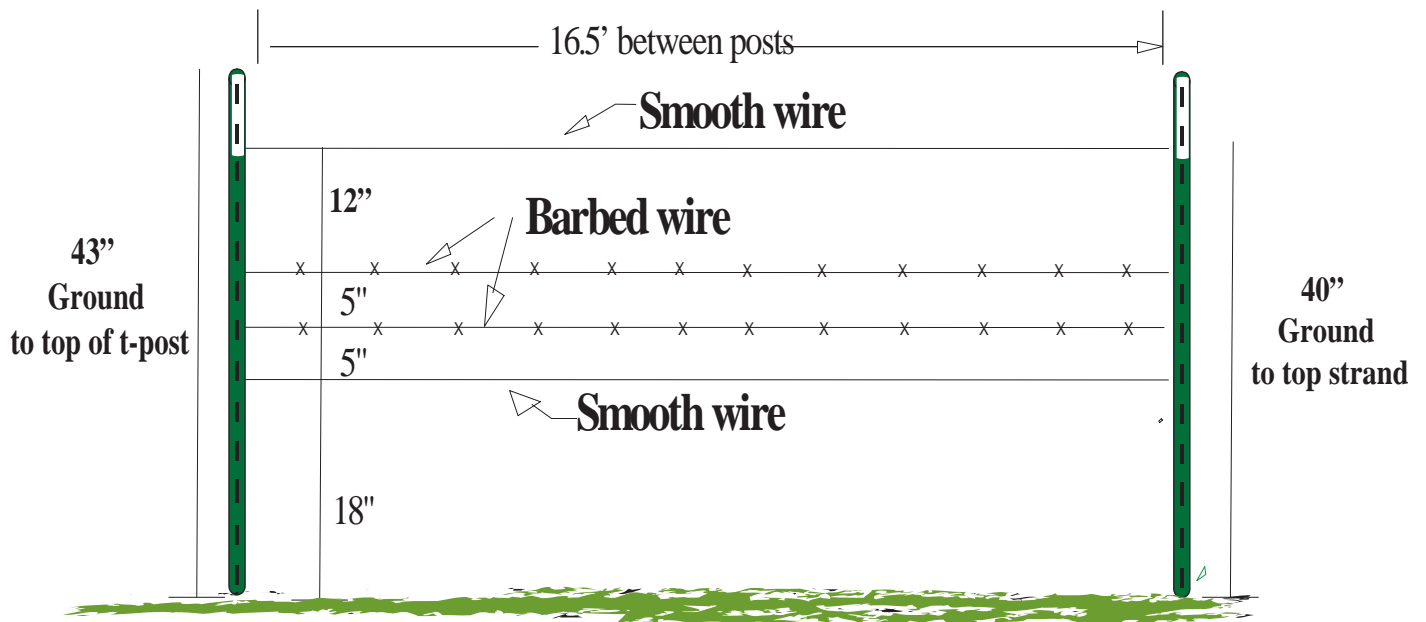
Interior Fencing - Use 60" (5.0') t-posts

Interior t-post length is 60" (5.0')
