FLOODING AND FLOOD-RELATED
DAMAGES REPORT

MORGAN HILL
SANTA CLARA COUNTY

October 13, 2009

Hydrology, Hydraulics and Geomorphology Unit

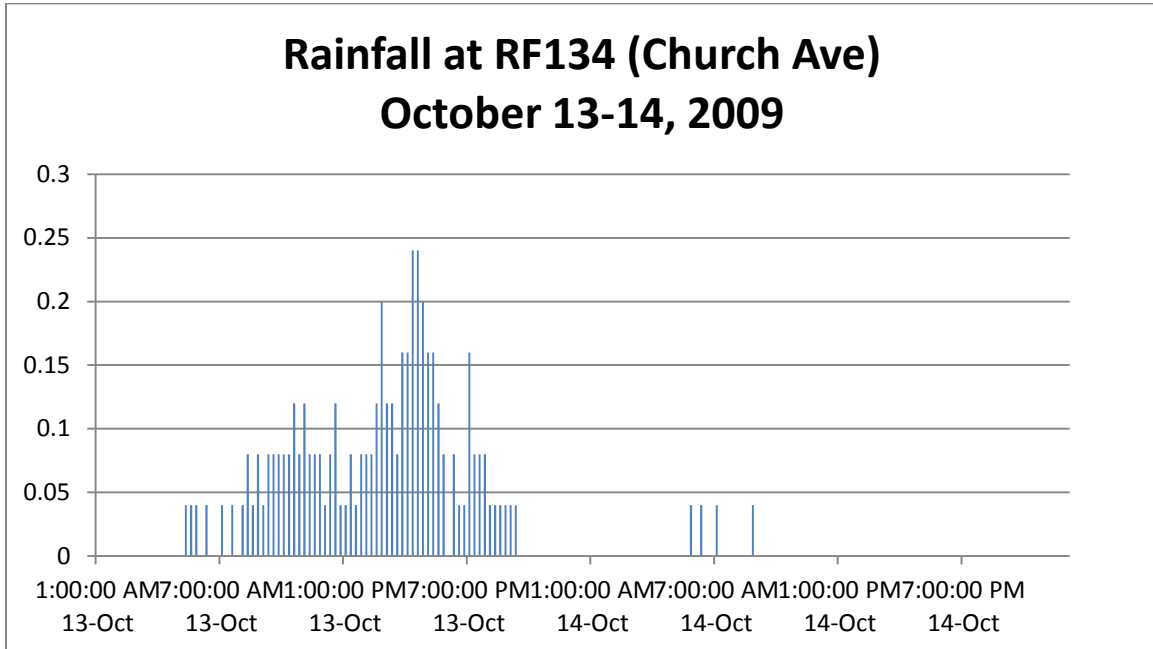
FIGURE 1

Figure 1 and 2 illustrate the recorded rainfall amount generated during October 13-14, 2009 near City of Morgan Hill. Figure 3 shows the 48-hour storm total in Santa Clara County during the storm.

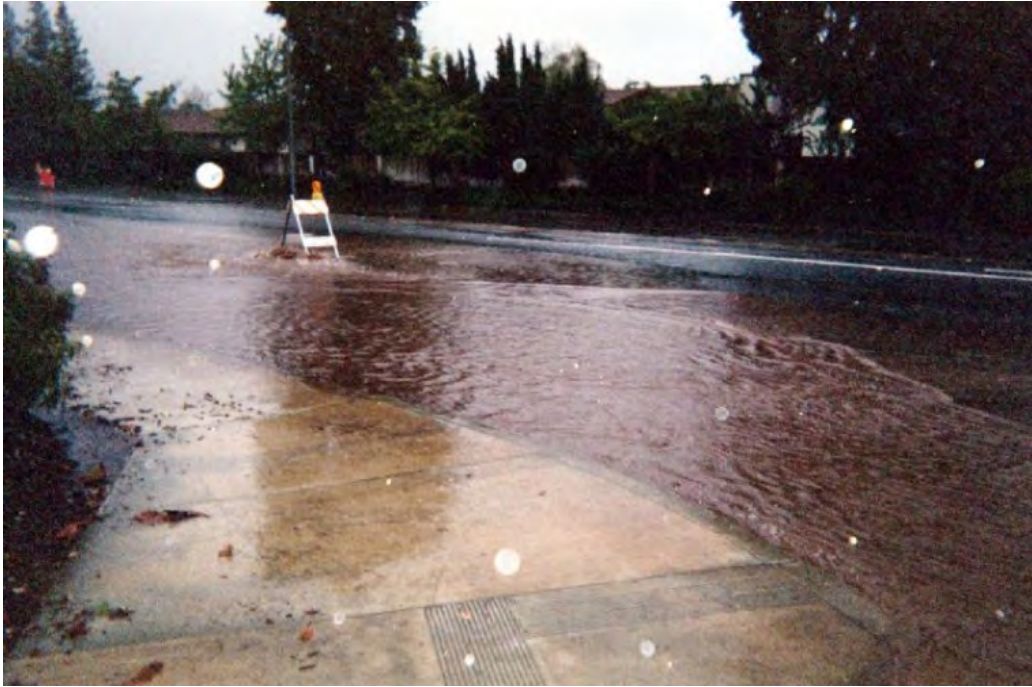
Photo 1: The intersection of Hale and Llagas Road is underwater as a result of the Oct. 13 storm.
Photo by Jason Bushman

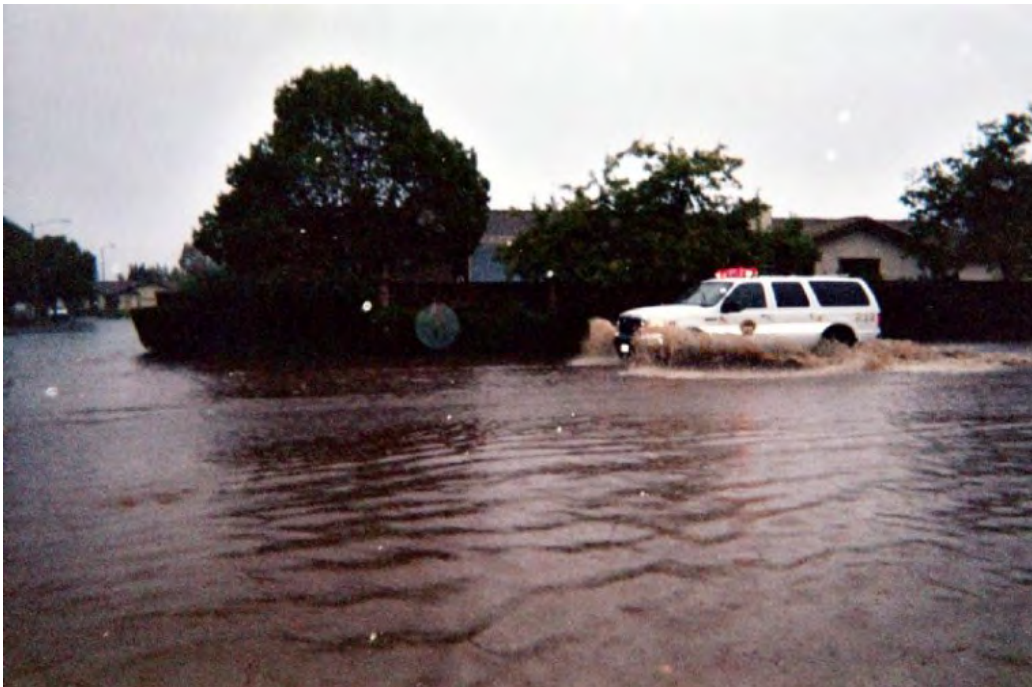
Photo 2: An emergency vehicle checks out flooded northwest Morgan Hill. Photo by Jason Bushman

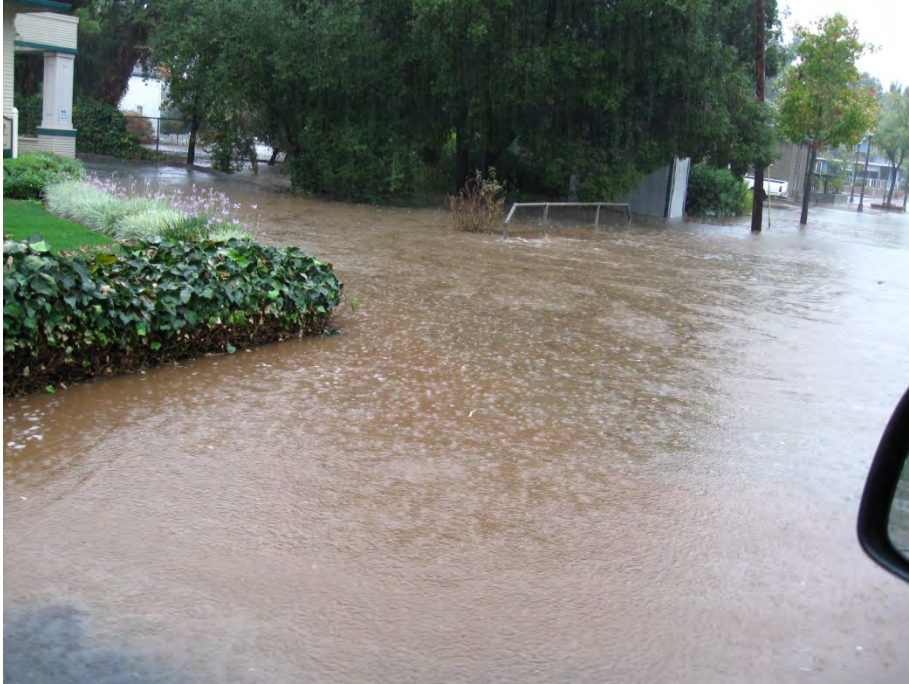
Photo 3: Little Llagas Creek over topping 5th Street, photo taken facing north. Photo courtesy Anthony Eulo, Program Administrator, Environmental Services Department of the City of Morgan Hill.

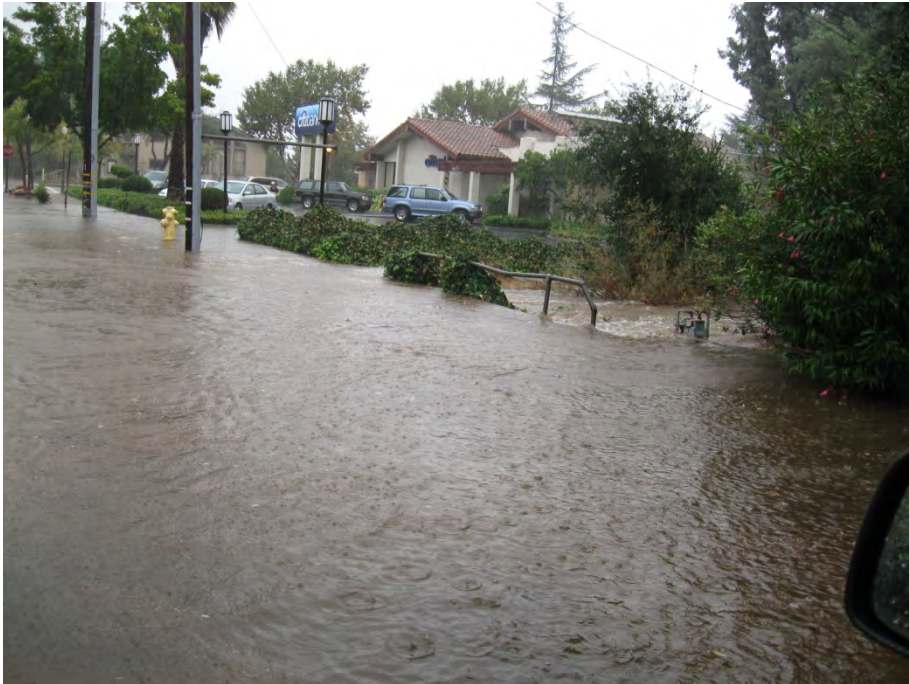
Photo 4: Flooding at the intersection of Monterey Road and East Fifth Street. Llagas Creek is shown to the right, facing south. Photo courtesy Anthony Eulo, Program Administrator, Environmental Services Department of the City of Morgan Hill.

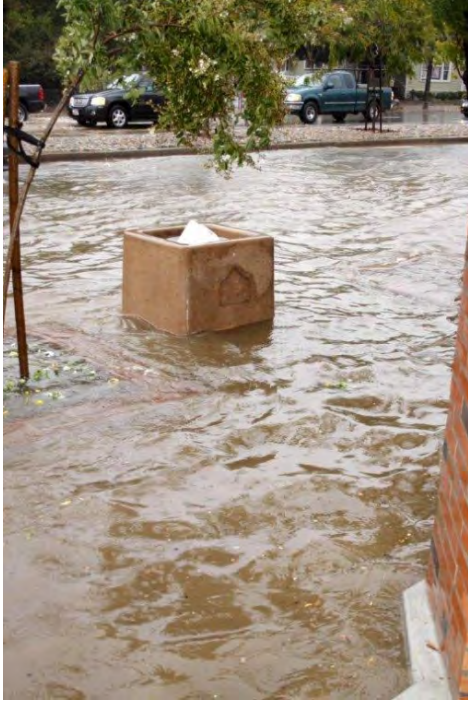
Photo 5: Flood waters inundate a city garbage can near Fourth Avenue. Photo by Jorge Briones

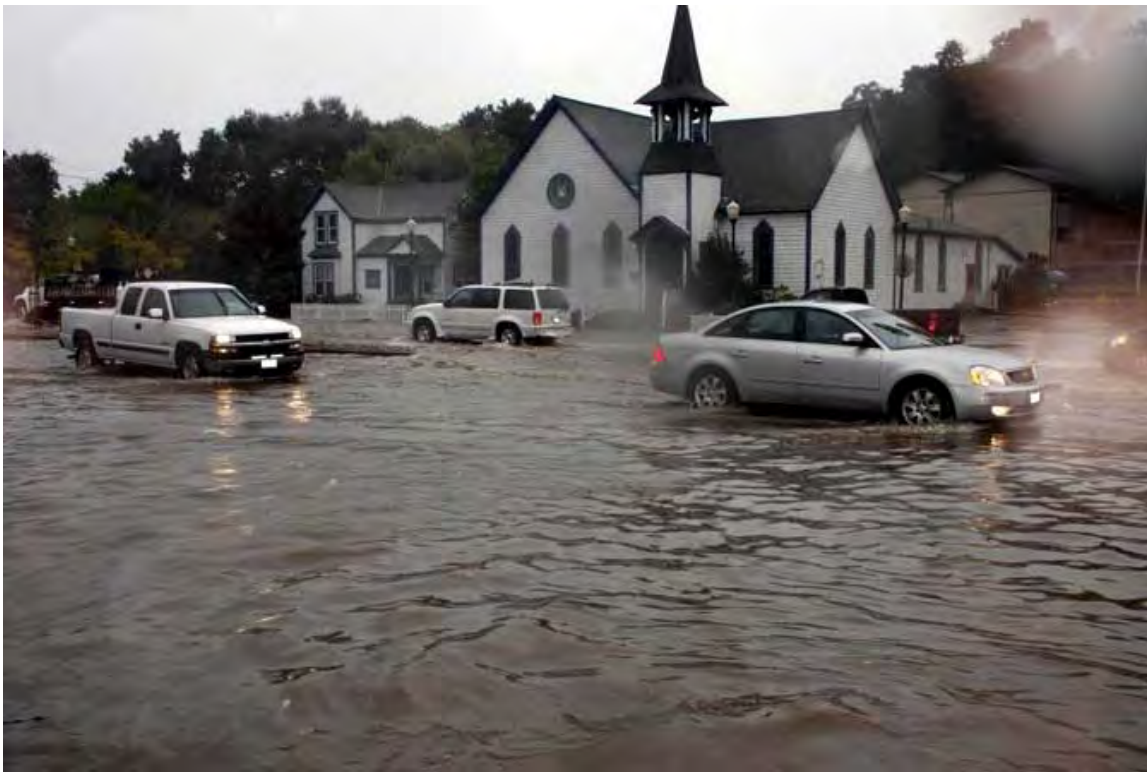
Photo 6: Monterey Road at 4th Street resembles a river during the October 13th storm. Photo by Jorge Briones

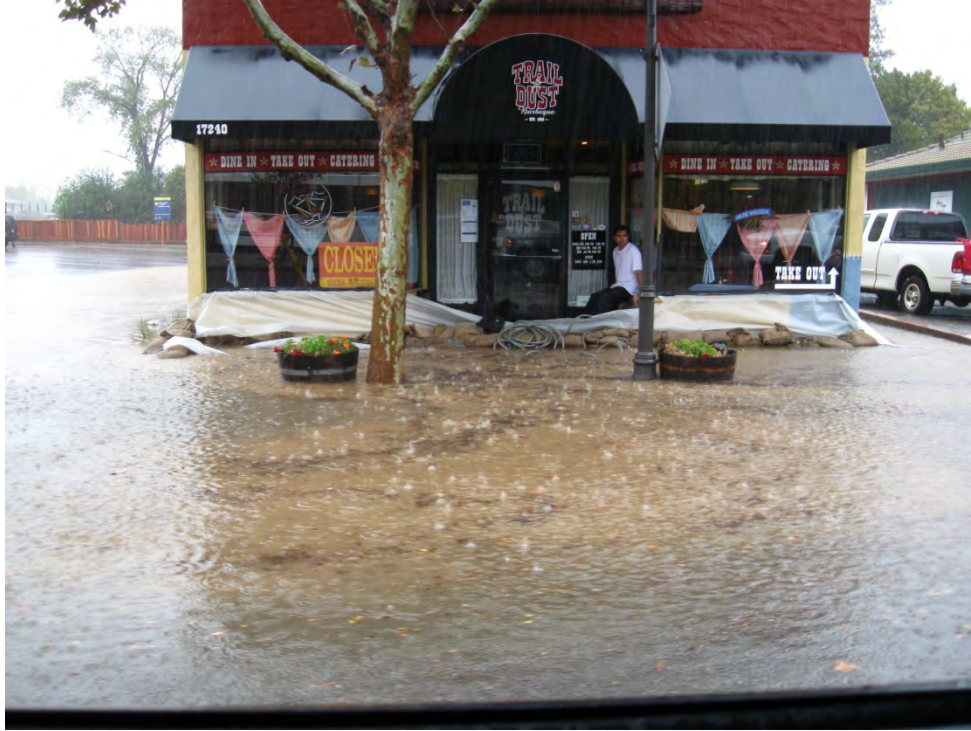
Photo 7: Flooding around Trail Dust Restaurant in Morgan Hill. Photo courtesy Anthony Eulo, Program Administrator, Environmental Services Department of the City of Morgan Hill.

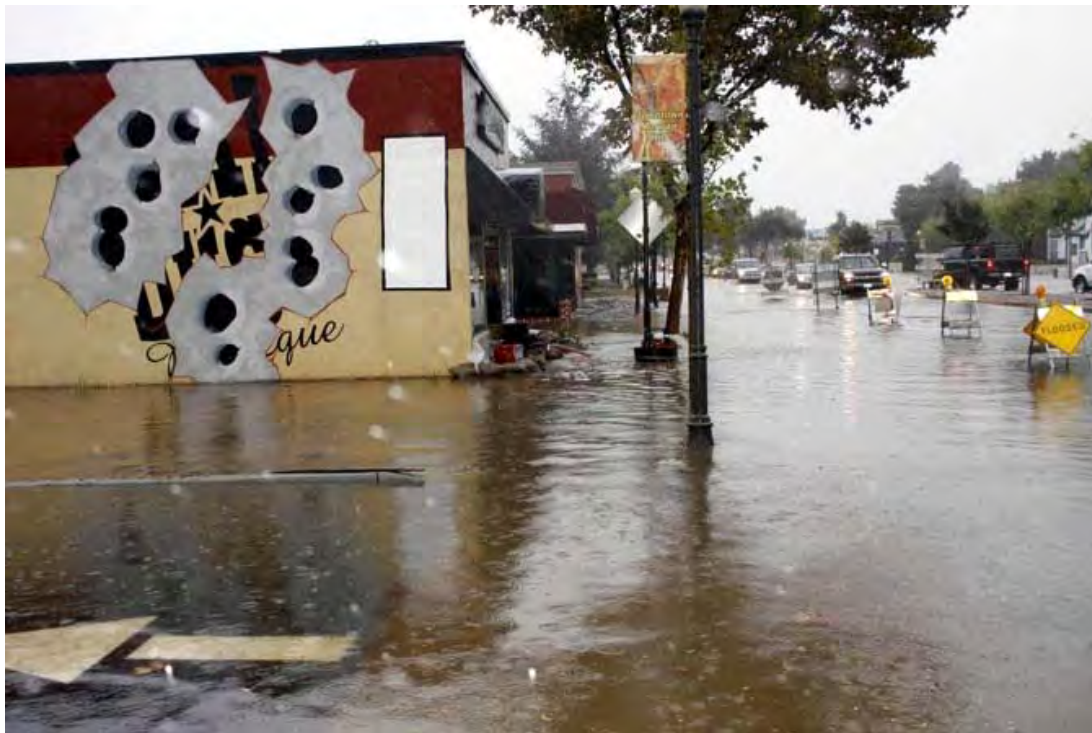
Photo 8: The parking lot just north of Trail Dust floods as a result of the Oct. 13 storm. Photo by Jorge Briones

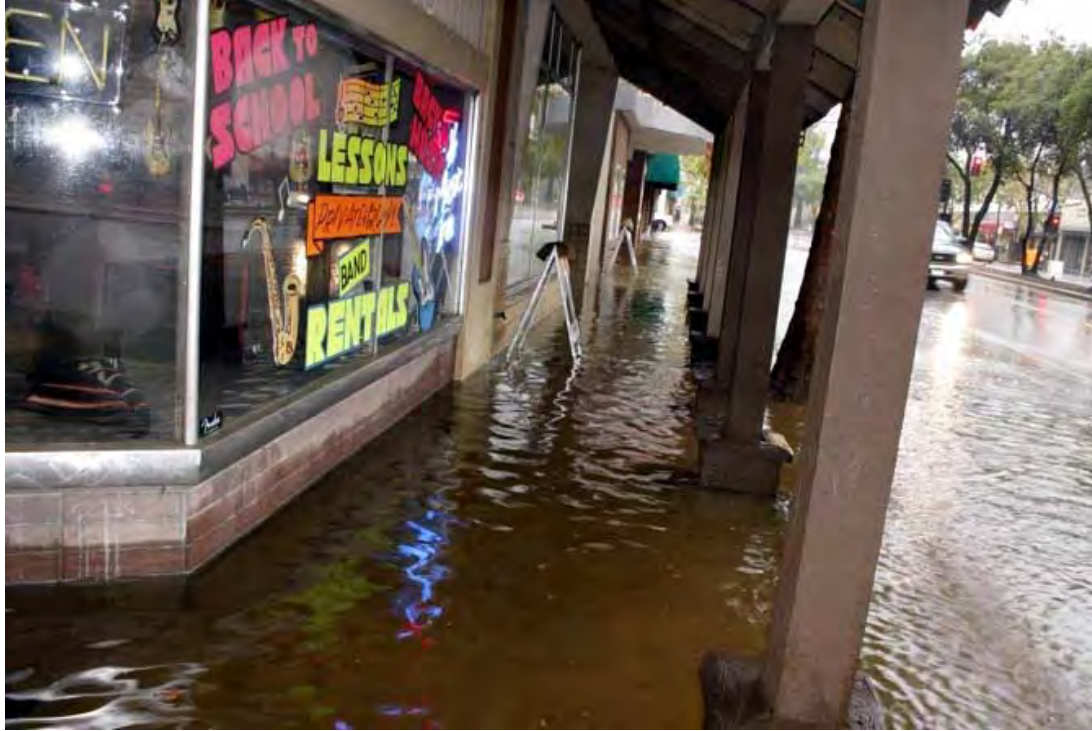
Photo 9: Flood waters cover the sidewalk in downtown Morgan Hill. Photo by Jorge Briones

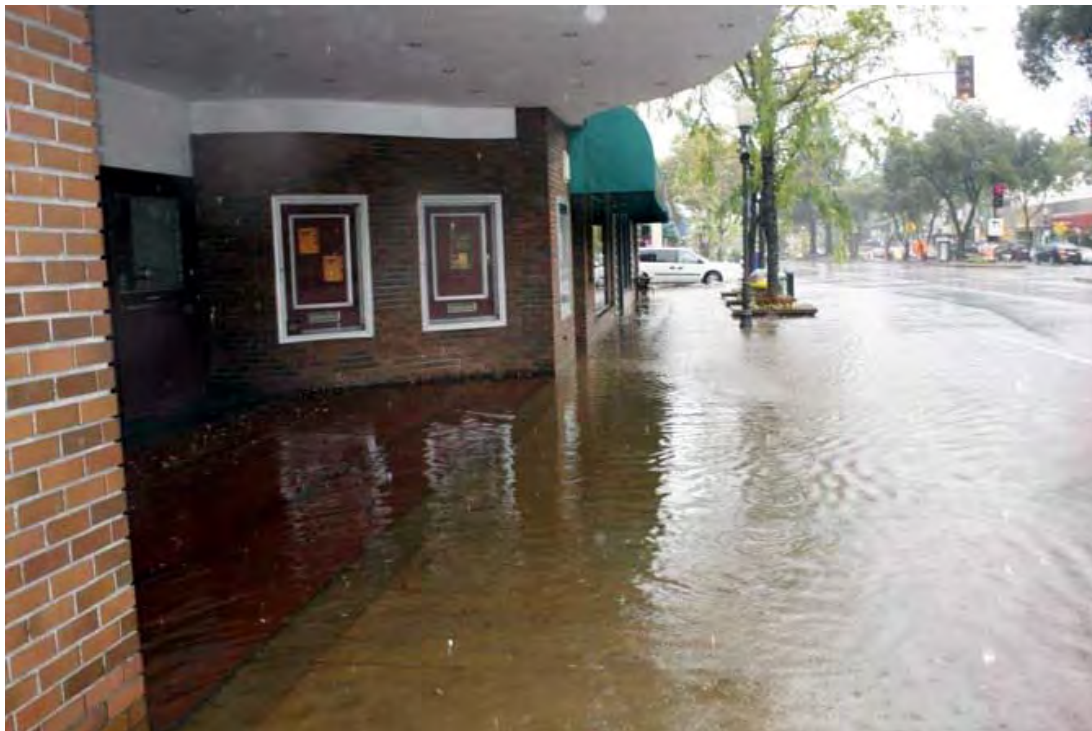
Photo 10: Water laps up against the front of the Granada Theater in downtown Morgan Hill during the Oct. 13th storm. Photo by Jorge Briones

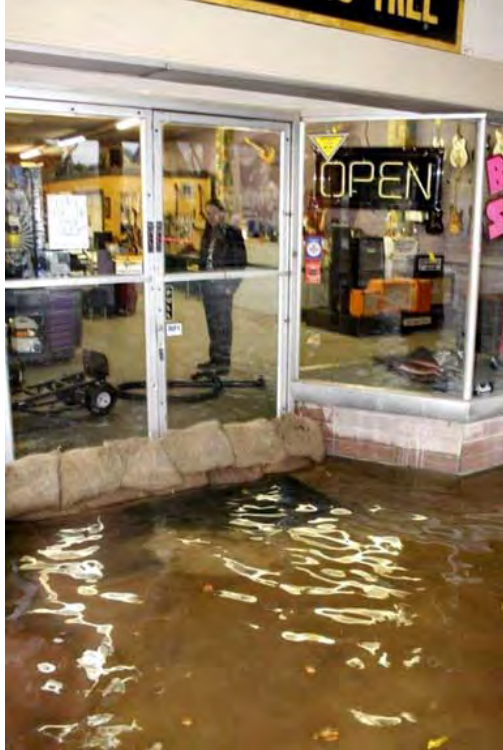
Photo 11: Sand bags help protect the entrance to The Music Tree in downtown Morgan Hill.
Photo by Jorge Briones

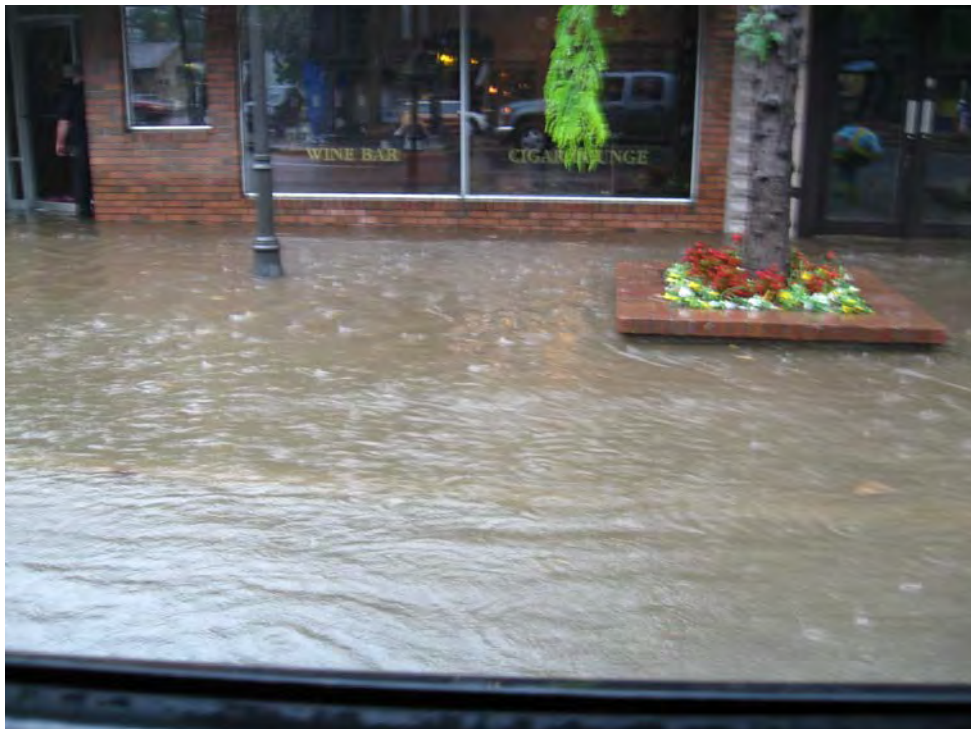
Photo 12: Flooding onto sidewalks in downtown Morgan Hill. Photo courtesy Anthony Eulo,
Program Administrator, Environmental Services Department of the City of Morgan Hill.

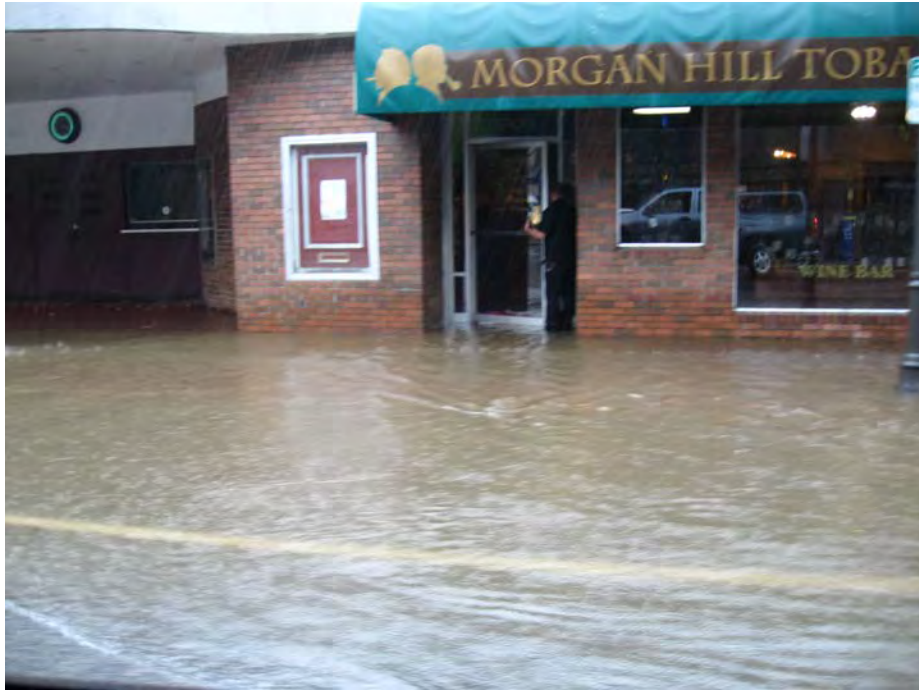
Photo 13: Flooding outside of Morgan Hill Tobacco, in Morgan Hill, California. Photo courtesy Anthony Eulo, Program Administrator, Environmental Services Department of the City of Morgan Hill.

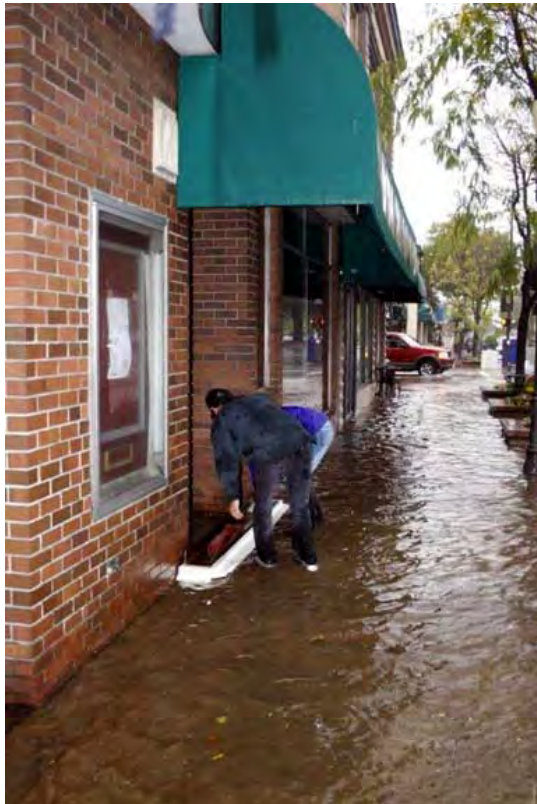
Photo 14: Flood waters lap against the front of the Morgan Hill Tobacco shop. Photo by Jorge Briones

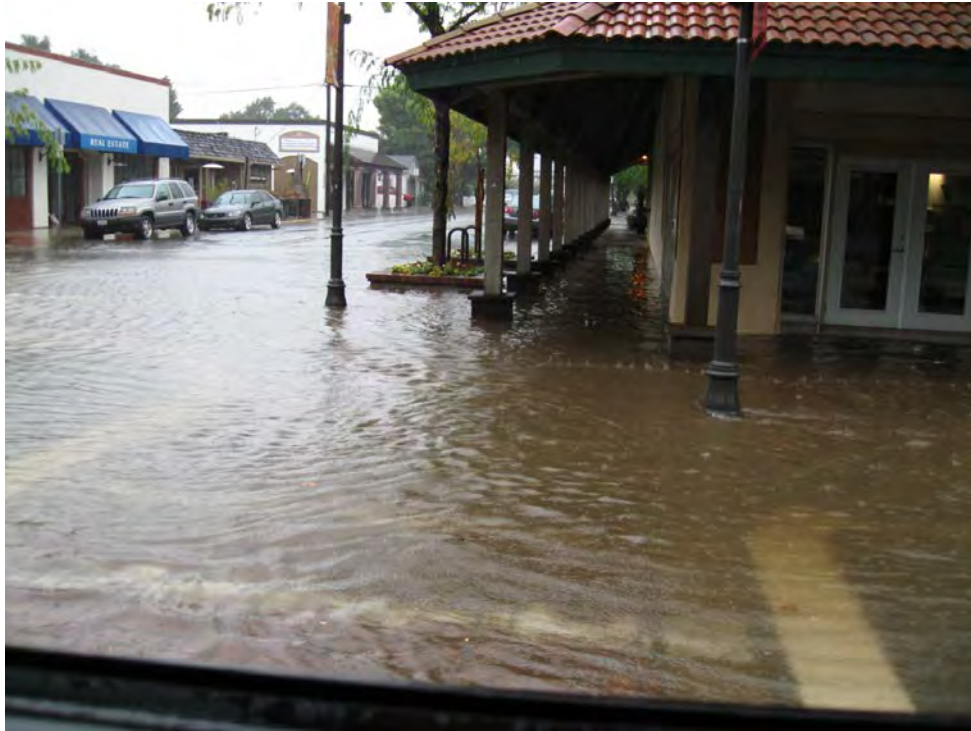
Photo 15: Flooding in downtown Morgan Hill, California. Photo courtesy Anthony Eulo, Program Administrator, Environmental Services Department of the City of Morgan Hill.

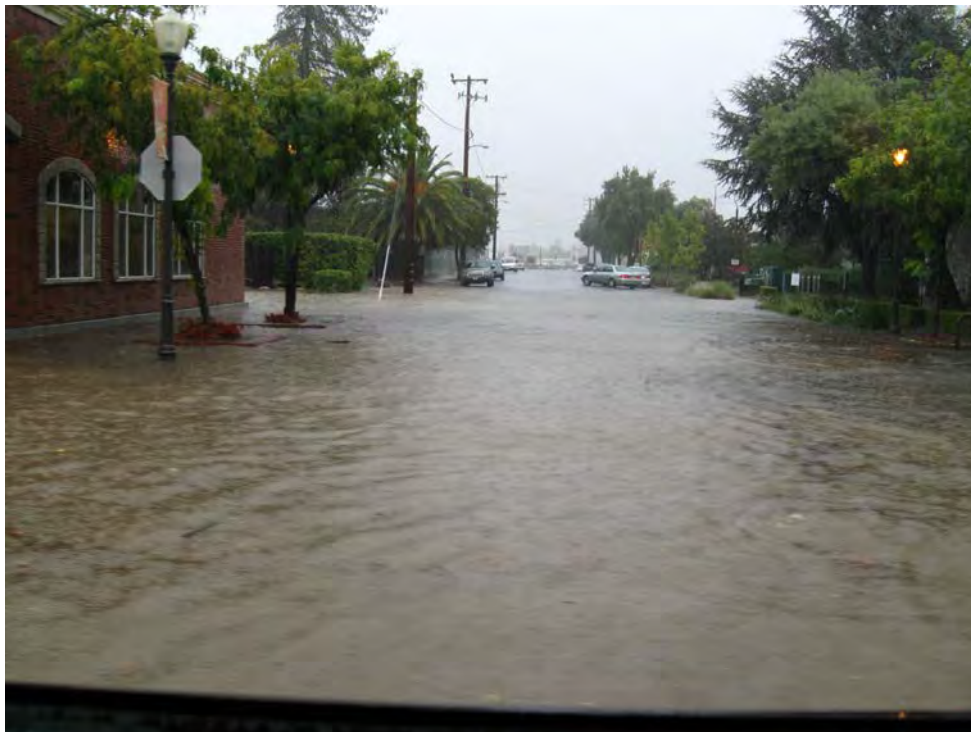
Photo 16: Photo courtesy Anthony Eulo, Program Administrator, Environmental Services Department of the City of Morgan Hill.

**Neighborhood South of 1000 block of West Edmundson Avenue,
North of Watsonville Road**

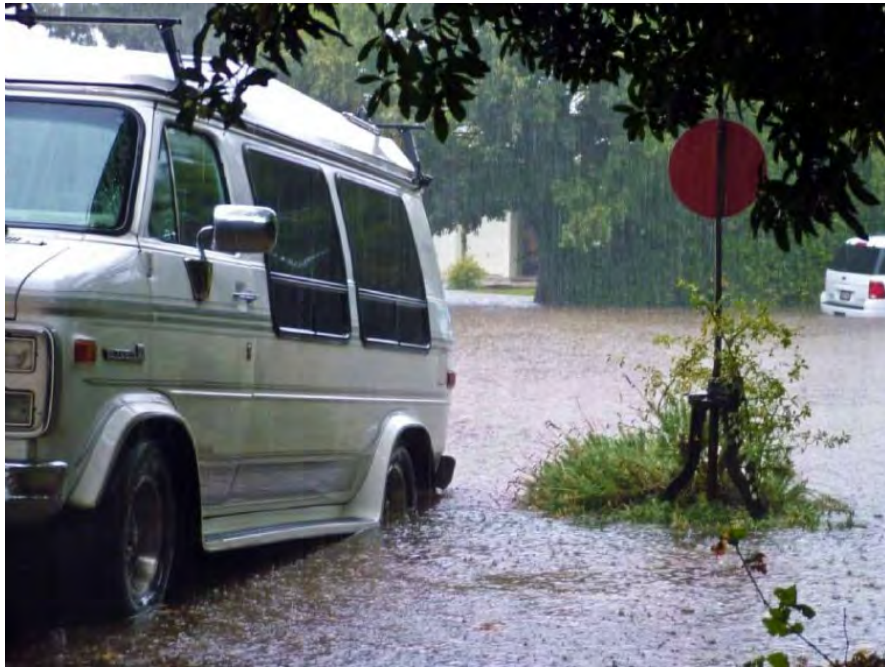
Photo 17: Waters climb the driveway of an Alamo Drive home Oct. 13. Photo courtesy the Grzan family

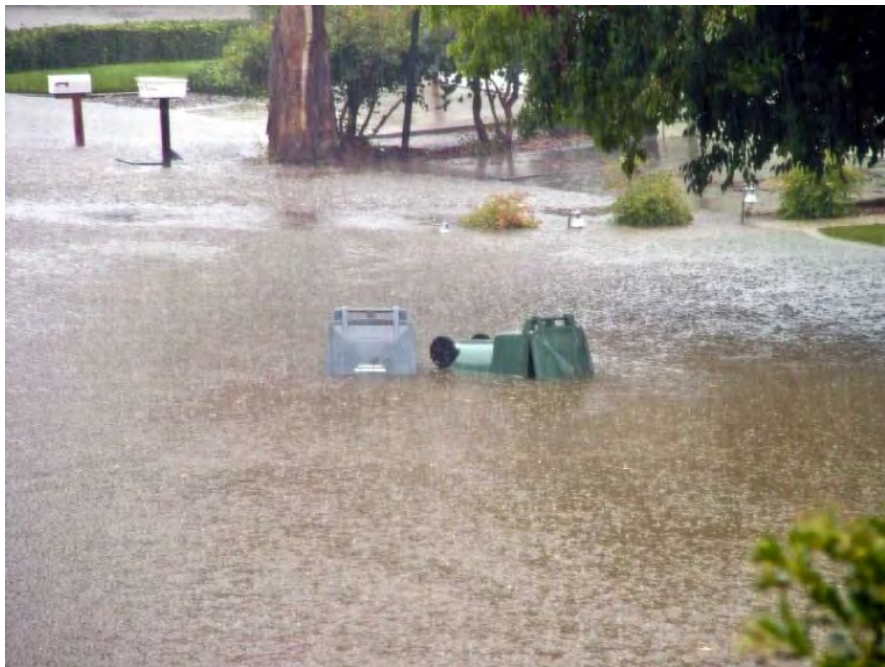
Photo 18: Two garbage cans are partially submerged on Alamo Drive in southwest Morgan Hill. Photo courtesy of the Grzan family

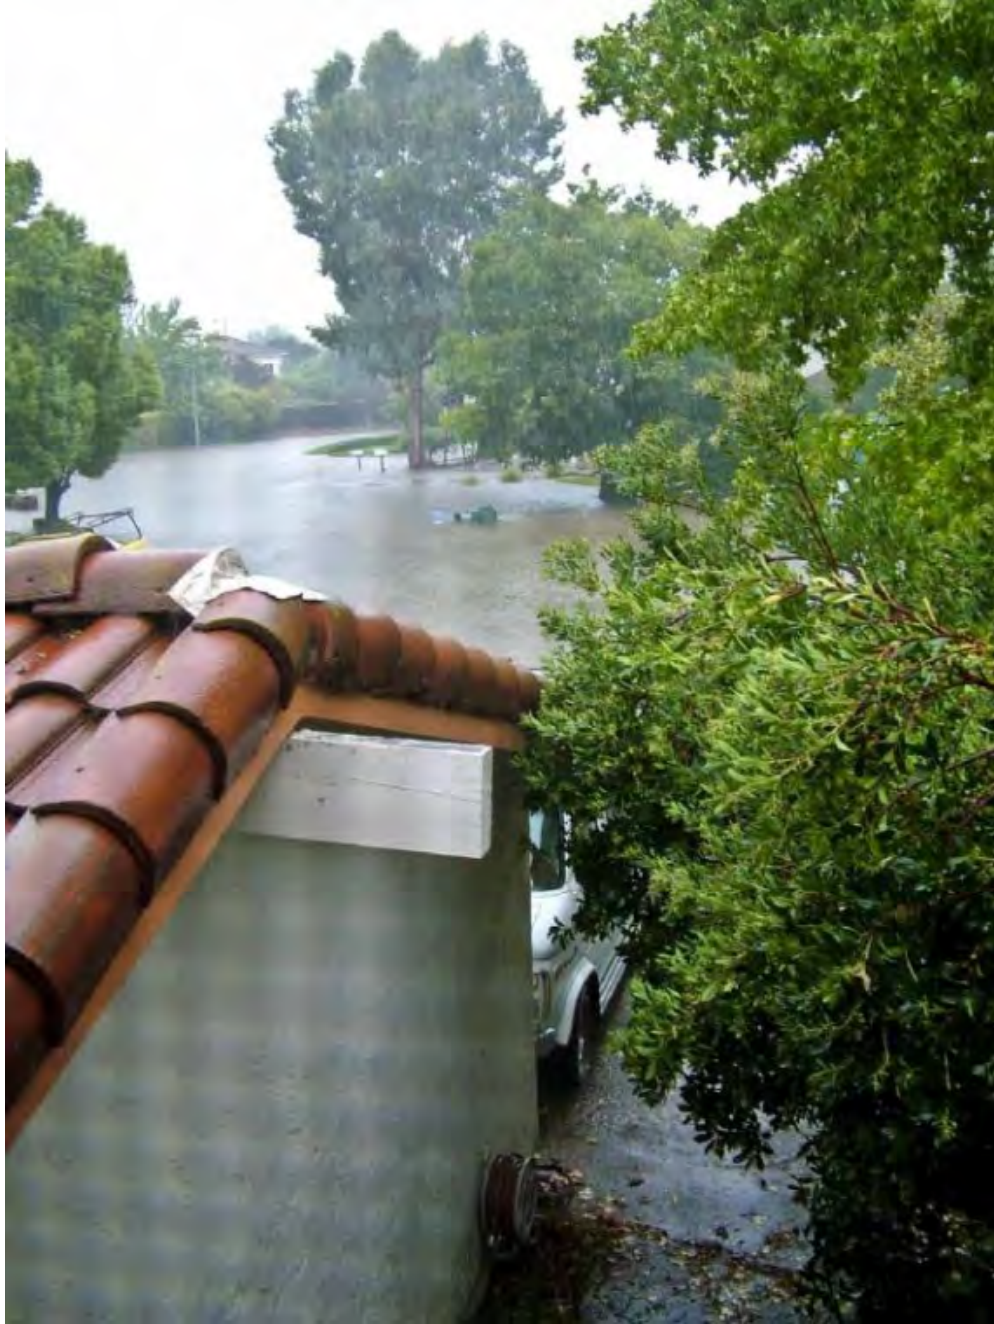
Photo 19: Alamo Drive is under water after nearly 7 inches of rain fell on Morgan Hill Oct. 13.
Photo courtesy the Grzan family

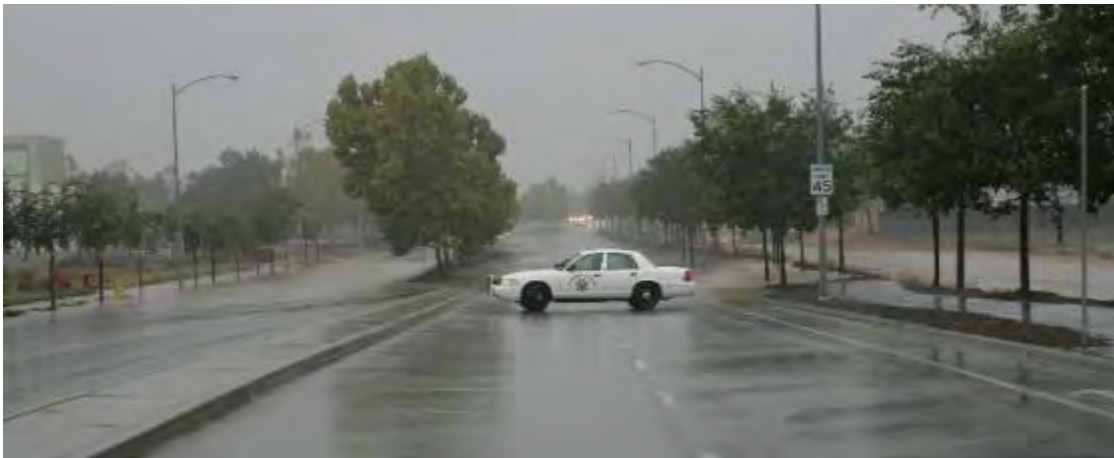
Photo 20: Police car closing a portion of Butterfield Blvd near Diana Avenue due to flooding.
<http://www.morganhillweather.com/gallery.html>

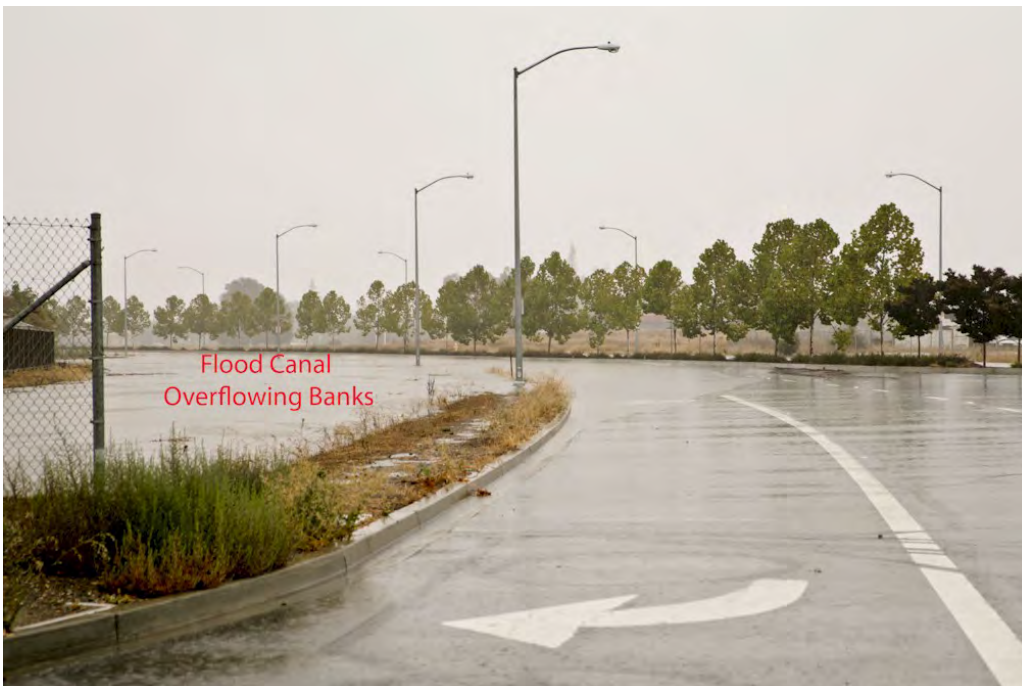
Photo 21: Annotation showing an overflowing flood canal next to Butterfield Blvd.
<http://www.morganhillweather.com/gallery.html>

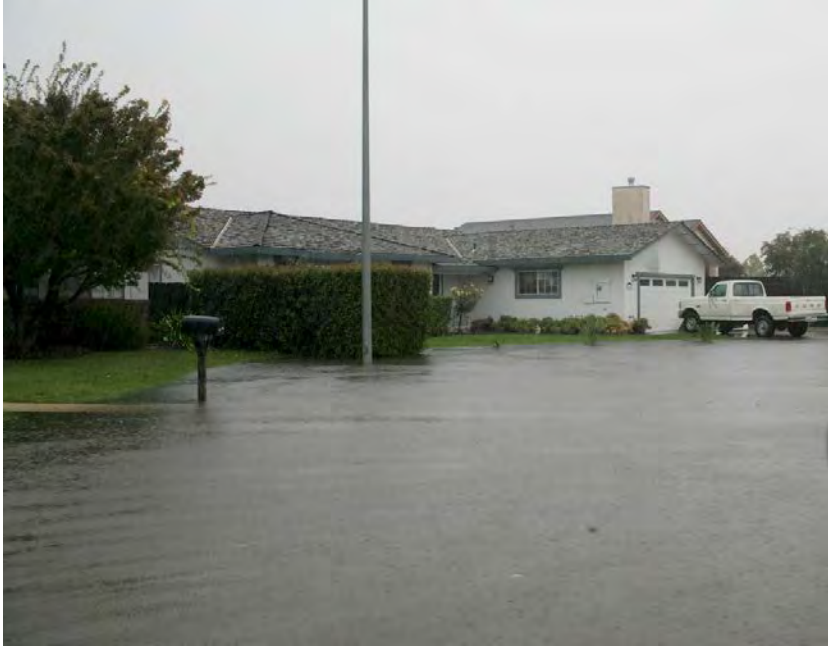
Photo 22: Flooding occurring on Cory Lane, running adjacent to Butterfield Blvd.
<http://www.morganhillweather.com/gallery.html>

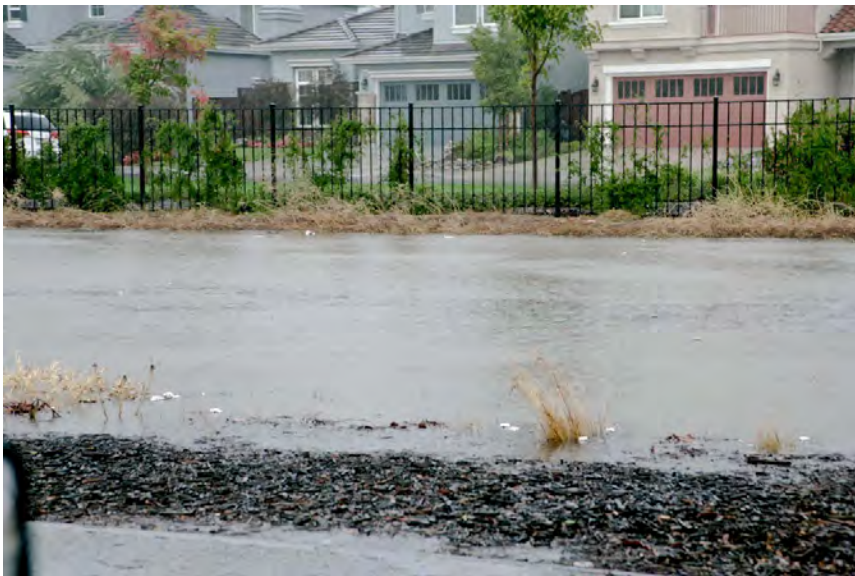
Photo 23: Flooding occurring in flood canal resulting in flooding on Butterfield Blvd.
<http://www.morganhillweather.com/gallery.html>
