SANTA CLARA VALLEY WATER DISTRICT

**MASSON FISHWAY 2007-2008 MONITORING REPORT
AND
ALAMITOS AND MASSON FISHWAY
2003-2008 SUMMARY REPORT**

Project No. 30102001

April 2009

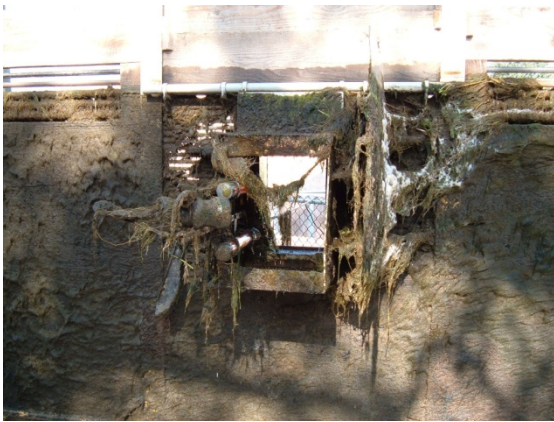
Figure 3. Alamitos Fishway deployment 2003-2004
Note small flow through weirs on sides.

The fishcounter structure has been altered over the years as field evaluations identified potential improvements. Initially, the panel was predominantly solid, with small metal grates to allow some flow through the weir separate from the fishcounter passage. A majority of the flow was forced through the counter opening (Figure 3). It was determined that the initial setup was not effective for all flows encountered at the Alamitos Fishway. It was found that during elevated flow events the water would wash over the top of the weir, allowing fish to jump over the weir and avoid passing through the fishcounter (Figure 4). Also, the fishcounter opening could reach velocities greater than 6 feet per second, which could encourage fish to leap over the counter, rather than swim through the elevated velocities at the counter opening. In order to improve fishcounter effectiveness at higher flows, large flow-through panels were added at the sides of the fishcounter to avoid the concentration of flow and excess velocities at the opening (Figure 5). This also aided in keeping water from flowing over the top of the structure in moderate flows. Regardless of the weir configuration, however, flows during larger events were too great to contain and water would cascade over the top of the weir.

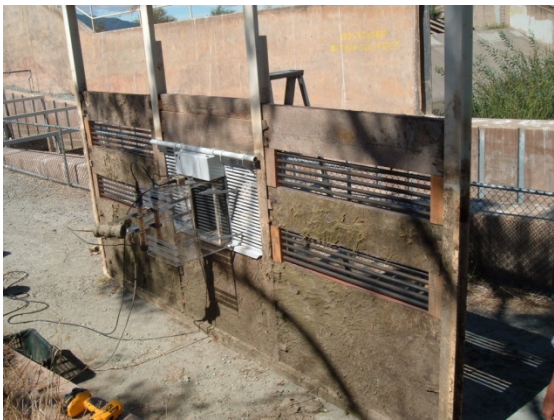
Figure 5. Alamitos Fishway deployment 2004-2006
Note larger flow through weirs and plexiglass extension

Initially, the fishcounter camera was mounted on an extended arm angled away from the counter opening. During the first year of monitoring photo confirmation of fish passage was difficult to attain as turbidity limited photo quality. In addition, many of the subjects moved at night and the infrared lighting did not sufficiently illuminate the fish for photographs. Also, several fish did not appear in the photo frame as they either swam through the counter either above or below the view of the camera or too far from the camera to capture an image through the turbid water. The lighting issue was improved when an engineer from Vaki supplied a pair of red LED light-bars to replace the infrared light source. At the Alamitos Fishway, the opening of the fishcounter was extended by an acrylic structure to direct the fish to swim past the camera (Figure 5). At the Masson Fishway, a steel structure was fabricated which included a steel extension to the counter opening to direct fish past the camera (Figure 6) and the structure was extended vertically to prevent water from spilling over the top of the counter (Figure 7).

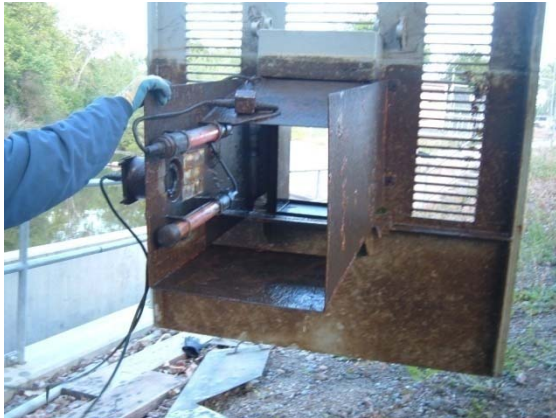
Figure 6. Masson Fishway deployment 2006-2008
Note flow through weirs on sides and metal extension collar to direct fish past the camera

The weir which houses the counter in the Masson Fishway is considerably smaller (5.7 feet wide) than the original configuration at the Alamitos Fishway (15.2 feet wide) (Figure 7). The difference in fishway design is due to the lower magnitude of flows received at the Masson Fishway, since the Guadalupe Creek watershed has a significantly smaller surface area than the area upstream of the Alamitos Fishway, which passes the flows which drain from Alamitos, Calero and Guadalupe Creeks (Figure 1). The location higher in the watershed resulted in improved water clarity due to lower turbidity and reduced debris in the water column which allowed the system to take better photographs.

Moving the fishcounter upstream in the Guadalupe Watershed combined with lower than usual precipitation in 2006-07 and 2007-08 reduced the instream turbidity levels and improved conditions for fishcounter photographs. In addition, a metal counter opening was added which brought the subjects closer to the camera and improved the photo quality. As a result, photos were of sufficient quality to identify both steelhead and Pacific lamprey. The seasonal timing (late February through early March) was also consistent with the expected steelhead and lamprey migrations. These two species, in particular, may have been present in previous years at the Alamitos Fishway, but not confirmed due to lack of confidence in the image quality.

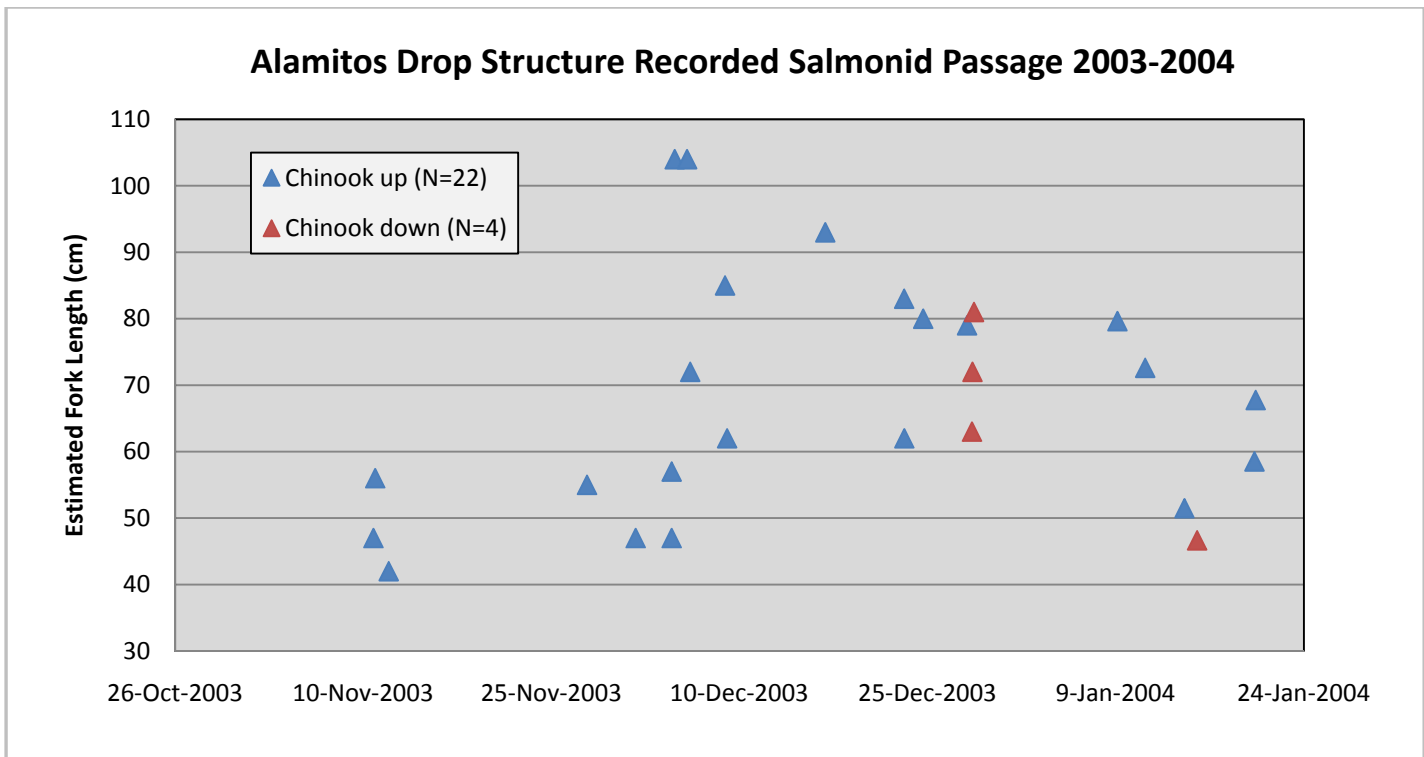
Figure 18. Salmonid Passage recorded at Alamitos Fishway 2003-2004

In the 2003-04 season at the Alamitos Fishway, 22 salmonids were documented moving through the counter upstream, while 4 were documented moving downstream. In 2004-05, 28 salmonids were documented moving upstream through the Alamitos Fishway, while 12 were documented moving downstream. In 2005-06, 15 salmonids were documented moving through the counter upstream, while 4 were documented moving downstream. In the first year at the Alamitos Fishway, 2003-04, distinguishing between Chinook salmon and steelhead was difficult due to the lack of conclusive photographs, therefore salmonids were lumped into one category. In subsequent reports in 2004-05 and 2005-06 smaller salmonids recorded in February through April were judged likely to be steelhead based on size and timing. Species designations in Figures 18-20 should not be considered absolute, but are the best fit based on knowledge of the system. In the first year at the Masson Fishway, in 2006-07, 42 steelhead were documented moving upstream through the counter, while 14 were documented moving downstream. No Chinook salmon were recorded at the Masson Fishway in 2006-07. For each season the counter results are considered confirmation that salmonids utilize both fishways, however, these numbers are not considered absolute population estimates due to the difficulties described in the methods section.

During the 5 monitoring seasons, several native and non-native fish species have been documented passing the fishcounter. Chinook salmon (*Oncorhynchus tshawytscha*) (Figures 8 and 9), steelhead (*Oncorhynchus mykiss*) (Figures 10 - 13), Pacific lamprey (*Lampetra tridentata*) (Figures 14 and 15), Sacramento sucker (*Catostomus occidentalis*) (Figures 16 and 17), common carp (*Cyprinus carpio*), largemouth bass (*Micropterus salmoides*) and green sunfish (*Lepomis cyanellus*) have been identified in photograph and silhouette images from the fishcounter. Analysis is focused on salmonid fish passage (Figures 18 - 23).
