# **Final Report**

## **Evaluation of Reverse Osmosis for Brackish Groundwater Desalination at Gilroy and Hollister, CA.**

**Martin Reinhard, Gary D. Hopkins,  
Jennifer S. Louie, Sophie Walewijk, Hefa Cheng  
Department of Civil and Environmental Engineering  
Stanford University  
Stanford, CA 94305**

August 2008

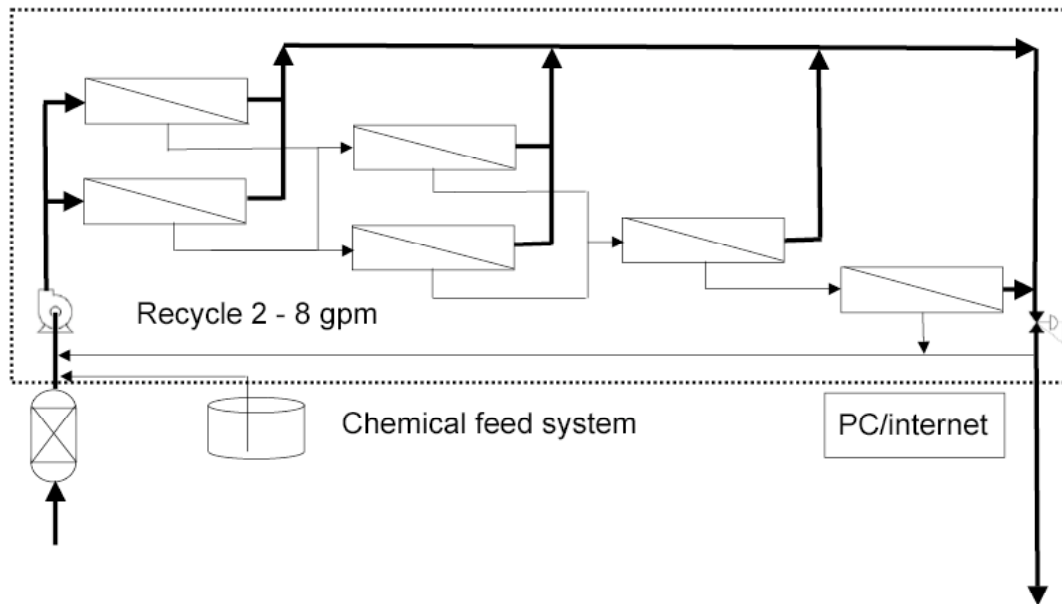
Figure 2. Simplified schematic of the RO pilot unit (A schematic of the systems is given in Appendix B).

The array shown above represents a two-stage system in a 2:1 configuration, with the first stage consisting of two parallel trains of two pressure vessels in series and the second stage consisting of a series of two pressure vessels. Each vessel housed three 4-in. x 40 in. elements rated to 300 psi operating pressure. The concentrate streams of the first two pressure vessels were combined and the configuration may be designated as a (2:2):(1:1) array. The design permeate flow was 15 and the system was equipped with a recycle loop that was adjustable from 2 and 8. This design allowed simulation of a full-scale 2:1 membrane configuration with full-scale vessels holding six elements each.

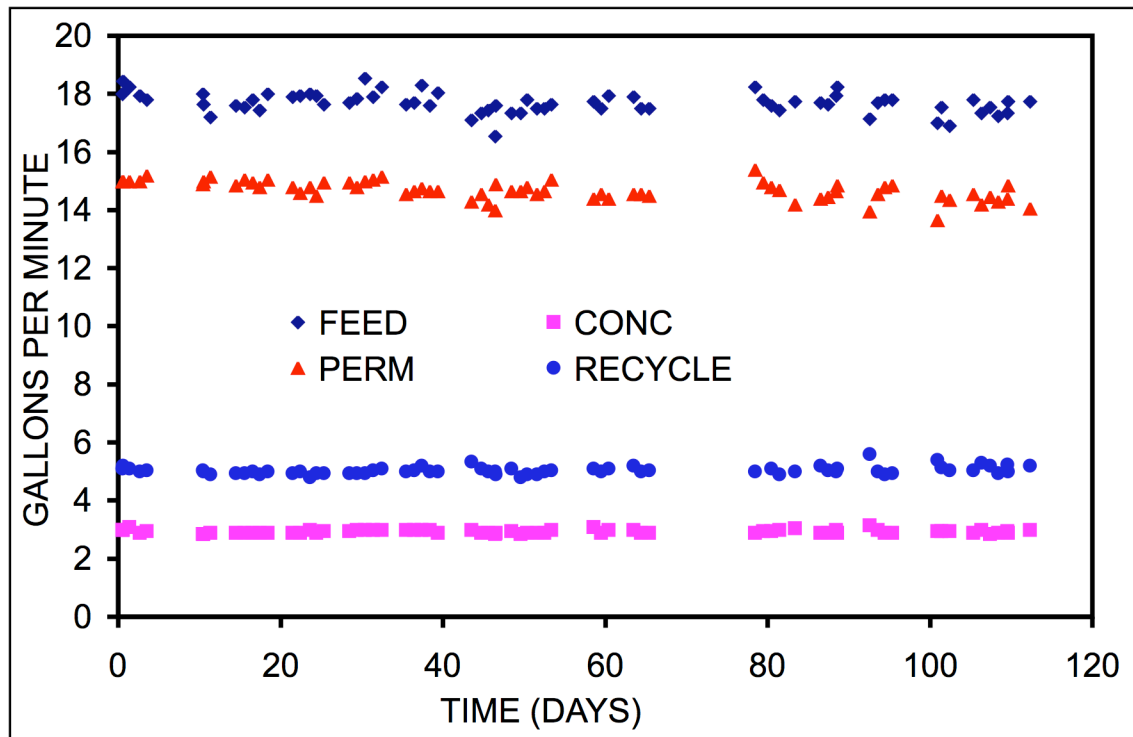
Figure 3. Gilroy plant: flows in feed, permeate, concentrate and recycle in the first period (10/17/06 - 2/06/07).

The flows during this time were maintained at the set points by manually adjusting pressure during site visits (often daily). The short data gaps were due to maintenance, the 13-day data gap was during the holiday break from December 22 through January 3.

**Hydraulic performance:** Figures 3 and 4 display the flow rates and the pressure data collected during the first three months of operation (10/17/06 - 2/06/07).

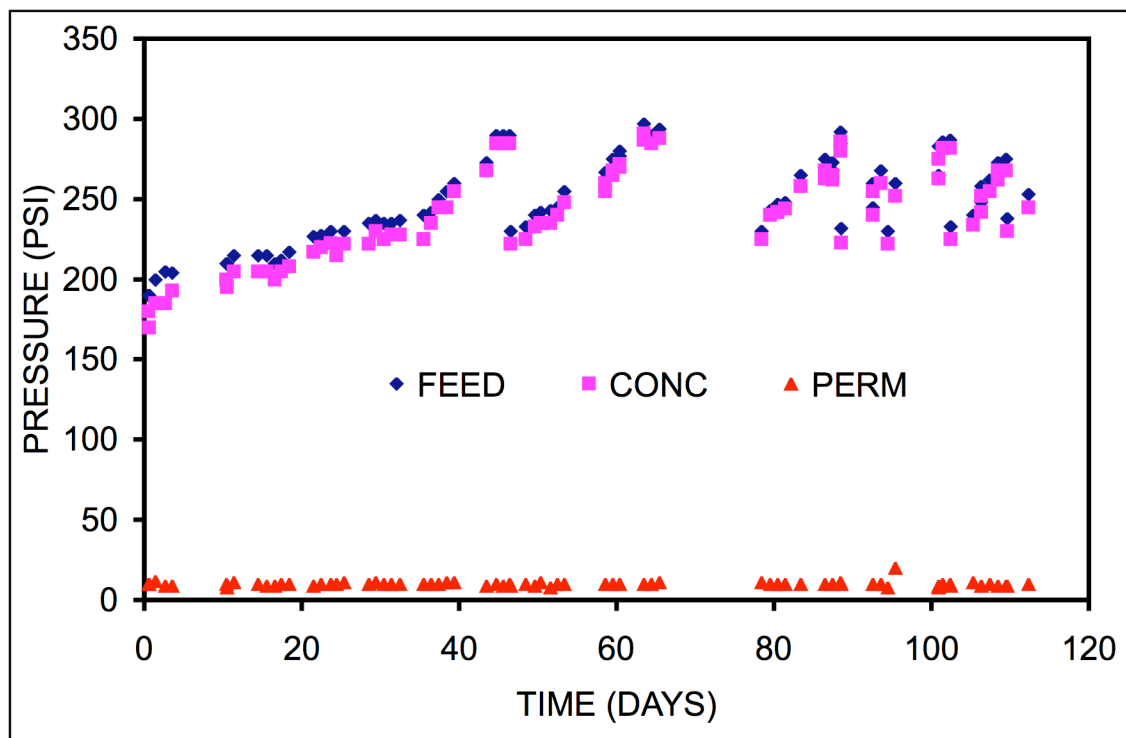
Figure 4. Gilroy plant: pressure profiles in the feed, concentrate and permeate during the initial period (10/17/06 - 2/06/07) while maintaining the flows shown in Figure 3.

The initial feed pressure increase (during the first 2 to 3 days of operation) to approximately 210 psi was attributed to membrane compaction. During the following four weeks, the pressure increased slowly by approximately 15% to 300 psi, which is the manufacturer's specified operational limit for these membranes. At this time, the system was cleaned with an acid solution (AM-11), after which water flux was restored and the operating pressure was reduced to about 225 psi. After another 2-week period, the feed pressure was again approaching 300 psi, at which point, the system was shut down for two weeks for winter break. Upon returning and restarting the system, the required feed pressure had dropped back to about 225 psi even though the system was not cleaned using a normal cleaning procedure suggesting either that the foulants (inorganic scale or biological deposits) redissolved.

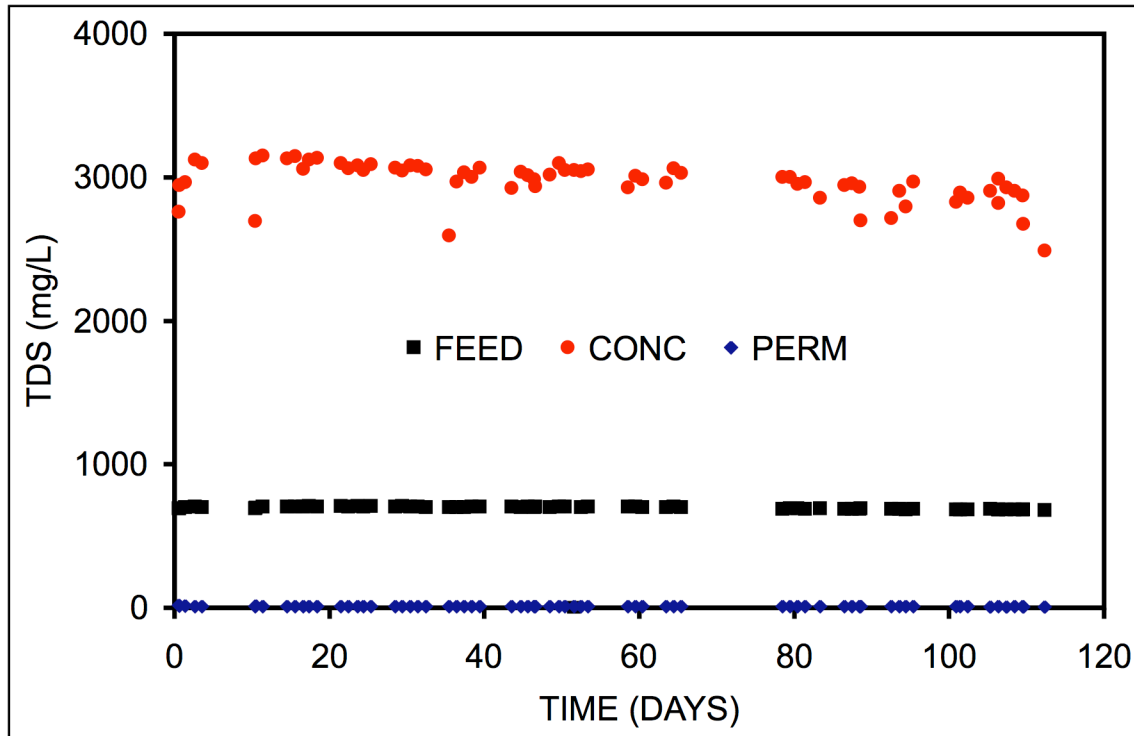
Figure 5. Gilroy plant: TDS concentration history in feed, concentrate and permeate (10/17/06 - 2/06/07).

The TDS data shown in Figure 5 indicate that the TDS (measured as electroconductivity) in the feed and in the concentrate remained relatively constant. The permeate TDS, which is shown in greater detail in Figure 6, decreased during the compaction period and then remained relatively stable at approximately 11 mg/L. Apparently salt rejection was largely independent of flow resistance and fouling. The pH in the concentrate was stable and higher than in the feed (Figure 7). The permeate pH was lower than in the feed, as expected. This observation has been observed by Belkacem et al. and is explained by the fact that  $H^+$  and  $CO_2$  permeate more easily through negatively charged membranes than the negatively charged counter ions (Belkacem et al., 2007). The pH decreased during the first 2 to 3 days by about 0.2 pH units; during the remaining study period, the pH decreased by approximately half a pH unit. The decrease appeared more rapid after the 13 day down period (at the end of the year). A possible explanation is that the isoelectric point of the membrane was lowered at that time. Figure 8 indicates that the overall performance of the RO plant in terms of salt rejection and water recovery was relatively stable with the average salt rejection at 98.4% (standard deviation (STD)  $\pm$  0.22%) and the water recovery at 83% (STD  $\pm$  1.6%).

**Salt Rejection and Water Quality:** Figures 5 and 6 show the TDS data, and Figure 7 shows the pH data, and Figure 8 indicates the overall performance of the plant in terms of recovery and rejection.

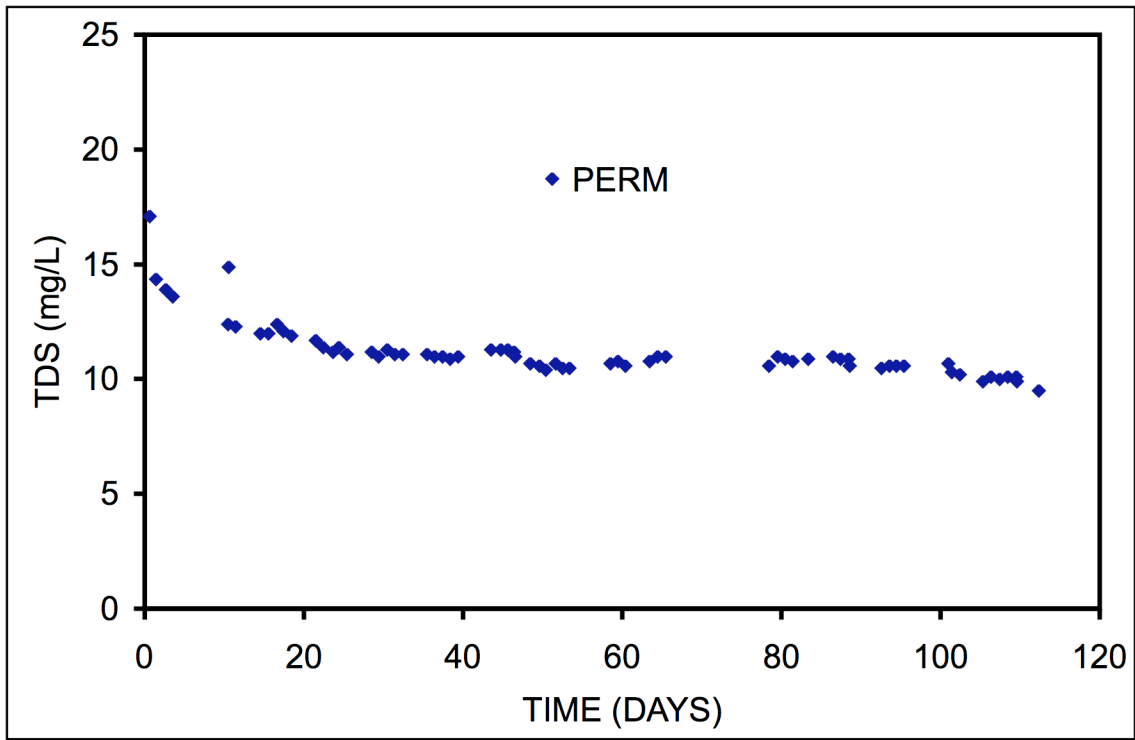
Figure 6. Gilroy plant: TDS in permeate concentration.

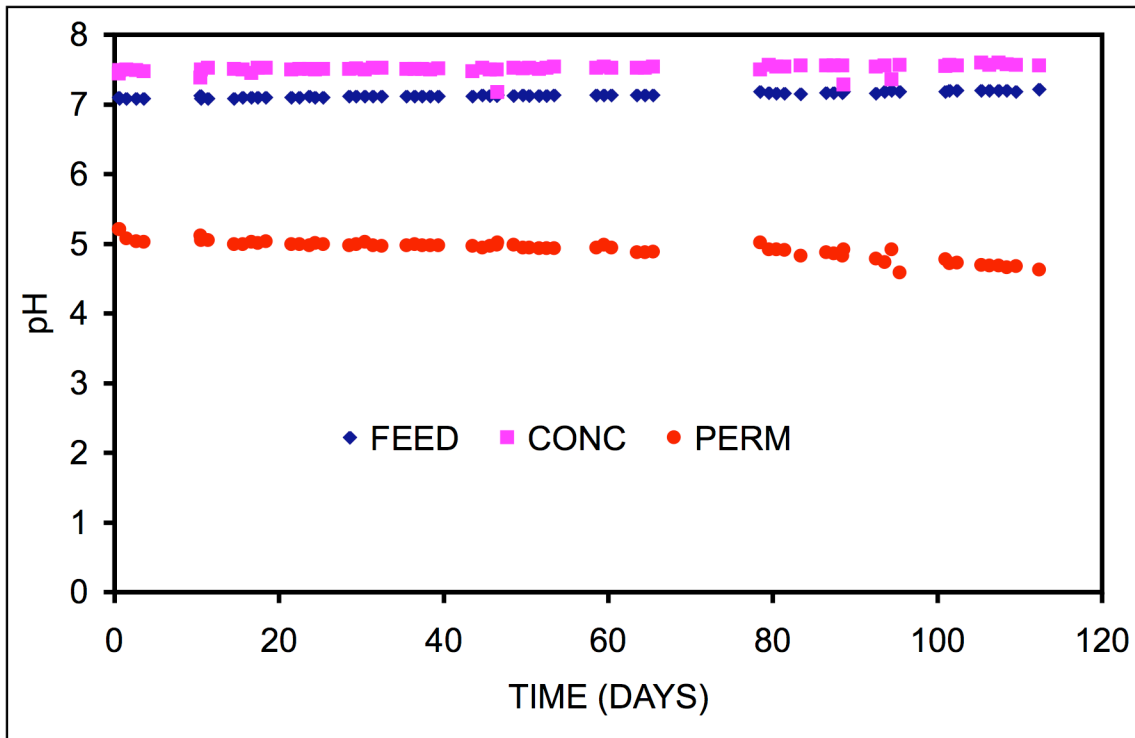
Figure 7. Gilroy plant: pH profiles.

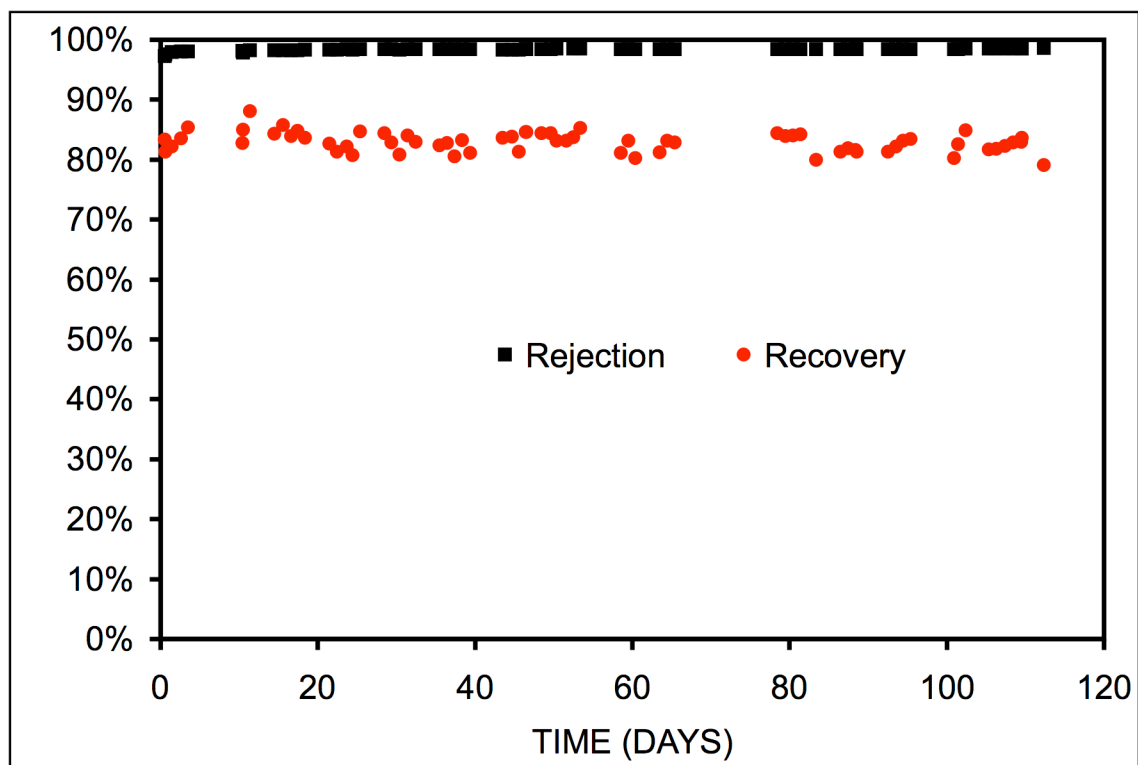
Figure 8. Gilroy plant: salt rejection and water recovery.

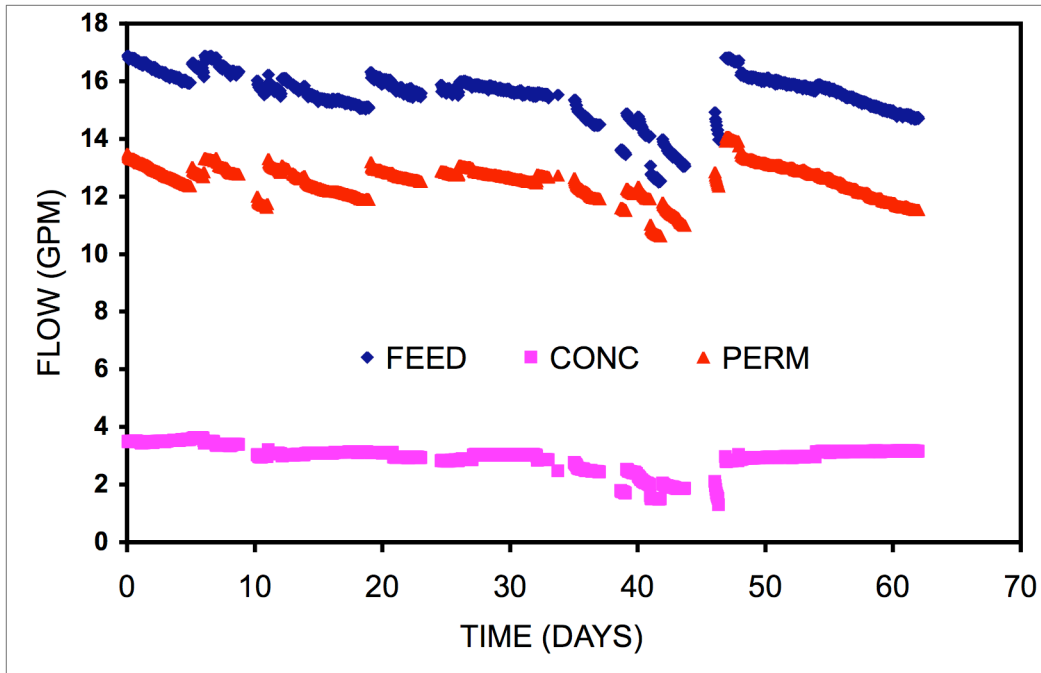
Figure 9. San Benito: Flows in the feed, concentrate, and permeate.

At startup on March 3, automated data collection began. The initial operational set points were feed 17 GPM, concentrate 3.5 GPM, permeate: 13.5 GPM and recycle flow 5.3 GPM, corresponding to a recovery of 79%. This was about 10% lower than during the initial operations in the fall in order to decrease initial system pressure. The initial pressure was approximately 260 psi and increased to approximately 280 psi within 5 days, after which the system received a 0.06% peroxide cleaning, followed two days later by a AM-11 (acid) cleaning.

**Hydraulic performance:** Figures 9 and 10 display the flow rates and the pressure data collected.

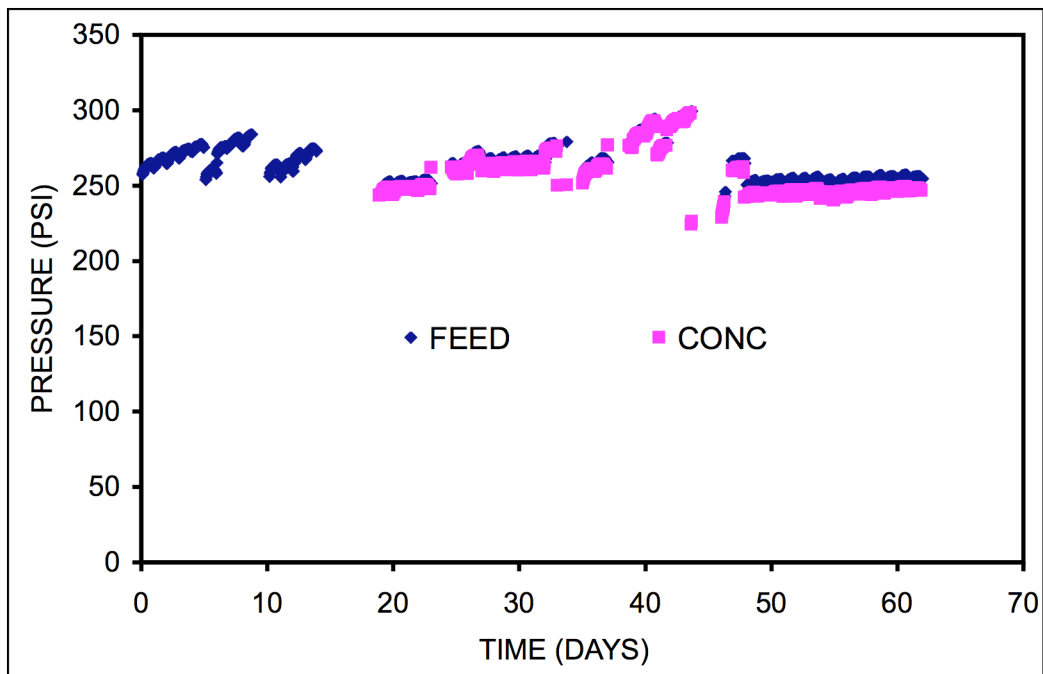
Figure 10. San Benito: Pressure profiles in the feed, concentrate and permeate during the initial period.

The operating pressure following the acid cleaning decreased back to approximately 260 psi. Two days later, another power failure shut the system down for nearly 24 hours.

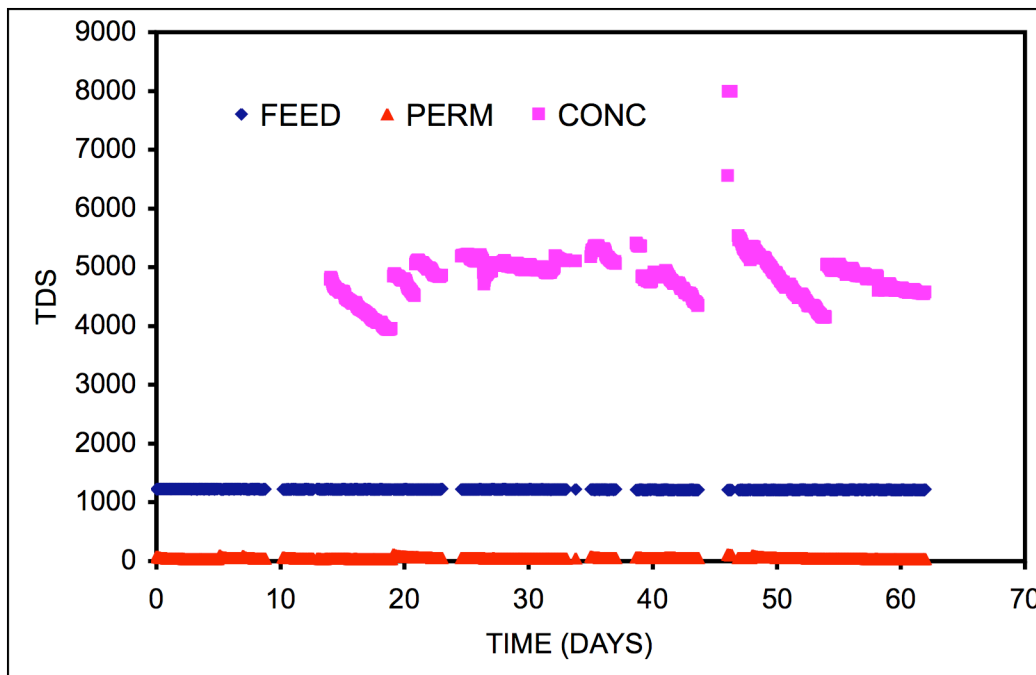
Figure 11. San Benito: TDS concentration history in feed, concentrate and permeate.

**Salt Rejection and Water Quality:** The results of scaling on the concentrate TDS probe and its cleaning can be seen in Figure 11. The TDS data indicate the TDS (measured as electroconductivity) in the feed remained relatively constant. Electroconductivity measurements are sensitive to the ion composition and thus are not linear. The TDS concentration in the permeate flow decreased rapidly after cleanings before approaching a value of approximately 60 mg/L, as shown in Figure 12. The reason for this dependence was not investigated, but may be caused by the antiscalant AM-11 used to clean the membranes. The reasons for the decreasing TDS after cleaning events are not clear.

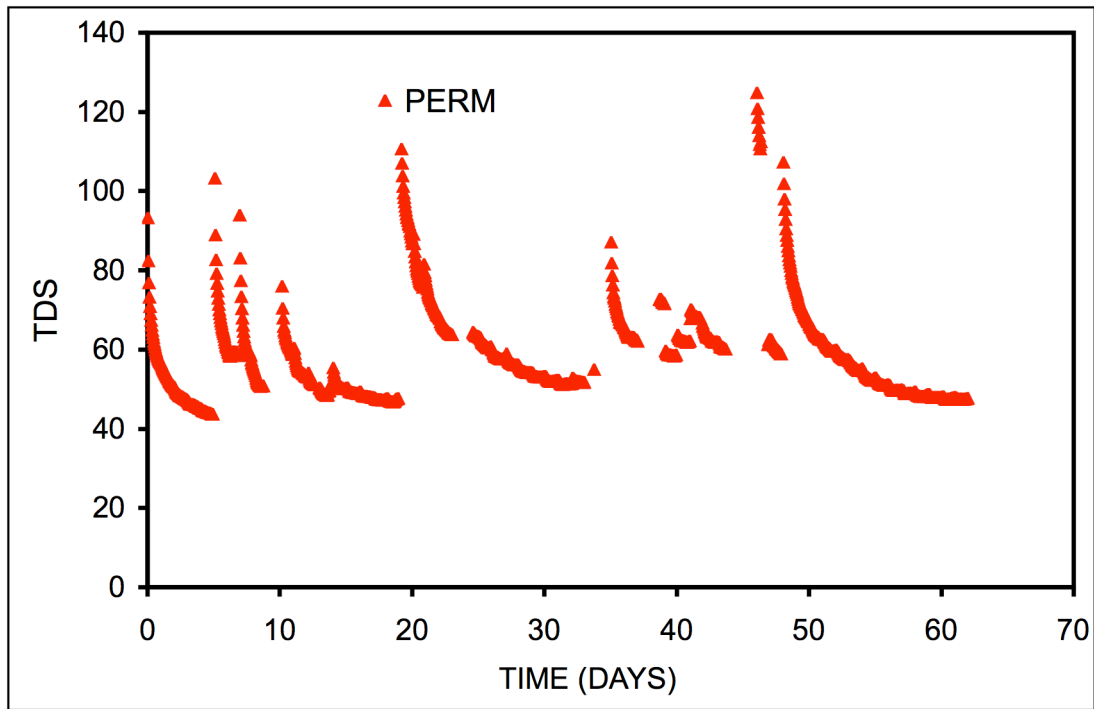
Figure 12. San Benito: TDS concentration in permeate.

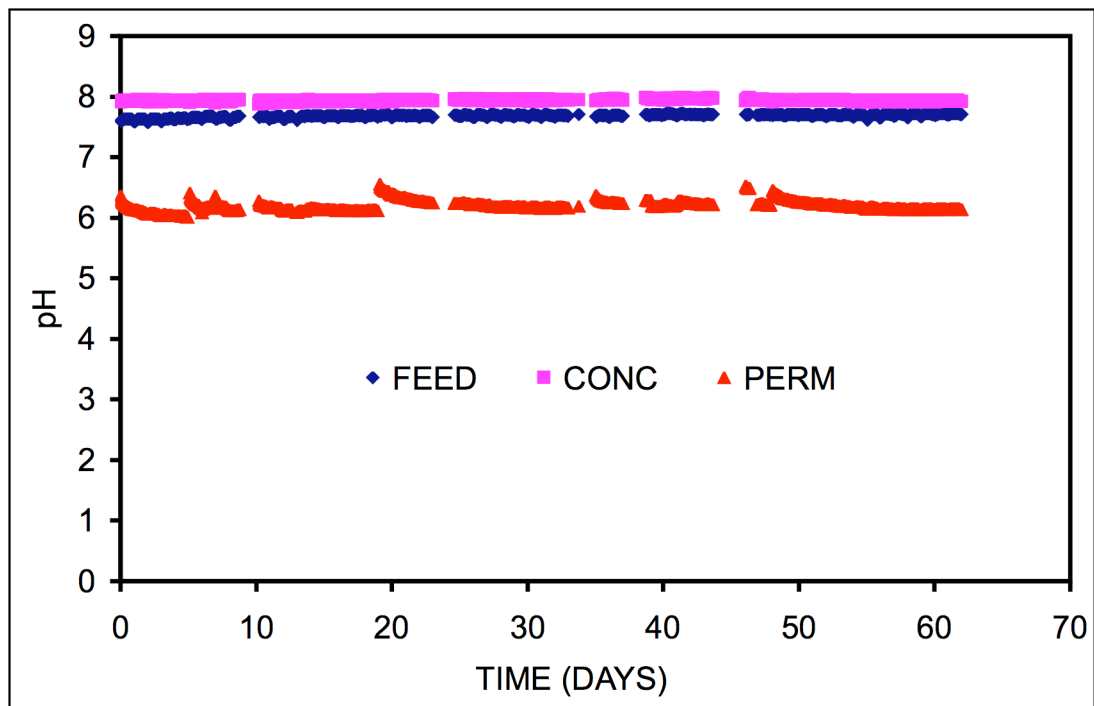
Figure 13. San Benito plant: pH profiles.

The spikes in pH coincided with cleaning events and the conductivity spikes. The cause of this is unclear at this point. Figure 14 shows the performance of the RO unit at San Benito. Average salt rejection and water recovery at this plant for was 96% (STD  $\pm$  0.29) at a water recovery of 79% (STD  $\pm$  3.1).

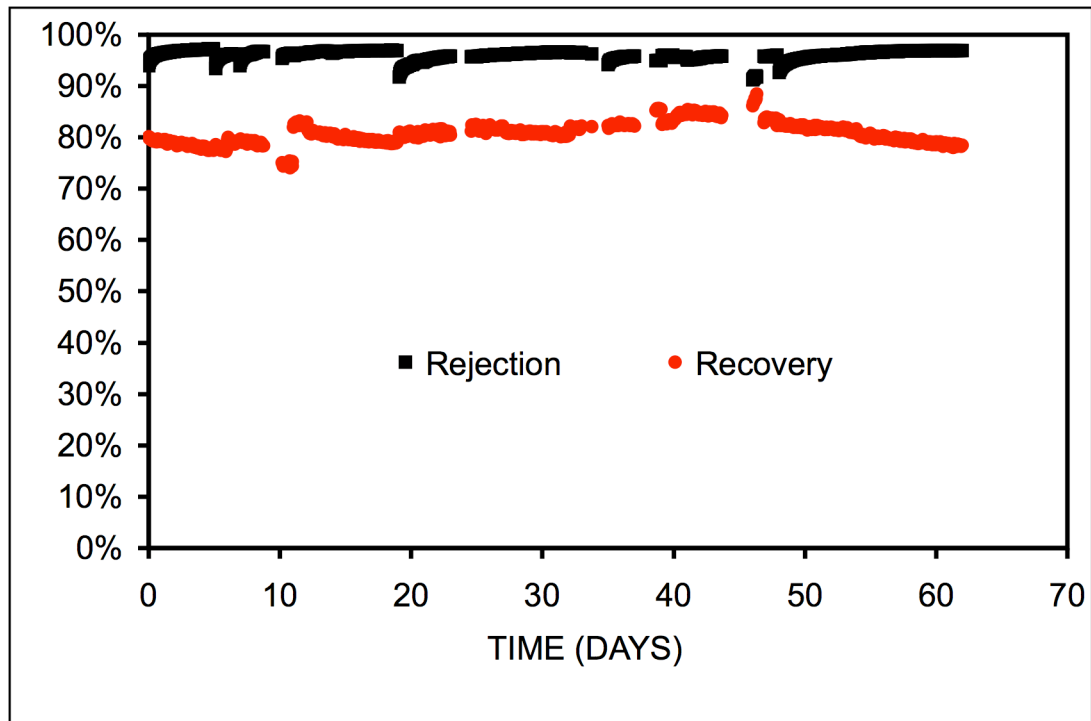
Figure 14. San Benito: Salt rejection and water recovery.

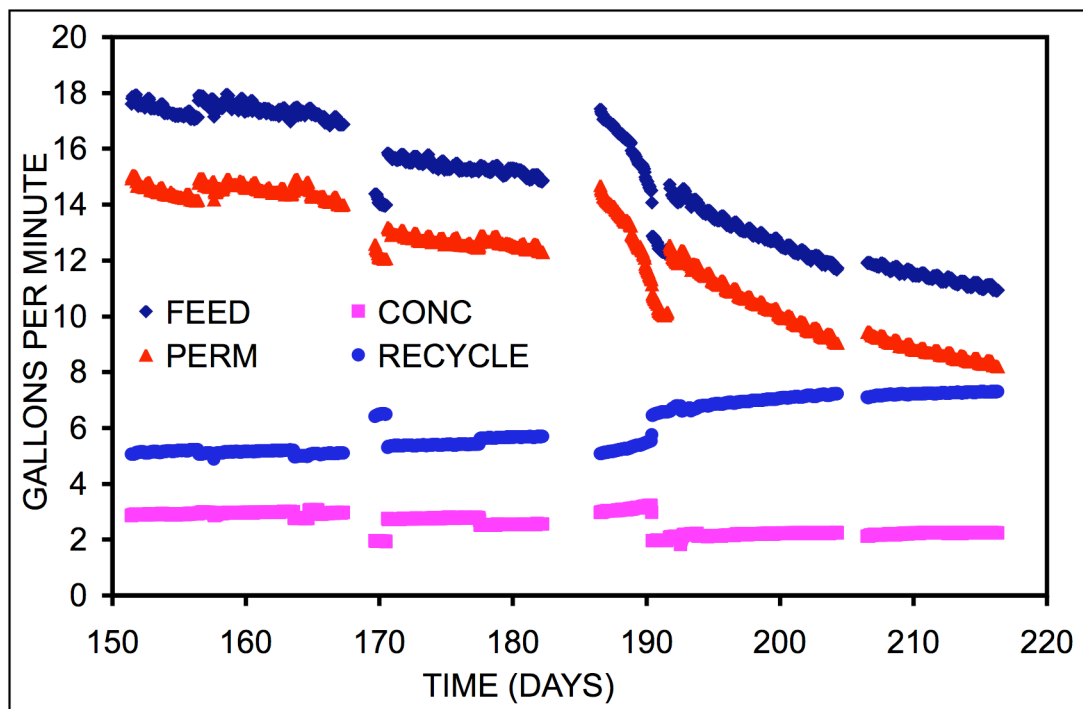
Figure 15. Gilroy: feed, permeate, recycle and permeate flows during the fouling study period. Changes in operational conditions are indicated in Figure 16.

At the beginning of the fouling studies, a single flat cell was installed and the addition of antiscalant (Flocon 260) was terminated. After about 15 days (on Day 165), 50 gallon 0.06% hydrogen peroxide cleaning was performed which had little impact. At Day 169, the system was cleaned with 120 gallon hydrogen peroxide (0.06%) and flowrates were decreased intentionally upon startup and the single flat cell was changed to a three flat cell configuration. At Day 183, the system was acid cleaned after pulling the last membranes from pressure vessels 3 and 4. A new antiscalant pumping system was installed to add Flocon 260 at a lower dosage, about 3.5 mg/L. Flowrates were increased upon startup. Five days later, the system was cleaned three times, peroxide followed by acid followed by peroxide. Then the system was restarted at a lower flowrate. Flowrates were allowed to decrease over the next 28 days. Elements were removed for internal autopsy at Day 206 and for autopsy by AMI on Day 218.

Figures 15 and 16 show the hydraulic performance and Figures 17 and 18 indicate TDS removals during the fouling study.

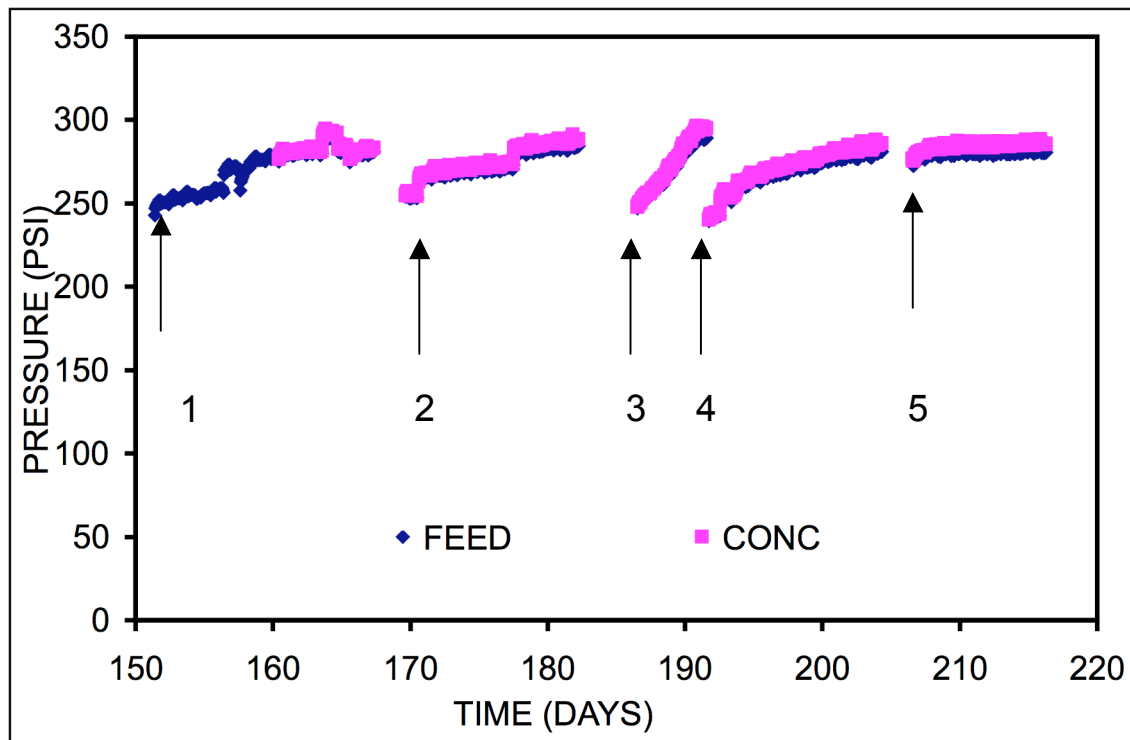
During the first 35 days of the fouling studies, the antiscalant (Flocon 260) was not added. When the pressure built up, a 0.06% hydrogen peroxide cleaning was performed but this had no impact. Upon restarting, flows were decreased in order to lower operating pressures.

Figure 16. Gilroy: feed, concentrate and permeate pressures during the fouling study period. 1: Hydrogen Peroxide, Restart at Lower Flows Cleaning; 2: Acid (AM-11) Cleaning; 3: Start Low Dose Falcon 260; 4: Hydrogen Peroxide/Acid/Hydrogen Peroxide Cleaning; 5: Removal of membrane for autopsy.

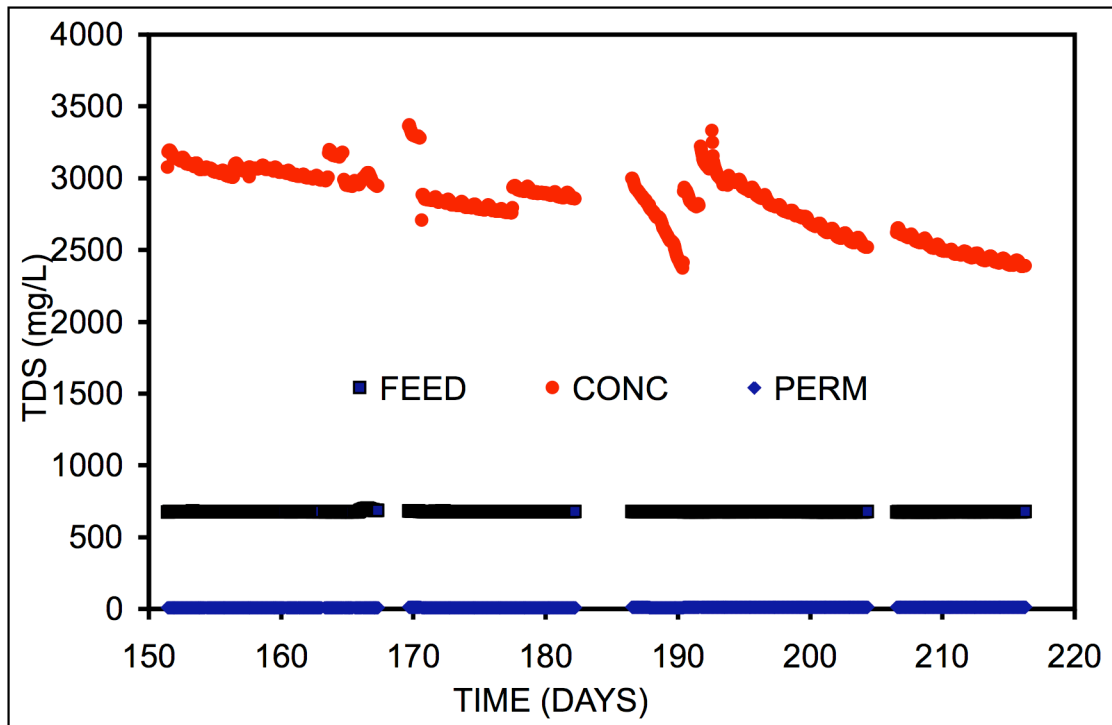
Figure 17. Gilroy: TDS in feed, concentrate and permeate flows during the fouling study period.

The variations in concentrate TDS show that it is sensitive to variations in concentrate flow for relatively fixed feed and permeate flows (Figure 17). As shown in Figure 18, the permeate TDS shows a gradual decrease in salt rejection over the time period of these fouling studies. Of interest is the data around Day 190 where there is a decrease in TDS over a period of time after restarting the system. This was commonly seen in the San Benito RO system and may indicate a leakage, possibly from extracting and replacing membranes for autopsy. The pH data shown in Figure 19 show the expected pH shifts.

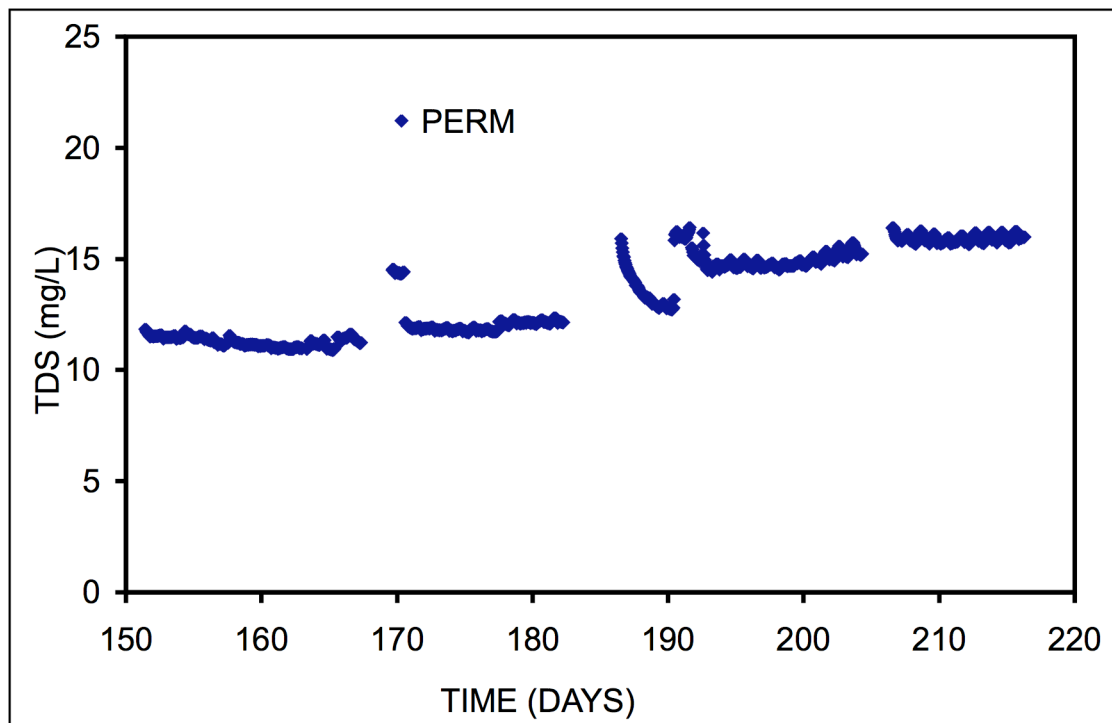
Figure 18. Gilroy: TDS in permeate during the fouling study period.

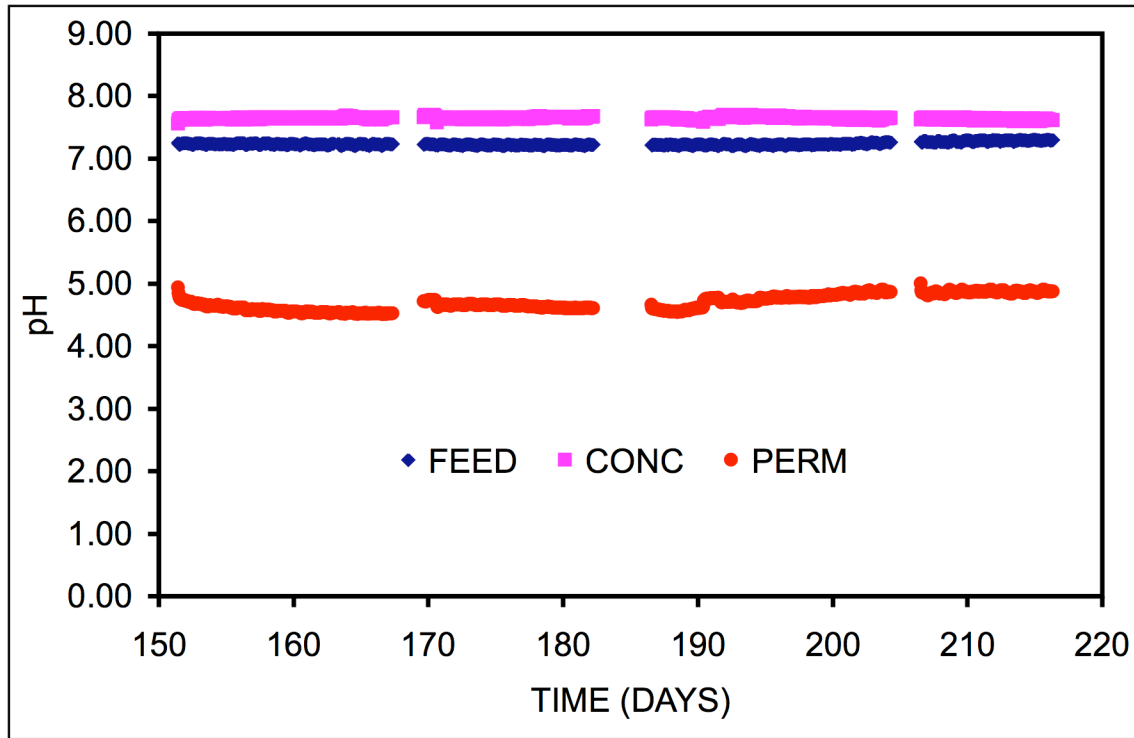
Figure 19. Gilroy: pH during the fouling study period in the feed, concentrate, and permeate.

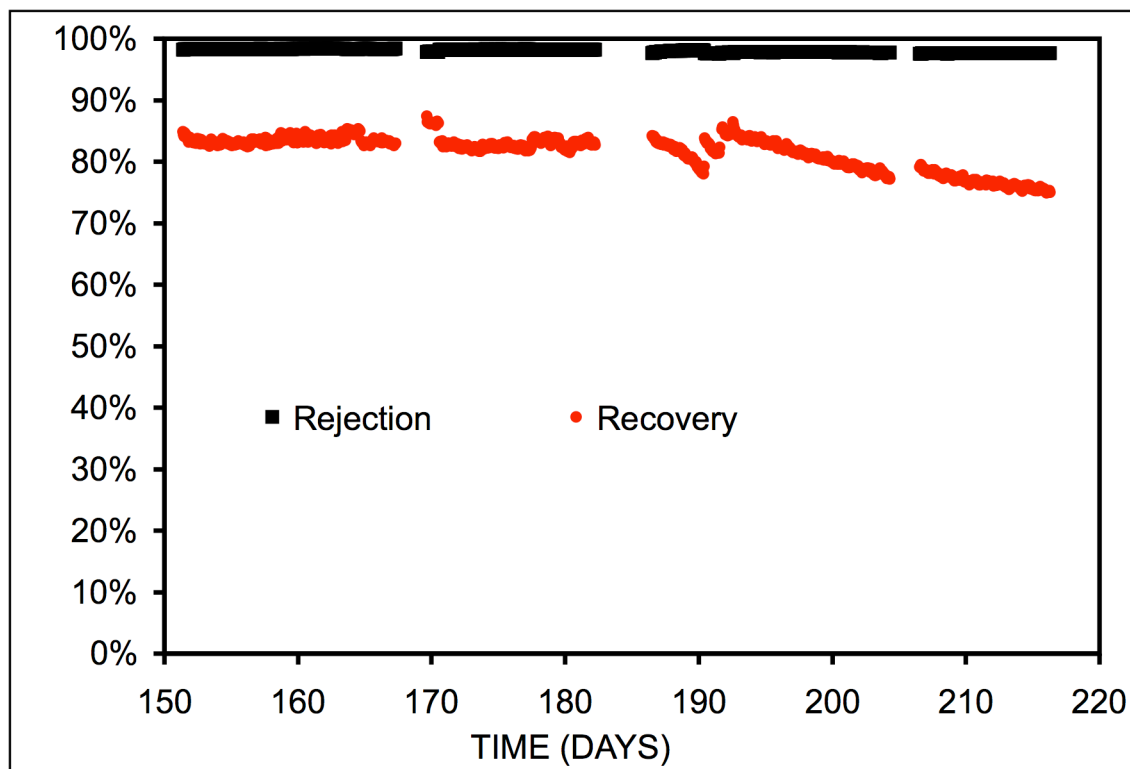
Figure 20. Gilroy: rejection and recovery during the fouling study period.

Figure 20 indicates rejection and recovery during the fouling study period when cleaning was discontinued. Recovery declined from Day 190 onward after the last cleaning event.

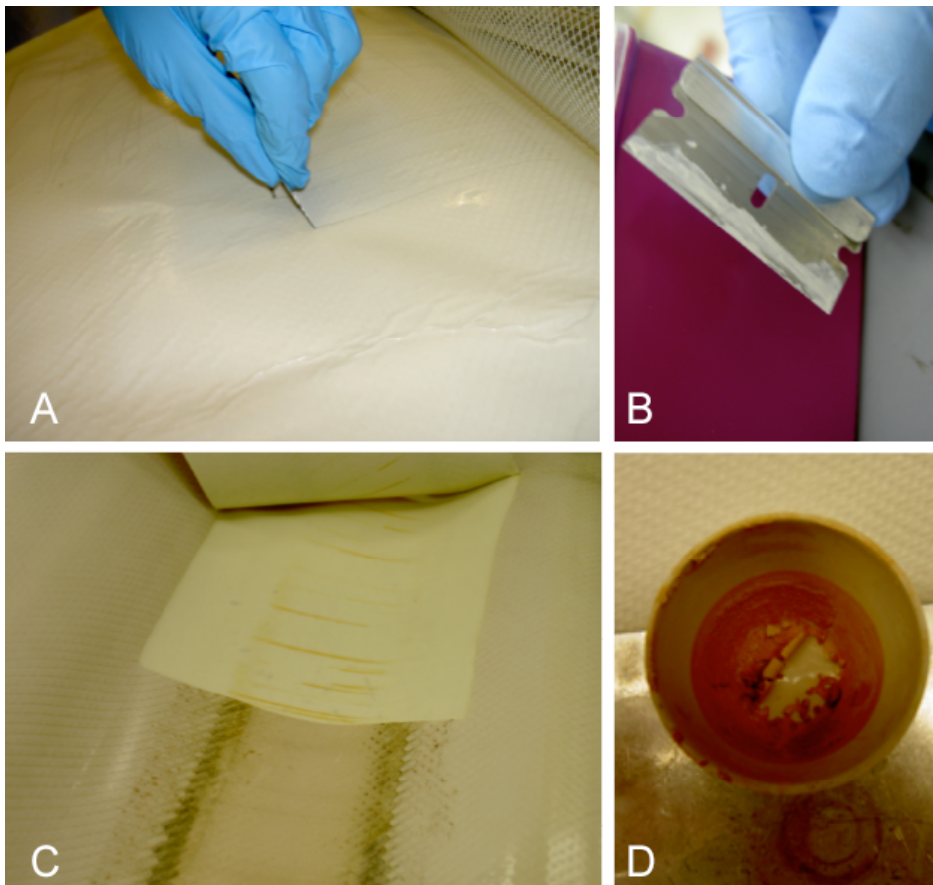
Figure 21. Visual inspection of membrane and collection of fouling material.

(A) Gilroy – Deposit collection using a sterile razor blade. (B) Gilroy – fouling material collected on a razor blade. (C) San Benito – The fouling material is the brown-green

Field and laboratory cleaning tests showed a fraction of flux loss was resistant to cleaning. To gain insight into the fouling mechanism an attempt was made to characterize the fouling material. Terminal elements of both plants were brought back to the laboratory and subjected to autopsy using a number of chemical and spectroscopic methods. Upon opening, the elements and the fouling layer were visually inspected. Photographs in Figure 21 depict the material collection and samples of the dried material.

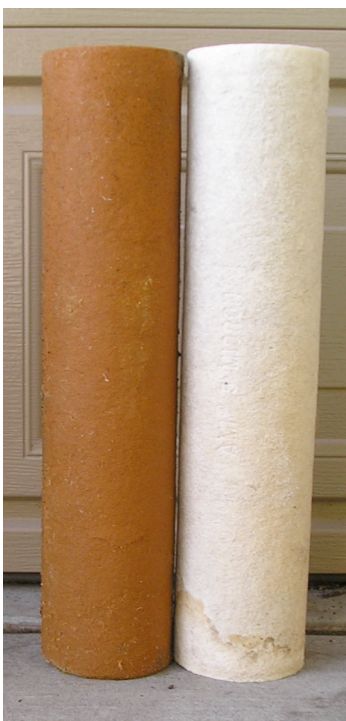
A spent 5-micron prefilter from the San Benito plant was analyzed to identify solids that were retained from the well water. Figure 22 shows a picture of the filter taken from the San Benito and the Gilroy sites on after approximately 500,000 and 1,000,000 gal of use.

Figure 22. Photograph of 5 micro pre-filters from San Benito (left) and Gilroy (right) sites after approximately 500,000 and 1,000,000 gal of use.

The two filters reflect the different geochemistry at the site, which was more reducing at the San Benito site. Samples of the discolored San Benito filter material were soaked in 0.2 mol/L nitric acid for several hours. The leachate was then diluted and analyzed with ICP. The results of these analyses are shown in Table 13. The data indicate the presence of iron but the form in which it was present cannot be determined. It appears likely that iron was present in soluble or colloidal form and was entrapped by the filter. The sulfide odor that developed after the deposits were dissolved in nitric acid may have been indicative for the presence of iron sulfides. Calcium and magnesium were also present at significant levels on the prefilter, and they probably existed in the forms of carbonate salts. Manganese was not found at significant level on the prefilter, which is consistent with the results shown in Figure 23.

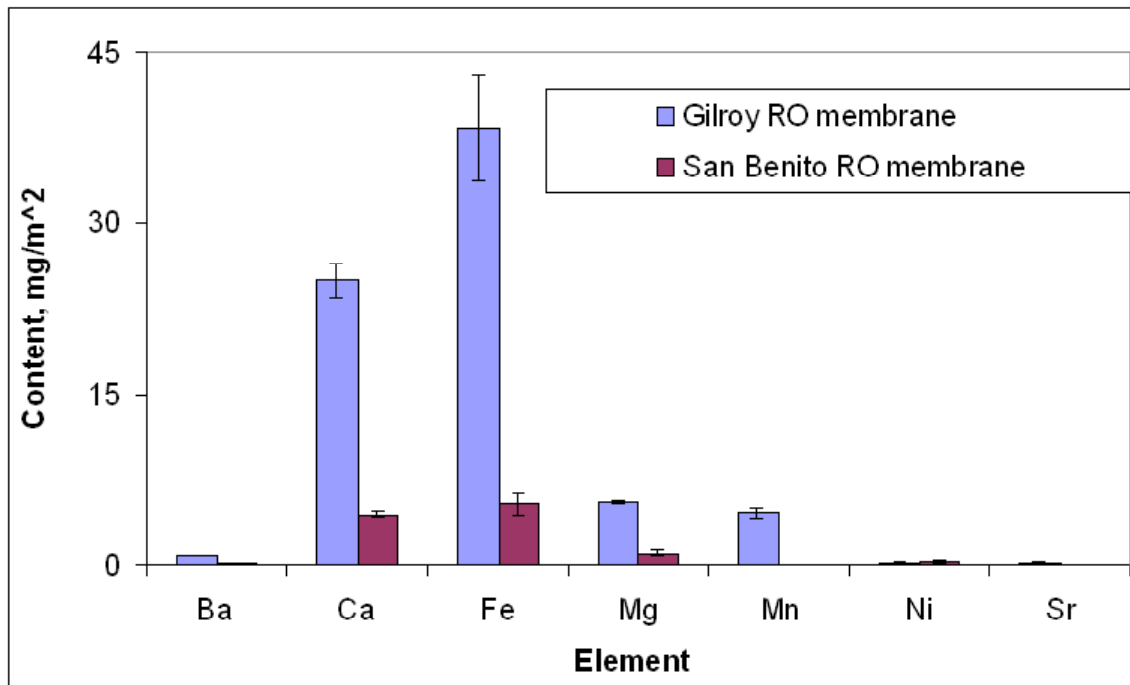
Small coupons were cut from the spent RO membranes from the Gilroy and the San Benito plants and were leached in 0.2 mol/L nitric acid for several hours. The elements detected by ICP analysis are indicated in Figure 22. The metal contents were higher on the membrane from Gilroy, which had been in operation for 6 months compared to 3 months for membranes at San Benito. Of the elements detected, calcium and iron were present in the highest quantities, followed by magnesium and manganese, traces of barium, nickel and strontium. After the November 21 power failure at San Benito, a white precipitate was collected in the recycle loop and the feed channel and was analyzed using X-ray diffraction (XRD). The spectrum of this material (not shown) indicated mixtures of amorphous solid. Elemental and spectroscopic analyses didn't reveal the type of phases that were deposited on the membranes and causing the observed flux decline.

Figure 23. ICP analyses of deposited material collected from the Gilroy and San Benito sites. Error bars represent the standard deviation of 4-fold replicate analyses.
