# **Final Report**

## **Evaluation of Reverse Osmosis for Brackish Groundwater Desalination at Gilroy and Hollister, CA.**

**Martin Reinhard, Gary D. Hopkins,  
Jennifer S. Louie, Sophie Walewijk, Hefa Cheng  
Department of Civil and Environmental Engineering  
Stanford University  
Stanford, CA 94305**

August 2008

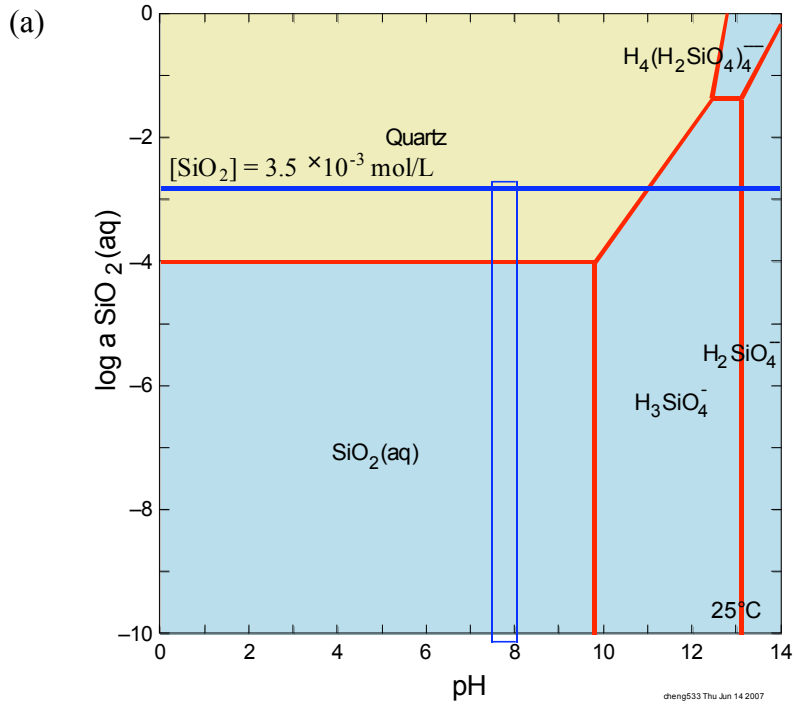
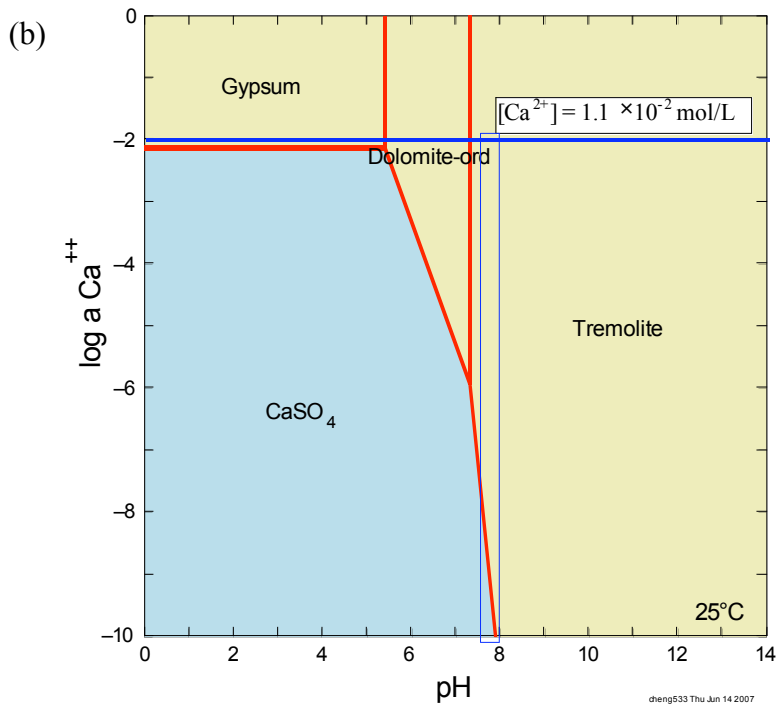
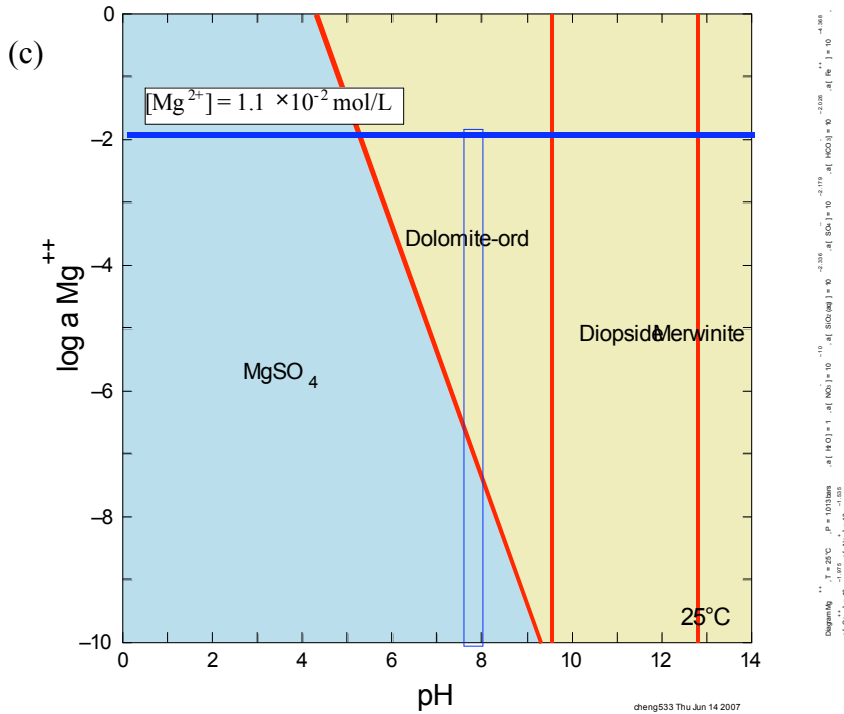
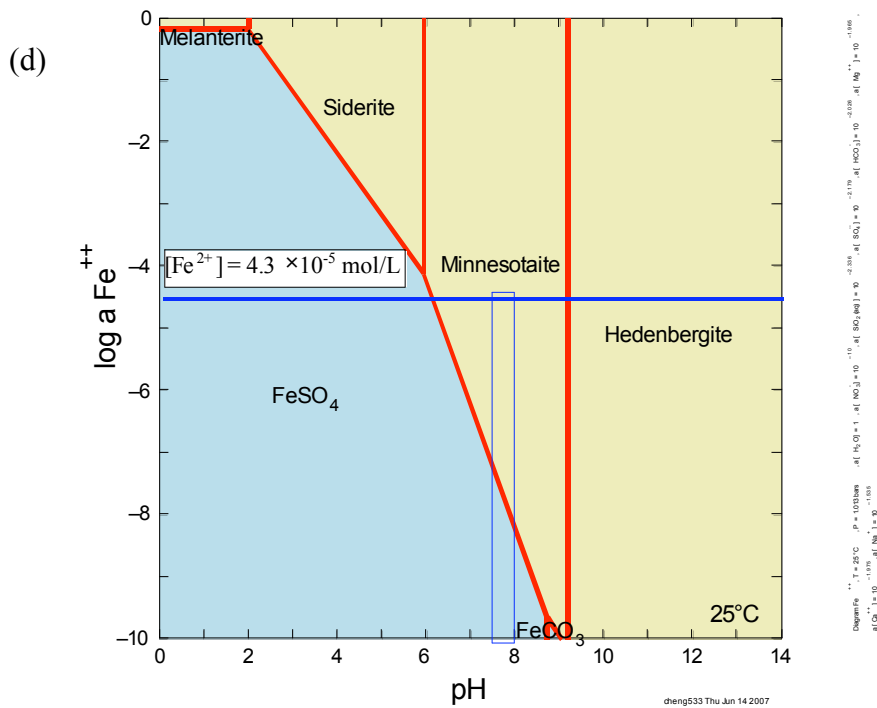
Equilibrium thermodynamic calculations were conducted in conjunction with laboratory testing to study the cause of RO membrane fouling. Mineral phase diagrams for the aqueous speciation and solubility of  $\text{SiO}_{2(\text{aq})}$ ,  $\text{Ca}^{2+}$ ,  $\text{Mg}^{2+}$  and  $\text{Fe}^{2+}$  were calculated with the Geochemist's Workbench (version 6.0) software package. Figures 24a to 24d show the phase diagrams for speciation of  $\text{SiO}_2$ ,  $\text{Ca}^{2+}$ ,  $\text{Mg}^{2+}$ , and  $\text{Fe}^{2+}$  in the RO concentrate of the Gilroy plant. At near neutral pH range,  $\text{SiO}_{2(\text{aq})}$  concentrations higher than  $10^{-4}$  mol/L become supersaturated (Figure 24a).  $\text{SiO}_{2(\text{aq})}$  concentration in the RO concentrate ( $3.5 \times 10^{-3}$  mol/L) is clearly above this limit, even without considering the concentration polarization effect. Amorphous silica does not appear on the phase diagrams here because it is not the thermodynamically stable form of  $\text{SiO}_2$ . The phase diagrams of  $\text{Ca}^{2+}$  (Figure 24b) and  $\text{Mg}^{2+}$  (Figure 24c) both suggest that dolomite controls aqueous solubilities of  $\text{Ca}^{2+}$  and  $\text{Mg}^{2+}$  at near neutral pH and that dolomite precipitation can occur in the RO concentrate even in the absence of concentration polarization effects. Finally, the phase diagrams of  $\text{Fe}^{2+}$  (Figure 24d) suggest that the  $\text{Fe}^{2+}$  ( $4.3 \times 10^{-5}$  mol/L) is supersaturated in the RO concentrate with respect to minnesotaite in the pH range of 7.5-8.0. It should be noted that the concentration polarization effect further increases the precipitation of minerals in the concentration polarization layer near the RO membrane surface compared to that in the bulk solution. Modeling RO rejection and scaling using the ROSA software package indicated potential silica scaling (Appendix G.)

Figure 24. Stability diagram and the concentration of (a) silica, (b) Ca<sup>2+</sup>, (c) Mg<sup>2+</sup>, and (d) Fe<sup>2+</sup> in RO concentrate of Gilroy plant. The pH of RO concentration is in the range of 7.5 to 8.0, as indicated in the diagrams.

Overall, the thermodynamic calculations indicate that significant silica precipitation can occur in the RO concentrate, while the precipitation and calcium-, magnesium-, and iron-

containing salts are also possible. These results are consistent with the high contents of calcium, magnesium, and iron in the prefilter and RO membranes observed in elemental analysis (with the exception of silicon, which was not measured). Confirmation of the chemical compositions of the fouling materials and the mineral phases that formed on the RO membranes was beyond the scope of this study. It will require more detailed laboratory and field investigations. Because the identity of the fouling materials remains unknown, the optimal antiscaling agents and cleaning procedures cannot be determined. Since manufacturers do not disclose the composition of the antiscaling agents, collaboration with manufacturers will be required to optimize the process. These calculations are based on the assumption that the solid phases formed are thermodynamically controlled and do not consider the rate at which the precipitates are formed. Furthermore, the calculations consider only the crystalline phase while amorphous mineral phases almost always precipitate first. The modeling considers a closed system without accounting for the possible carbon dioxide passage through the membrane. Solid phases formed on the concentrate side of the membrane are not necessarily the cause for the observed flux decline because interactions with the membrane could depend on size, surface properties, and membrane-solid interactions, which are unknown. Because analytical data are consistent with the phases predicted by modeling, scaling inhibitors should be targeted towards to control the precipitation of silica, dolomite and potentially iron sulfide.
