PART IV //

LANDSCAPE CHANGE

Part IV assesses how the historical landscape has been transformed into present-day conditions. In the first section, we summarize major events in the land use history of the watershed. Next we describe the trajectories of change in landscape features and associated habitats. In the final section, we discuss some of the implications for watershed restoration and management.

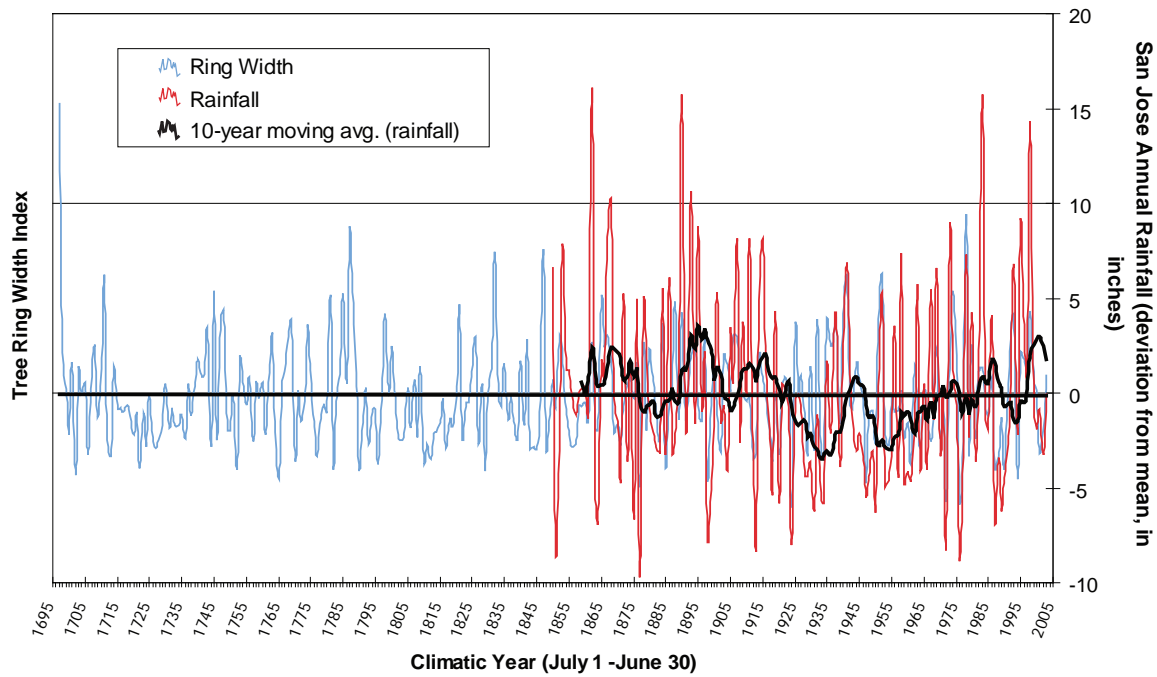
FIGURE IV-1. CLIMATE TIMELINE FOR SANTA CLARA VALLEY. Rainfall data for San Jose, 1874-2004, with 1850-1873 extrapolated based upon San Francisco data, courtesy of Jan Null. Tree ring data from a blue oak near Alum Rock Park (unpublished data provided by David Stahle, University of Arkansas).

The present-day landscape is the product of previous land use events and activities, superimposed upon natural landscape patterns. Climatic variation and catastrophic events also drive landscape change (**FIGURE IV-1**). Understanding landscape change is particularly important in urban watersheds with complex histories of modification, where streams are responding to a combination of recent and historical impacts. This section summarizes the land use history of the Coyote Creek watershed. Several of the major land use trends affecting Coyote Creek are illustrated in **FIGURE IV-2** using a single temporal axis. The following chronology summarizes some of the significant impacts to provide a basis for the discussion of landscape trajectories.

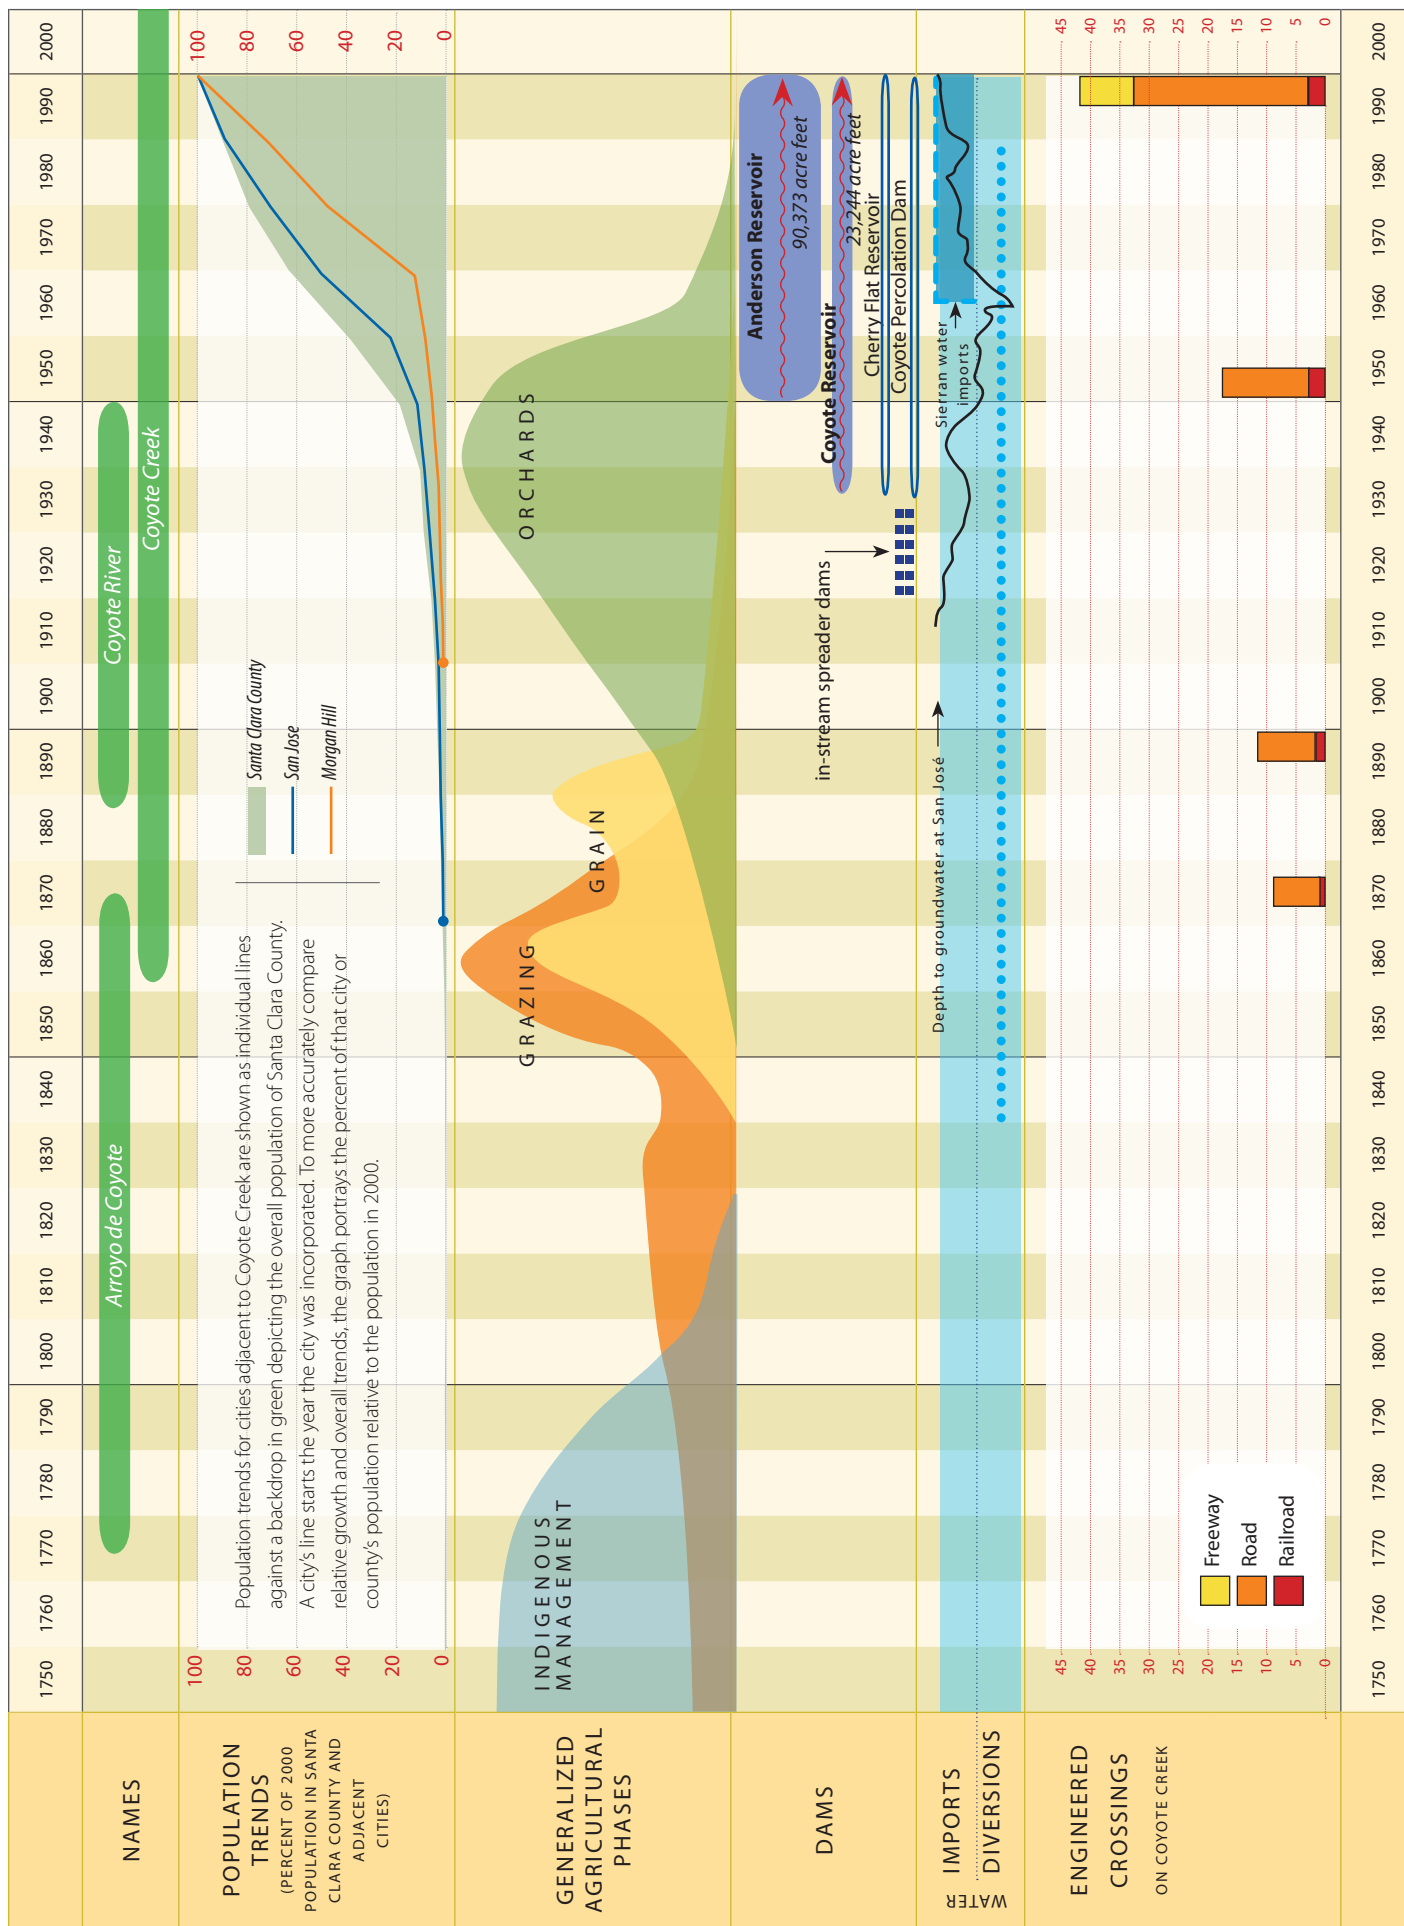
FIGURE IV-2. LAND USE TIMELINE FOR COYOTE CREEK.

Rapid soil depletion and shifting markets lead to the decline of wheat farming, which peaked at an estimated 60,000 acres within the County, and replacement largely by orchards (see FIGURE IV-2; Broek 1932: 106).

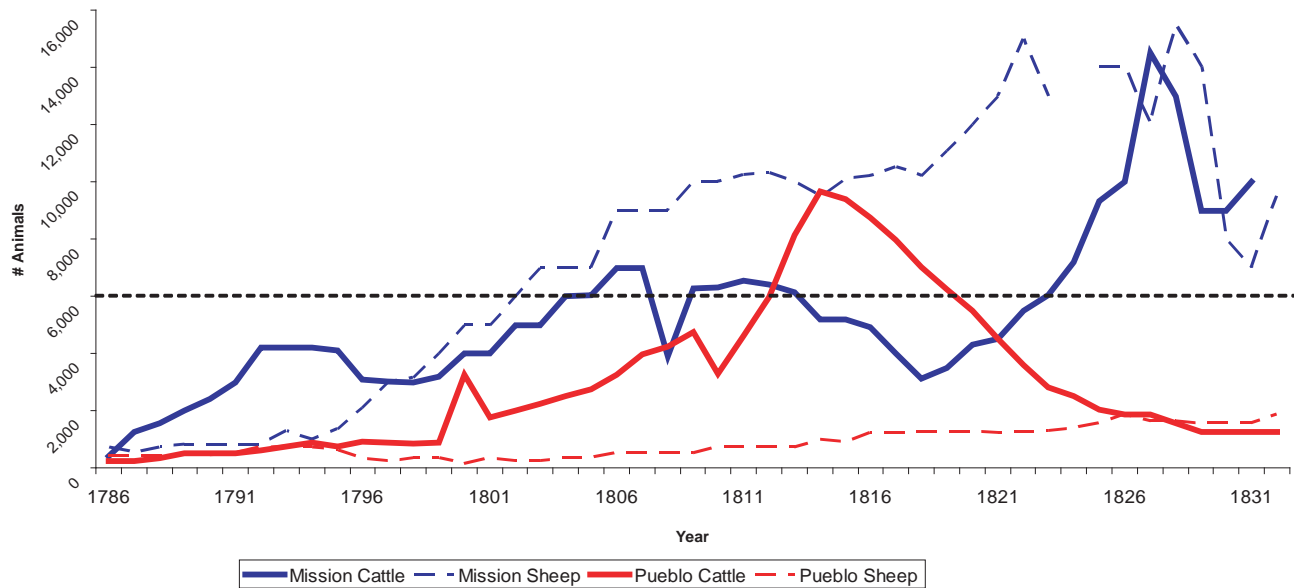
FIGURE IV-3. MISSION ERA STOCKING LEVELS IN THE SANTA CLARA VALLEY. In 1798 Guadalupe River was established as the eastern boundary for the Mission Santa Clara ranch (Friedly 2000: 126), so Pueblo San Jose activities are most relevant to Coyote Creek. While the Mission reported high numbers of sheep, Pueblo ranching seems to have focused primarily on cattle. Numbers increased gradually until about 1810, reached a moderately high level for about a decade, then decreased steadily. The dashed black line indicates what would be a moderate stocking density of one cow in 10 acres (Bancroft 1890), based upon our estimate of the Pueblo's valley floor ranchland. Stocking data from Broek (1932), Jackson and Castillo (1995), and Friedly (2000).

tively low for the first quarter-century of operation. By 1812, Pueblo cattle stocking levels correspond to a moderate density (dashed black line = ~1 cow in 10 acres; Bancroft 1890). Intensity increases, then decreases for the next two decades (**FIGURE IV-3**).

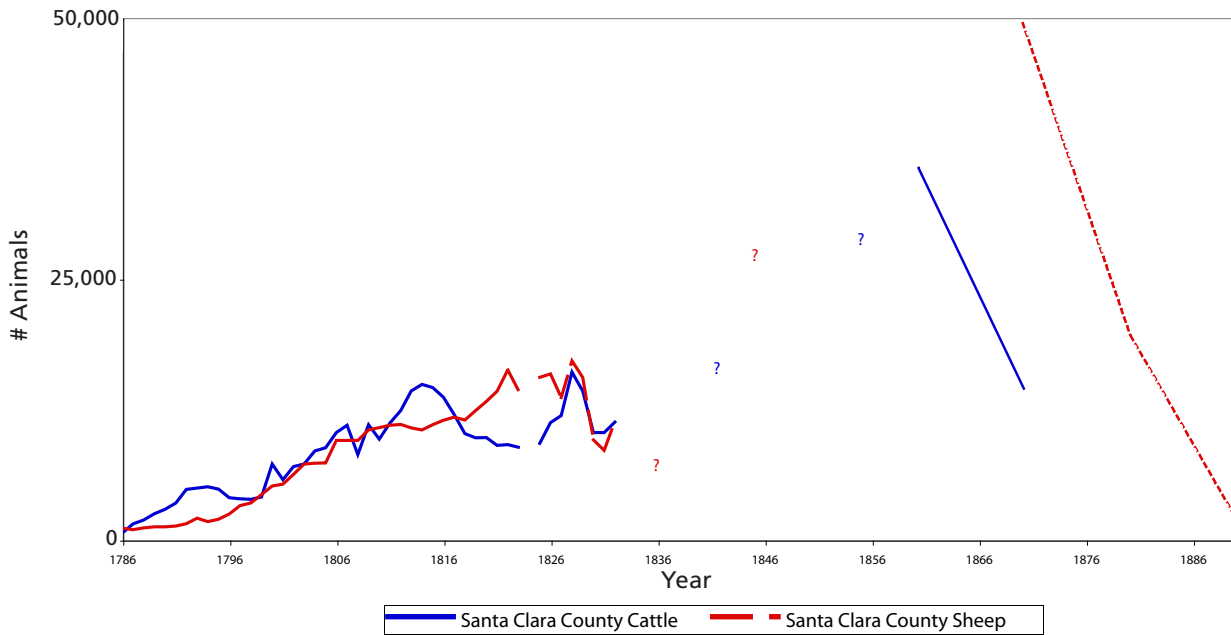
FIGURE IV-4. REPORTED NUMBERS OF CATTLE AND SHEEP IN SANTA CLARA COUNTY, 1786-1896. This graph looks at the entire County, not just Coyote Creek. During the Mission era, stock numbers show an overall increase until the disbanding of the missions in the early 1830s. It is likely that numbers increased substantially during the 1840s, based upon individual rancho reports. Numbers prior to 1834 are the sum of Pueblo San Jose and Mission Santa Clara values; County livestock data from Broek (1932).

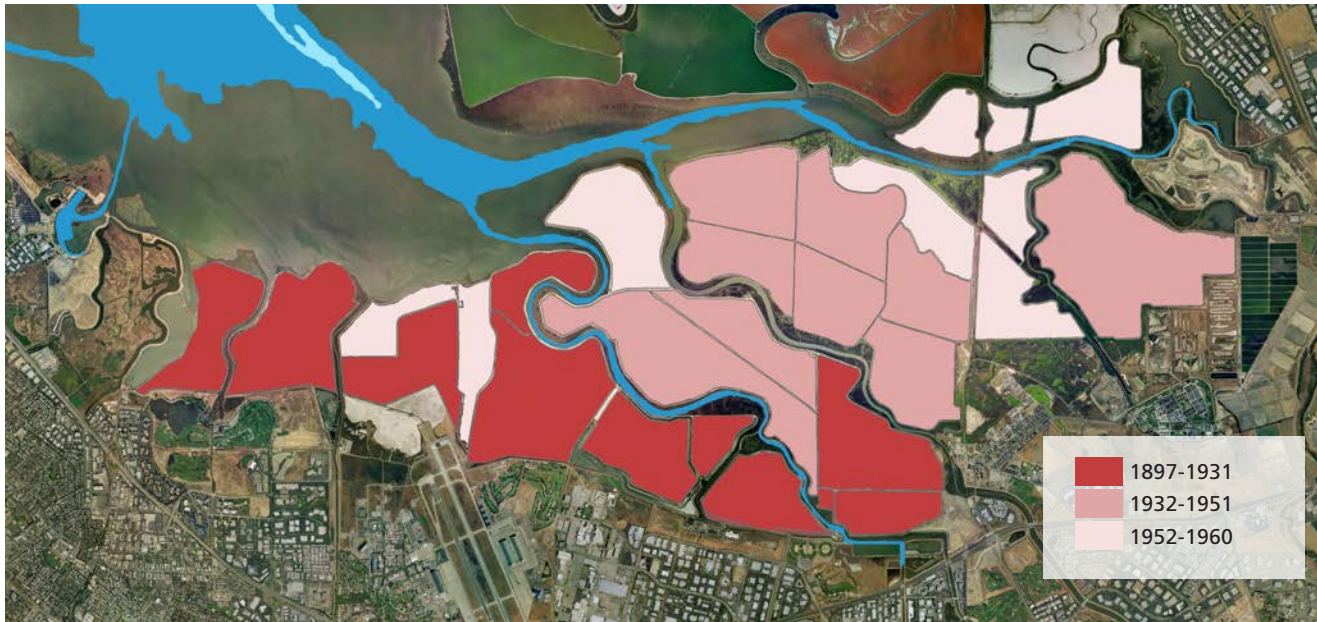
FIGURE IV-6. TIMING OF SALT POND DEVELOPMENT AT THE NORTHERN END OF SANTA CLARA VALLEY. The area at the mouth of Coyote Creek (right side) was one of the last Bayland areas in the region to be diked (2002 Imagery Copyright 2005 AirPhotoUSA, LLC, All Rights Reserved).

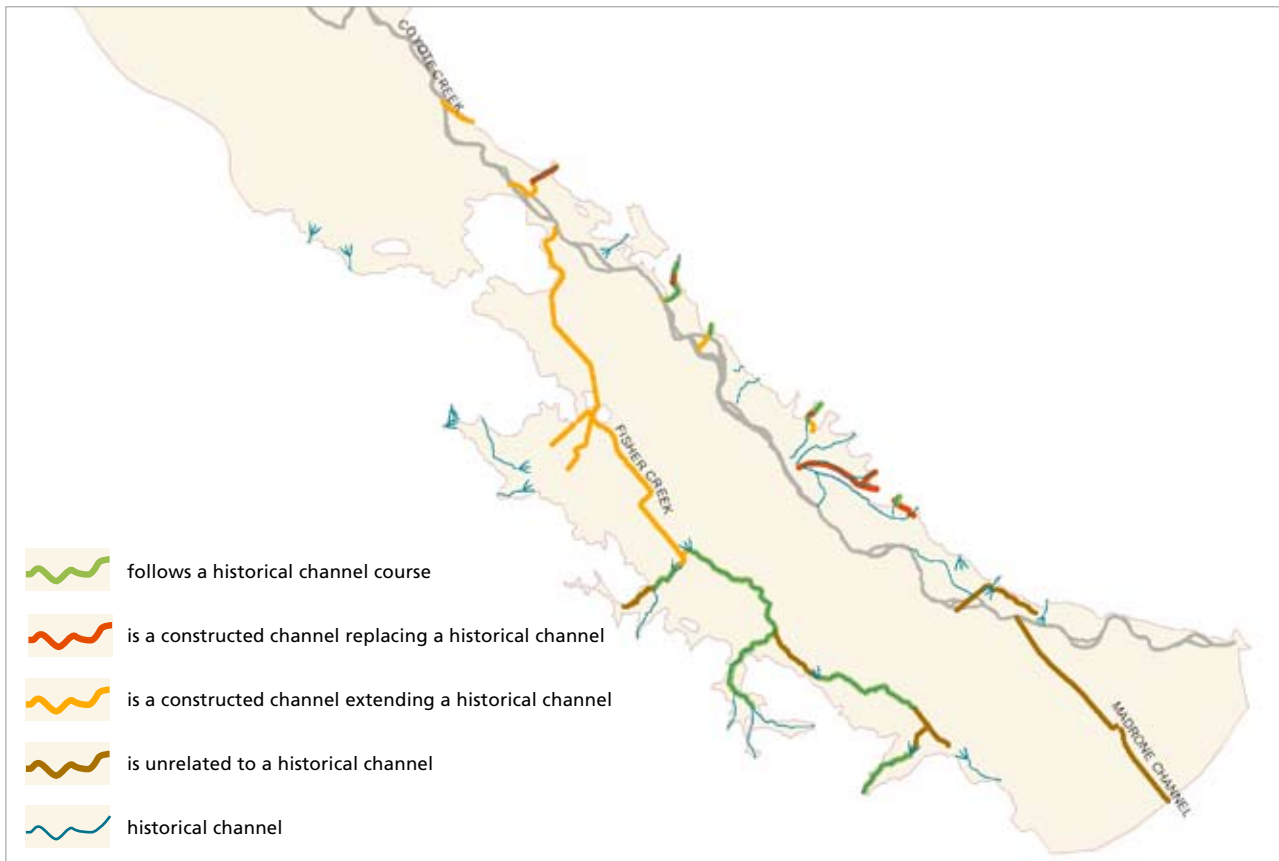
FIGURE IV-7B. ORIGIN OF MODERN CREEKS TRIBUTARY TO COYOTE CREEK (TOP). Nearly two thirds of the tributary drainage network on the valley floor is artificial channel, mostly created to extend discontinuous creeks to the Coyote mainstem.

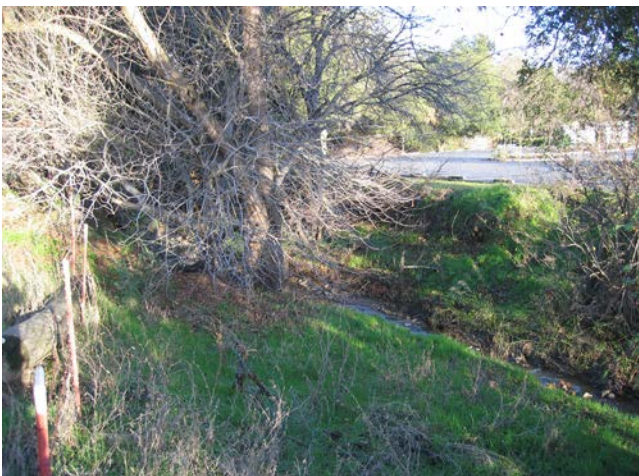
FIGURE IV-10. CHANNEL FORM AT SOUTH BABB CREEK JUST ABOVE CLAYTON ROAD. Sherman Day described channel geometry at the site in 1854 (p. 509): “deep gully (8 feet deep) 50 links [= 33 ft.] wide.” Channel geometry at this site, which has relatively little upstream development, appears to have been highly stable over this period.

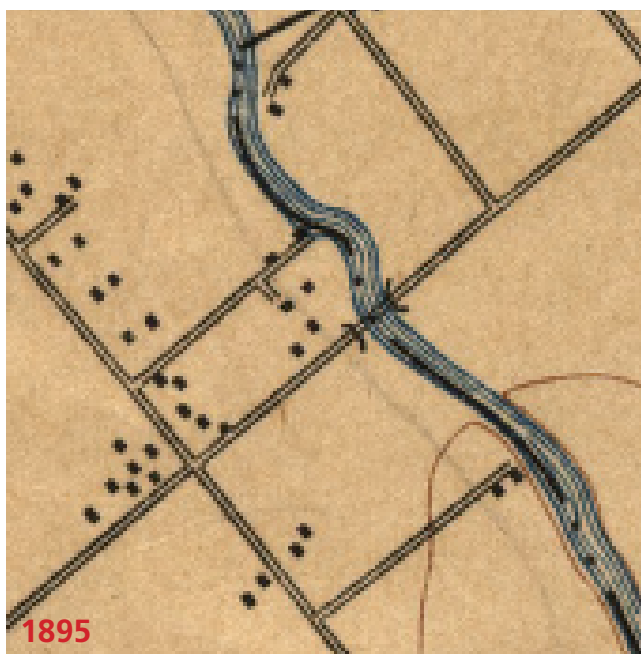
Upstream of Ogier Ponds/Highway 101, braided channel morphology transitioned to a sinuous, meandering channel with common secondary channels. This more thickly wooded reach corresponds largely with perennial flow conditions downstream from the canyon mouth.

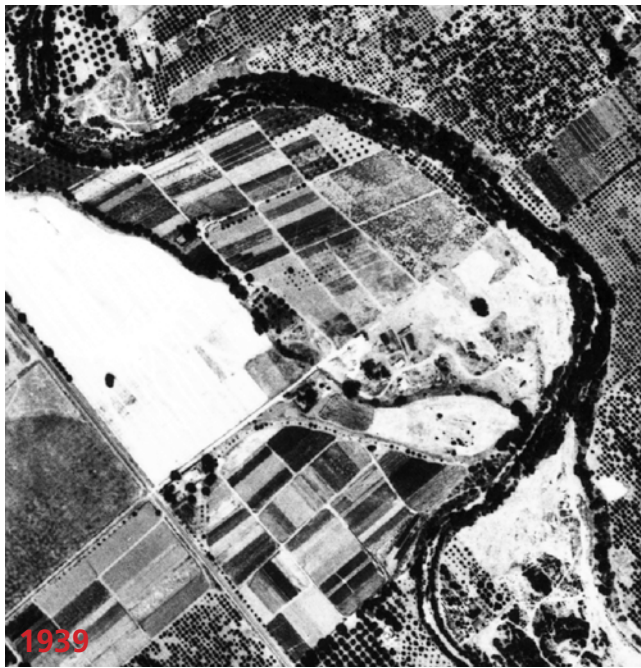
FIGURE IV-14. COYOTE CREEK AT KELLEY PARK, 1939 (LEFT) AND 2002 (RIGHT). Coyote Creek follows a highly sinuous course in this reach. Historical maps (Hermann 1905, Thompson and West 1876) also show secondary channels, which appear to correspond with lines of riparian vegetation distinct from the main channel in 1939 (AAA 1939). By 1939, farms occupy most of the floodplain bench area along the creek; presently, orchard remnants, a parking lot, and several large sycamore trees can be found. A housing development was recently built on the odd peninsula jutting into the creek area at lower middle (2002 Imagery Copyright 2005 AirPhotoUSA, LLC, All Rights Reserved).

Another historical realignment was described just south of this reach at Kelley Park by Ouchi (Ouchi 1983 in Schumm et al. 2000; **FIGURE IV-14**). By comparing USGS quadrangles from 1895 and 1961, he identified a substantial increase in channel sinuosity, which was ascribed to gradient alteration resulting from land subsidence. However, we found that most, if not all, the “new” meanders were, in fact, shown by other early maps (e.g. Thompson and West 1876, McMillan 1904) as primary or secondary channels. These local maps were produced at a more detailed scale than the USGS sources.

It appears that any channel change at this site involved flow-switching (transfer or relocation of the dominant discharge-carrying channel) between primary and secondary channels and, like that observed to the north, took place prior to most land subsidence. Considering these two contiguous reaches together, the interpretation most well supported by historical data is that this highly sinuous reach has been naturally dynamic during historical times.

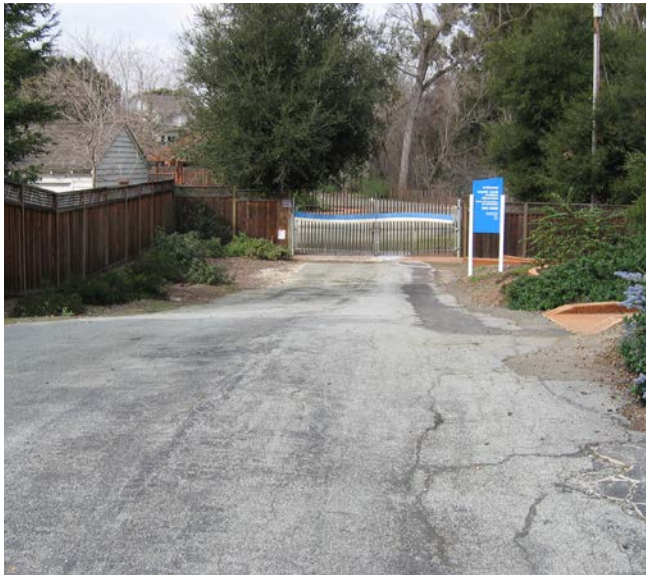
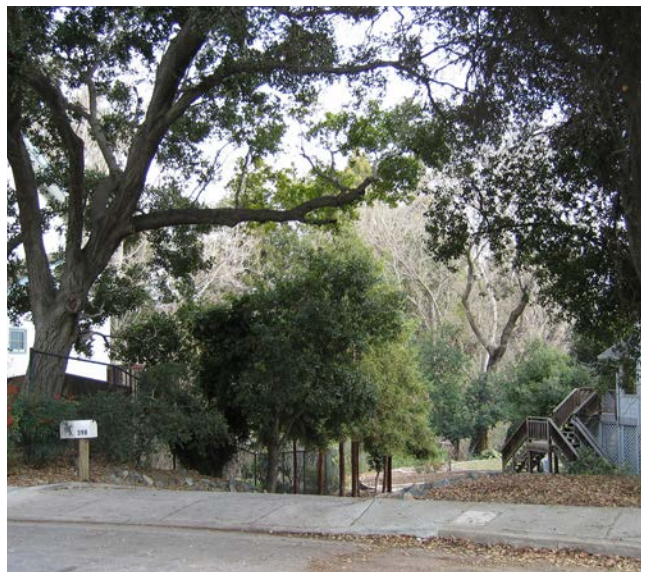
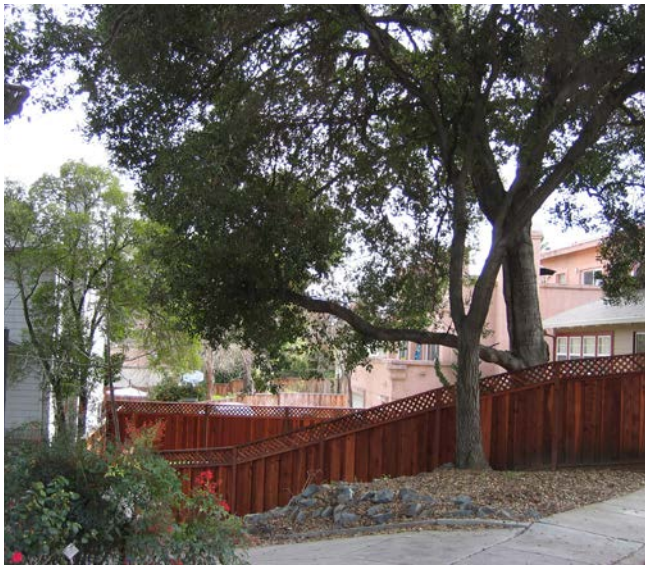
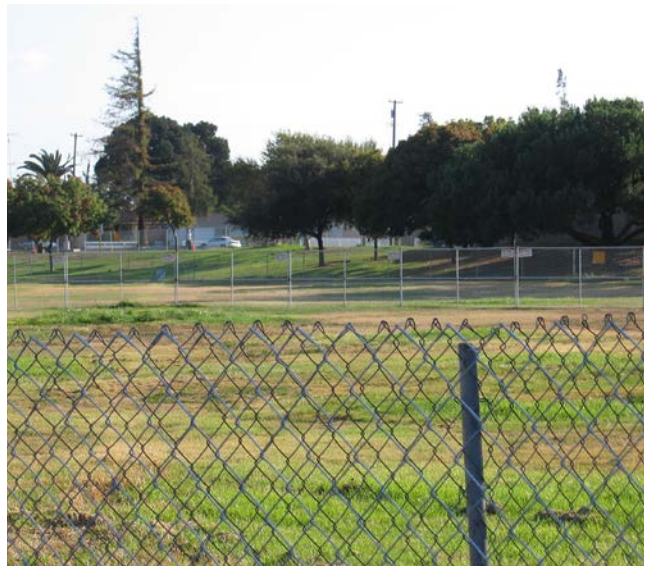
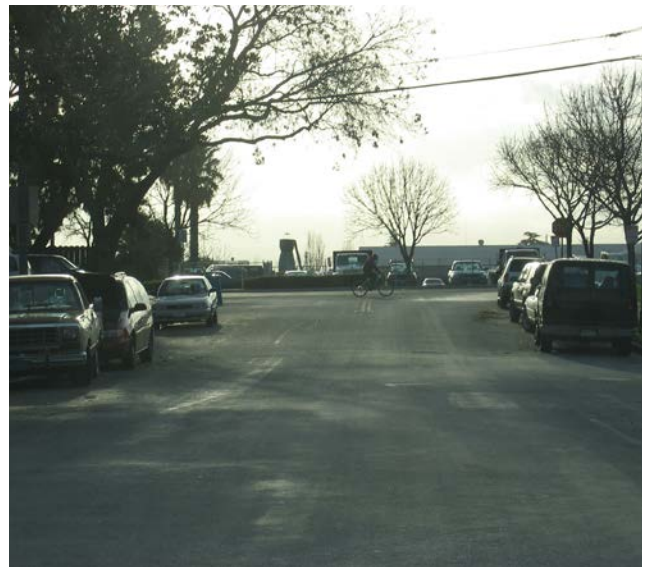
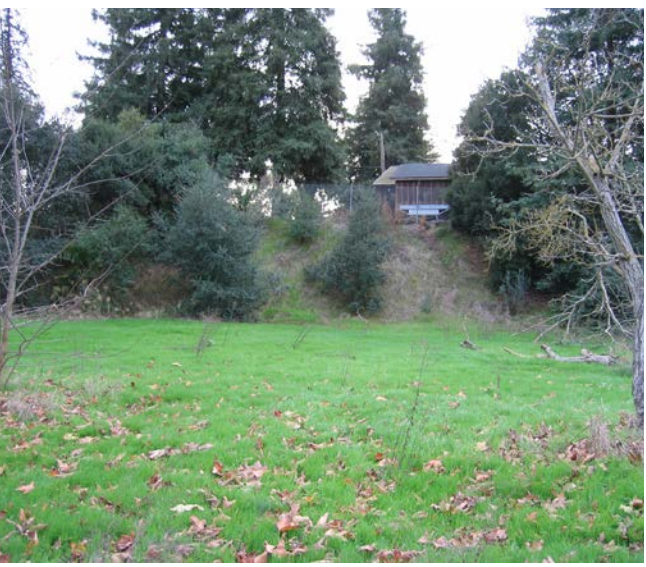
FIGURE IV-15. STREAM BENCHES ALONG MID-COYOTE CREEK. Despite filling and grading, these features are still evident along many parts of the creek as distinct “drops” below the adjacent valley floor terrace. Locations are, clockwise from upper left: the Santa Clara Valley Water District’s Coyote Creek Outdoor Classroom; private residences on Arroyo Way near William Street Park; Watson Park; Kelley Park; Nordale Ave. near Kelley Park; and private residences on Arroyo Way.

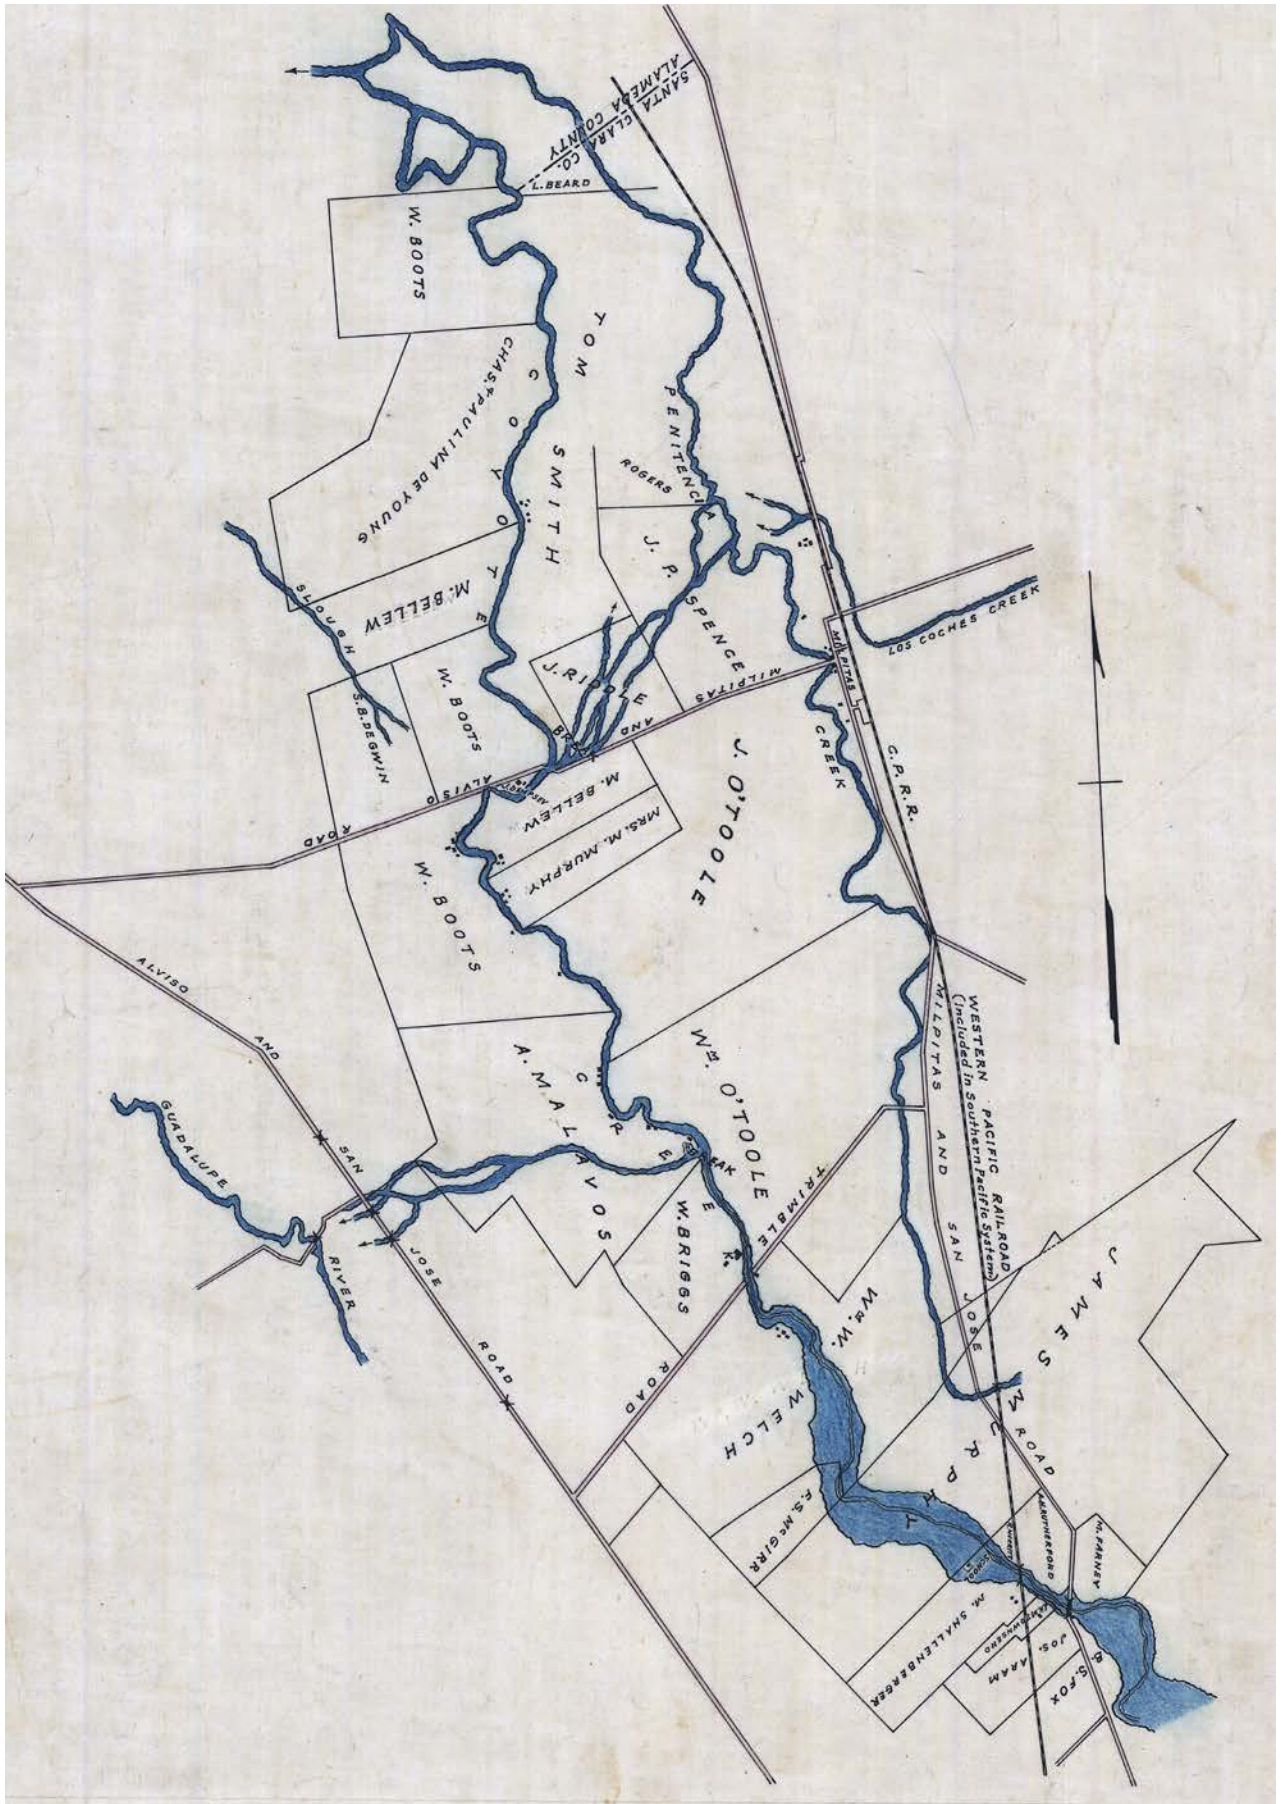
FIGURE IV-17. LOWER COYOTE CREEK HISTORICAL OVERFLOW PATTERNS. This map shows the series of “breakouts” along Coyote Creek. Overflow channels extended all the way to Guadalupe River and Lower Penitencia Creek. It also shows the pattern of wide and narrow stream reaches (Herrmann 1874d, courtesy Santa Clara County Surveyors Office).

The exact year in which the many breakouts documented by Herrmann (1874c) occurred has not been determined, but examination of newspaper records for the previous several years shows no obvious mention of major flooding. It is possible that the damage was caused by the famous 1862 flood which affected much of California (Charlene Duval personal communication). The lower reach was clearly aggradational and shallow, with substantial sediment supply.

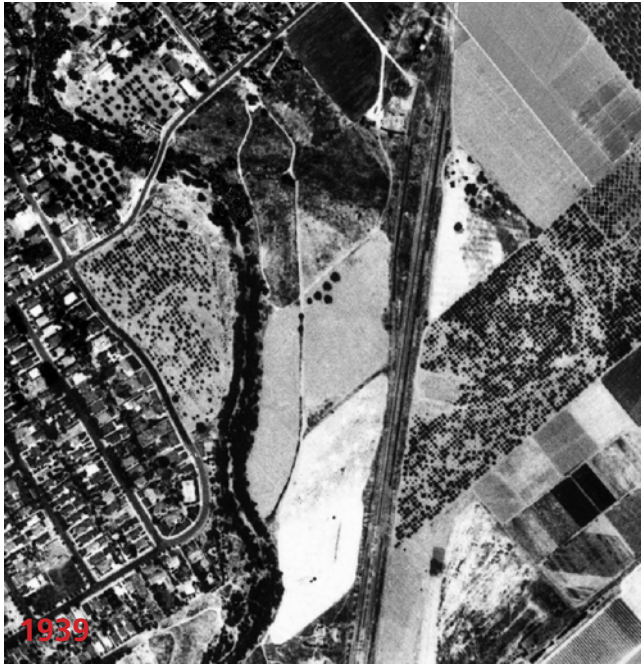
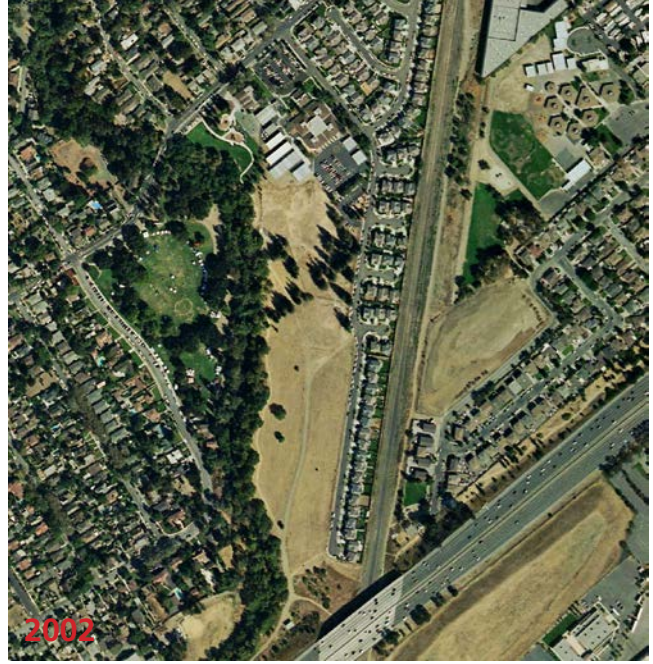
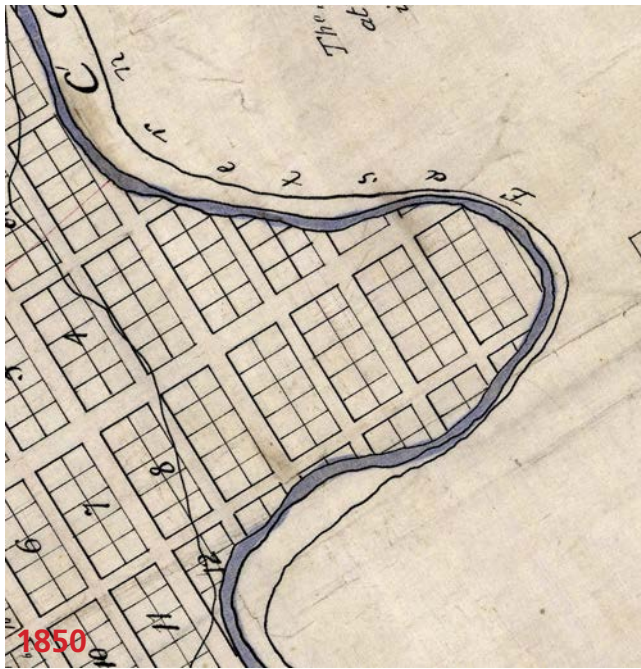
FIGURE IV-18. COYOTE CREEK AT WILLIAM AND OLINDER PARKS IN 1850 (LOWER LEFT), 1939 (UPPER LEFT), AND 2002 (RIGHT). Some evidence of the former main channel course shown by White (1850; courtesy Santa Clara County Surveyors Office) is visible in 1939 (AAA 1939) as less vigorous orchard growth. Martin Park (the triangular green field in the upper right corner of the modern photo) corresponds with the former main channel (2002 Imagery Copyright 2005 AirPhotoUSA, LLC, All Rights Reserved).

Flood-prone conditions here may result in part from the unusually extreme reduction in channel area at the site, where a flood-prone bench historically extended more than 1000 feet to the east (FIGURE IV-18). Prior to fill, this reach also likely had a significant secondary channel that meandered all the way to Martin Park (and which was the primary channel circa 1850; White 1850). The secondary channel and large available high flow capacity on the adjacent benches likely reduced historical flooding extent at the site. Now, with more effective flood protection along much of the creek, remnants of these features may provide some of the few remaining conduits for flood flow.

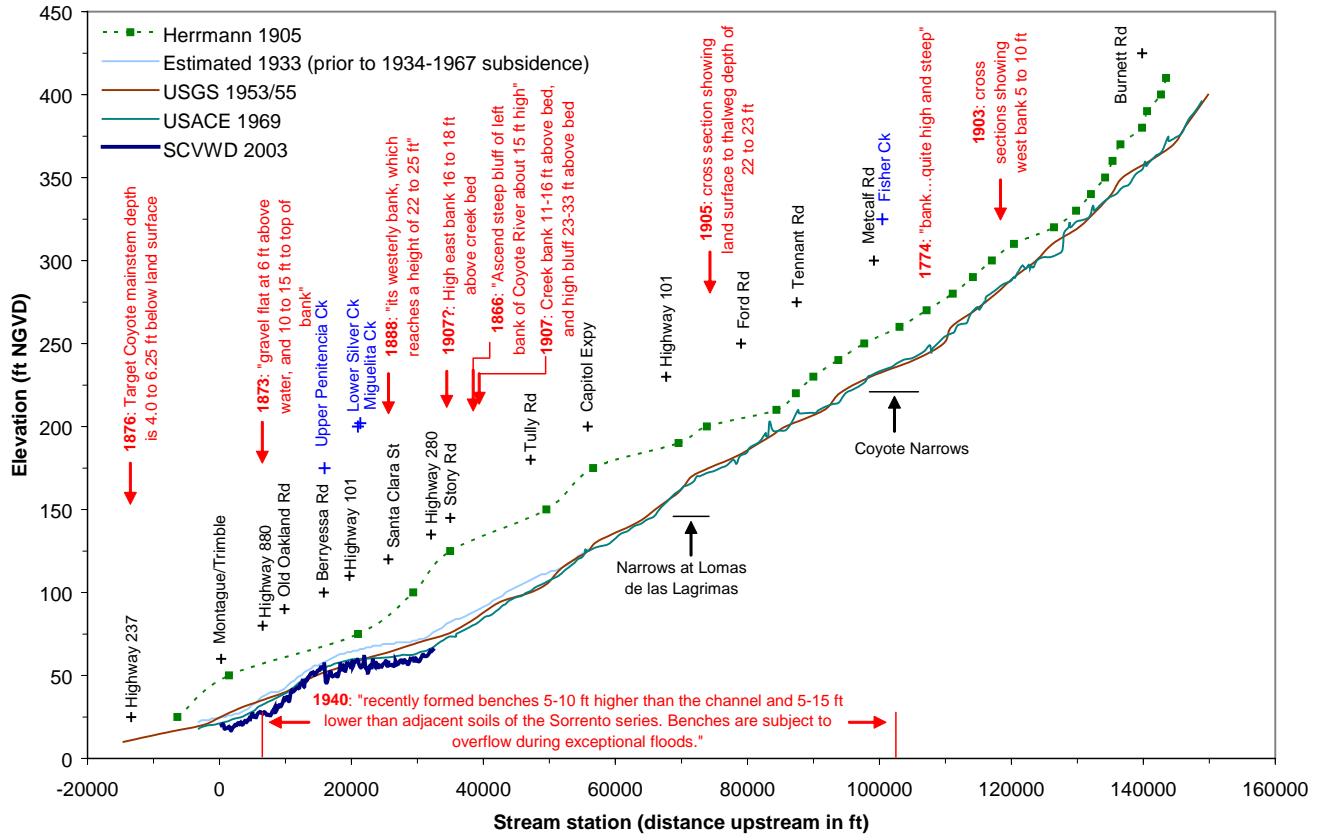
FIGURE IV-19. HISTORICAL AND MODERN LONGITUDINAL PROFILE DATA FOR COYOTE CREEK. See text for details. Comparison to the other data sets indicates that the profile based on Herrmann (1905) is not of comparable accuracy. The Mid-Coyote reach is shown in more detail in **FIGURE II-20**.

We compiled a longitudinal profile for the entire Coyote Creek valley floor length from the 1969 survey by the US Army Corps of Engineers (US ACE [1969]1970; **FIGURES IV-19** and **IV-20**). We also created a standard longitudinal profile based on contour lines from the current USGS 7.5 minute quadrangles. These data, often the only stream gradient information available for a watershed, have generally not been updated since their original creation. In the case of Coyote Creek, the USGS contour data are truly historical, originating in 1953-1955.

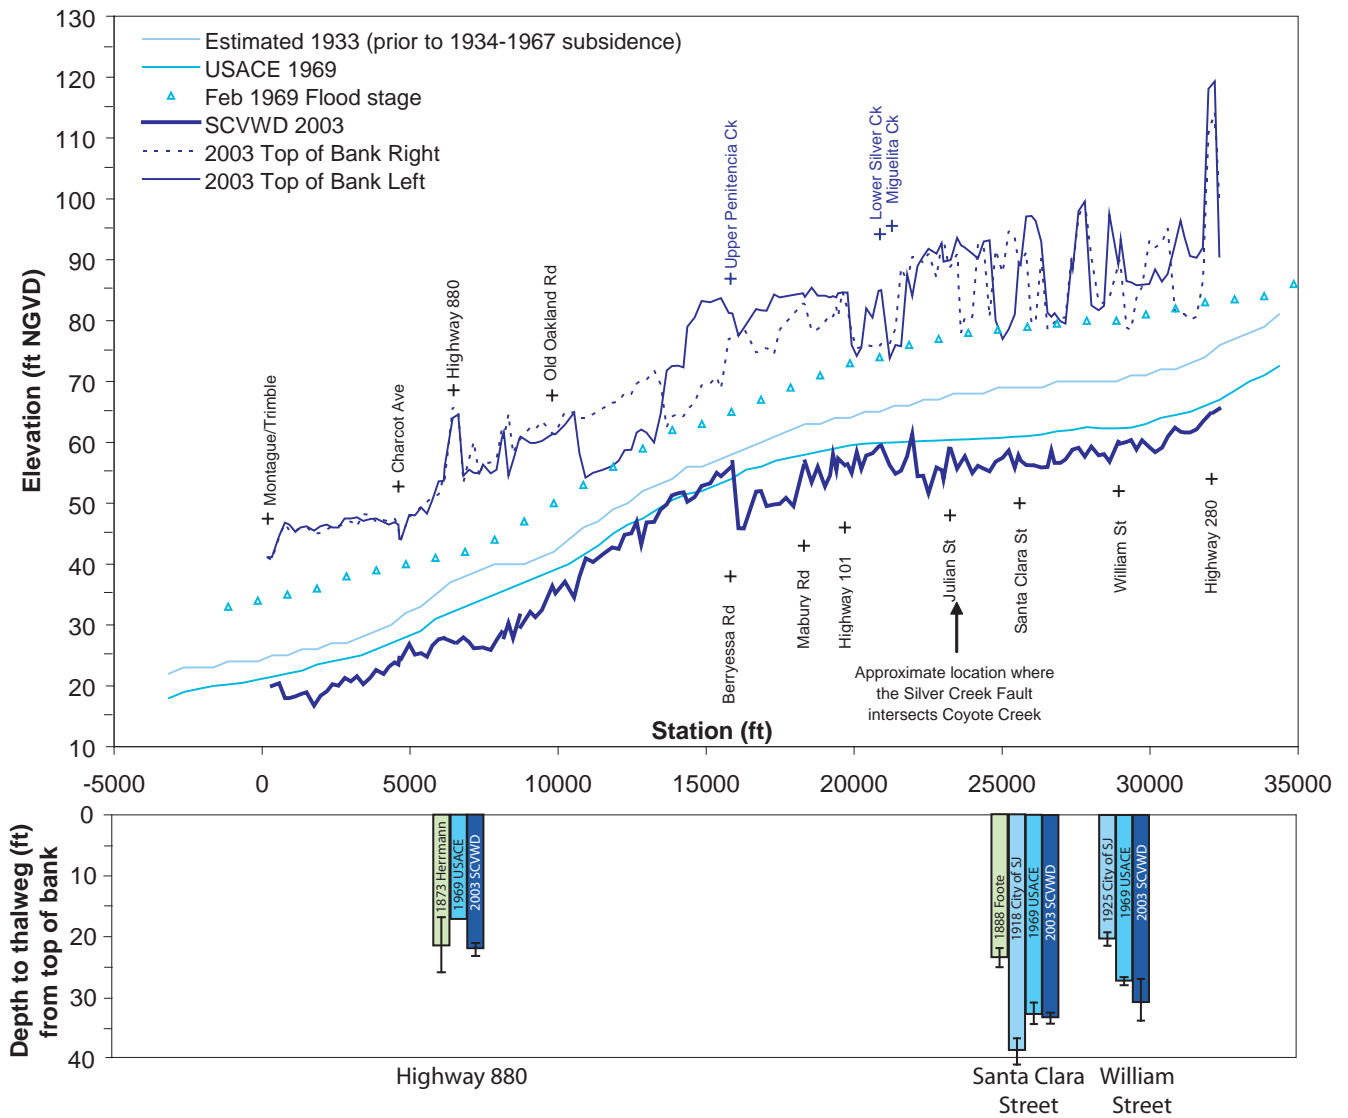
FIGURE IV-20. HISTORICAL AND MODERN LONGITUDINAL PROFILE DATA FOR COYOTE CREEK. See text for details. Since some historical data were not referenced to NGVD (and given changes due to subsidence), we also compiled channel depth data in reference to “top of bank” for this reach (lower part). Error bars on the lower chart indicate the data range (e.g. narrative information such as “22-25 feet” or variability among depths measured from profile).

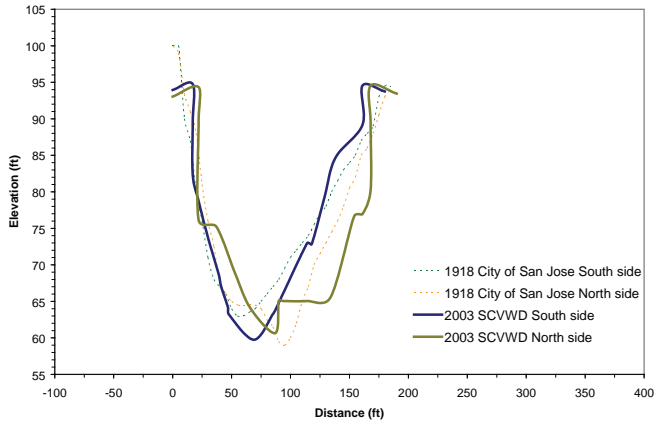
FIGURE IV-22. MEASURED CROSS-SECTIONS AT THE SANTA CLARA STREET BRIDGE. Note the South side cross-sections represent the channel surface on the upstream side of the bridge, while North side cross-sections represent the channel surface on the downstream side. 1918 data from the City of San Jose Department of Public Works. 2003 data from the Santa Clara Valley Water District.

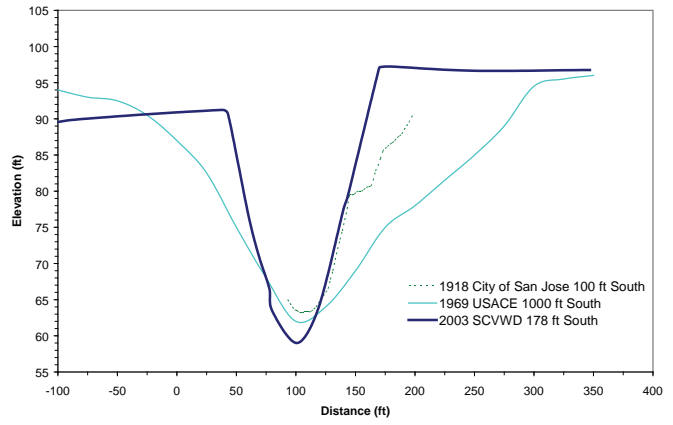
FIGURE IV-23. MEASURED CROSS-SECTIONS TAKEN UPSTREAM FROM THE SANTA CLARA STREET BRIDGE. Note that the three cross-sections represent different locations along the channel length. The 1918 data is from 100 ft south of the bridge (City of San Jose, Department of Public Works, 1918). The 1969 data is from 1000 ft south of the bridge (USACE [1969]1970). The 2003 data is from 178 ft south of the bridge (Santa Clara Valley Water District 2003).

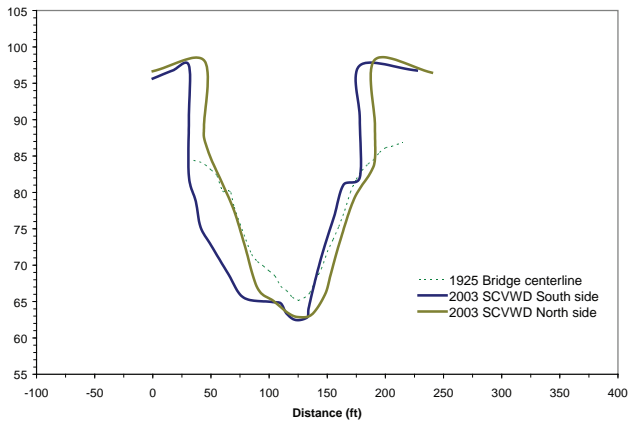
FIGURE IV-24. MEASURED CROSS-SECTIONS AT THE WILLIAM STREET BRIDGE. The 1925 cross-section represents the channel surface at the bridge centerline (City of San Jose, Department of Public Works, 1925). The 2003 South side data represents the channel surface on the upstream side of the bridge, while the 2003 North side data represents the channel surface on the downstream side of the bridge (Santa Clara Valley Water District 2003). We moved the 1925 data down 8 ft to match subsidence shown by Poland and Ireland (1988).

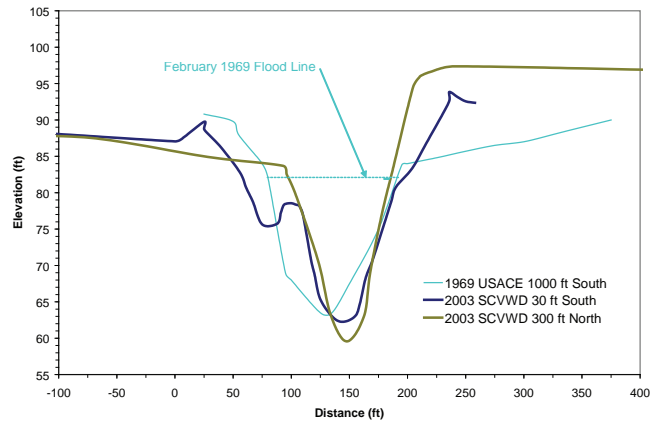
FIGURE IV-25. MEASURED CROSS-SECTIONS TAKEN UPSTREAM FROM THE WILLIAM STREET BRIDGE. Note that the three cross-sections are representing different locations along the channel length. The 1969 data is from 1000 ft south of the bridge, and also shows the flood peak elevation from the February 1969 flood (USACE [1969]1970). The 2003 South side data is from 30 ft upstream of the bridge, and the 2003 North side data is from 300 ft downstream of the bridge (Santa Clara Valley Water District 2003).

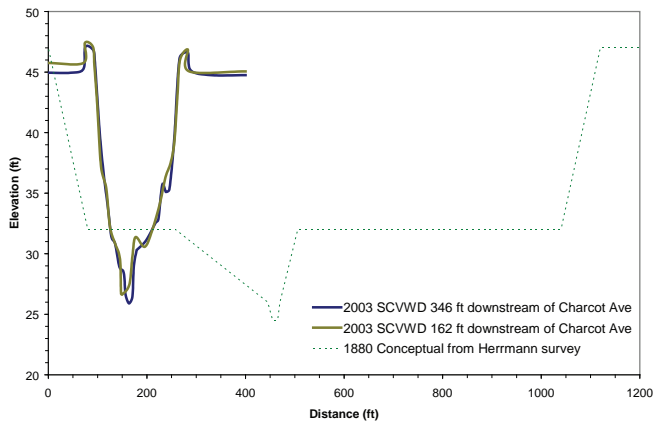
FIGURE IV-26. MEASURED AND CONCEPTUAL CROSS-SECTIONS FROM THE HIGHWAY 880/CHARCOT AVE AREA. Note that the three cross-sections are representing different locations along the channel length. The conceptual cross-section is taken from notes and maps from the circa 1874 survey by Herrmann (Herrmann 1874c). The 2003 data show cross-sections from 346 ft and 162 ft downstream from the Charcot Avenue bridge (Santa Clara Valley Water District 2003).

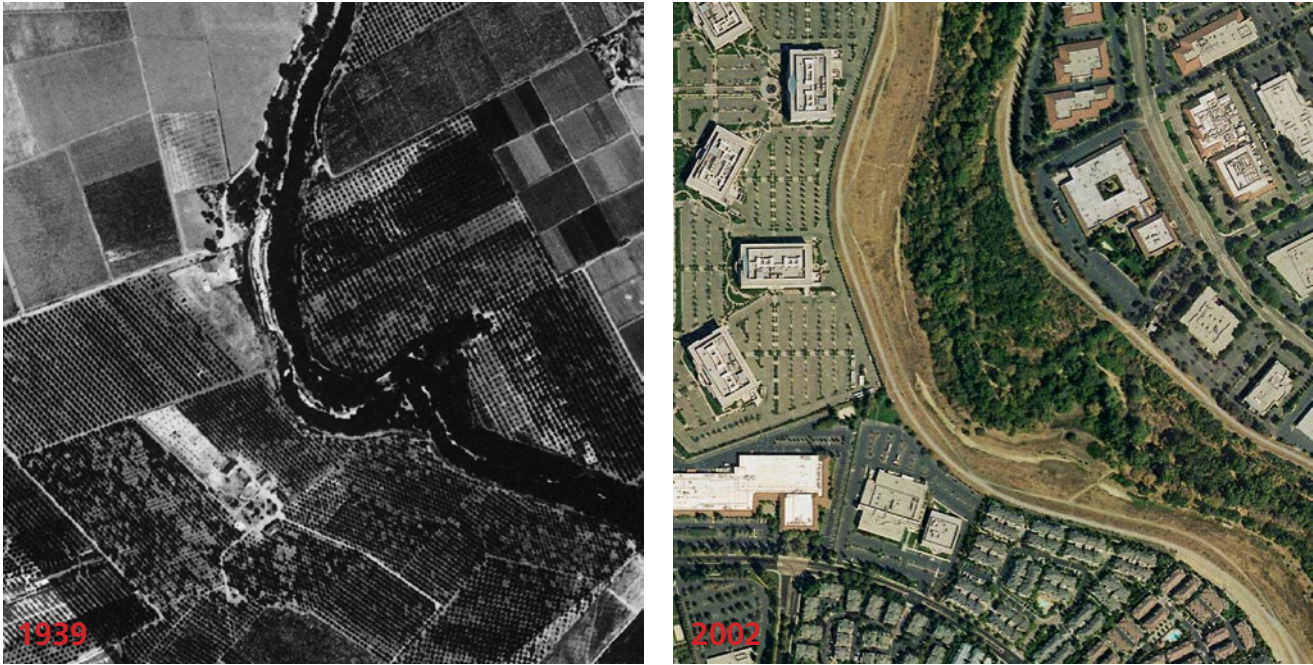
FIGURE IV-28. RIPARIAN RECOVERY ON LOWER COYOTE CREEK BETWEEN 1939 (LEFT) AND 2002 (RIGHT). Location immediately upstream of Tasman Drive (AAA 1939; 2002 Imagery Copyright 2005 AirPhotoUSA, LLC, All Rights Reserved).
