PART IV //

LANDSCAPE CHANGE

Part IV assesses how the historical landscape has been transformed into present-day conditions. In the first section, we summarize major events in the land use history of the watershed. Next we describe the trajectories of change in landscape features and associated habitats. In the final section, we discuss some of the implications for watershed restoration and management.

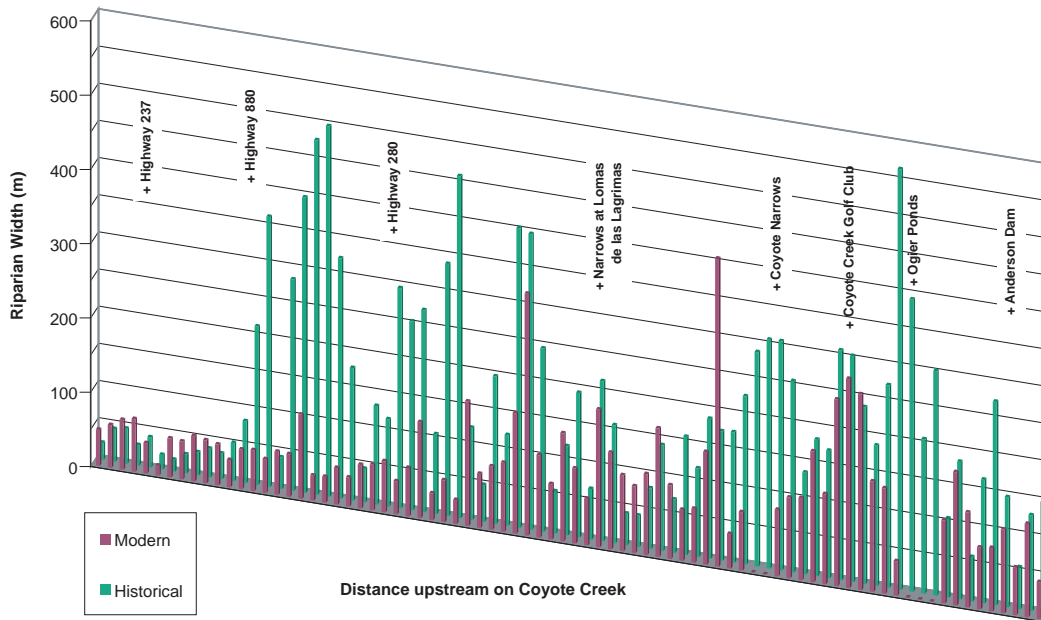
FIGURE IV-29. HISTORICAL CHANGE IN COYOTE CREEK RIPARIAN AREA WIDTH. This graph illustrates the variation between narrow and broad channel reaches along the creek under historical conditions (green bars). Comparison with the modern data (red bars) shows how streamside impacts also vary substantially along the creek. The Coyote Creek Golf Club area shows up as an important reach that has maintained broad riparian function. Reaches immediately above and below, where the channel flows through large ponds, have no effective riparian width and represent restoration opportunities.

One of the important land use impacts to Coyote Creek has been the encroachment into the broad channel area of parking lots, mobile home parks, commercial buildings, percolation ponds, and other features. Some of this land use involves landfill, but in many other places activity has simply moved into the creek channel area. As early as 1874, Herrmann’s Coyote River Survey noted “Bank leveled down and planted in orchard” (Herrmann 1874a) and calculated the area each streamside landowner stood to gain by reclaiming stream benches through the “Proposed Improvements” (FIGURE IV-16). Cumulative encroachment of the channel has inevitably reduced overall capacity while placing structures within the range of predictable flooding. An illustration of the reduction of the active channel or riparian area is given in FIGURE IV-29 and discussed in the section on riparian change.

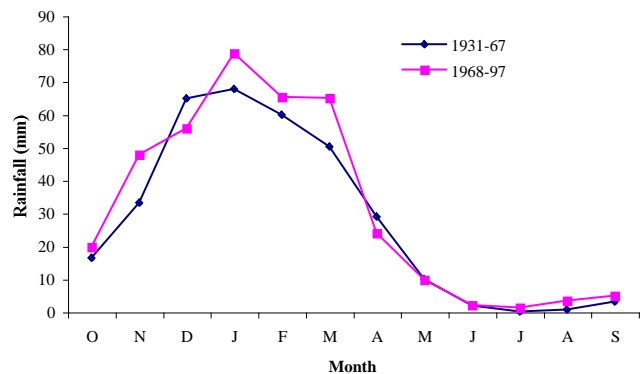
FIGURE IV-30. CHANGE IN MONTHLY RAINFALL DISTRIBUTION FOR SAN JOSE. Average rainfall in the last three decades of the 20th century was greater than the previous decades. Graph from McKee et al. (2003).

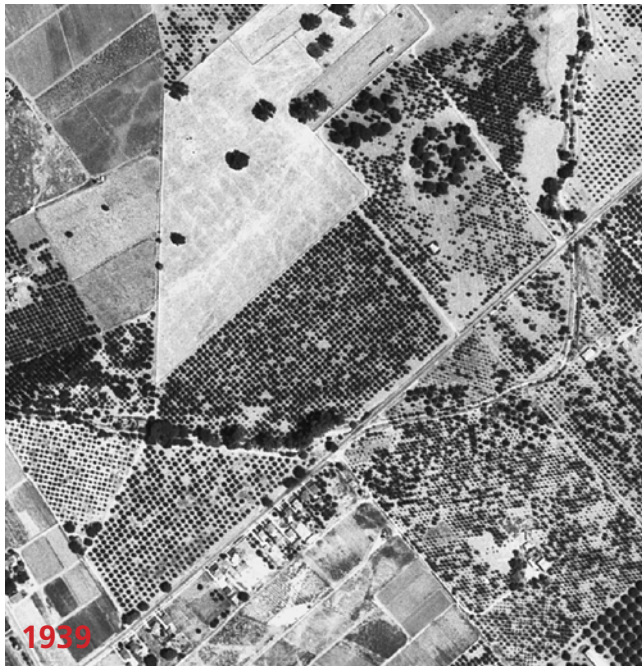
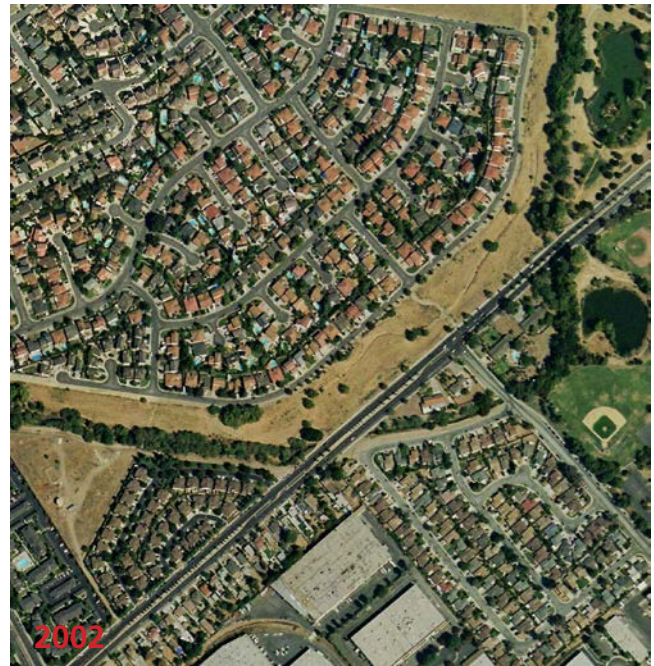
FIGURE IV-31. RIPARIAN RECOVERY ON UPPER PENITENCIA CREEK BETWEEN 1939 (LEFT) AND 2002 (RIGHT). The gaps in riparian forest visible in 1939 (AAA 1939), presumably the result of adjacent agricultural practice, have substantially filled in the subsequent years (2002 Imagery Copyright 2005 AirPhotoUSA, LLC, All Rights Reserved).

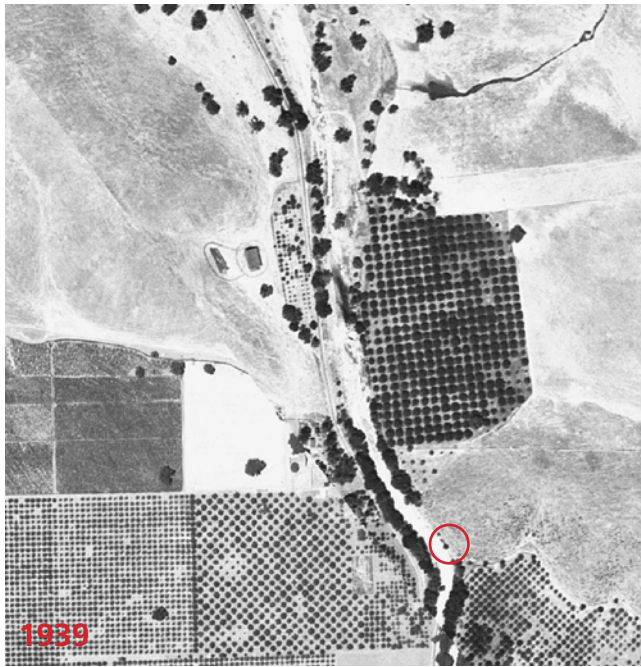
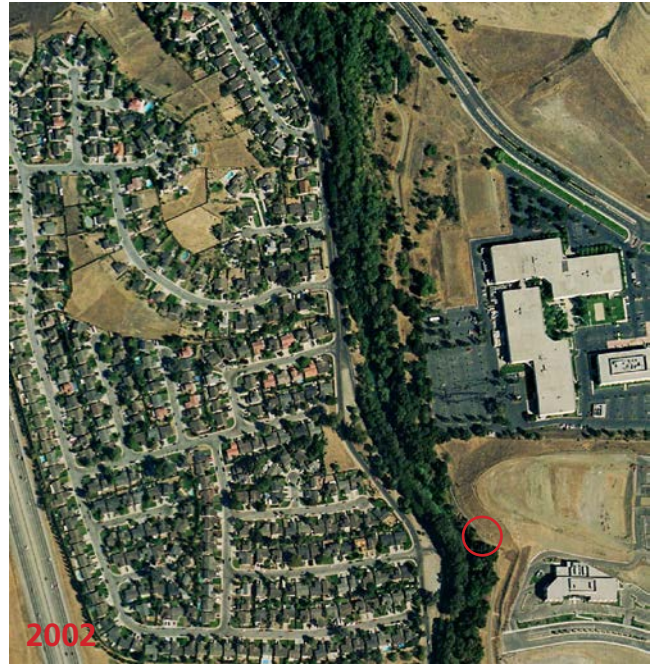
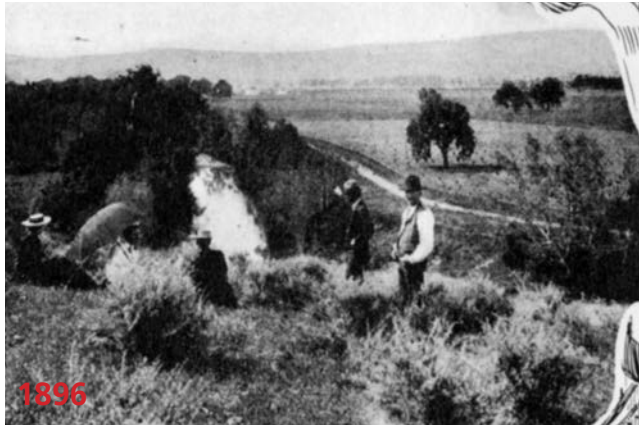
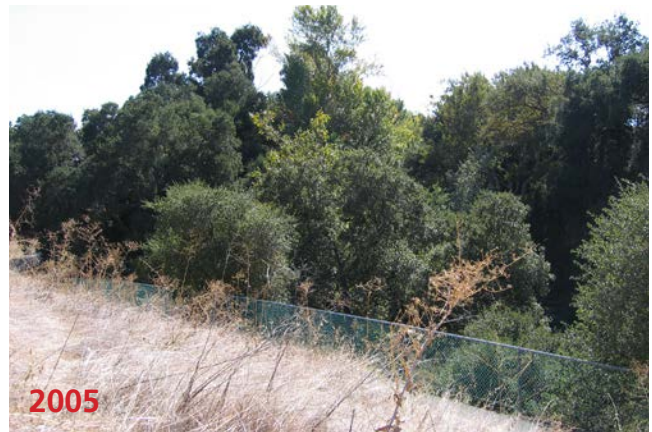
FIGURE IV-32. CHANGES IN COYOTE CREEK RIPARIAN HABITAT ALONG COYOTE ROAD BETWEEN 1896 AND 2005. This set of photographs investigates riparian changes using both aerial and ground-based photographs. As shown in the 1939 photograph (upper left; AAA 1939), the northern half of this reach was broad and characterized by scattered trees. In the southern portion, lines of riparian trees followed a narrow channel, with some gaps. The 1896 photograph of the Swickard property (lower left; from Shortridge 1896, courtesy History San José) appears to have been taken at the point marked on the aerial photographs, looking south along the narrow channel reach. This view also shows gaps in riparian trees. The 2002 (upper right; Imagery Copyright 2005 AirPhotoUSA, LLC, All Rights Reserved) and 2005 (lower right) views demonstrate increased riparian cover, and the expansion of dense riparian forest into the former open sycamore woodland habitat to the north.

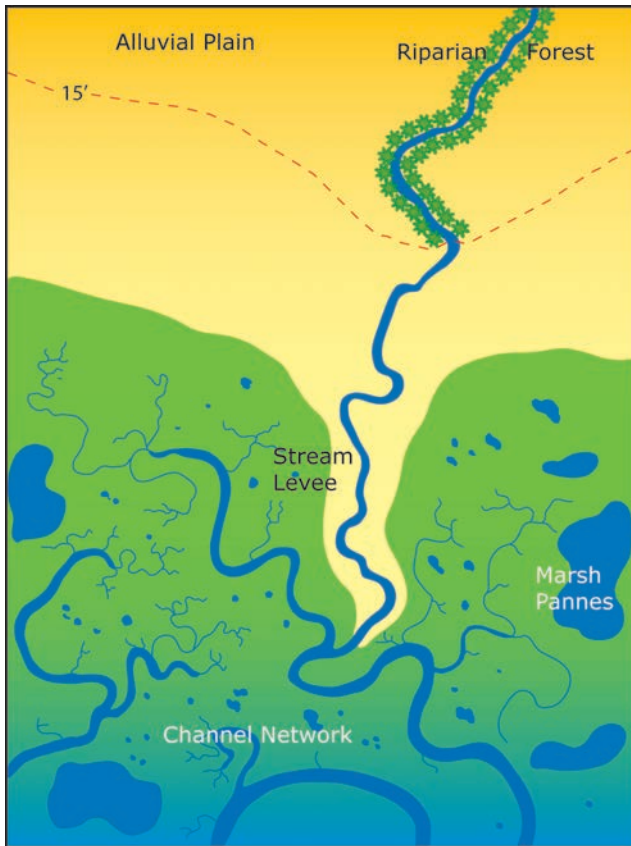
TABLE IV-33. SCHEMATIC DIAGRAM OF THE RIPARIAN TIDAL TEMPLATE.

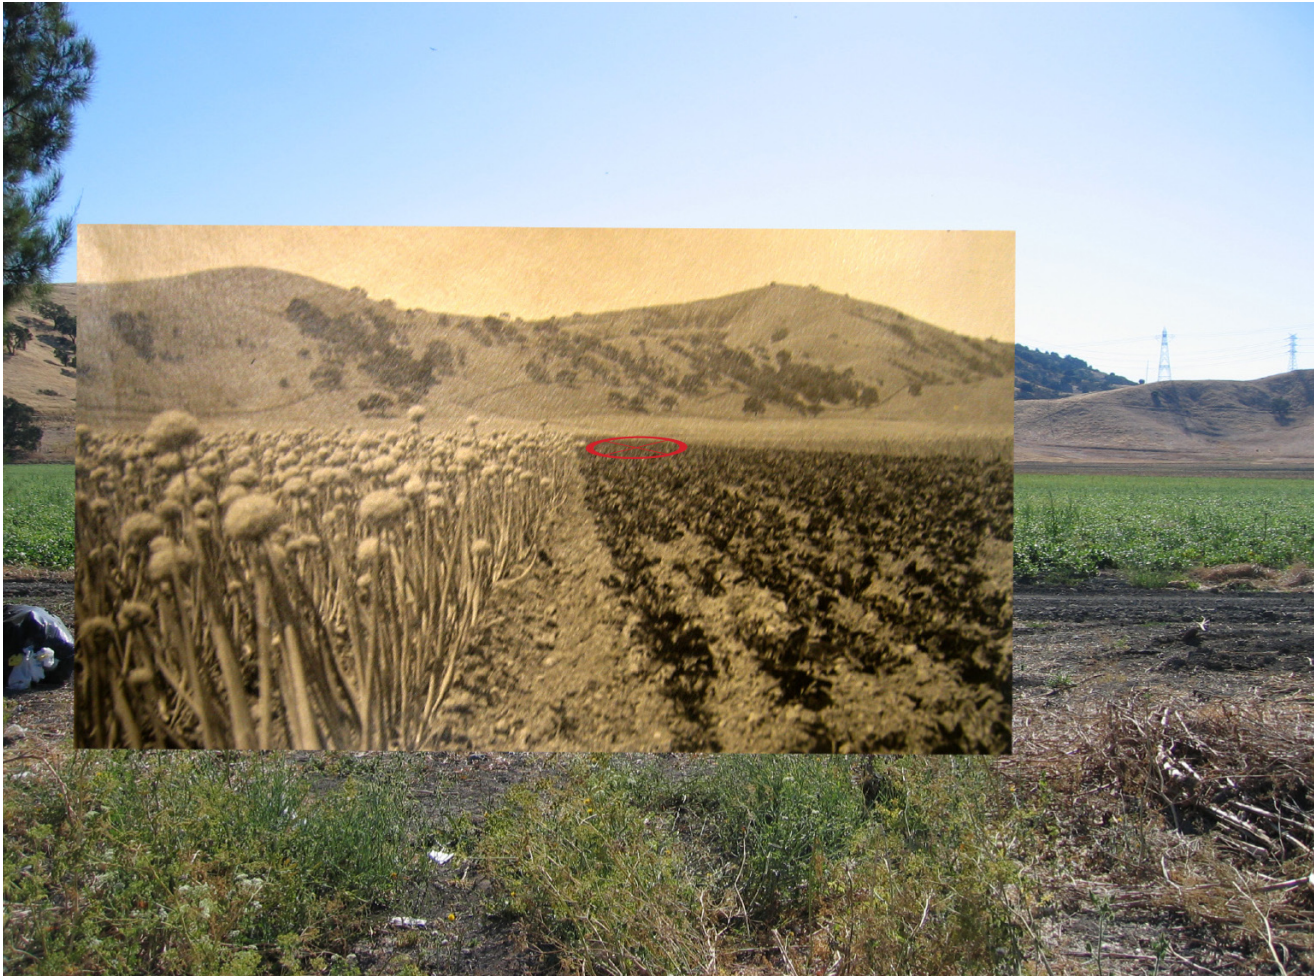
FIGURE IV-34. LAGUNA SECA 1919/2005. The area has changed relatively little since the reclamation for agriculture in the early part of the 20th century. Red circle shows location of **FIGURE III-30**. SCVWD Vault 1919: 169, courtesy Santa Clara Valley Water District.

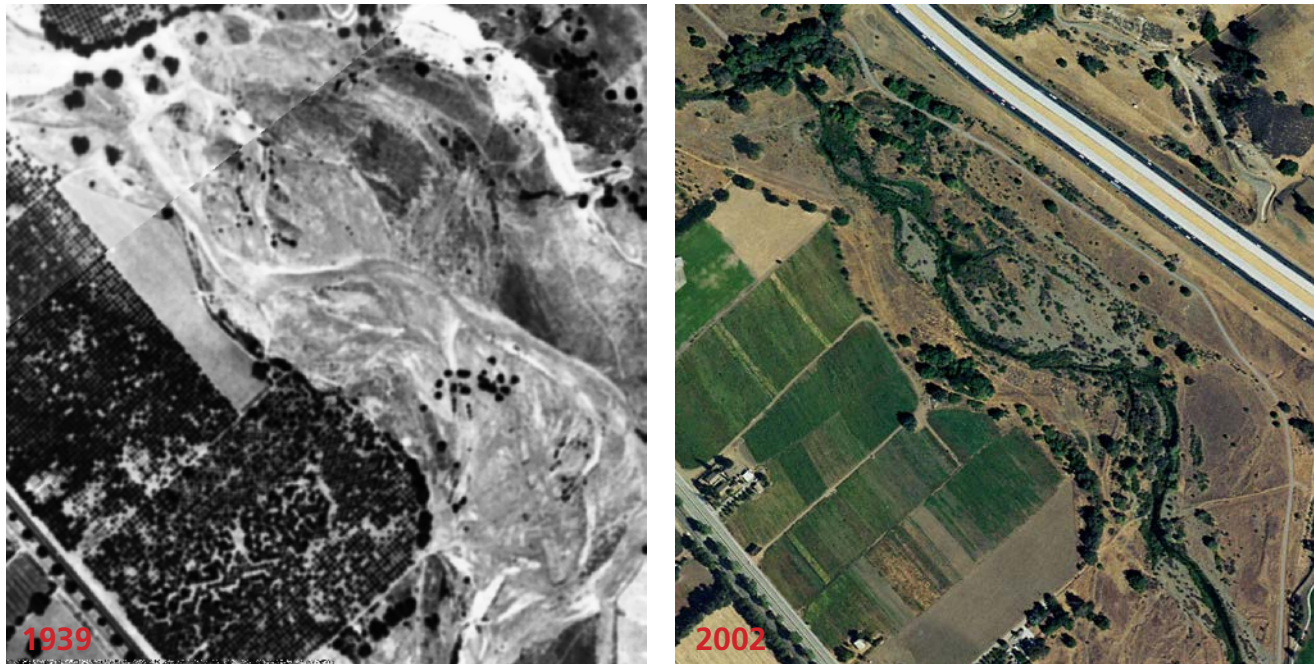
FIGURE IV-35. COYOTE CREEK IMMEDIATELY DOWNSTREAM OF THE COYOTE CREEK GOLF CLUB IN 1939 (LEFT) AND 2002 (RIGHT). Braided channel pattern with riparian scrub and occasional large trees can be seen in both images, but there is more riparian vegetation along the main channel in the recent image (AAA 1939; 2002 Imagery Copyright 2005 AirPhotoUSA, LLC, All Rights Reserved).

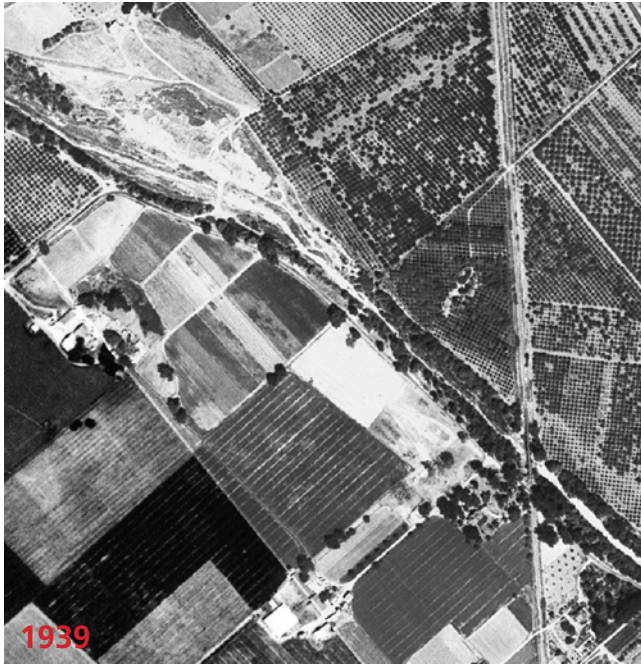
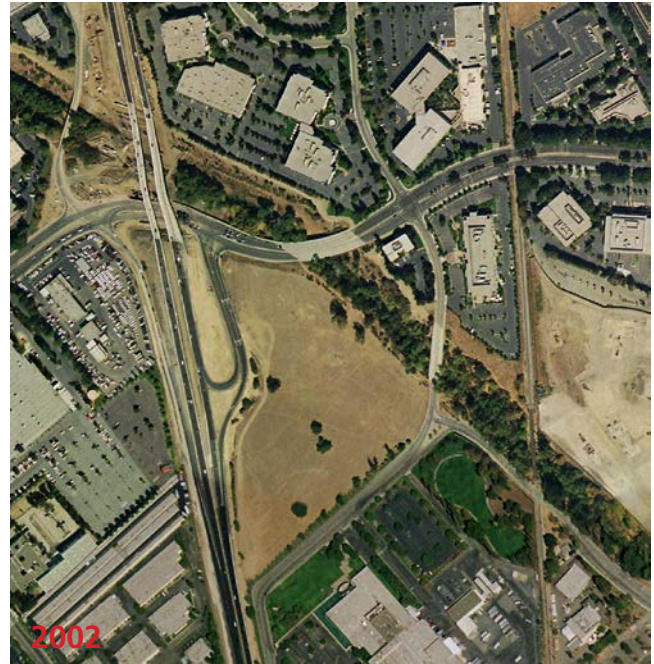
FIGURE IV-36. COYOTE CREEK CHANNEL AT HIGHWAY 880 CROSSING, CIRCA 1800 (LOWER LEFT), 1939 (UPPER LEFT), AND 2002 (RIGHT). The 1800 view identifies naturally broad and narrow channel reaches, which are not easily distinguished in the more recent aerial photography. Naturally wide reaches may have potential for floodplain restoration. For example, the undeveloped area in the center of the 2002 image is a former stream bench that remains flood-prone. Highway 880 runs north-south on the left side of the 2002 image. The *San Jose Mercury News* building can be seen at image bottom, immediately right of the highway. (AAA 1939; 2002 Imagery Copyright 2005 AirPhotoUSA, LLC, All Rights Reserved).
