Coyote Creek Flood Protection Project

Problem Definition and Refined Project Objectives

May 21st, 2019 Public Meeting
San José Conservation Corps
1560 Berger Drive
6:30 – 8:30 pm

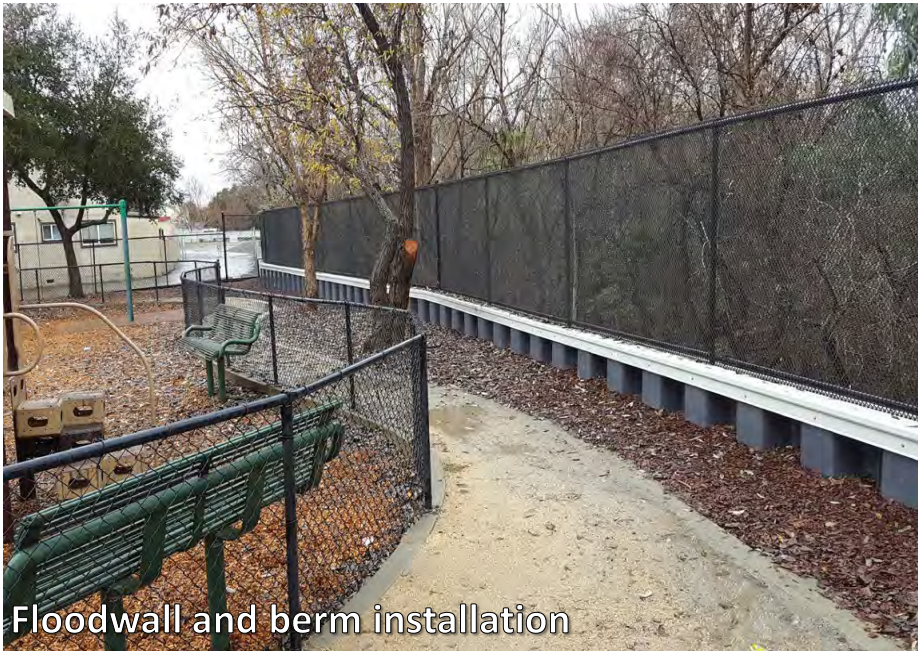
Floodwall and berm installation

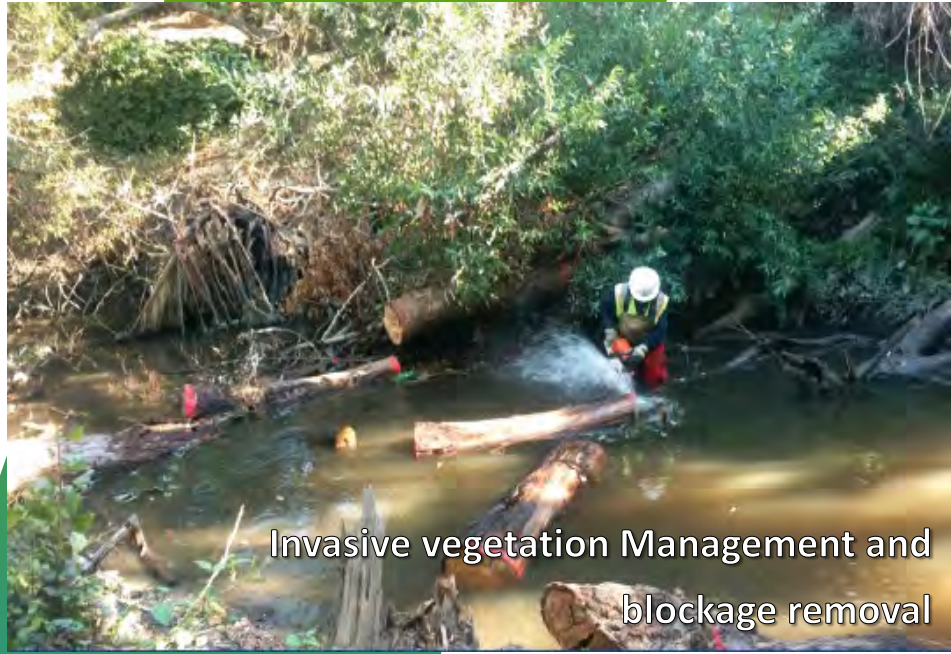
Invasive vegetation Management and blockage removal

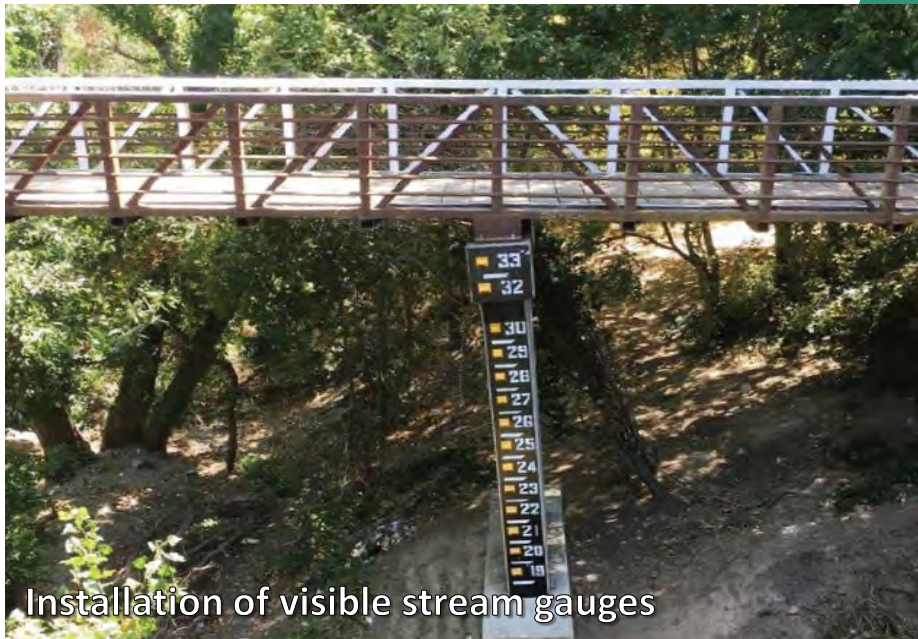
Installation of visible stream gauges

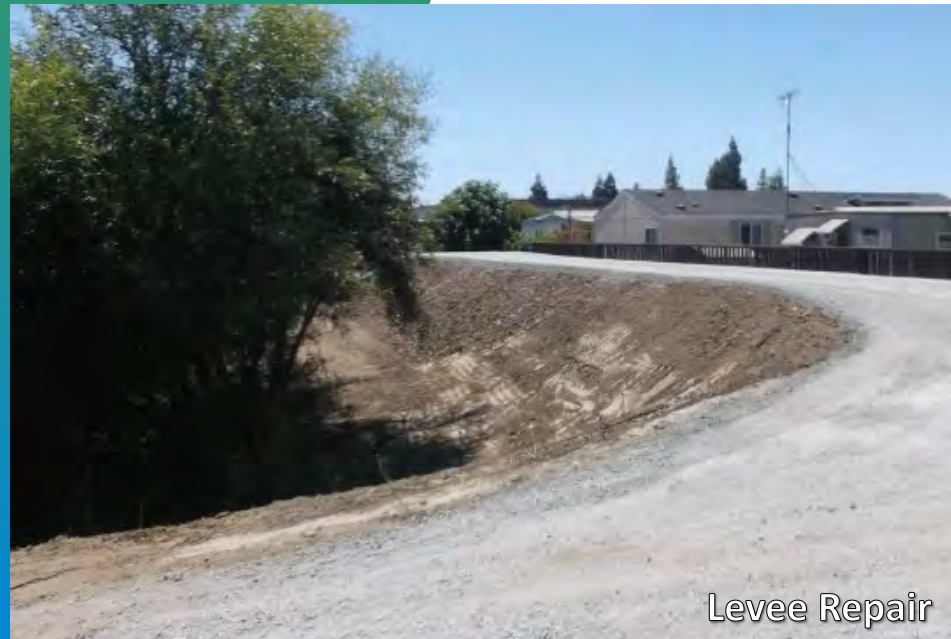
Levee Repair

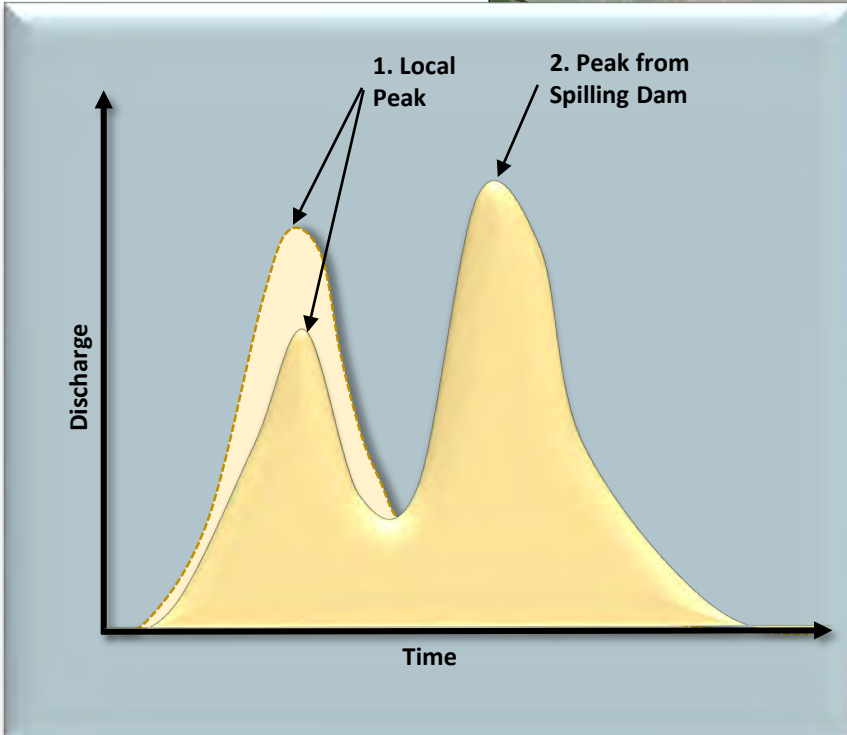
Local Peak versus Upper Watershed Peak

Two main flow contributions to Coyote Creek in response to a rainfall event:

1. Direct watershed input from local tributaries, and/or
2. Upper watershed input

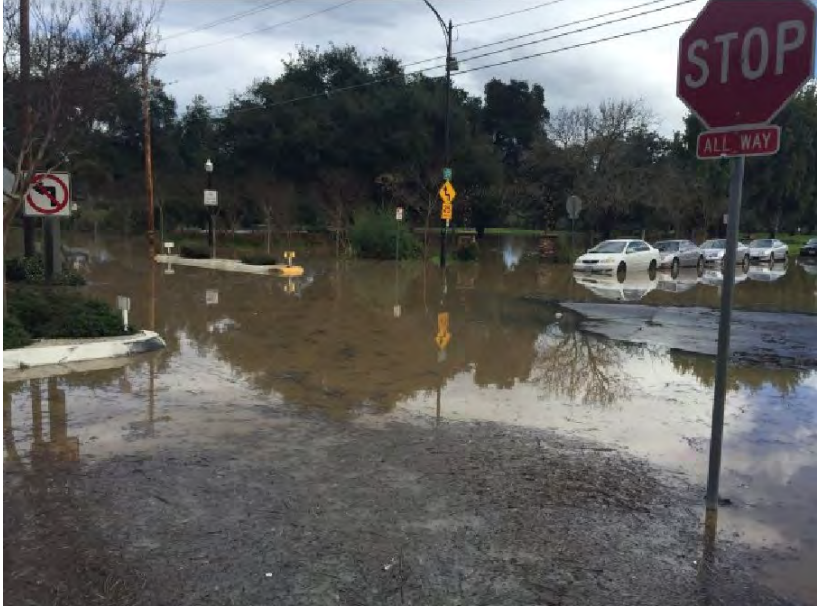
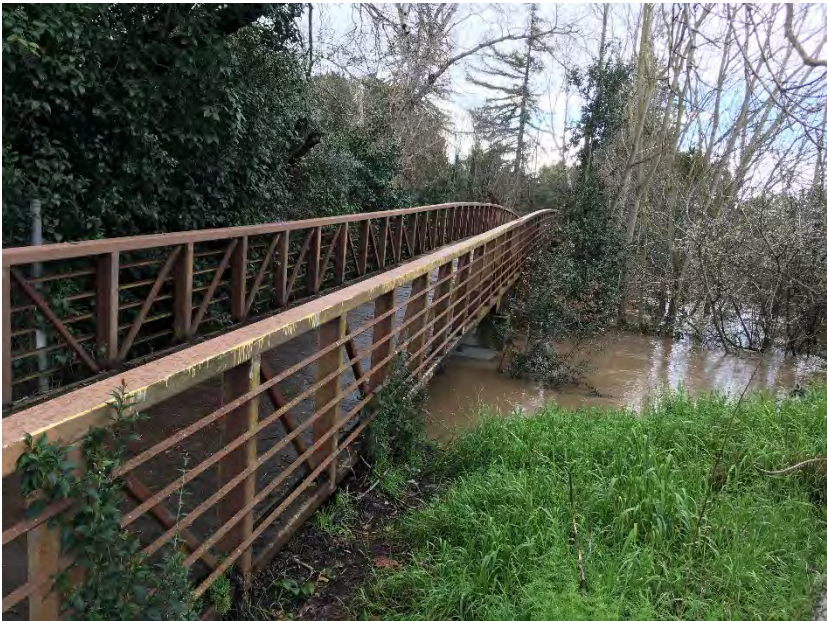
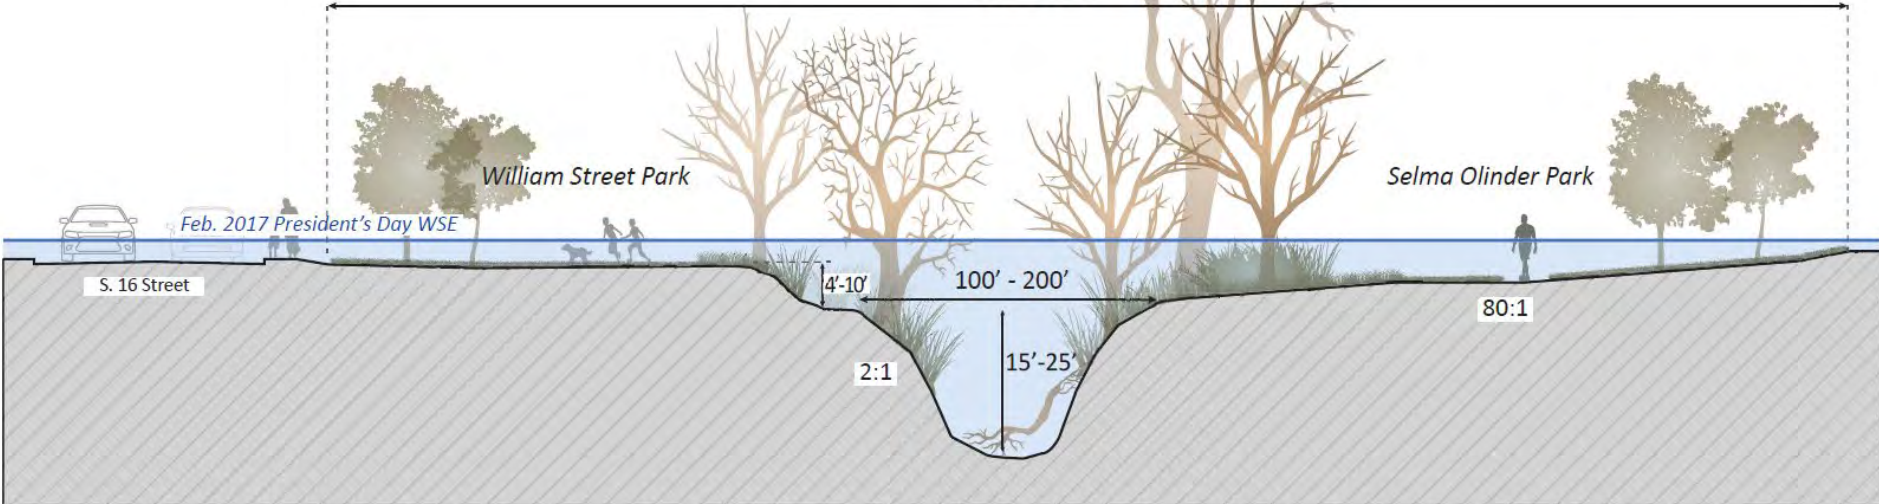
Reach 7: East Santa Clara Street to I-280

400' - 1000'

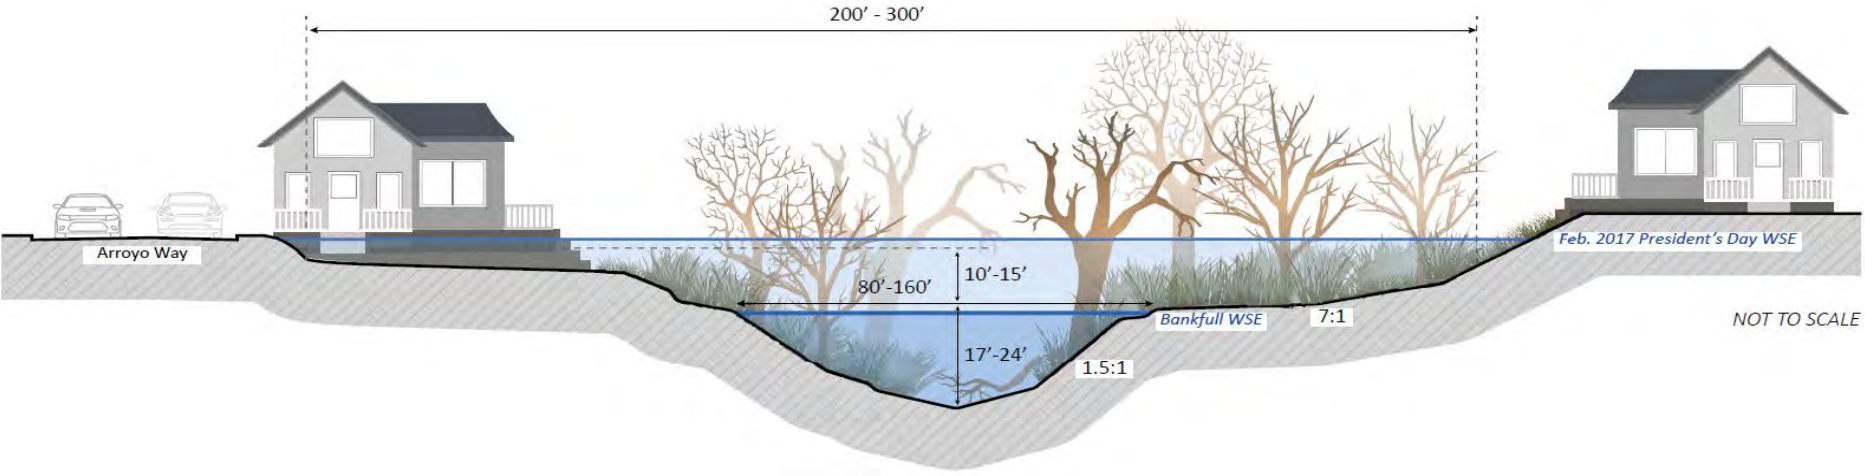
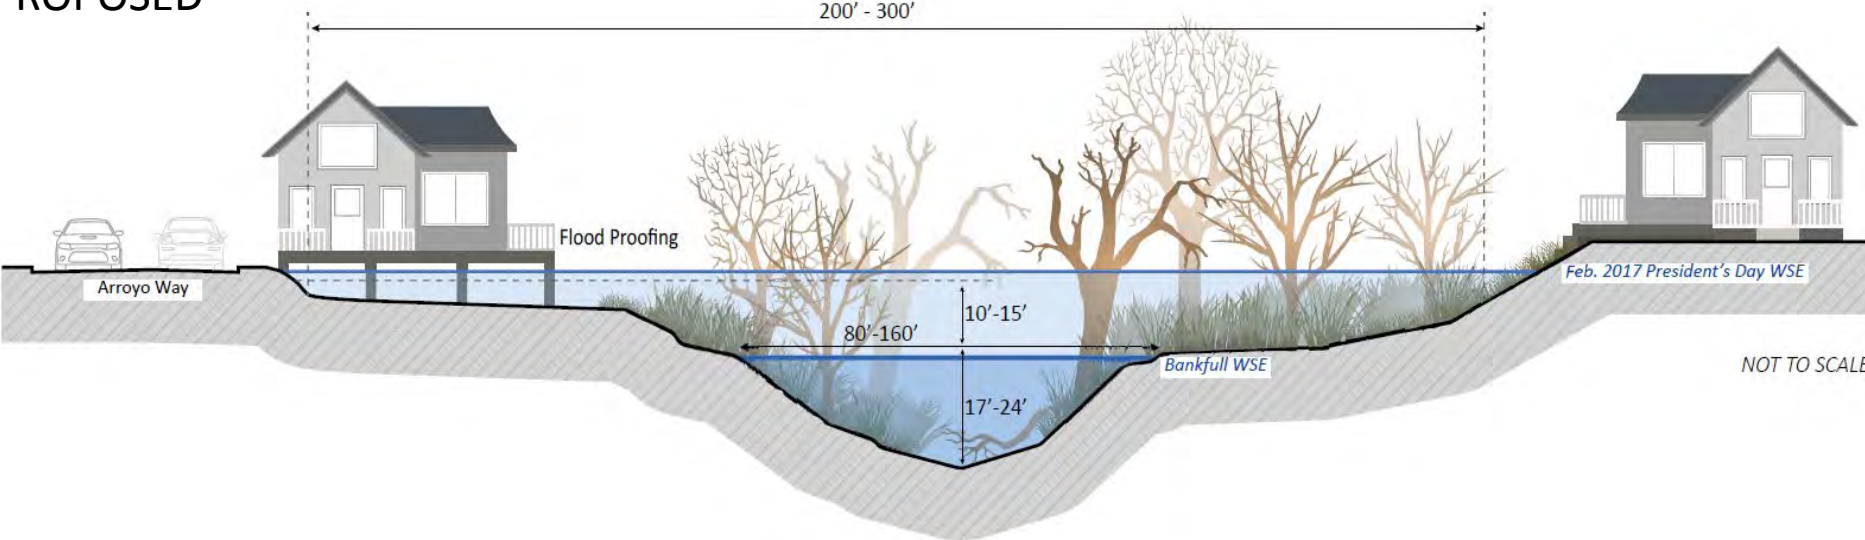
Flood Proofing

EXISTING

PROPOSED

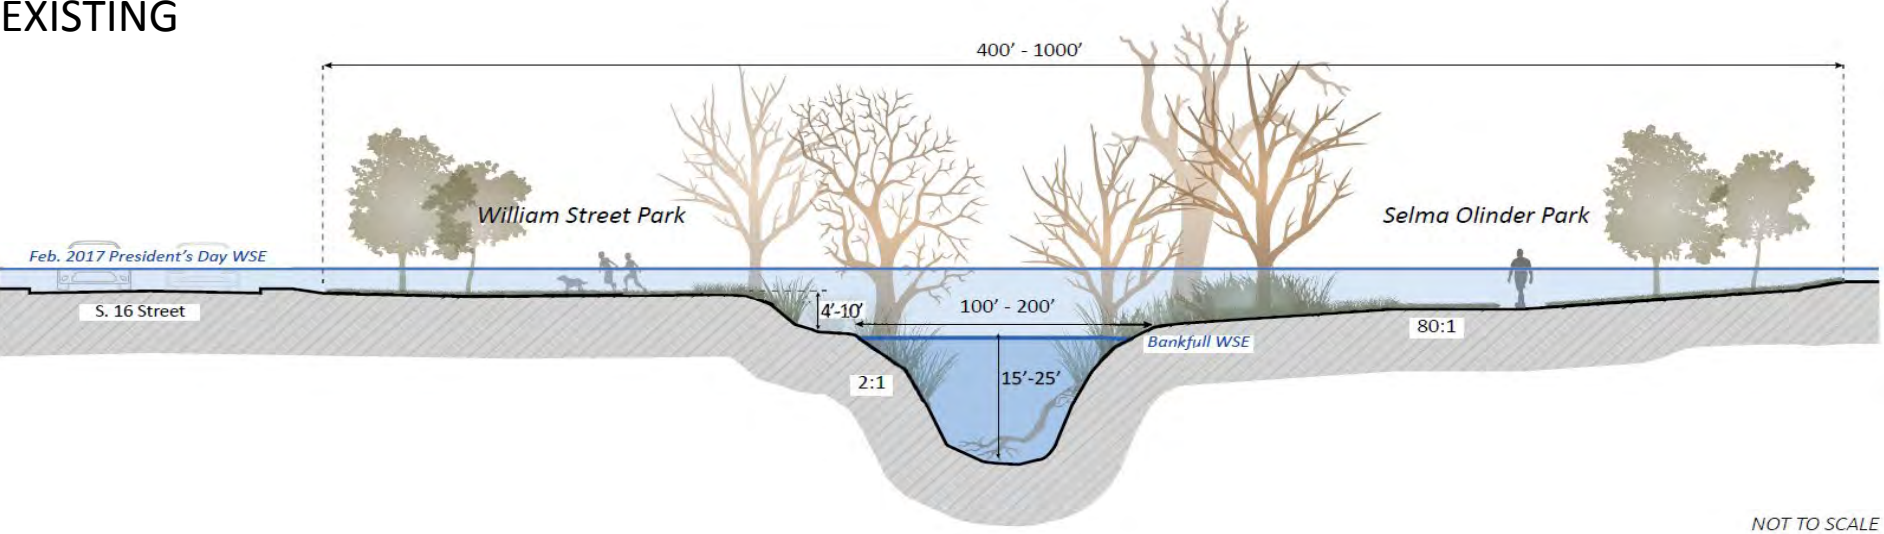
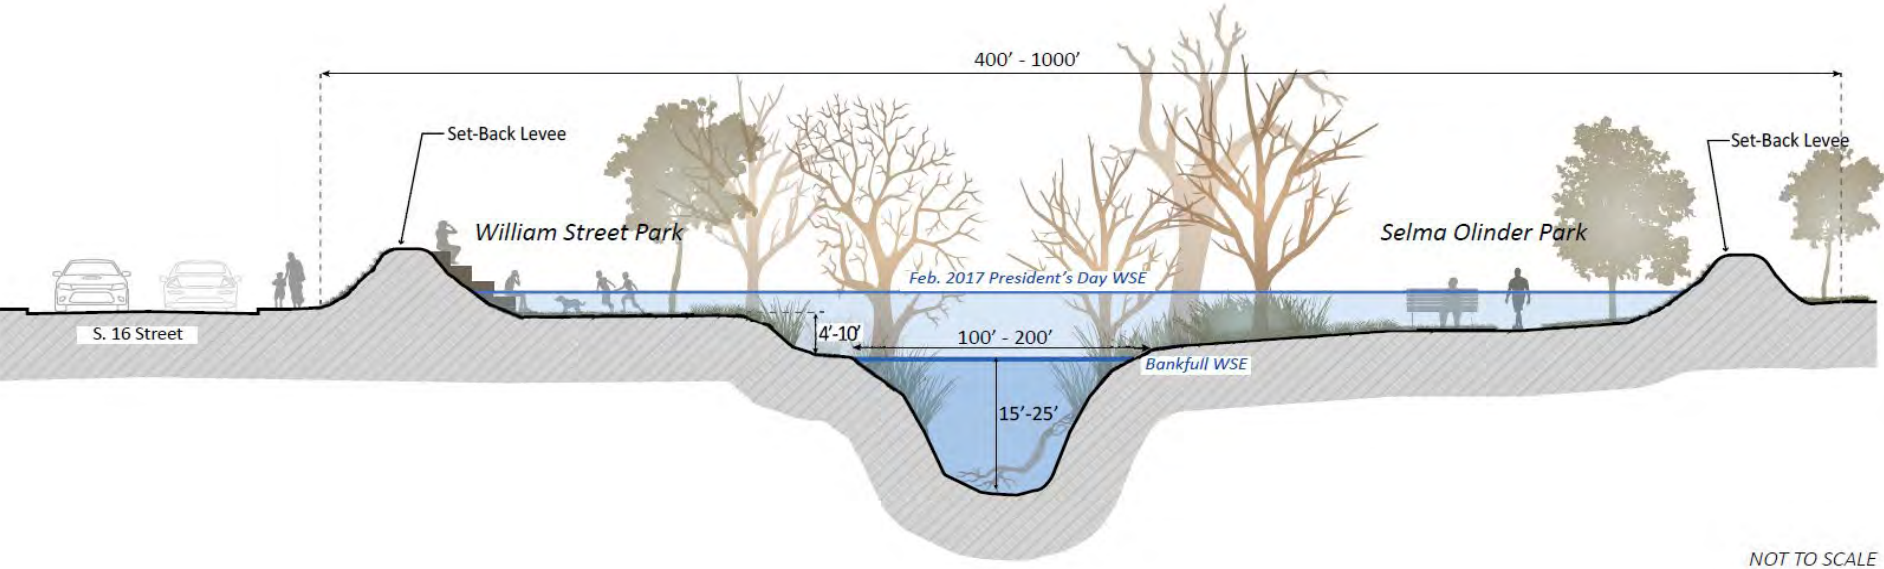
Set-back berms and levees

EXISTING

PROPOSED

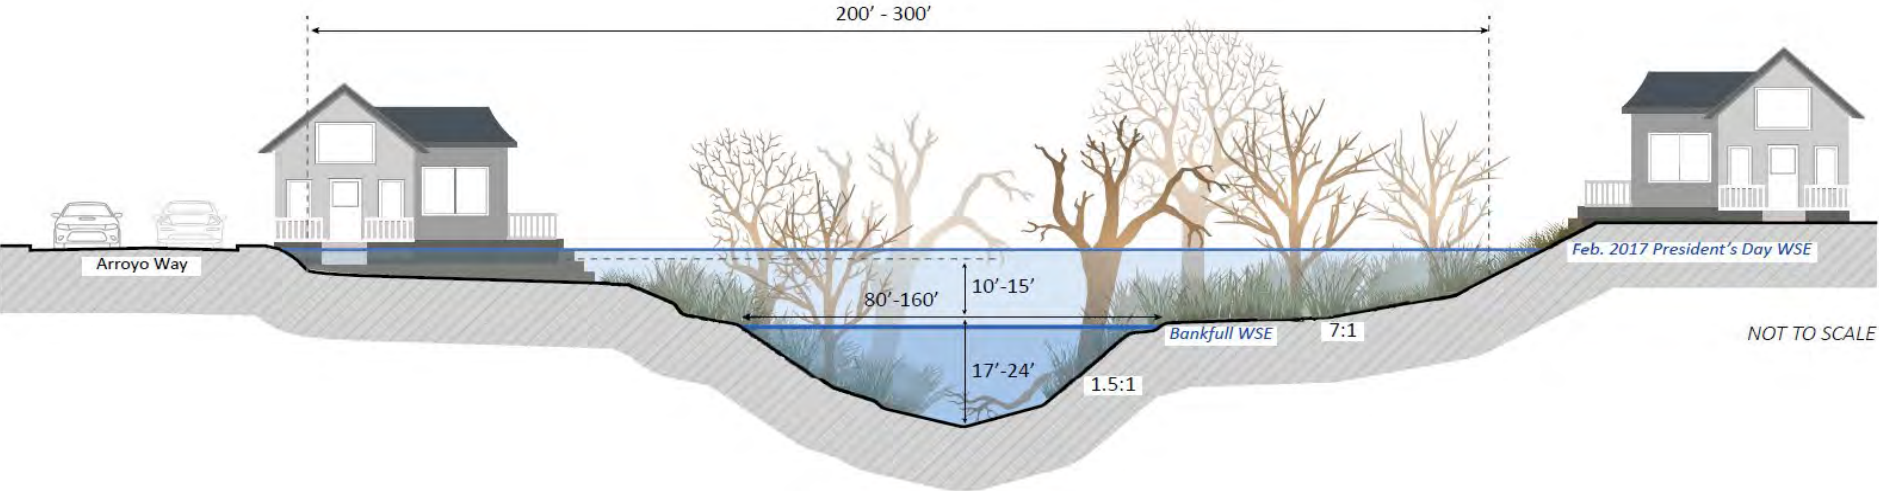
Floodwalls

EXISTING

PROPOSED

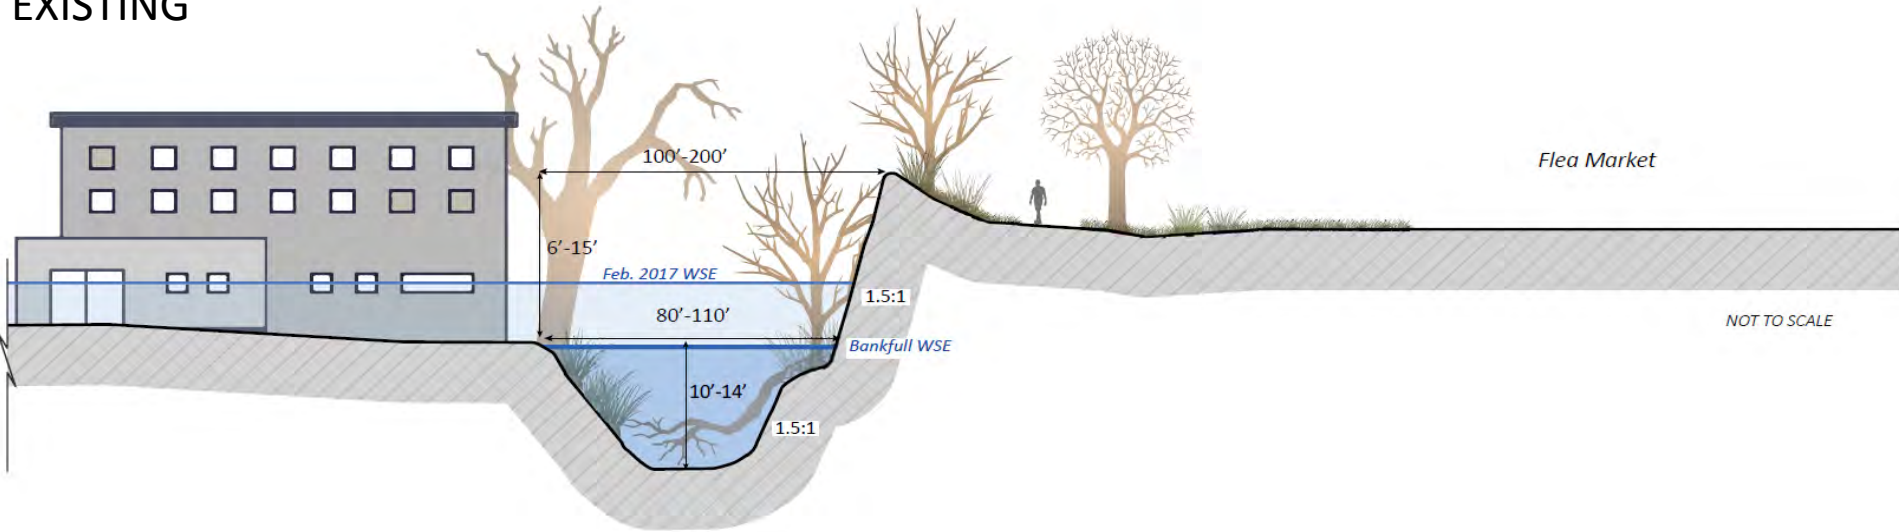
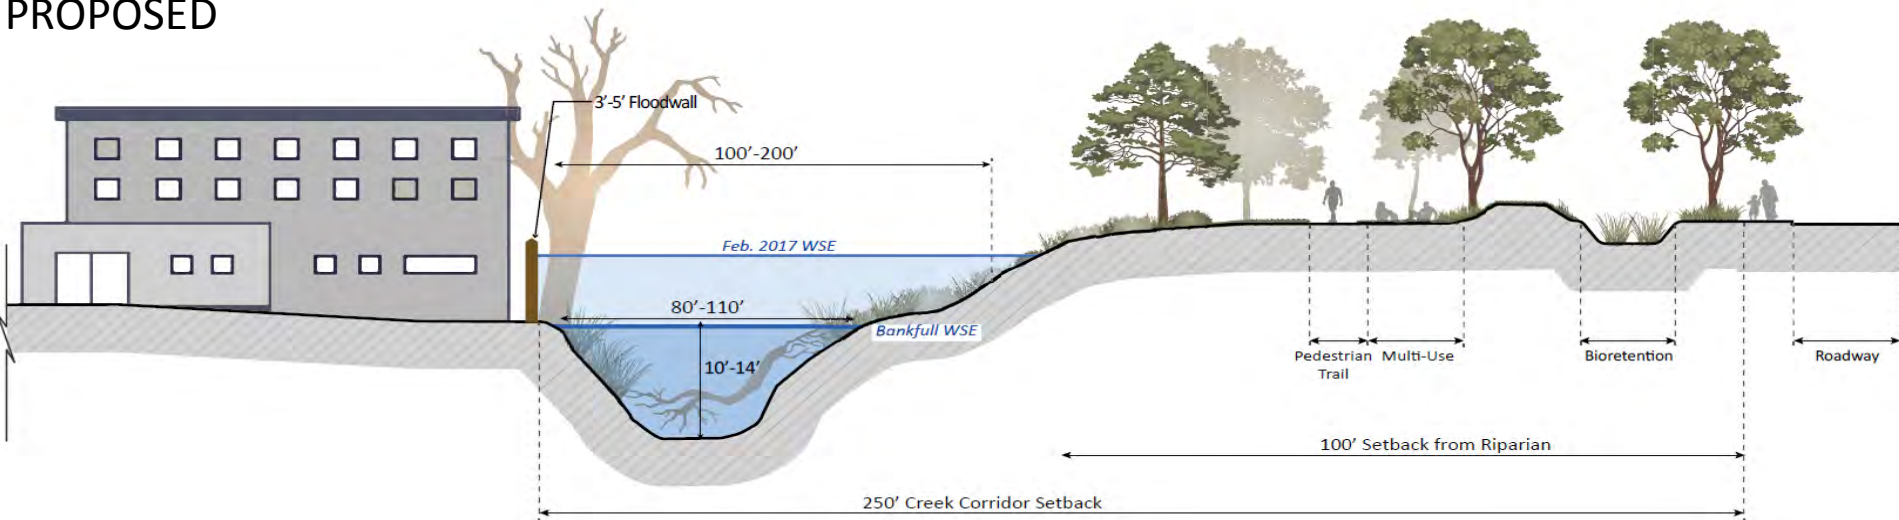
Flood protection and additional enhancements

EXISTING

PROPOSED
