FINAL REPORT
COYOTE CREEK WATERSHED HISTORICAL ECOLOGY STUDY
HISTORICAL CONDITION, LANDSCAPE CHANGE, AND RESTORATION POTENTIAL
IN THE EASTERN SANTA CLARA VALLEY, CALIFORNIA

PREPARED FOR THE SANTA CLARA VALLEY WATER DISTRICT MAY 2006

COYOTE CREEK WATERSHED HISTORICAL ECOLOGY STUDY //

**HISTORICAL CONDITION, LANDSCAPE CHANGE, AND RESTORATION
POTENTIAL IN THE EASTERN SANTA CLARA VALLEY, CALIFORNIA**

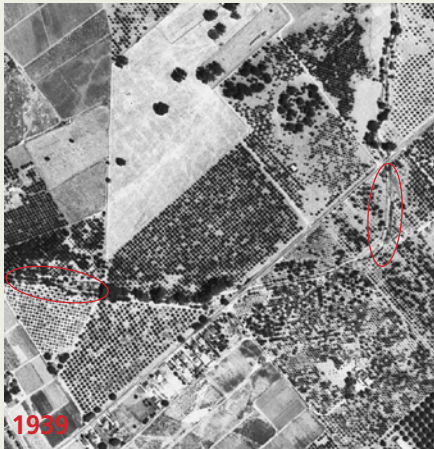
RIPARIAN RECOVERY In this set of aerial photographs, riparian forest along Upper Penitencia Creek – heavily impacted by agriculture in the 1930s – has significantly expanded with the creation of a protective land use buffer.

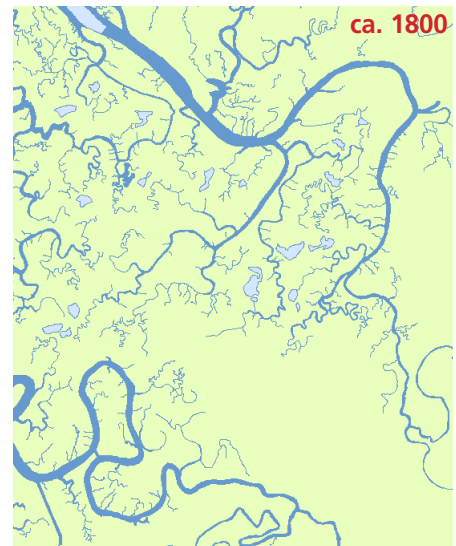
HISTORICAL (CA. 1800) BRACKISH MARSHLAND PATTERNS: tidal sloughs and pannes.

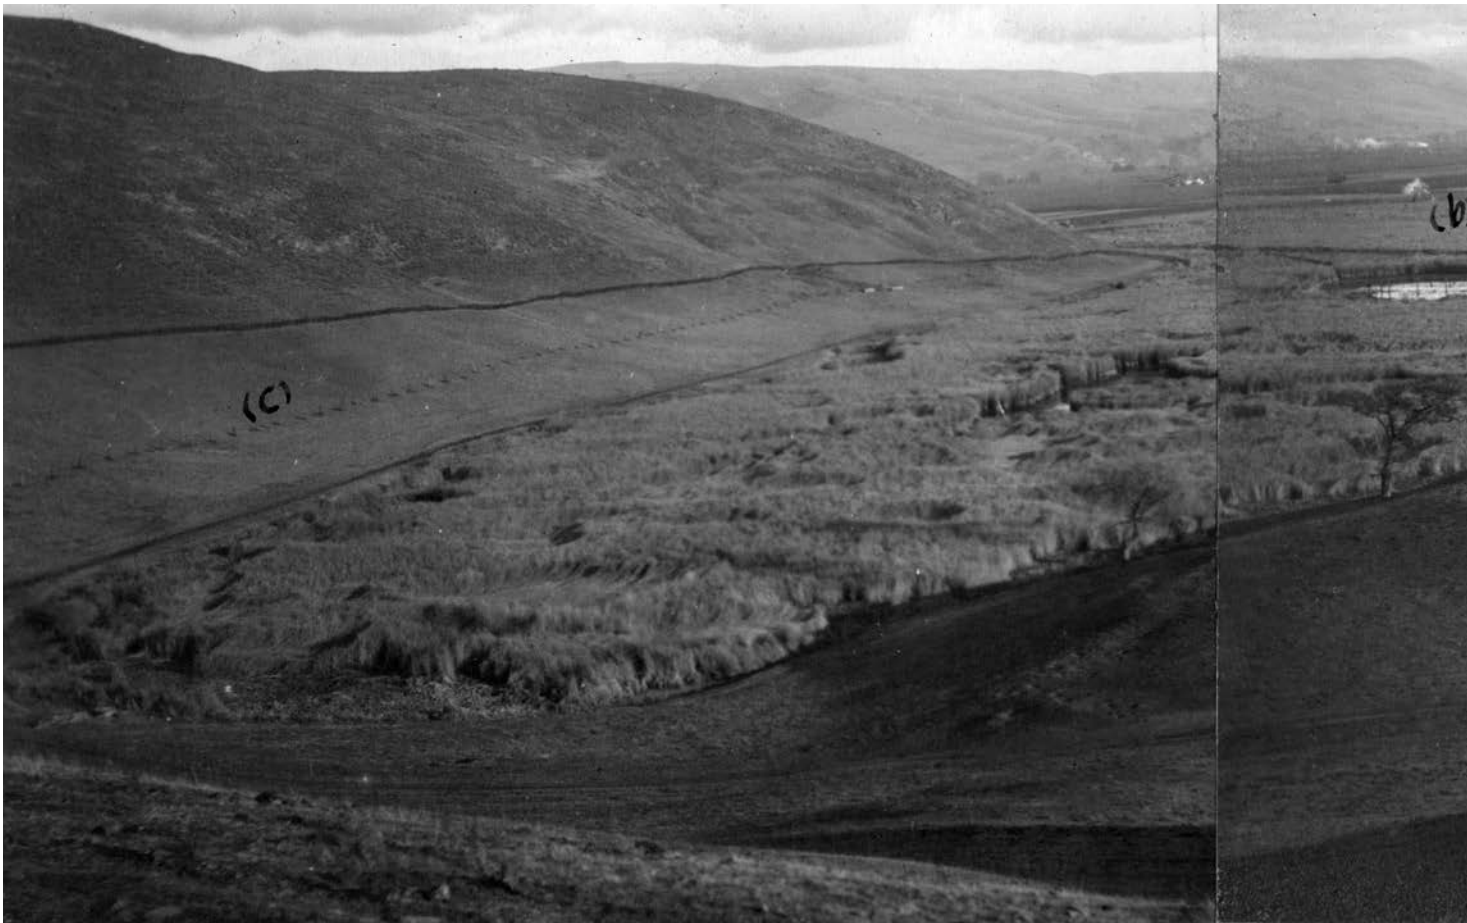
LAGUNA SECA, 1916. Looking southeast across the northern end of the *laguna*: tall tules, open water ponds, Tulare Hill at left (letters on photographs refer to photographer's notes; red circle at extreme left in Laguna Seca map series above shows photographer location).

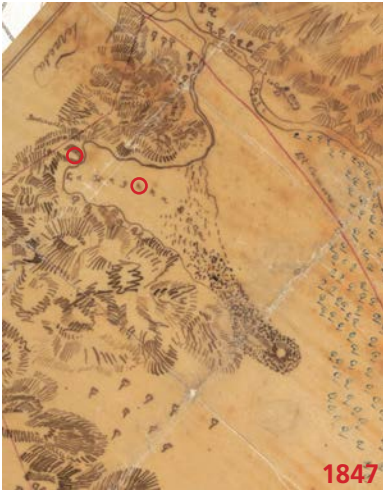
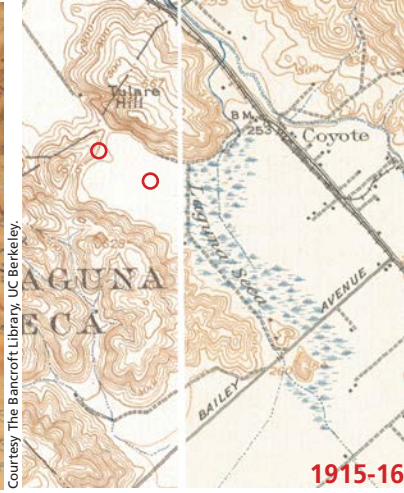
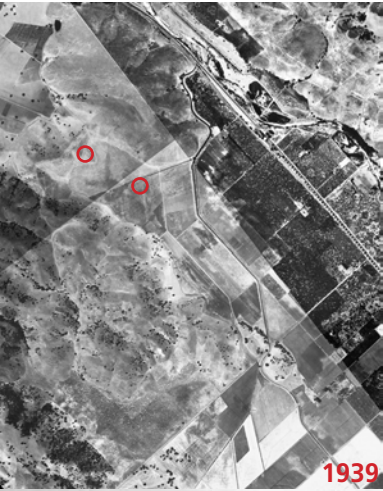
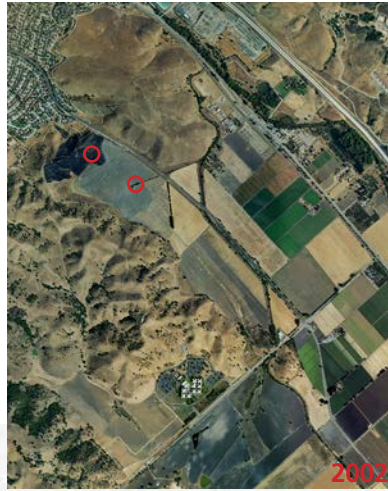
LAGUNA SECA THROUGH TIME

1847

1915-16

1939

2003

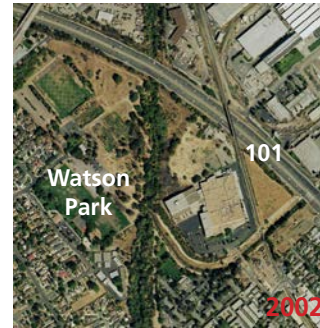
A ONCE-BROAD CHANNEL AREA with wide inset stream benches becomes a city landfill and then Watson Park.

(BELOW) DOTTED LINE IDENTIFIES AREAS OCCUPYING FORMER STREAM BENCHES.

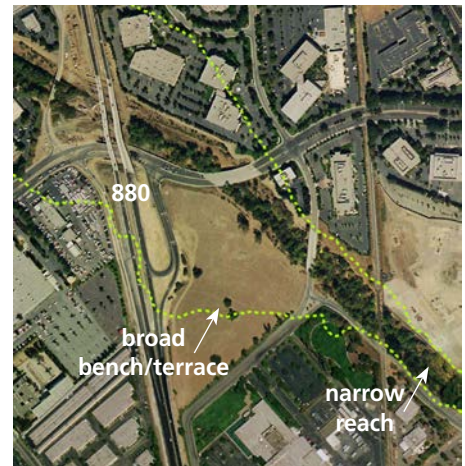
Existing flood-prone benches provide potential flood capacity. In the Mid-Coyote reach, there are many broad stream benches still subject to flooding. A number of these areas remain in public ownership, some of which could be designed to support and benefit from occasional flooding.

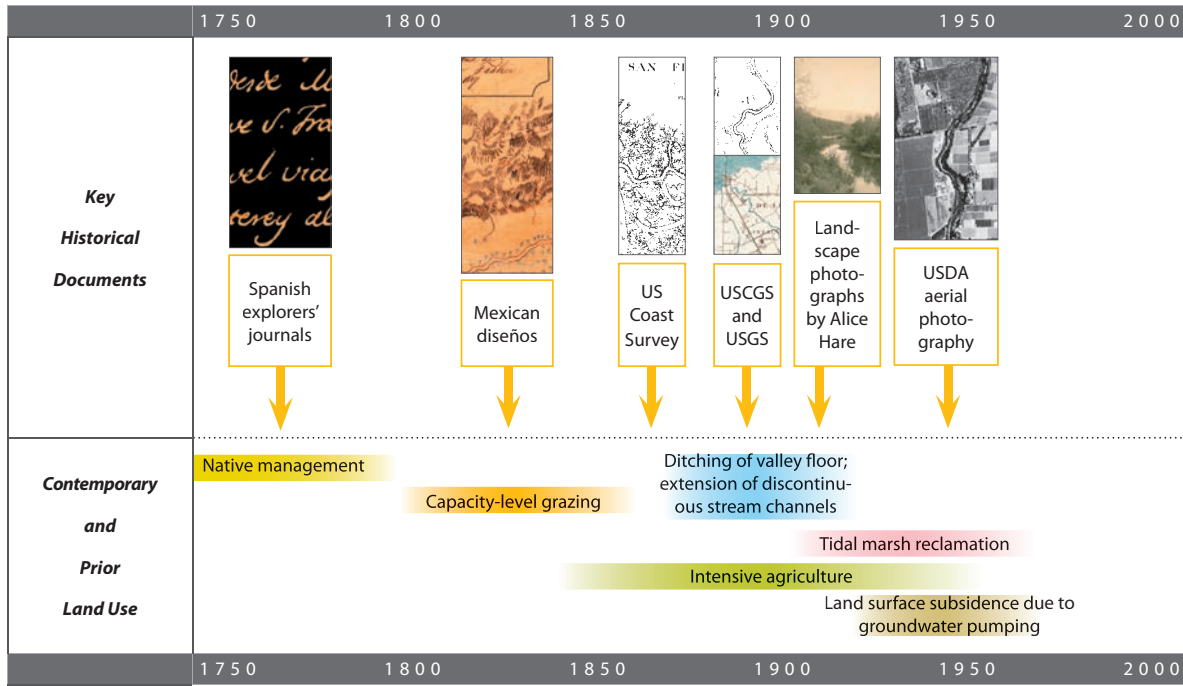
FIGURE I-1. DOCUMENT TIMING IN RELATION TO LAND USE HISTORY. Historical documents should be examined with an understanding of the prior land uses that have shaped a given site (from Grossinger and Askevold 2005).

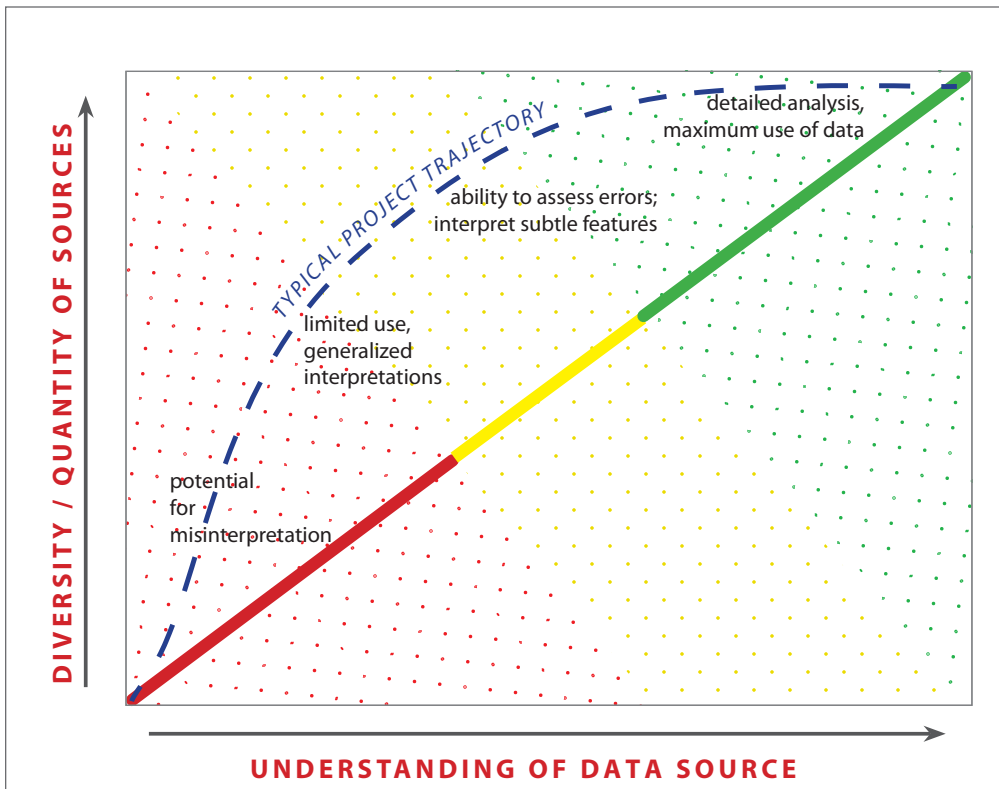
FIGURE I-2. IMPORTANCE OF A LARGE DATA SET AND SOURCE SCHOLARSHIP to accurate interpretation of historical data. In early stages of a project, there are many new sources and relatively little understanding of them. After an aggressive data collection phase, the number of new available documents diminishes and comparative analysis increases source understanding.

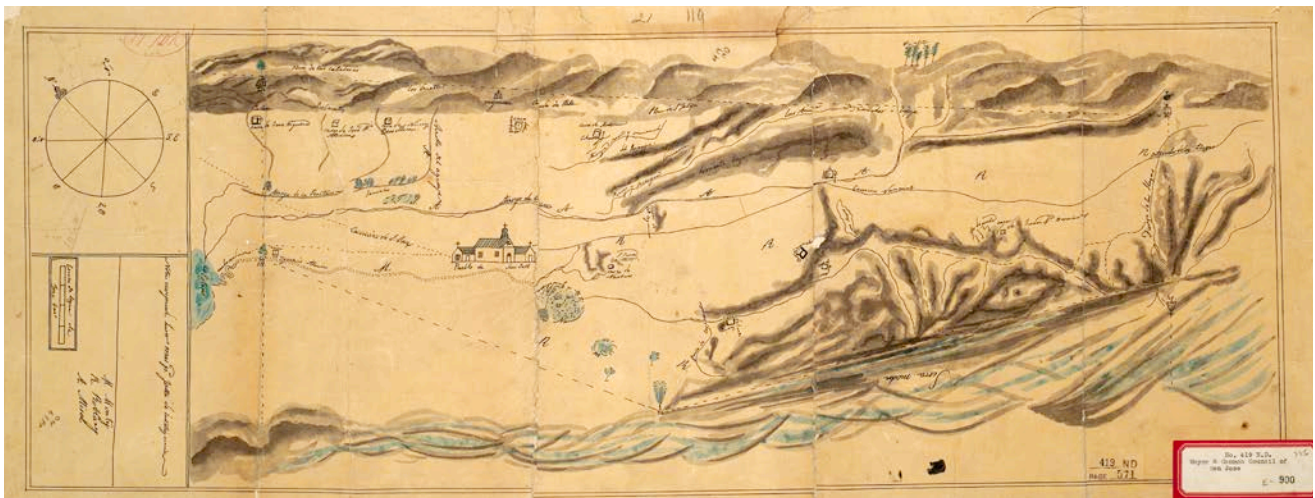
US District Court, Northern District [184-?]a. Land Case Map E-900.
Courtesy The Bancroft Library, UC Berkeley.

"THE LONG LINE FOLLOWED GENERALLY THE COURSE OF THE SANJON, BEING A LITTLE WITHOUT IT AT THE SOUTHERN END, AND A LITTLE WITHIN IT AT THE NORTHERN END." (DAY 1852)

As the Mission system disintegrated, influential Mexican citizens submitted claims to the government for land grants. The accompanying sketches of desired land, generally produced by anonymous, untrained men, show distinctive features of the land such as creeks, wetlands, and woods, often with watercolors, handwritten annotation, and varying systems of symbols and styles. Despite their substantial information content, they have been rarely used for environmental research.
