PART II //

HISTORICAL LANDSCAPE CONDITIONS AT THE WATERSHED SCALE

In Part II we develop a landscape framework for the Coyote Creek watershed. In the first section, we summarize the drainage patterns and habitats that characterized the Coyote Creek watershed prior to Euro-American modification, with particular attention to the valley floor. In the second section, we divide the watershed into five major landscape types that help explain landscape history and organize thinking about environmental restoration and management. The third section defines the major habitat types of the Santa Clara Valley and describes how we map them.

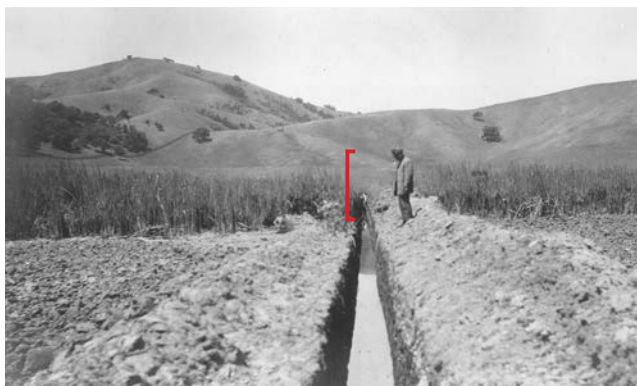
FIGURE II-10. “WATER STOOD FIVE FEET ABOVE GROUND SURFACE BEFORE RECLAMATION” [text from original photo caption]. Photograph taken immediately following the construction of drainage ditches through Laguna Seca (SCVWD Vault 1917).

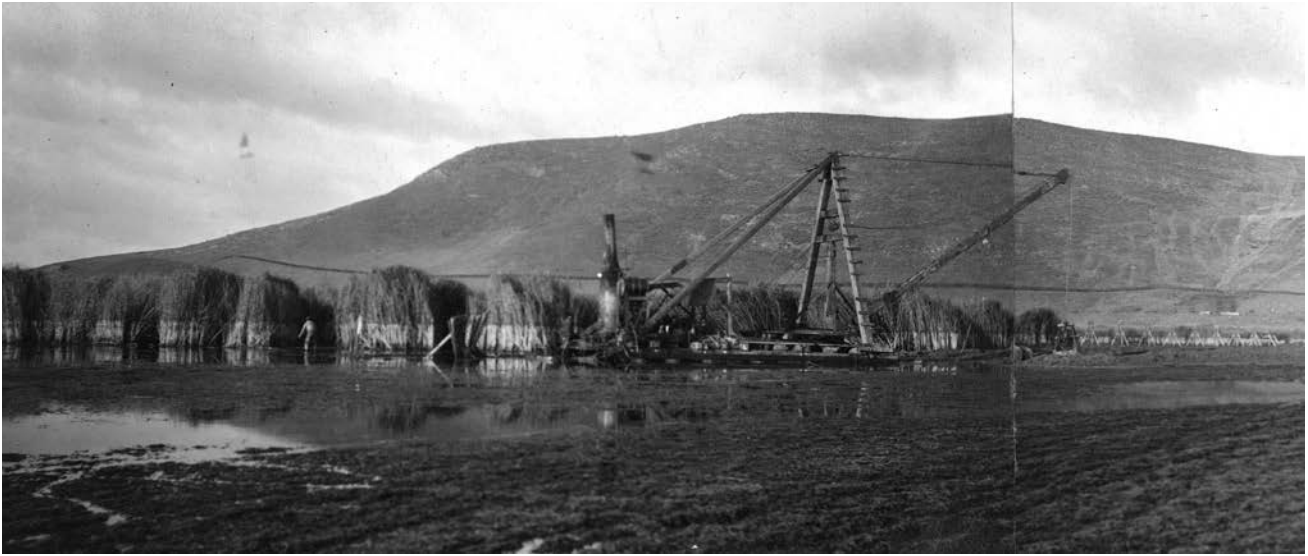
FIGURE II-11. "LAGUNA SECA RECLAMATION", 1916. "Bottom of Lagoon on December 28, 1916, showing Clam-shell machine at end of Ditch. Discoloration on tules [sic] shows height of water before drainage. Small shallow pools are from drainage water still coming from tules and flowing to Ditch" [text from original photo caption] (SCVWD Vault 1916: 66-67).

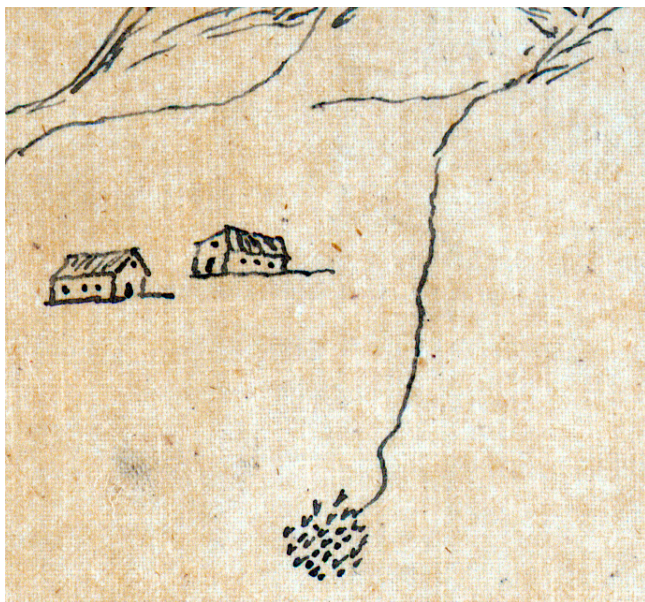
U.S. District Court 1870.

FIGURE II-12. DEPICTIONS OF WILLOW GROVES DOWNSTREAM OF UPPER PENITENCIA CREEK (top three images) and BERRYESSA CREEK (lower image) in early Spanish and American maps (courtesy Santa Clara County Surveyors Office (top two maps), and The Bancroft Library, UC Berkeley).

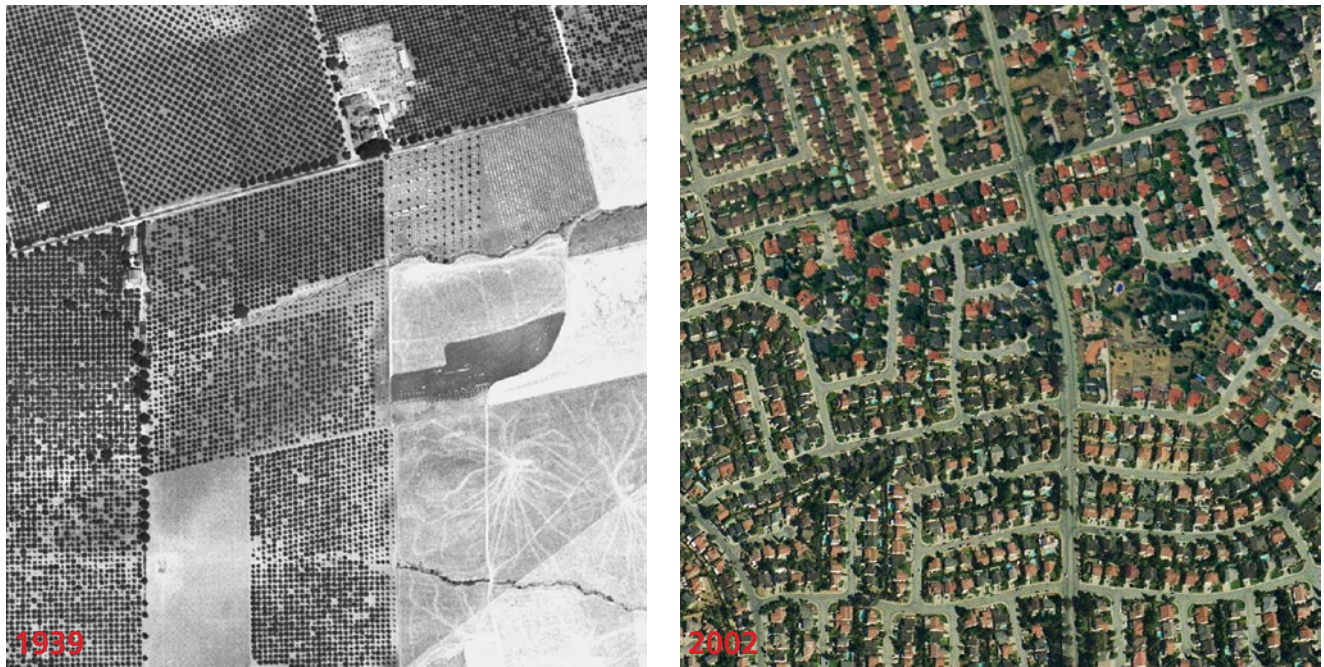
FIGURE II-13. THE LOWEST NATURAL REACHES OF NORWOOD CREEK, 1939 (LEFT) AND 2002 (RIGHT). The creeks flow right to left; Norwood Creek is above, an unnamed smaller creek is below. Spiderlike cow path patterns can be seen in the grazed area at lower right. Norwood and Ruby Avenues intersect at upper middle (AAA 1939; 2002 imagery copyright 2005 AirPhotoUSA, LLC, All Rights Reserved).

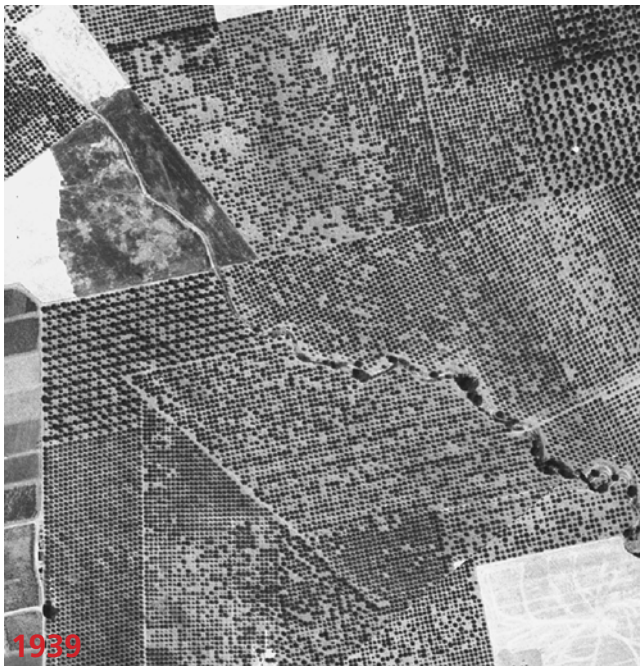
FIGURE II-14. THOMPSON CREEK IN 1939 (LEFT) AND 2002 (RIGHT). Thompson Creek flows to the northwest here, immediately downstream of Aborn Road. Note expansion of riparian vegetation (AAA 1939; 2002 imagery copyright 2005 AirPhotoUSA, LLC, All Rights Reserved).

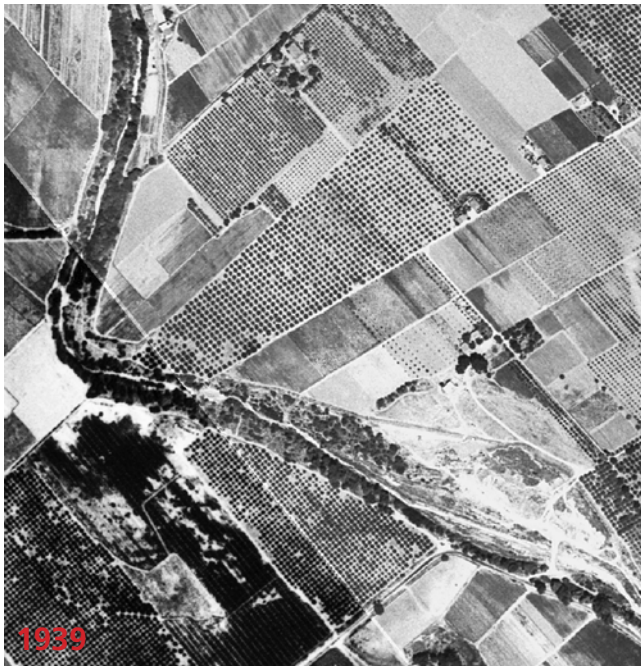
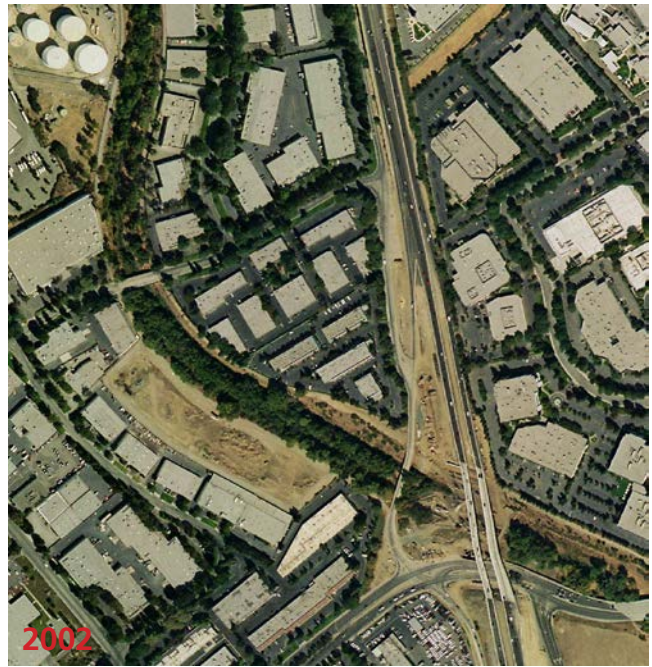
FIGURE II-19. COYOTE CREEK AT HIGHWAY 880: 1874 (LOWER LEFT), 1939 (UPPER LEFT), AND 2002 (RIGHT). Change in this reach has been extensive. In 1874, Hermann's Coyote River Survey documented a narrow main channel with some linear riparian habitat and broad adjacent benches partly occupied by willow thickets (his field notes indicate the tree species). By 1939, much of the former active channel area is occupied by agriculture, although the location of the willows and parts of the adjacent bars or benches can still be identified. The 1972 flood control project removed the channel's sharp turn; the banks have since been colonized by riparian vegetation (AAA 1939; 2002 imagery copyright 2005 AirPhotoUSA, LLC, All Rights Reserved; Herrmann 1874c).

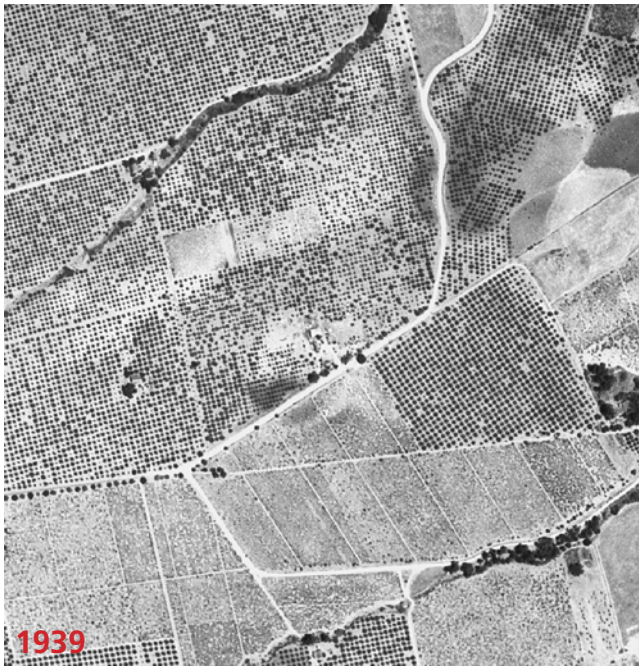
FIGURE II-20. QIMBY CREEK AT THE BASE OF THE FOOTHILLS IN 1939 (LEFT) AND 2002 (RIGHT). Downstream extent of visible riparian vegetation in 1939 is similar on Quimby Creek (image lower right), the unnamed creek to the north, and other nearby systems. By 2002, the creek to the north is no longer aboveground and riparian vegetation has expanded on the remaining portion of Quimby Creek. Chaboya Road runs through the middle of both images (AAA 1939; 2002 imagery copyright 2005 AirPhotoUSA, LLC, All Rights Reserved).

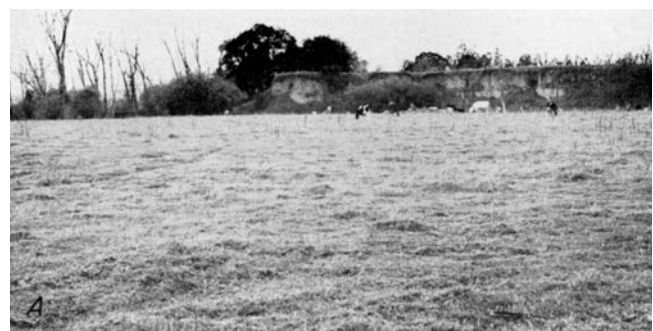
FIGURE II-21. CATTLE GRAZING on stream bench along Coyote Creek (Gardner et al. 1958).

These conditions are often indicated by the descriptors “gravel bar” or “gravel bed” (e.g. Herrmann 1874b,c), showing recent sediment transport/deposition, and are generally noted by Gardner et al. (1958) as “a growth of grass and brush” on the Coyote Creek “benches.” Amateur naturalist Mary Carroll (1903) notes the presence of *Mentzelia laevicaulis* in “sandy beds of the dry creeks” generally within Santa Clara Valley.

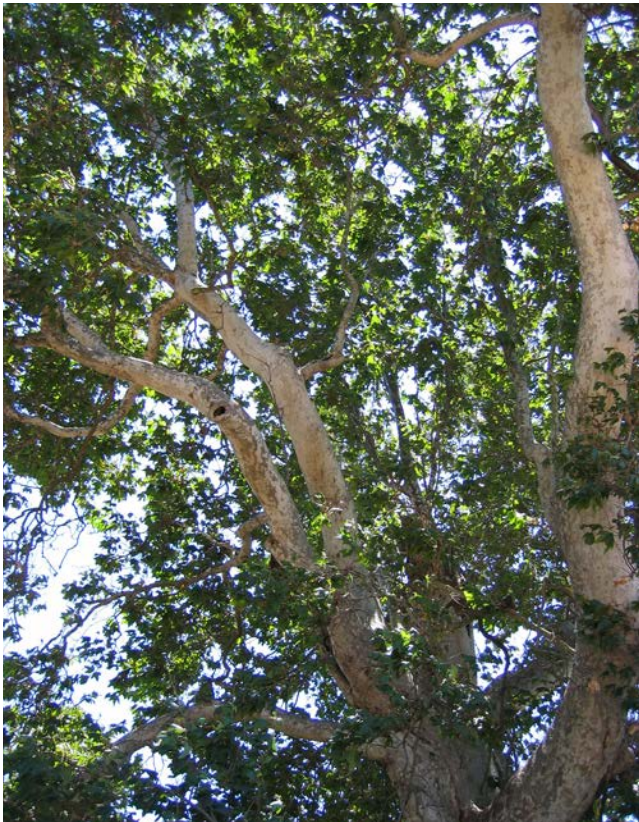
FIGURE II-23. SYCAMORE on occasionally flooded terrace of Coyote Creek, near Coyote Creek Golf Club.

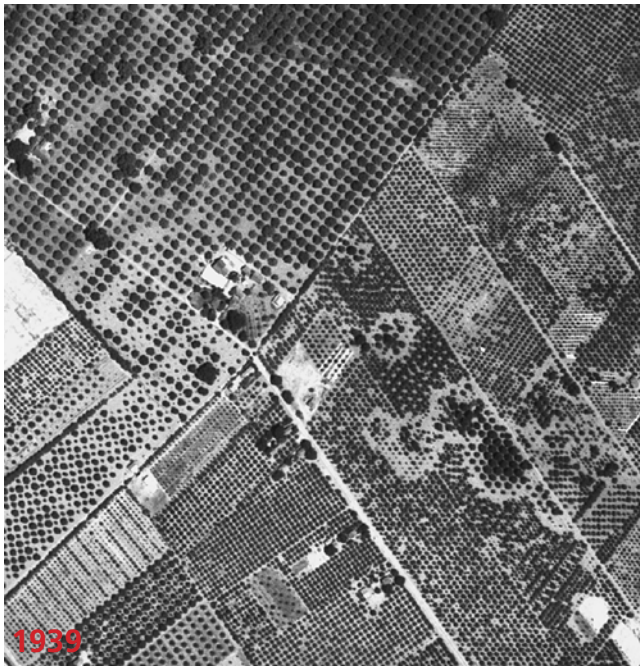
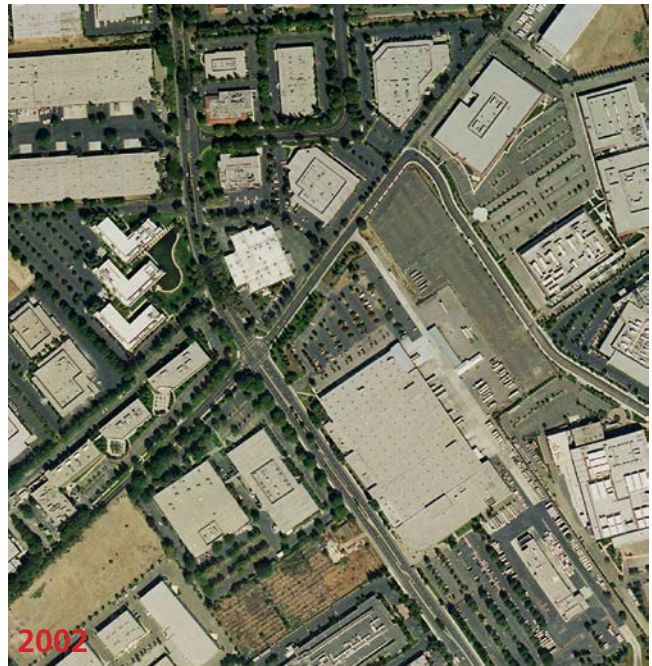
FIGURE II-24. EARLY AERIAL PHOTOGRAPHIC EVIDENCE FOR VALLEY OAK SAVANNA. Several large trees scattered within the orchard at upper left in the 1939 image (left image) are probably valley oaks. Additionally, the circular disease patterns visible at center right indicate the probable location of valley oaks recently removed for orchard planting, whose roots have caused oak root rot. There are no obvious residual trees in 2002 (right image) (AAA 1939; 2002 imagery copyright 2005 AirPhotoUSA, LLC, All Rights Reserved).

This is not to say that most of the oaks were not cut down over time, but that the decline was gradual and heterogeneous, varying by property and land use (as can be seen by examining remnant patterns in the 1939 aerial photography). In those parts of the Bay Area naturally endowed with valley oak savanna, there tended to be some recognition of their cultural value. For example,

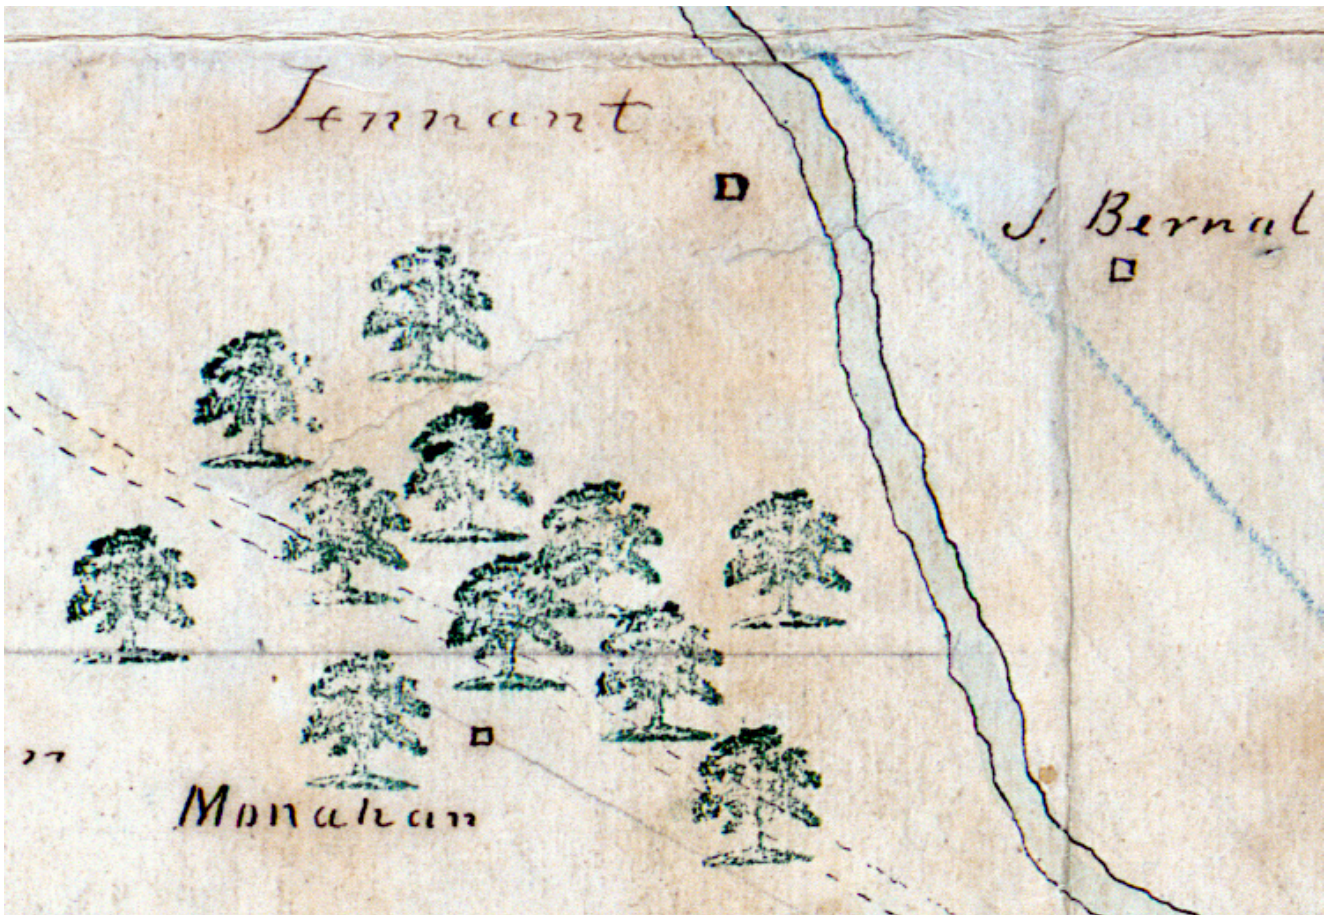
FIGURE II-25. DEPICTIONS OF VALLEY OAK SAVANNA using a tree stamp and text (lower right) (Healy, U.S. Dist. Court 1859, courtesy The Bancroft Library, UC Berkeley).

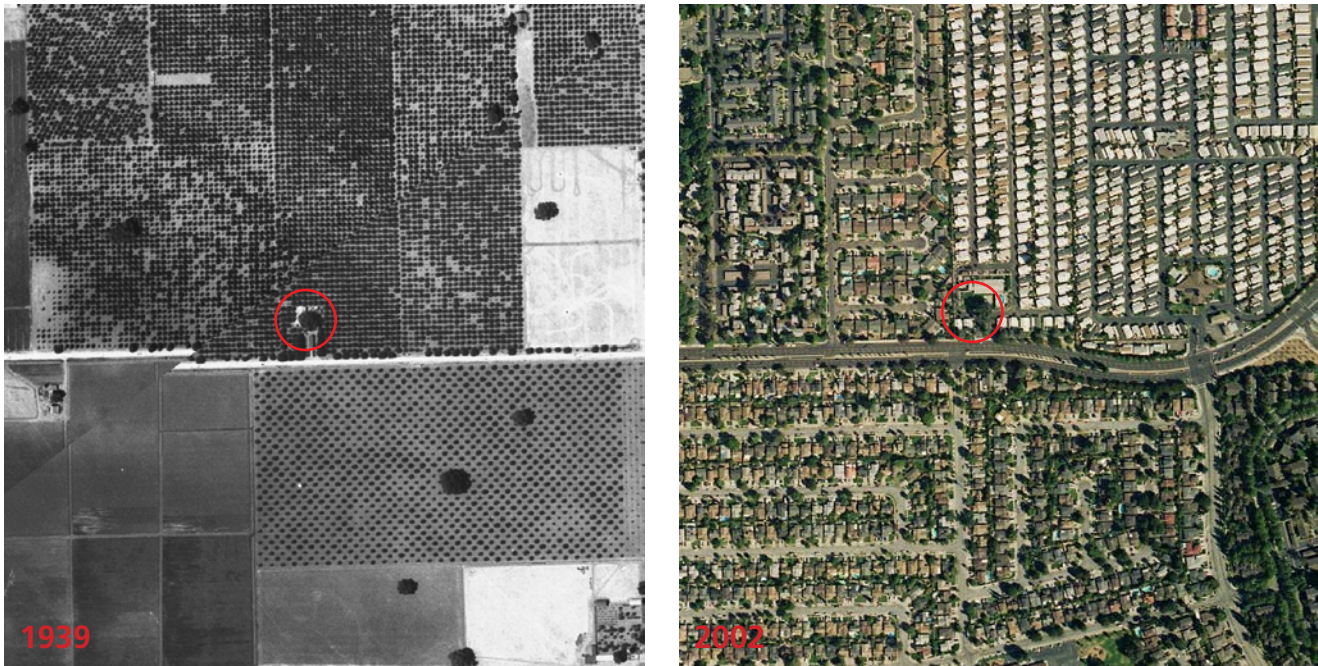
FIGURE II-27. BLOSSOM HILL ROAD IN 1939 (LEFT) AND 2002 (RIGHT). Aerial photographic overlay allows the identification of at least one persisting, heritage oak tree, shown in **FIGURE II-28** (AAA 1939; 2002 imagery copyright 2005 AirPhotoUSA, LLC, All Rights Reserved).
