Anderson Dam Seismic Retrofit Project Update

Public Meeting – City of Morgan Hill | March 22, 2017

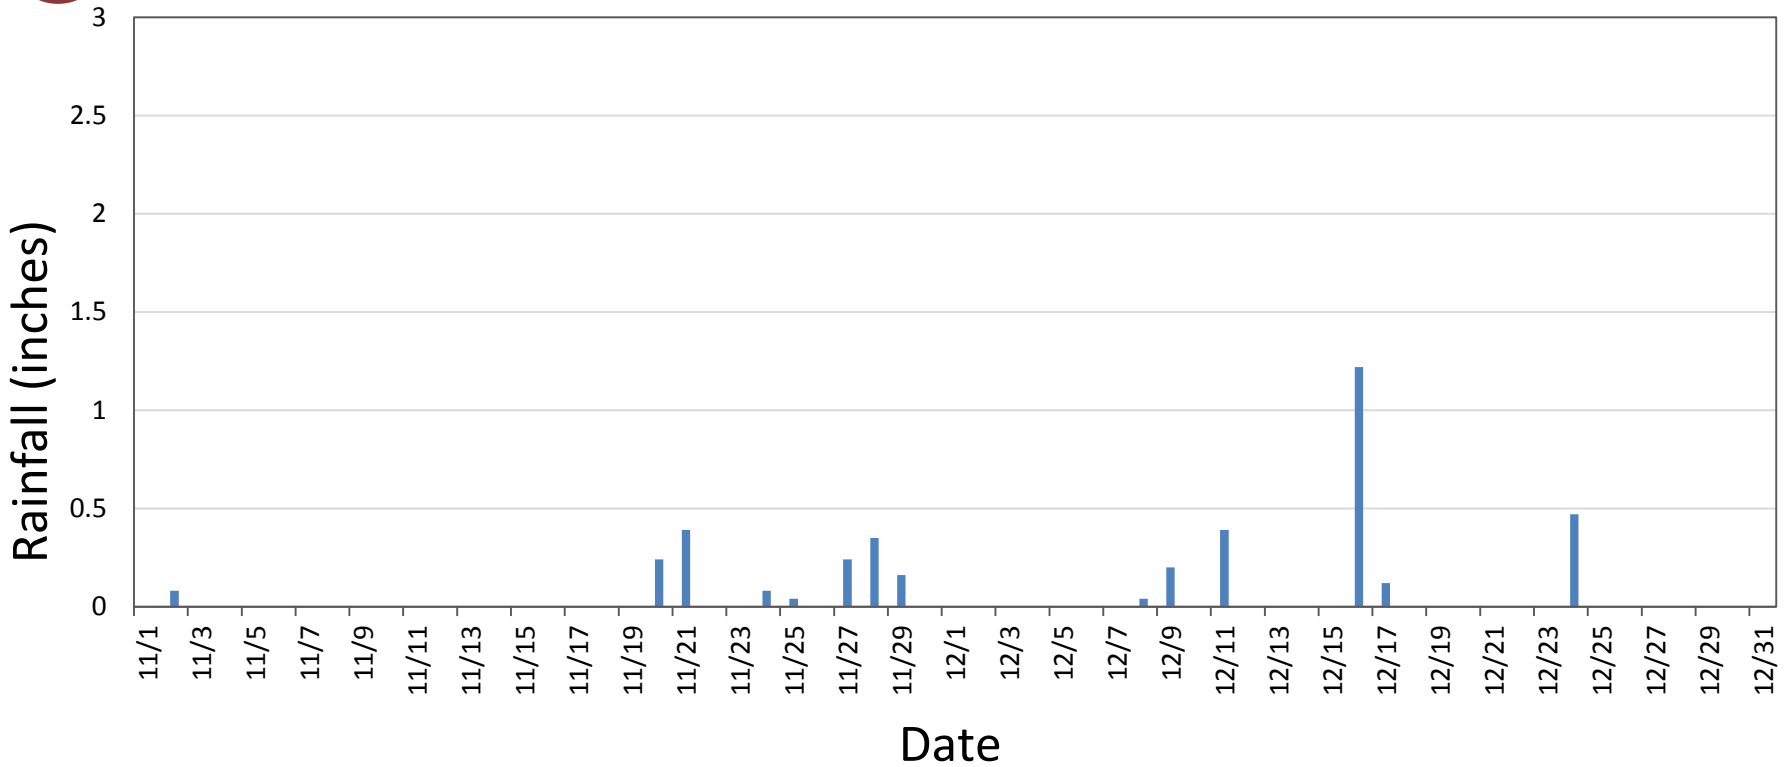
Coyote Reservoir Rainfall: November 1 – December 30, 2016

1 Coyote Reservoir Precipitation Gauge (ALERT gauge 6021)

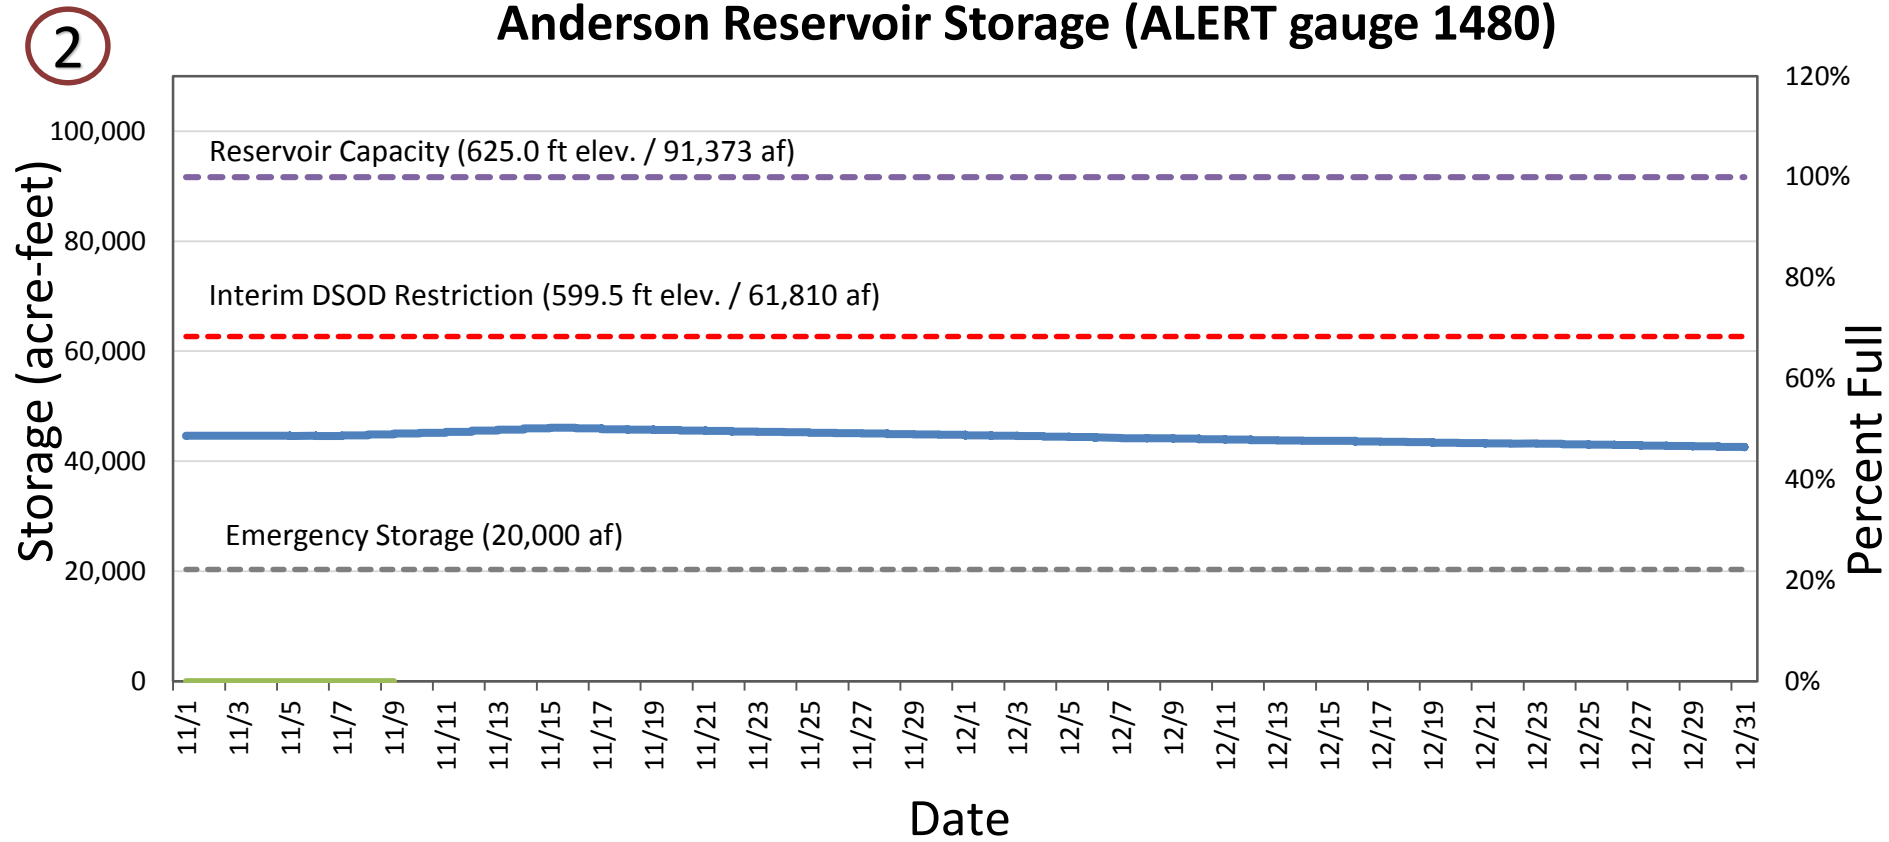
Anderson Reservoir Storage: Nov. 1 – Dec. 30, 2016

Note: Anderson Reservoir Actual Storage Level is **solid blue line**

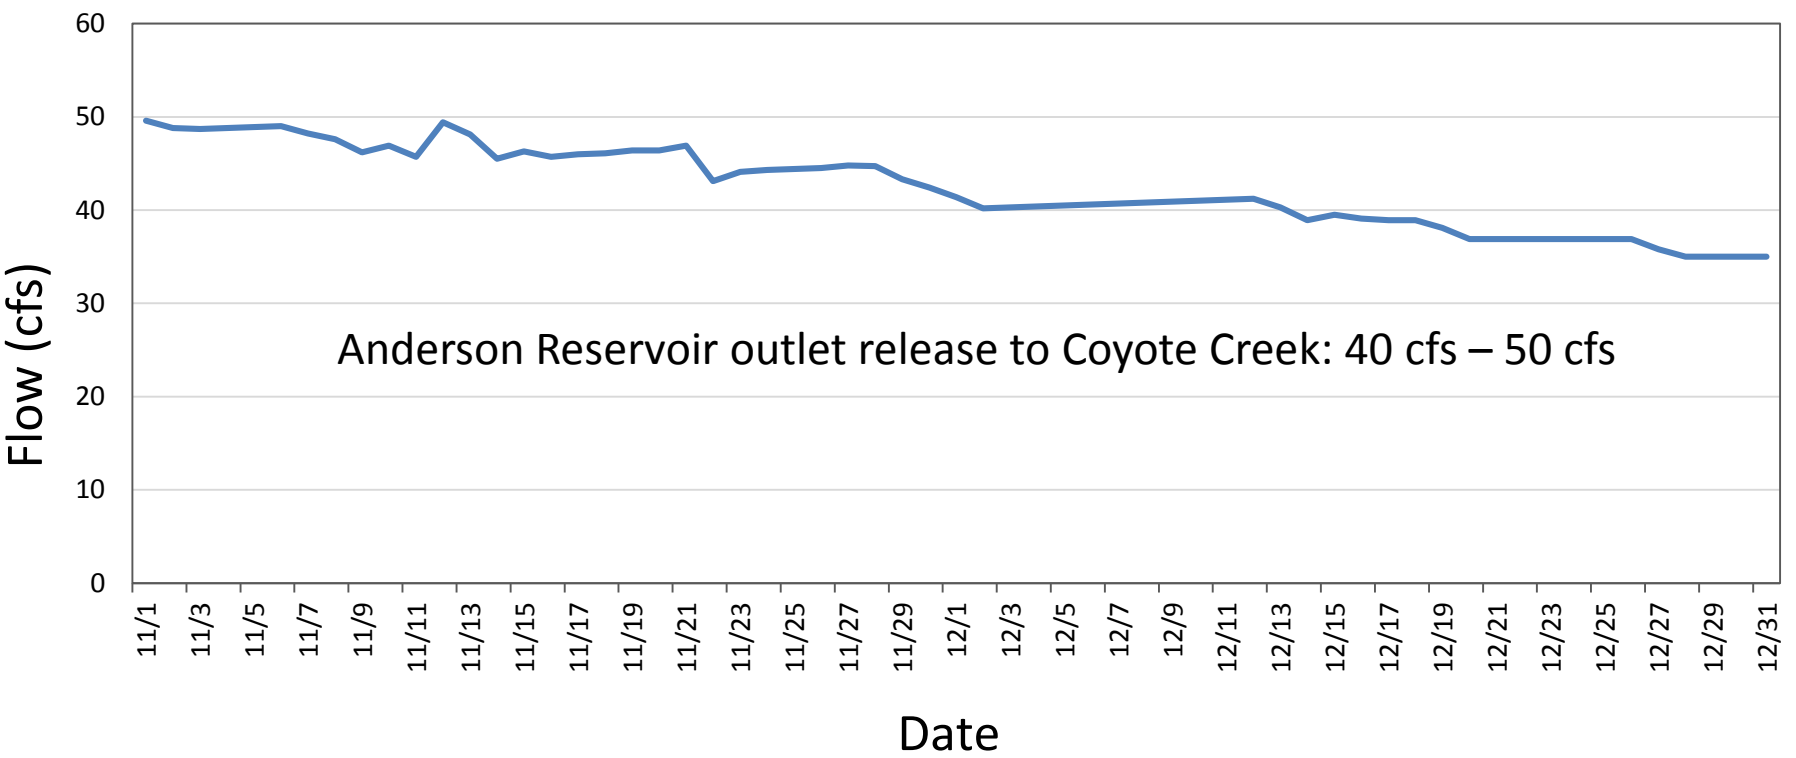
Coyote Creek Flows: November 1 – December 30, 2016

Coyote Creek at Madrone Streamflow Gauge (ALERT gauge 5082)

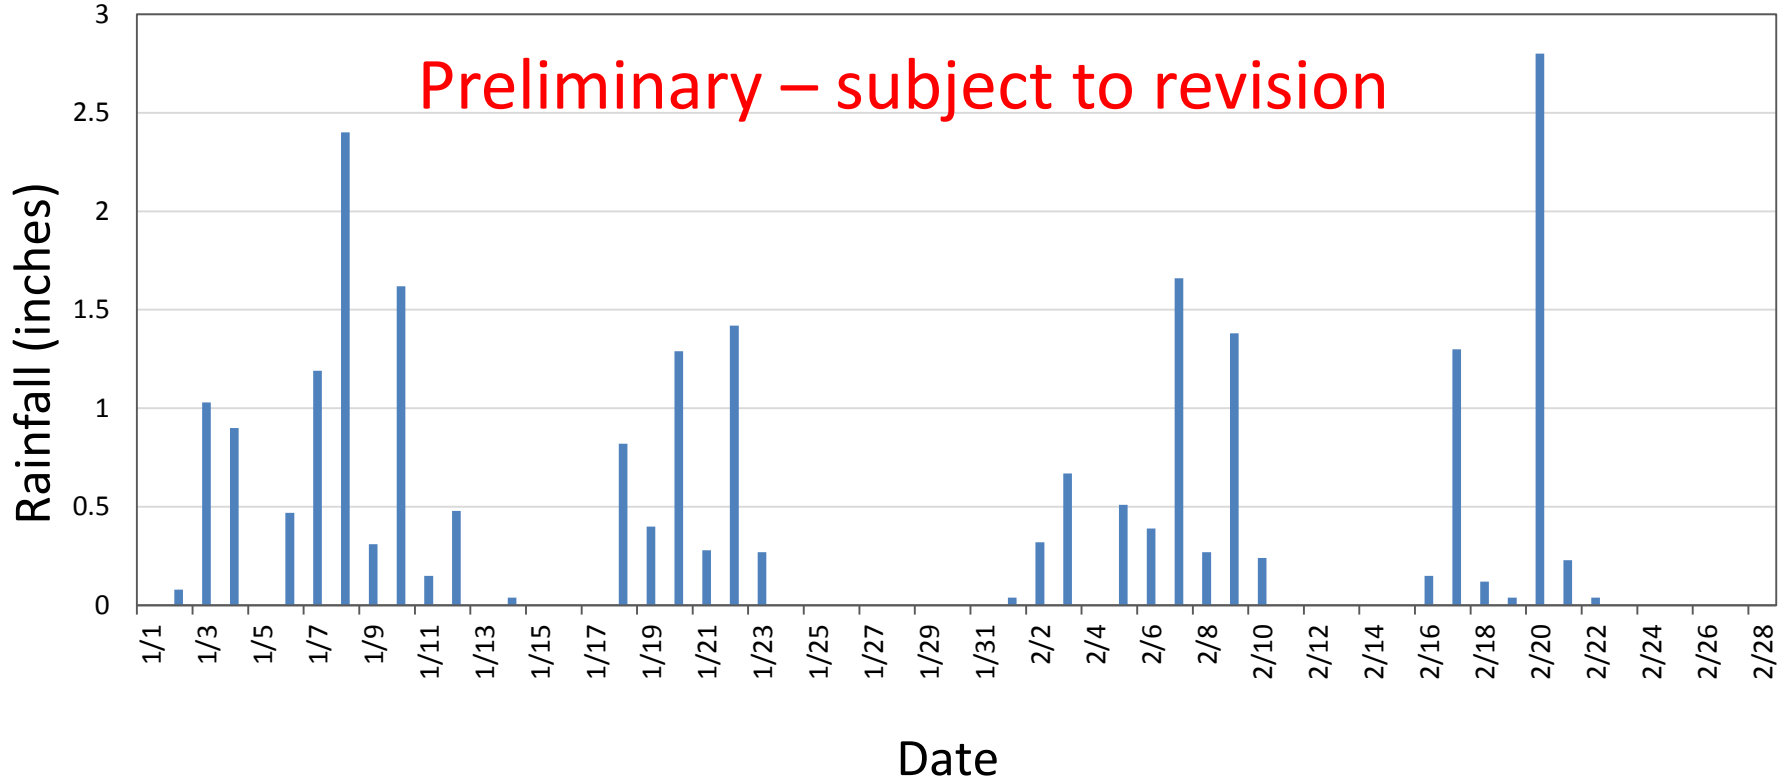
Coyote Reservoir Rainfall: January 1 – February 28, 2017

Coyote Reservoir Precipitation Gauge (ALERT gauge 6021)

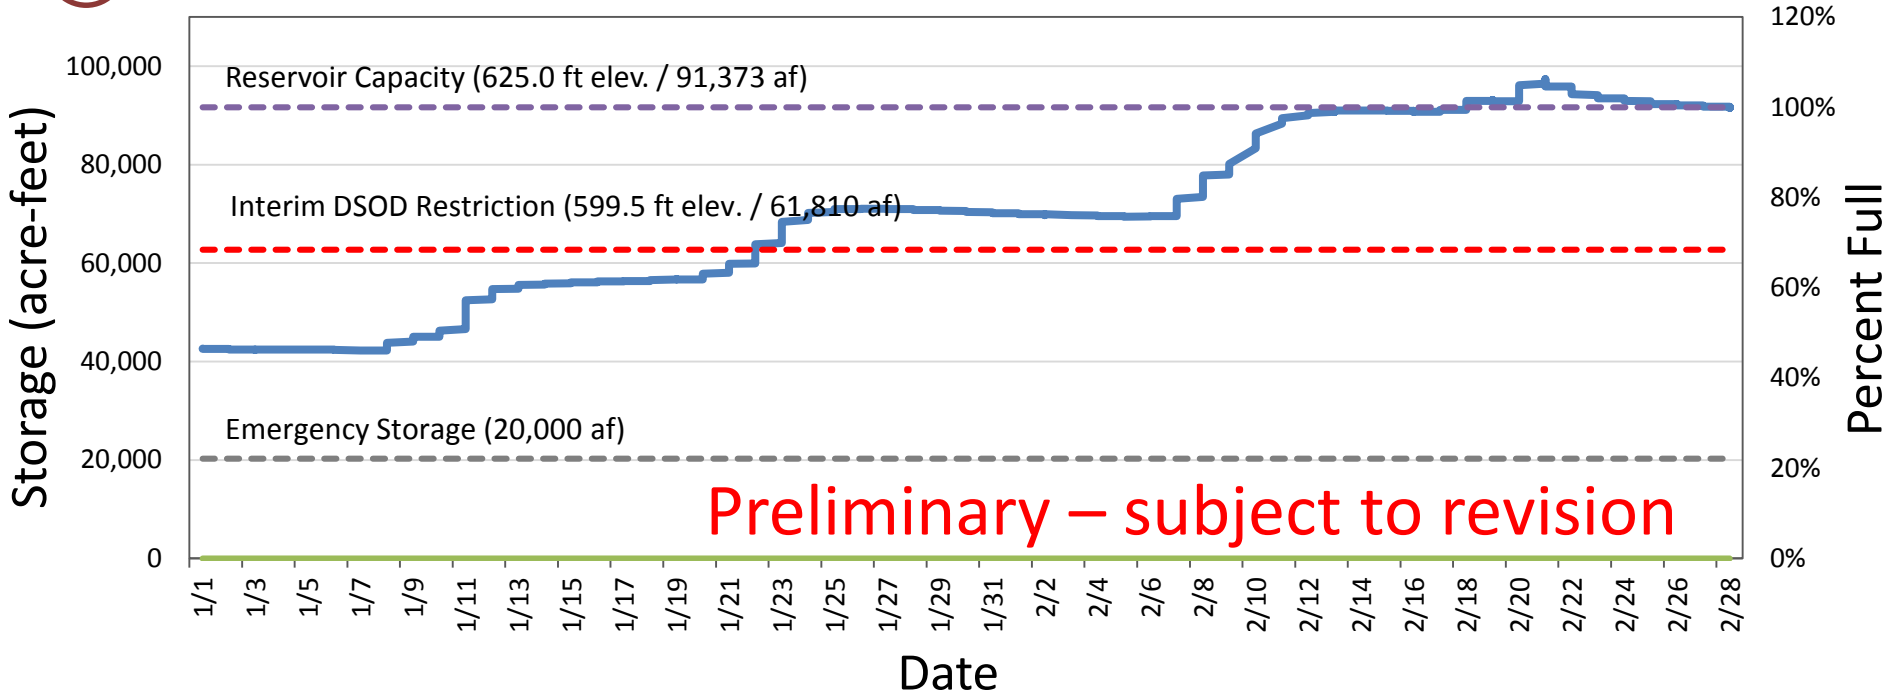
Anderson Reservoir Storage: Jan. 1 – Feb. 28, 2017

Note: Anderson Reservoir Actual Storage Level is **solid blue line**

5 Anderson Reservoir Storage (ALERT gauge 1480)

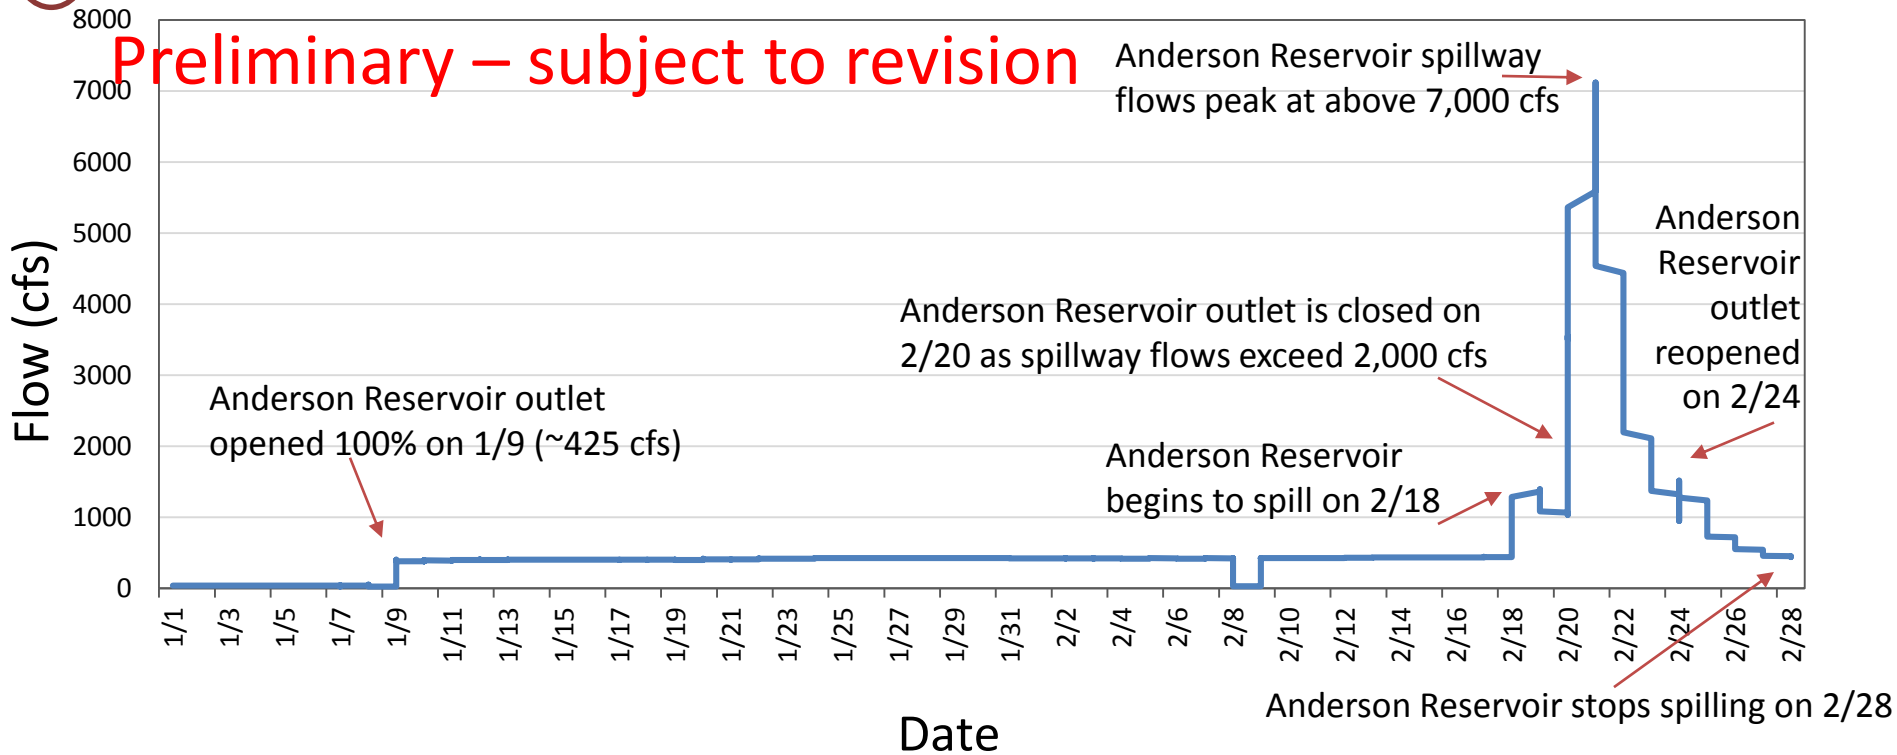
Coyote Creek Flows: January 1 – February 28, 2017

Coyote Creek at Madrone Streamflow Gauge (ALERT gauge 5082)

Preliminary – subject to revision

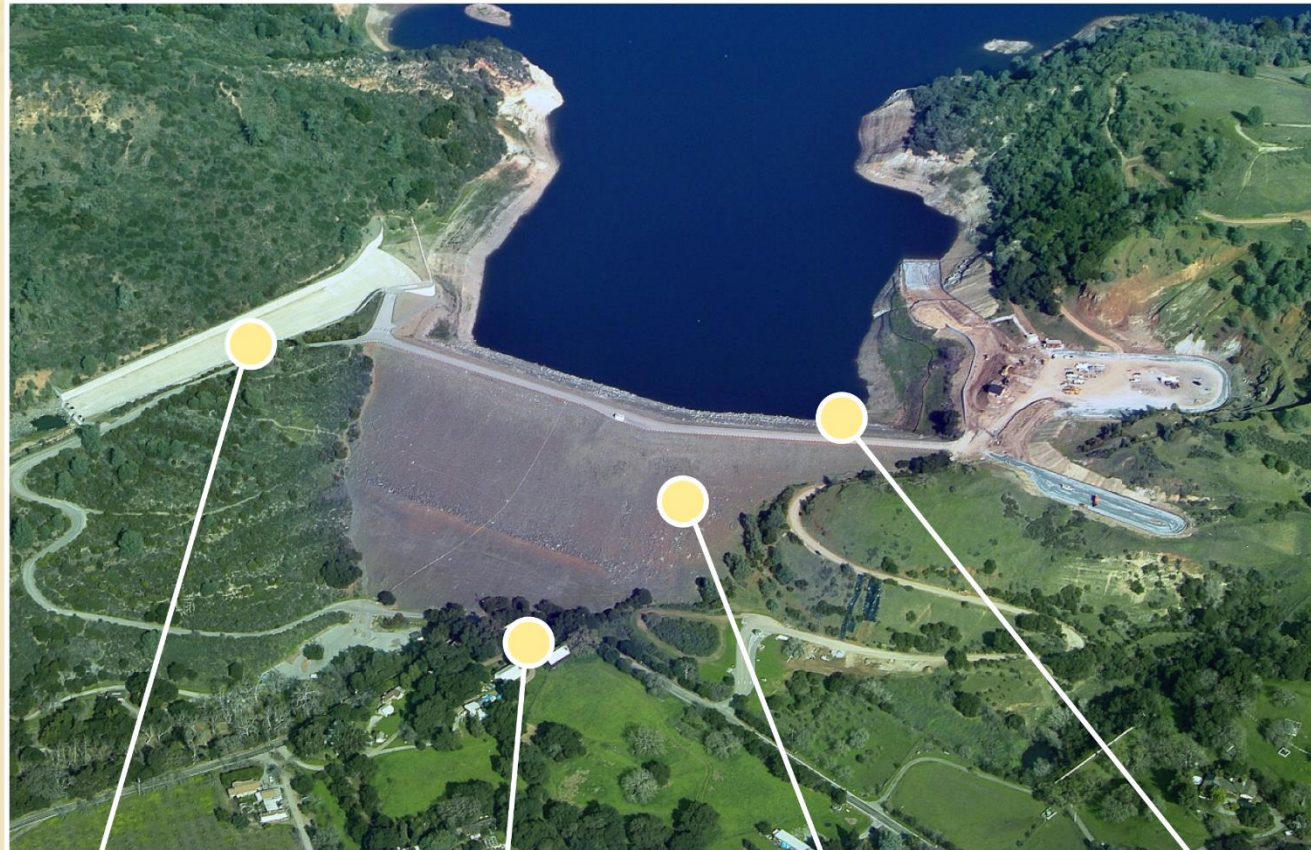
Anderson Dam Existing Configuration

Spillway

Outlet pipe

Dam embankment

Crest of dam

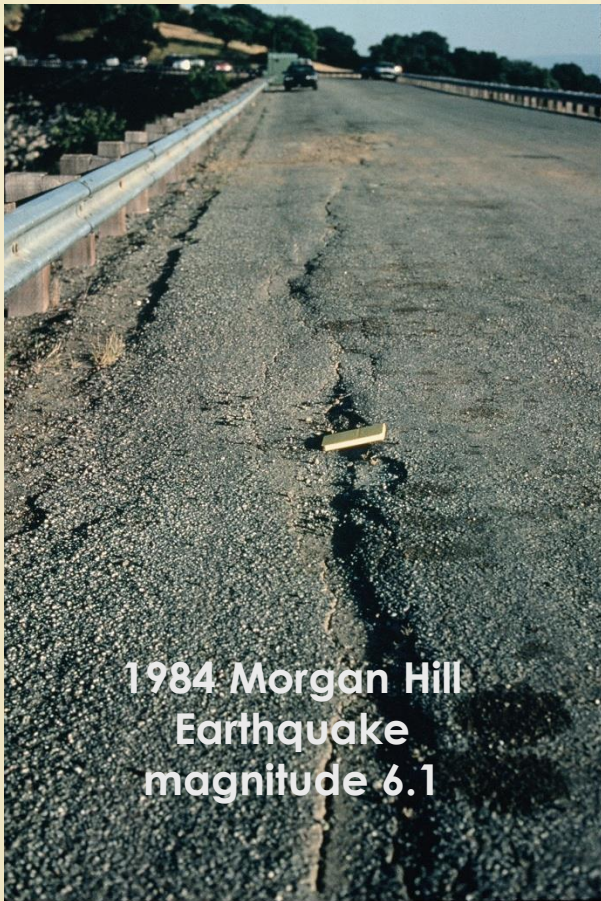
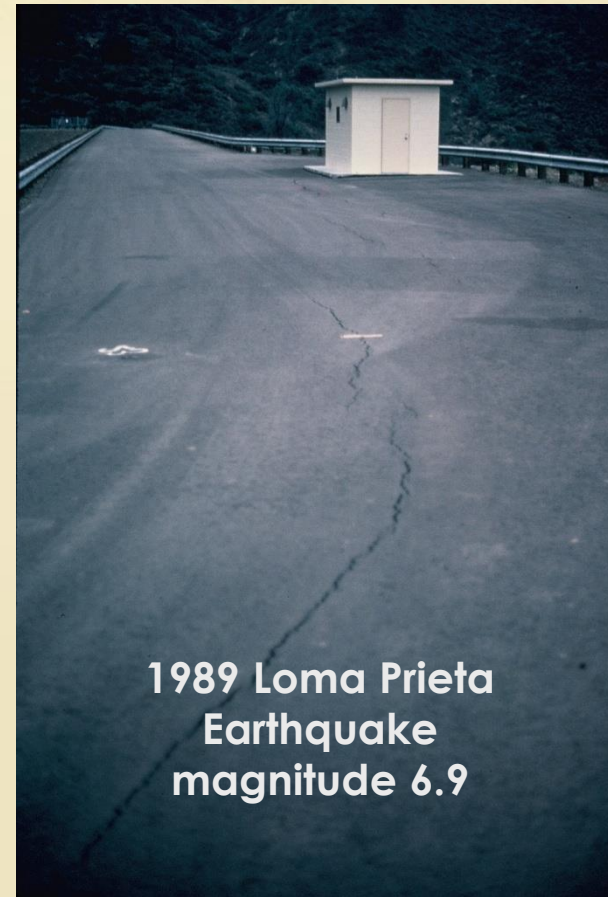
Anderson Dam Historical Earthquake Impacts

Embankments - Minor longitudinal cracking on dam crest

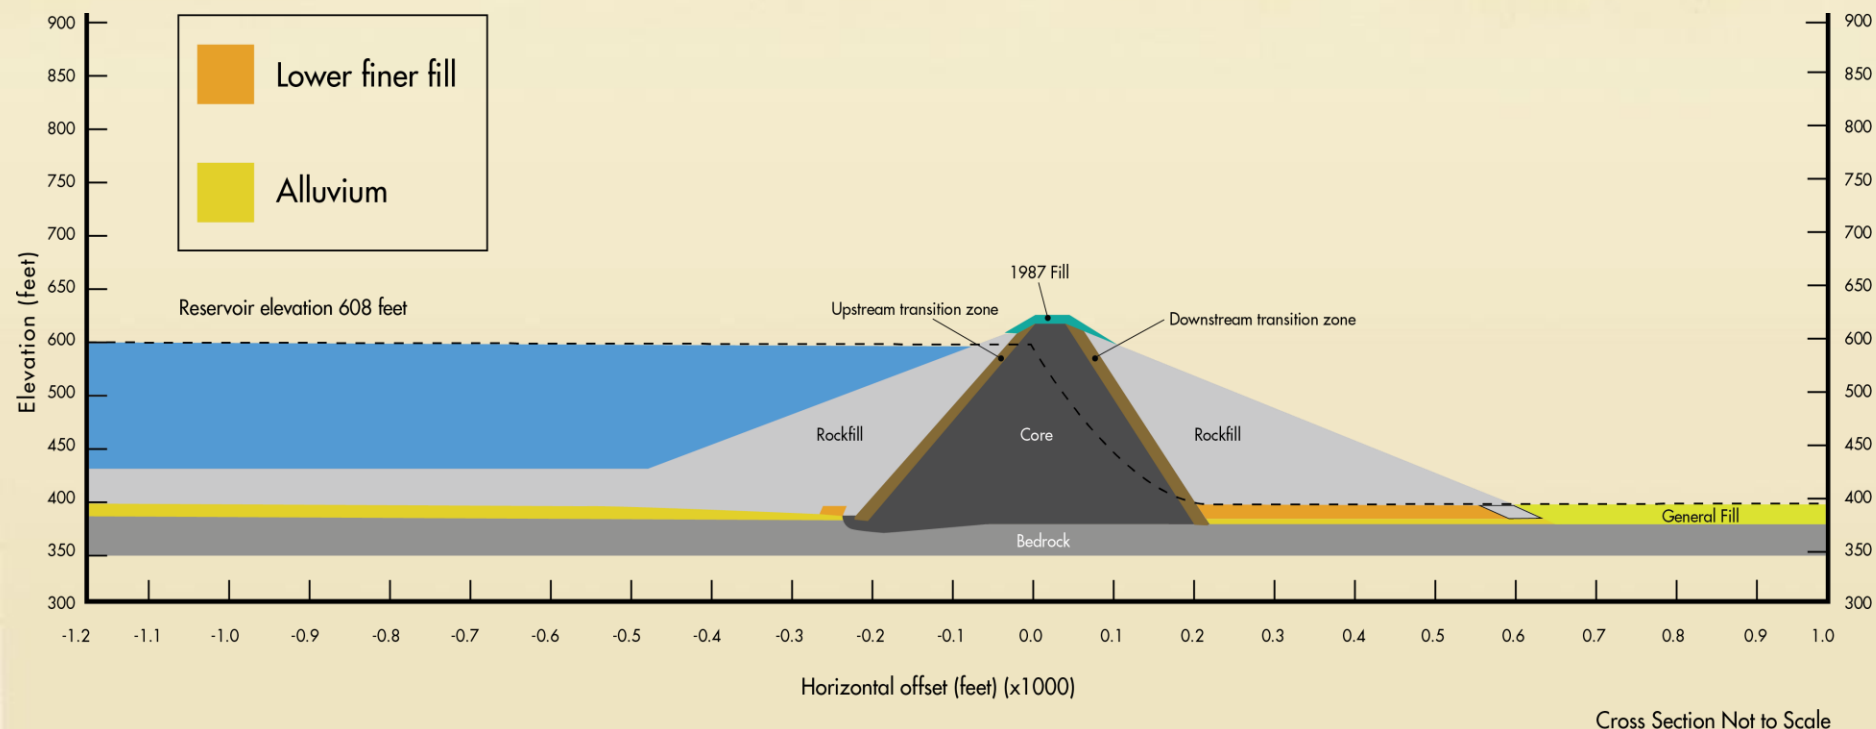
Existing Embankment Cross-section

Lower finer fill and alluvium predicted to liquefy during the maximum credible earthquake

- ▶ **Magnitude 7.2 Earthquake on the Calaveras Fault or M6.6 on the Coyote Creek Fault**
 - ▶ Embankment slumps up to 25 feet due to liquefaction of lower fine fill and alluvium
 - ▶ Outlet conduit buckles up to 4 feet due to fault rupture on the Range Front Fault
- ▶ **Changes in Regulatory Requirements (DSOD and FERC)**
 - ▶ Outlet works does not meet current emergency drawdown criteria
 - ▶ Spillway undersized for Probable Maximum Flood

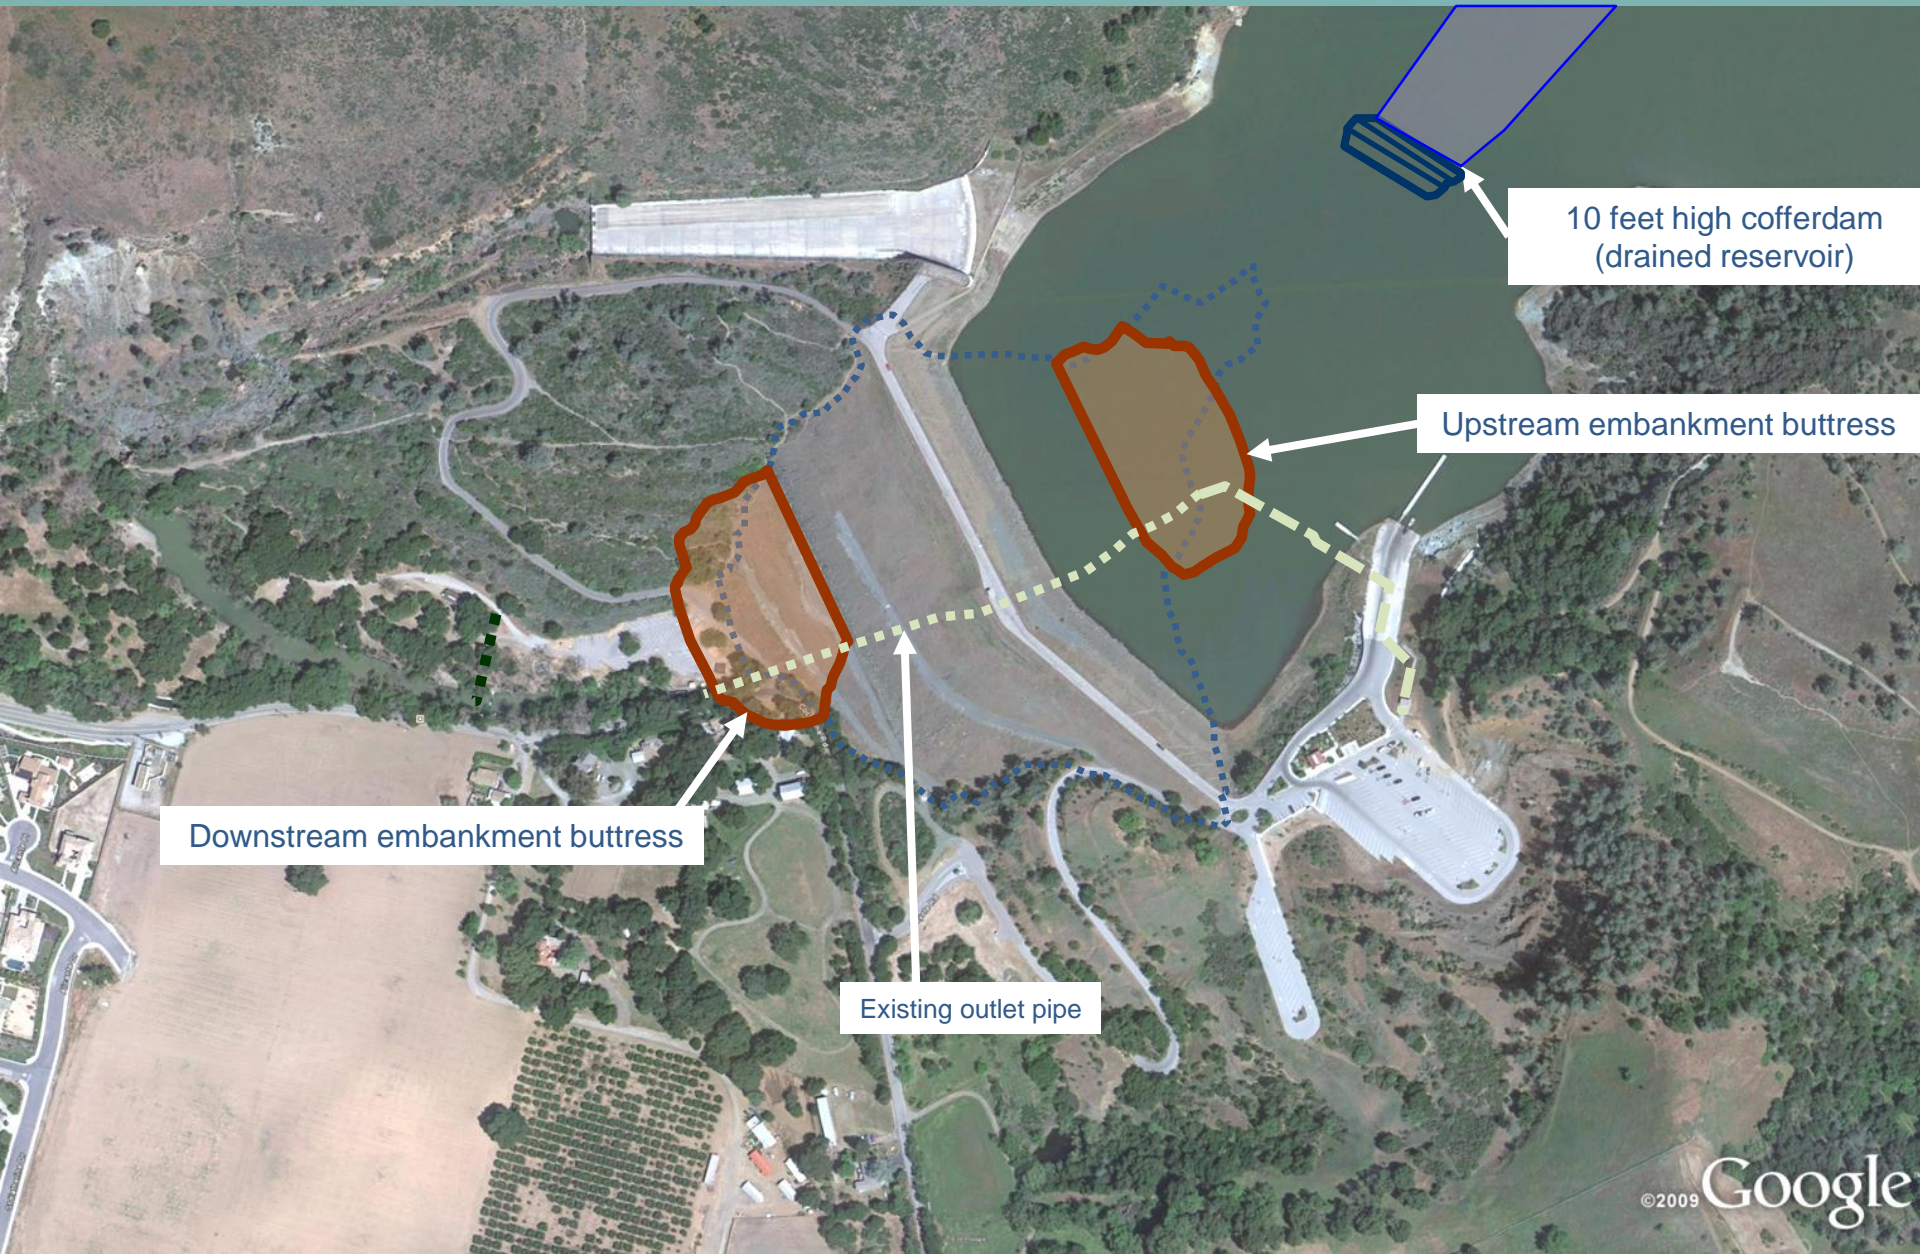
Initial Project: Address Liquefaction

10 feet high cofferdam
(drained reservoir)

Upstream embankment buttress

Downstream embankment buttress

Existing outlet pipe

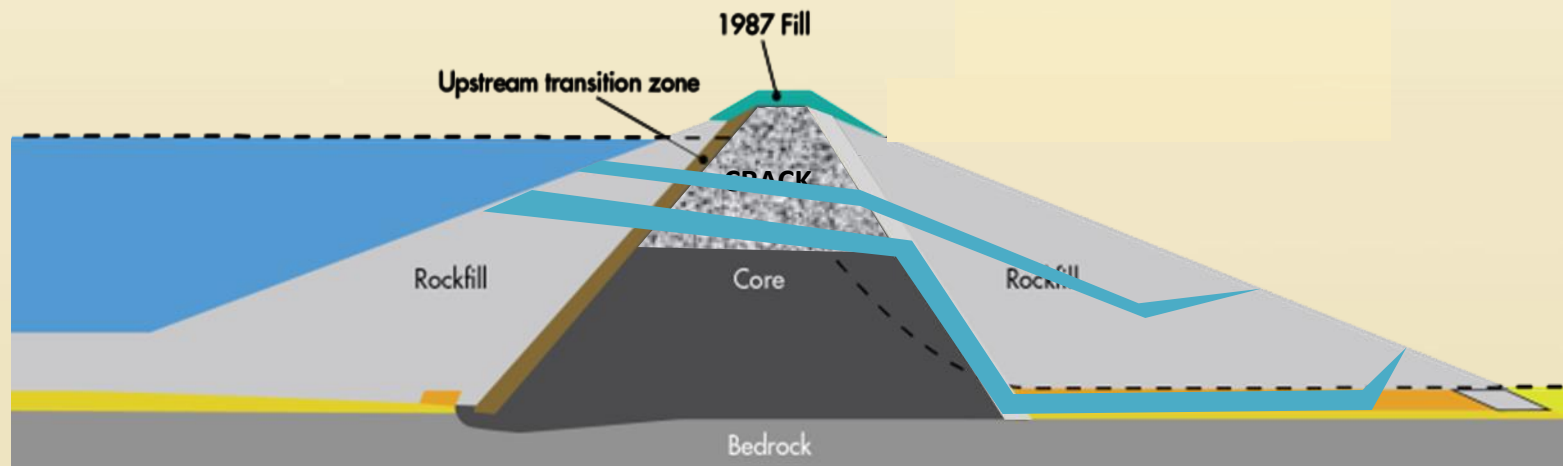
Dam Failure by Fault Rupture

- ▶ Key Findings
 - ▶ Downstream transition zone not functional
 - ▶ Impermeable core of the dam may crack
 - ▶ Seepage (piping) may occur

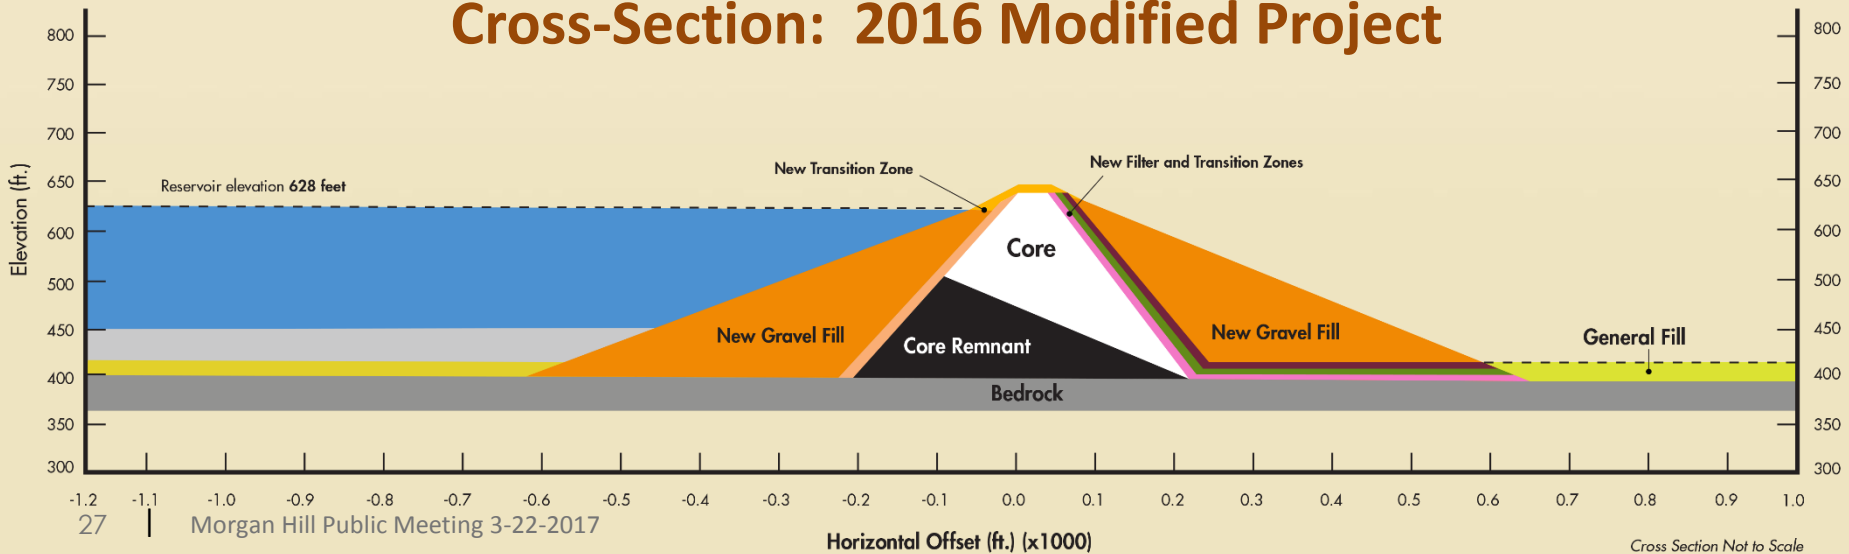
Cross-Section: 2016 Modified Project

- ▶ Retrofitted embankment similar footprint to existing dam.
- ▶ Remove all liquefiable material (compared to previous buttress approach)
