Valley Water

2020 Annual Report

Large Landscape Program

February 26, 2021

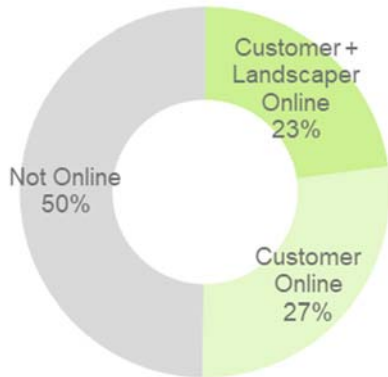
Online Engagement: Commercial

Public sites were highly engaged with 75% of their sites being viewed online. Commercial sites, in contrast, had 50% of sites viewed online. An important distinction with commercial sites is that their irrigation is frequently managed by independent landscape contractors. We find our program works best when landscapers are connected as a stakeholder. In 2020, 23% of commercial sites were actively being viewed by a landscaper online.

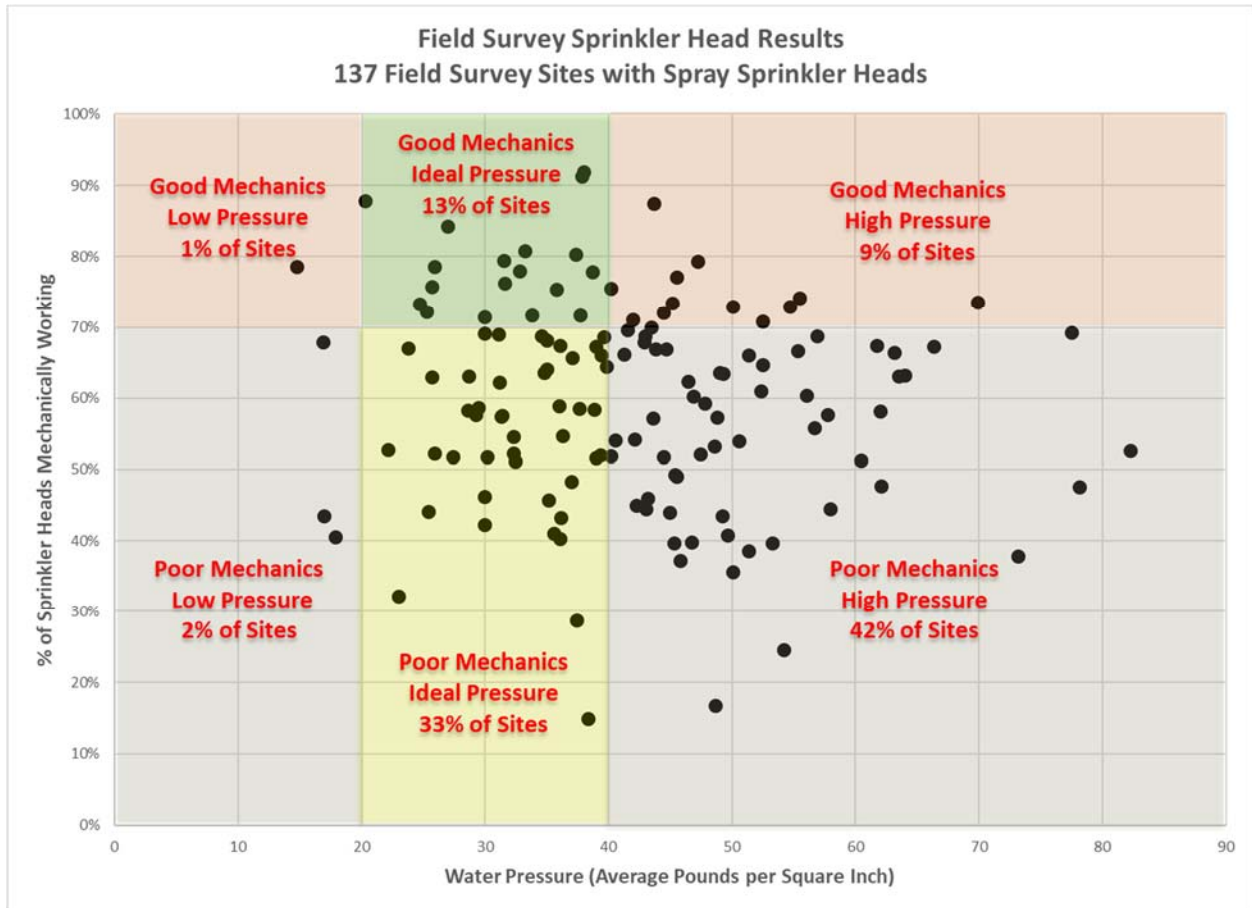
For 137 field survey sites having spray sprinkler heads, we measured both mechanical fitness and water pressure. Only 23% of sites had greater than 70% of their spray heads in good mechanical condition (delivering water to intended rootzones via non-leaking, properly-aligned spray bodies and nozzles). Only

46% of sites had average water pressures operating in their desired range (20 to 40 pounds per square inch). Only 13% of sites were both mechanical fit and operating at desired pressures; poor irrigation scheduling and/or inaccurate landscape area measurements caused these sites to be targeted for a field survey. Because field surveys are targeted toward low performing sites, these findings are not representative of all sites in the program.

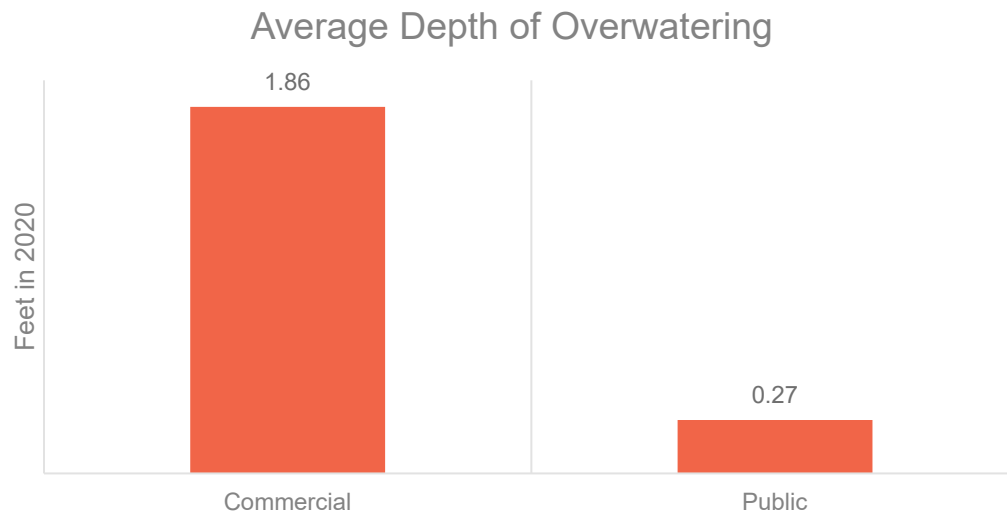
Customer Type. Commercial sites have made progress but still have significant potential for improvement. Public sites are operating closer to optimal levels. Additional engagement efforts targeted toward commercial stakeholders can help close this gap, such as improved customer relationship management and improved tools to create irrigation controller maps.

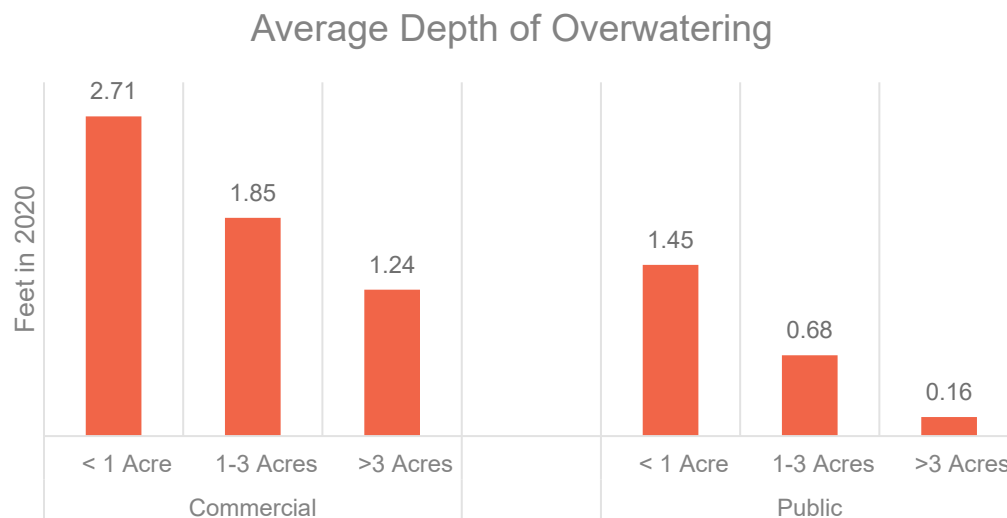
Site Size. Larger landscapes tend to be more efficiently irrigated. Although smaller sites use less water by volume, their potential to reduce overwatering on a percentage basis is greater. Small sites with less than one acre of landscape also make up 54% of total sites in the program.

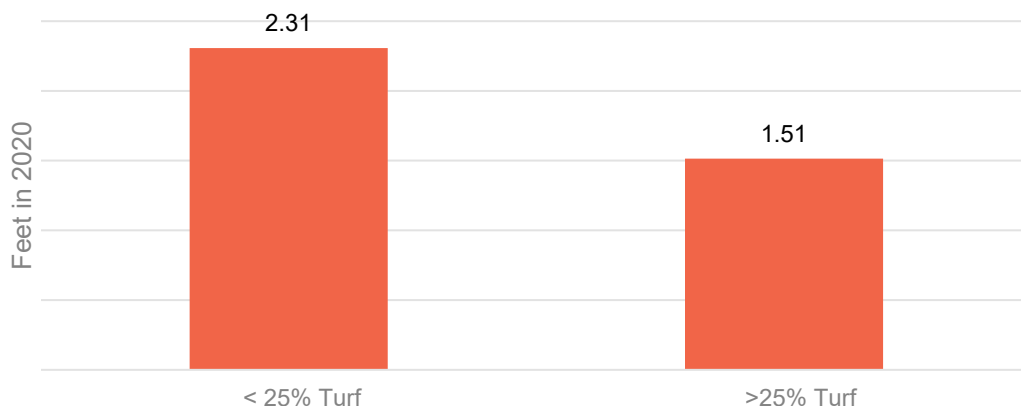
Average Depth of Water Applied by Turf % Commercial Sites

Plant Type. Half of commercial sites have less than 25% of their irrigated landscapes planted in cool season turfgrass with the remainder in shrubs, trees and groundcovers. In 2020, sites with less turf overirrigated more. Shrubs have different irrigation system and scheduling considerations, and our data

suggest they have more potential for future efficiency improvements. We do not make a similar comparison with public sites because they are largely planted in turf.

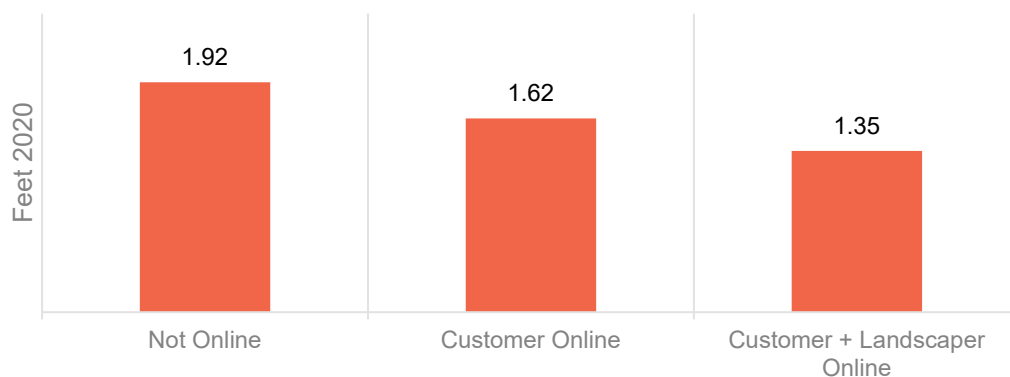
Average Depth of Overwatering by Engagement: Commercial Sites

Engagement Mode. For commercial sites, those accessing the Waterfluence website overwater less than sites mailed paper reports. We find overwatering is 30% less when landscape contractors are actively included as stakeholders, relative to sites mailed reports.

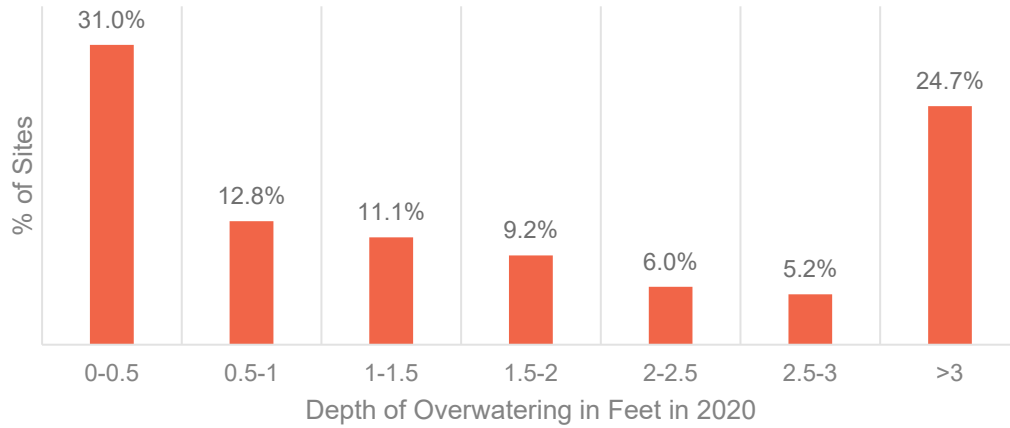
Frequency of Overwatering

Frequency of Site Overwatering. A benefit of this program is that problem sites can be readily identified with respect to irrigation efficiency. Overwatering by more than 2 feet occurred at 36% of sites, predominately small and commercial. These sites are targeted for verification of water budget assumptions, landscape field surveys, program engagement, and financial incentives, among other tactics to improve performance.

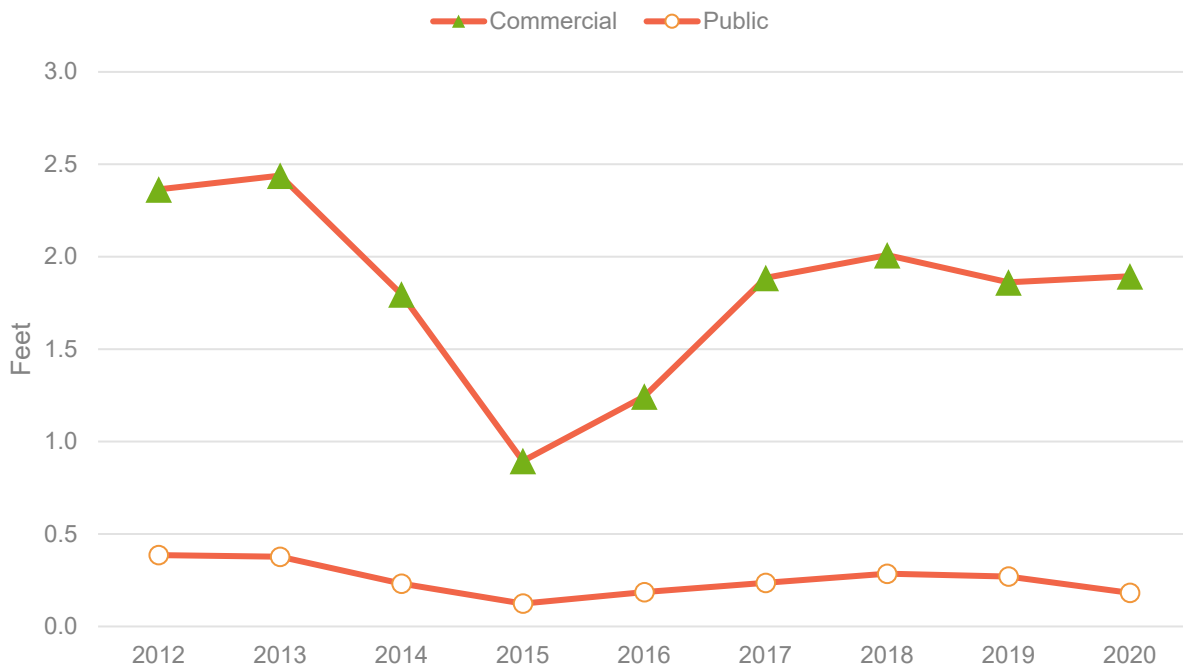
Average Depth of Overwatering

Overwatering at both commercial and public sites dropped significantly after 2013, reaching a low point during a 2015-16 statewide drought. Overwatering rebounded in subsequent years but is still 29% below 2013 levels.

- ▶ **Irrigation Efficiency Trends.** Overwatering at both commercial and public sites dropped significantly after 2013, reaching a low point during a 2015-16 statewide drought. Overwatering rebounded in subsequent years but is still 29% below 2013 levels.

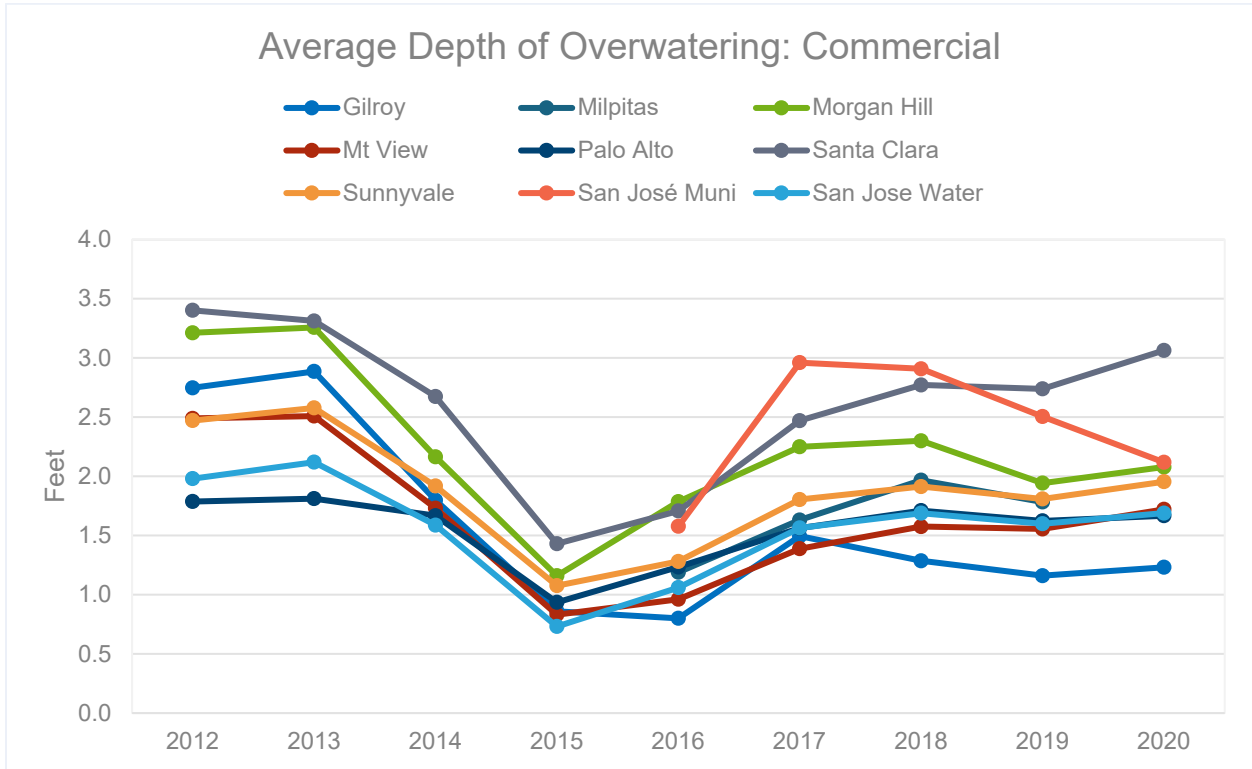
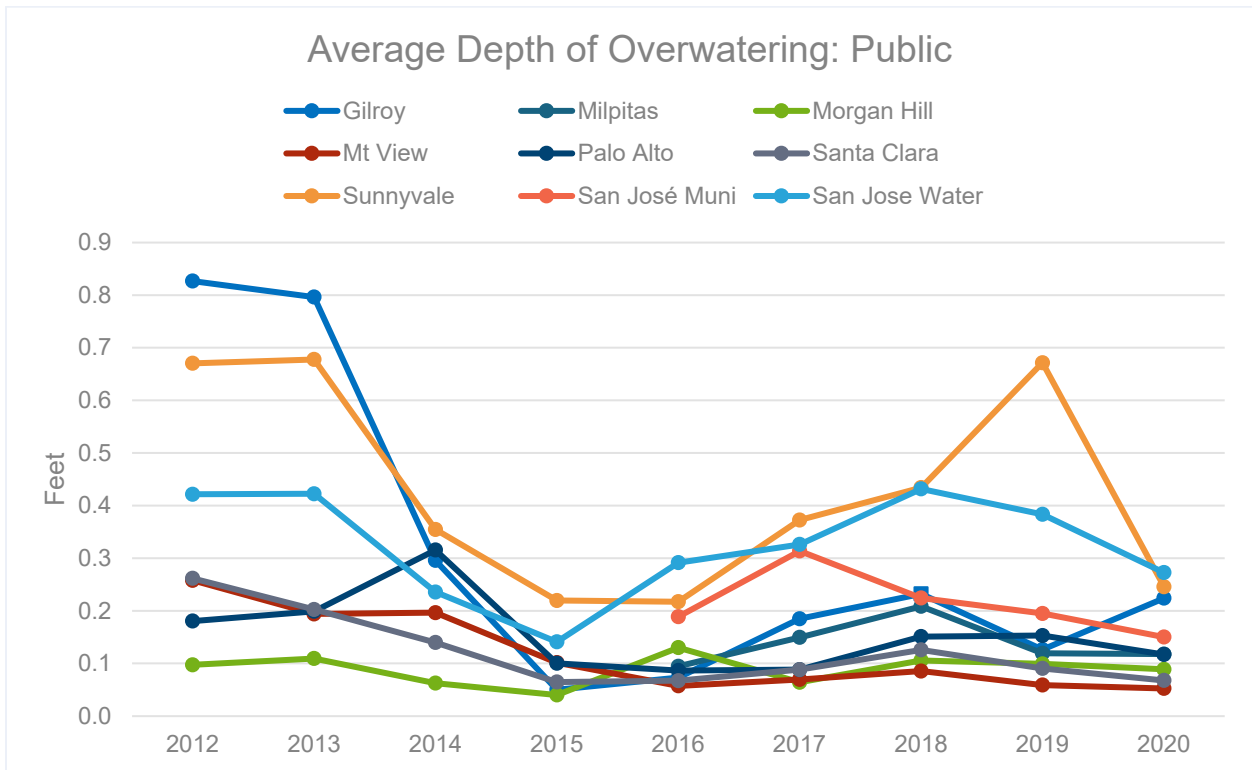
All retailers generally followed these overall trends between 2012 and 2020.
