SANTA CLARA VALLEY WATER DISTRICT

Rancho Cañada de Pala Preserve Area 3 Long-term Management Plan

SANTA CLARA VALLEY WATER DISTRICT
5750 Almaden Expressway
San Jose, CA 95118
November 2015

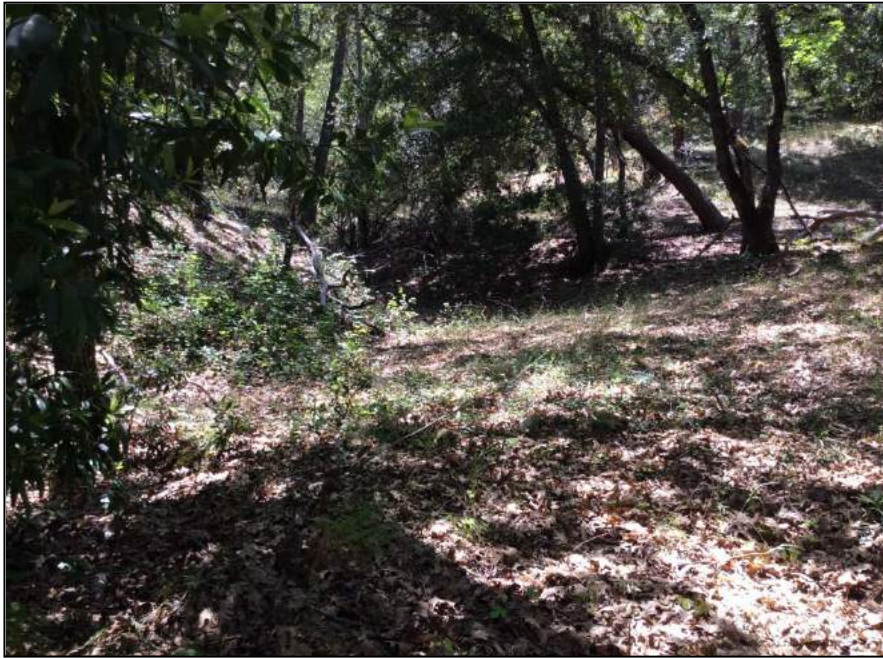
Photo 1. Ephemeral streams cross the drivable road on Area 3 at several locations. This is a representative photo, taken facing downstream from the road at SC1.

The majority of the ephemeral and intermittent streams within Area 3 appear laterally stable. The single drivable road in Area 3 crosses these drainages at five locations (SC 1–SC 5, Figure 5), and these stream crossings are all ford crossings that lack infrastructure, with the exception of one collapsed wooden retaining wall at SC 4 (Photo 2, Appendix B, Figure 6). Previously, the wall functioned to stabilize the stream banks, and has since been damaged by high water flows and erosion. At the same location, a headcut and gully have formed on the downstream side of the road. One headcut was also noted on the downstream side of SC 5 (Photo 4, Appendix B, Figure 6), but the remainder of the stream crossings did not exhibit any significant erosional damage (Photo 1, Appendix B, Figure 6). Limited areas of path formation caused by use by

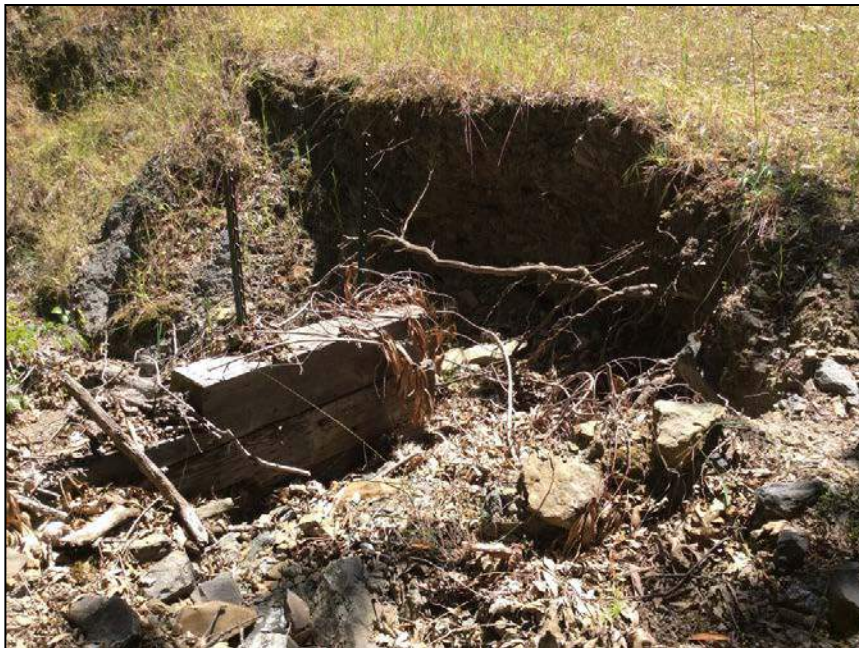
Photo 2. Damaged wooden retaining wall and headcut at SC4, just downstream of the drivable road. This stream is ephemeral and only conveys flows during and immediately following storm events.

Road rehabilitation will repair one stream crossing (SC 4) in Area 3 observed to have erosion and potential maintenance issues (Photos 2-3, Appendix B, Figure 6). In this location, the drainage has eroded into the roadbed, which was previously stabilized by a wooden retaining wall that has collapsed. Although these issues are minor, placement of small amounts of 6–12 inch rock just downstream from the stream crossing, and smaller rock within the road bed, will allow for continued use of the road and limit further erosion. Additional repairs at this location are not anticipated to be needed, but the stability of the repair will be monitored as part of the routine road condition monitoring (Section 7.2). Routine road maintenance (i.e., to maintain the road surface and minimize erosion) will be conducted as described in Section 7.2.

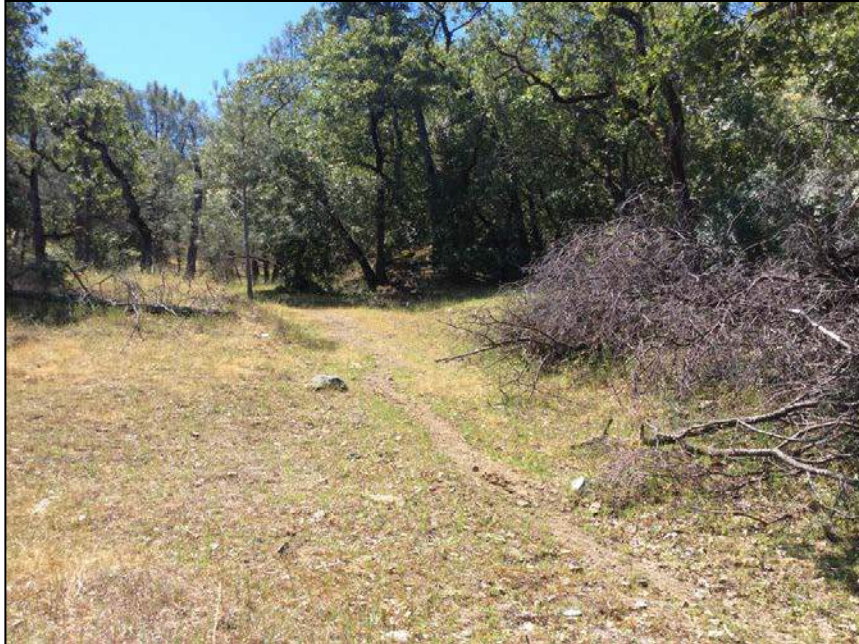
Photo 3. The roadway to the south and upslope of SC4 has not been recently traveled because of the erosional damage at the stream crossing.

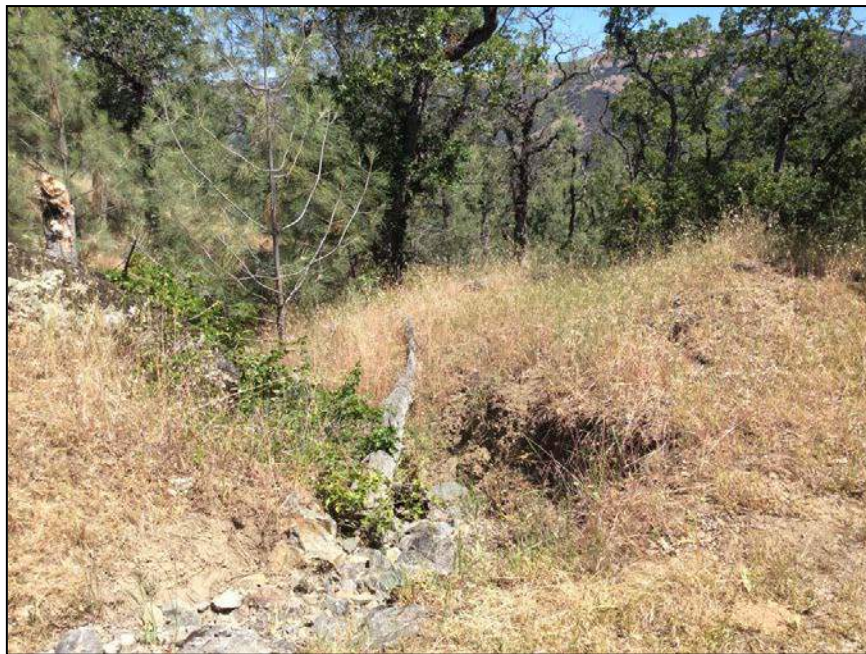
Photo 4. Small headcut beginning to form at SC5, just downstream of the drivable road.

The drivable road in Area 3 crosses ephemeral and intermittent streams at five locations (SC 1–5, Figure 5). These stream crossings are not associated with any infrastructure, such as culverts; rather, they are ford crossings. The drainages are shallowly incised at each stream crossing. Water travels across the road as sheet flow, and when it is present, it is very shallow (a few inches deep at most) (Photo 1, Appendix B, Figure 6). However, a collapsed wooden retaining wall was observed at SC 4 during the field surveys. Previously, the wall functioned to stabilize the stream banks, and has since been damaged by high water flows and erosion (Photo 2, Appendix B, Figure 6). At the same location, a headcut and gully have formed on the downstream side of the road. At the time of the May–June 2015 surveys, SC 4 was impassable by vehicles and this prevented driving along the entirety of the road within Area 3 (Photo 3, Appendix B, Figure 6), although all portions of this loop road were accessible from adjacent Area 1. Only one additional erosional feature was noted at the stream crossings on Area 3: a small headcut beginning to form on the downstream side of SC 5 (Photo 4, Appendix B, Figure 6).

A minor headcut is present just downstream of SC 5. This headcut is just beginning to form, but it may create a small amount of erosion within the stream (Photo 4, Appendix B, Figure 6). Although this issue is extremely minor, placement of a few 12–24-inch boulders at this location will buffer the flow of water and prevent further erosion of the headcut. Additional repairs at this location are not anticipated to be needed, but the stability of the repair will be monitored as part of the routine stream condition monitoring. Routine monitoring and management of streams will be conducted as described in Section 6.1.

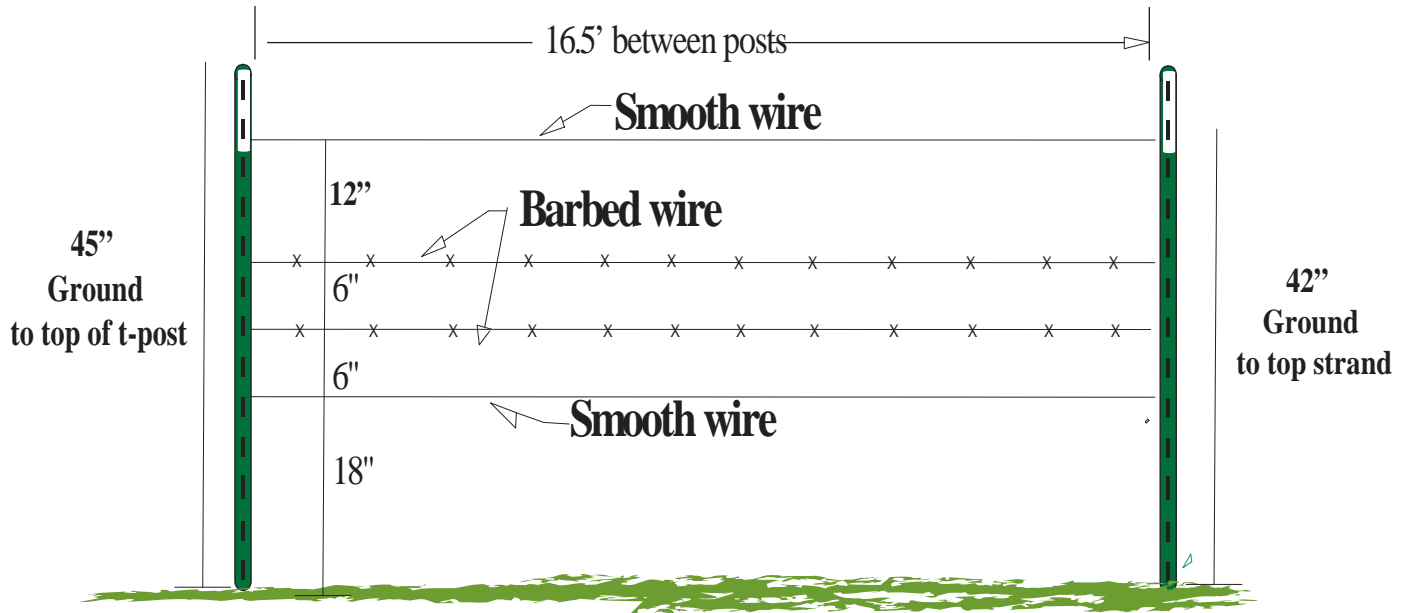
Road Side - Use 66" (5.5') t-posts

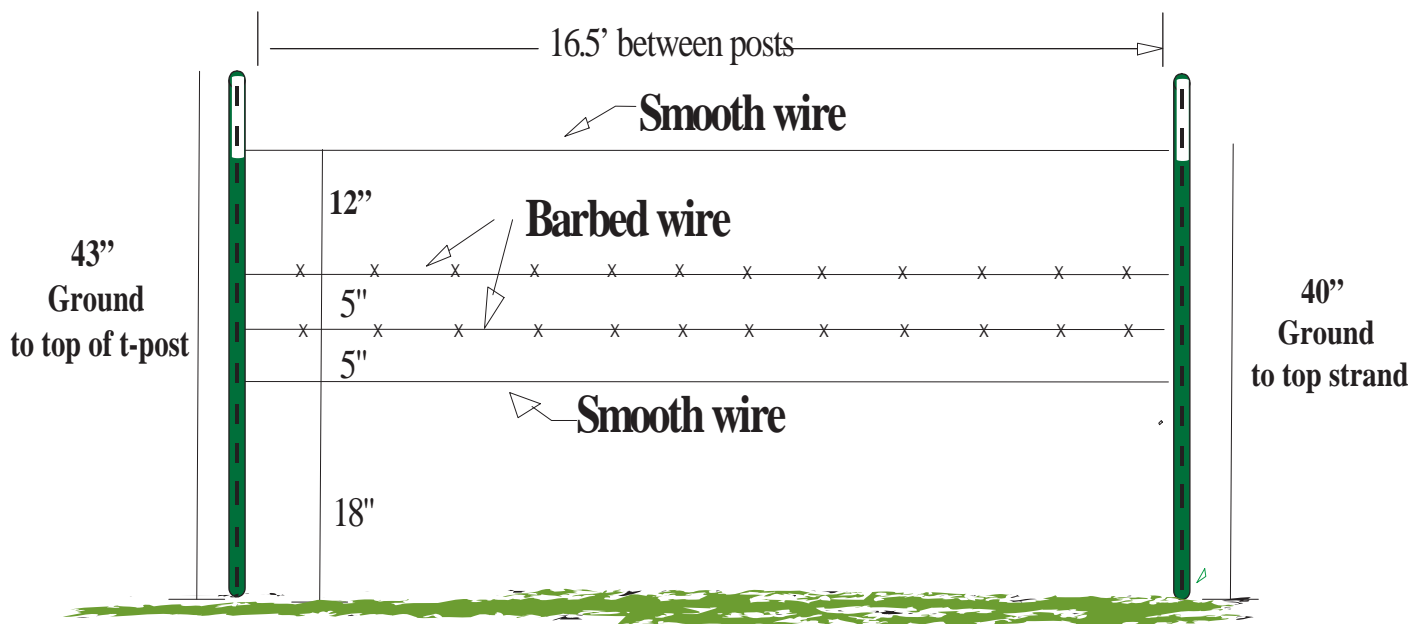
Interior Fencing - Use 60" (5.0') t-posts
