FLOODING REPORT (FINAL)

COYOTE CREEK, UVAS CREEK, SAN FRANCISQUITO CREEK,
AND WEST LITTLE LLAGAS CREEK

JANAURY AND FEBRUARY OF 2017

*Prepared by the Hydraulics, Hydrology, and Geomorphology Unit
November 2017*

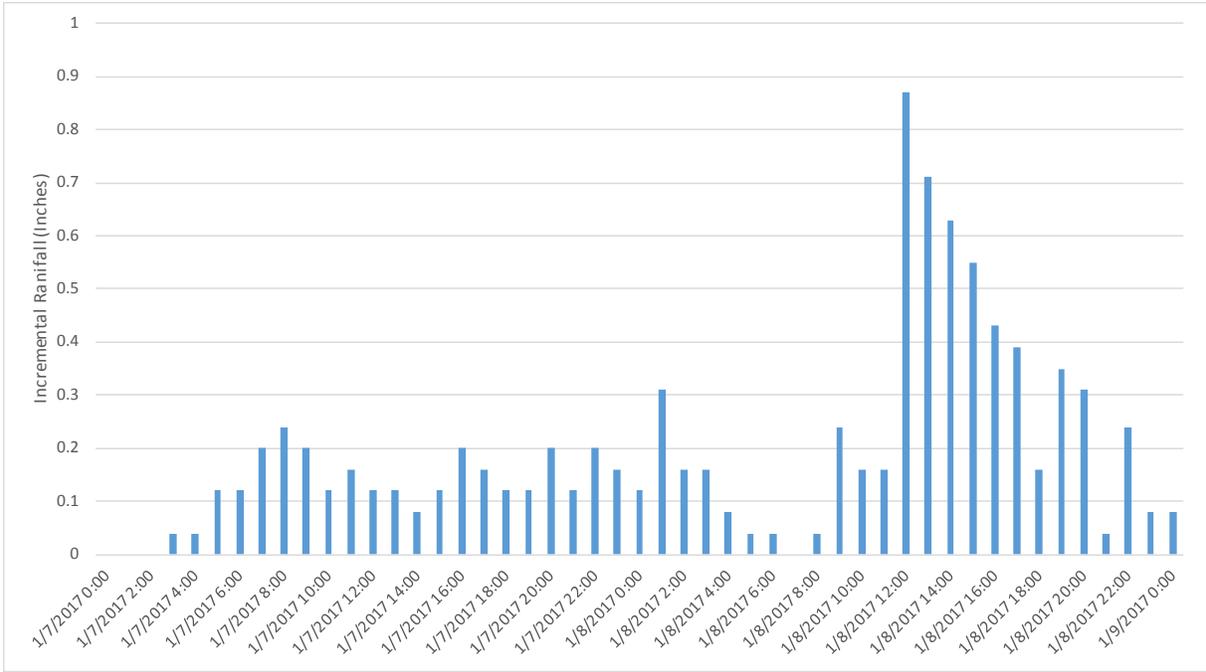
Figure 1: Uvas Canyon County Park Rainfall (1/7 - 1/9)

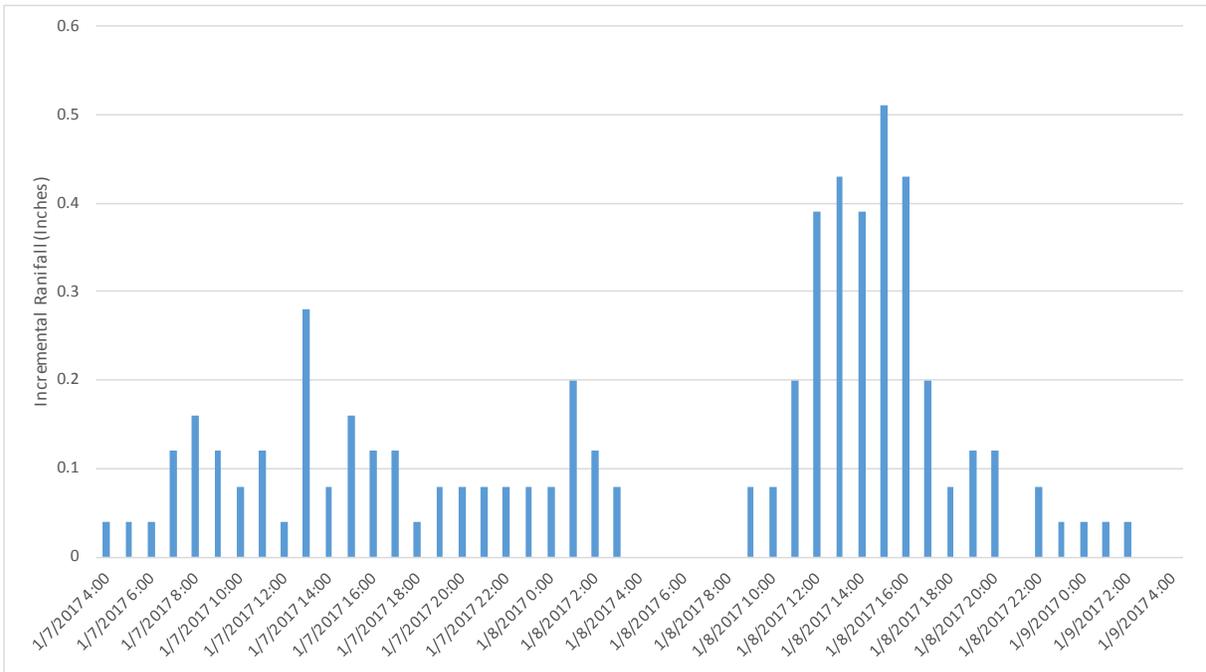
Figure 2: West Little Llagas Rainfall (1/7 - 1/9)

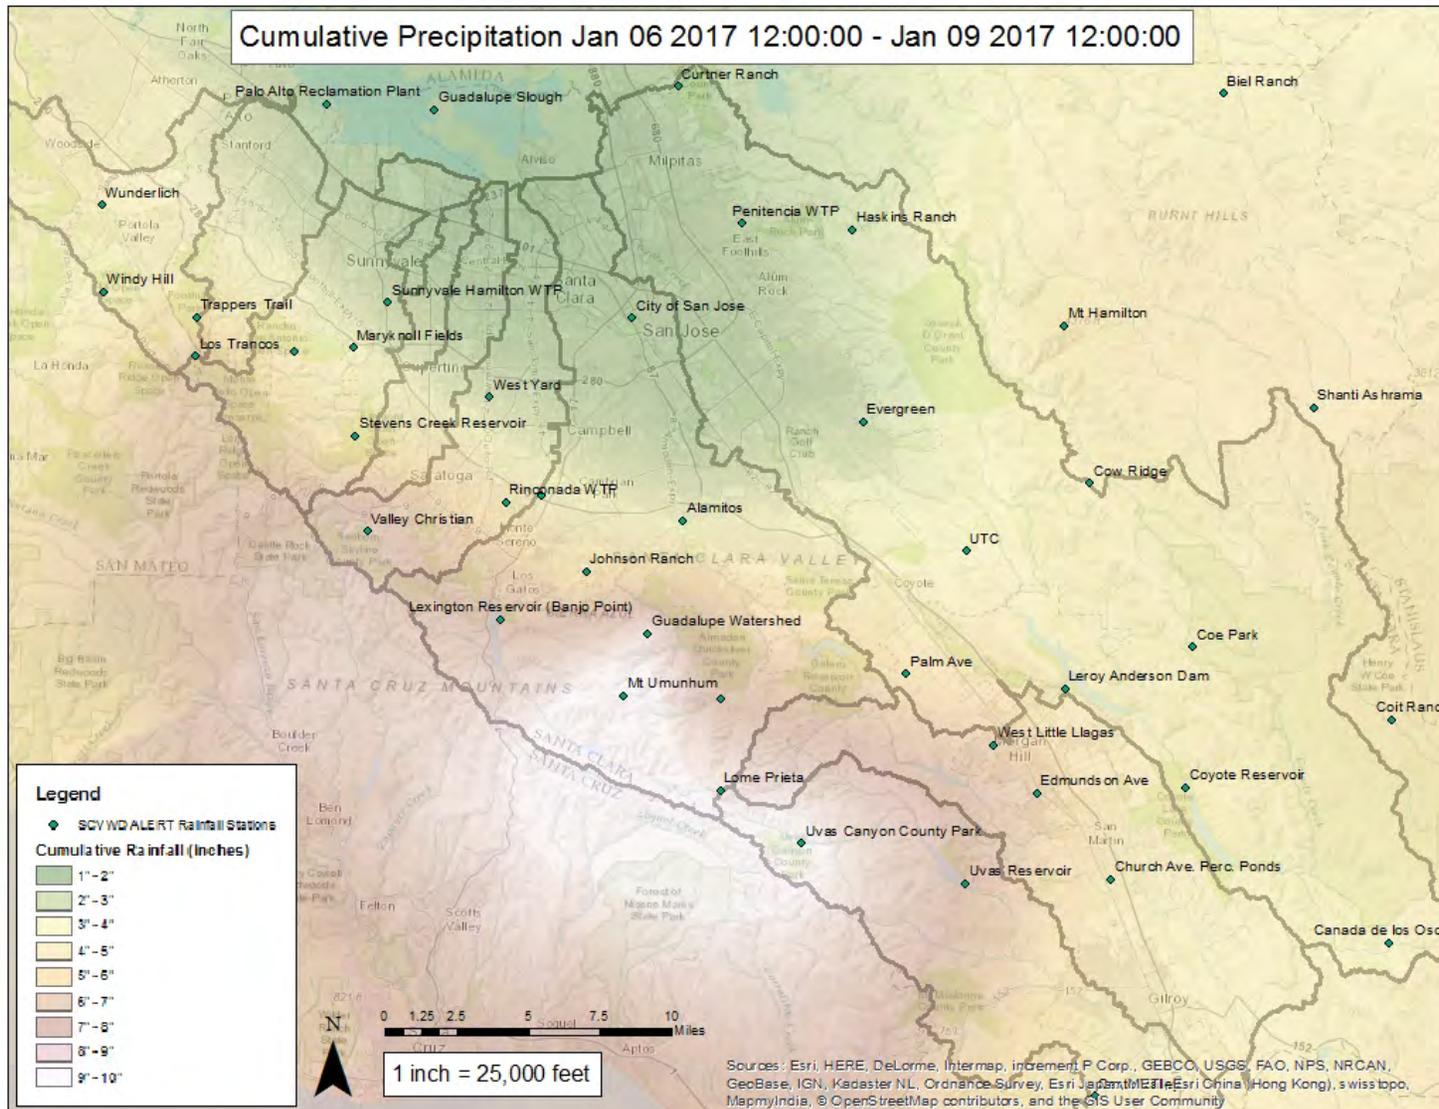
Figure 3: County Rainfall Totals (1/6 - 1/9)

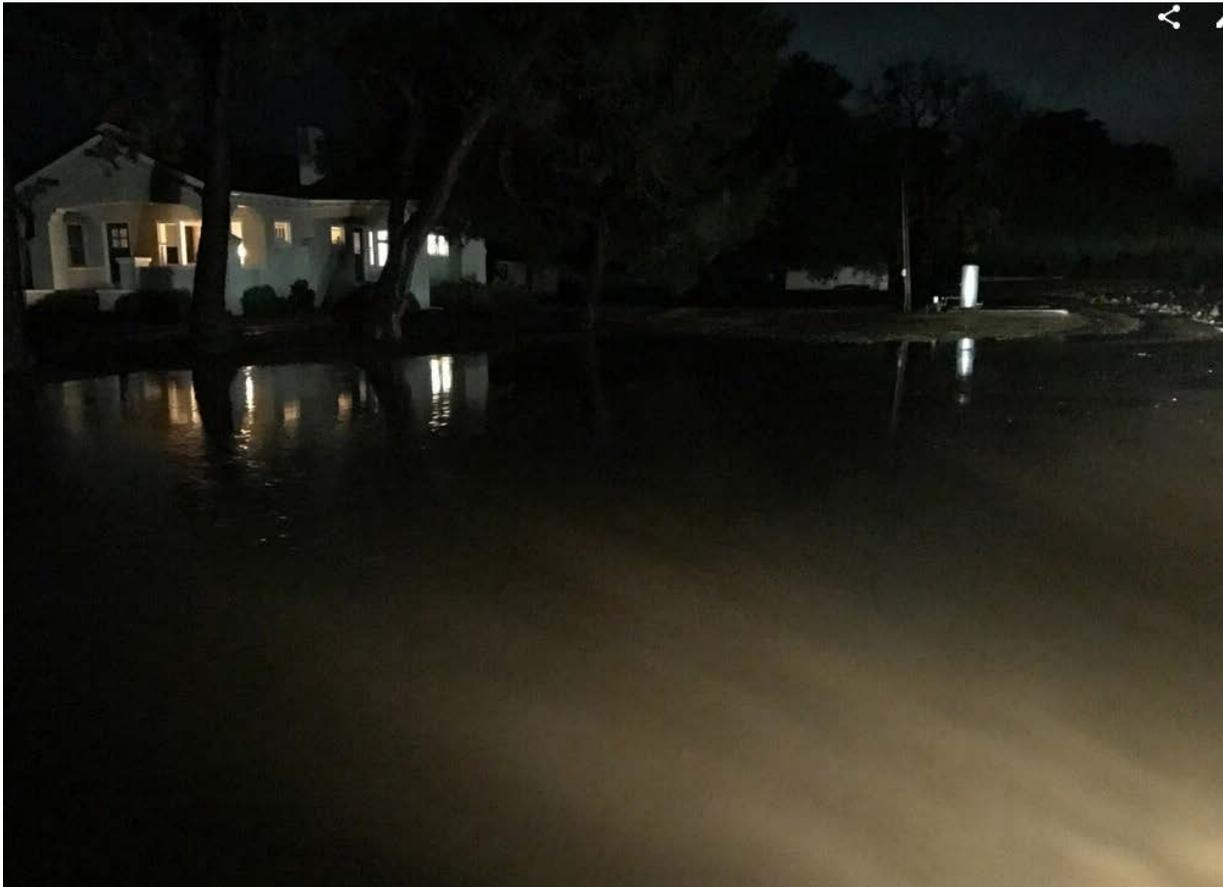
Figure 4: Picture - Flooding from Uvas Creek at Monterey Frontage Road near US-101

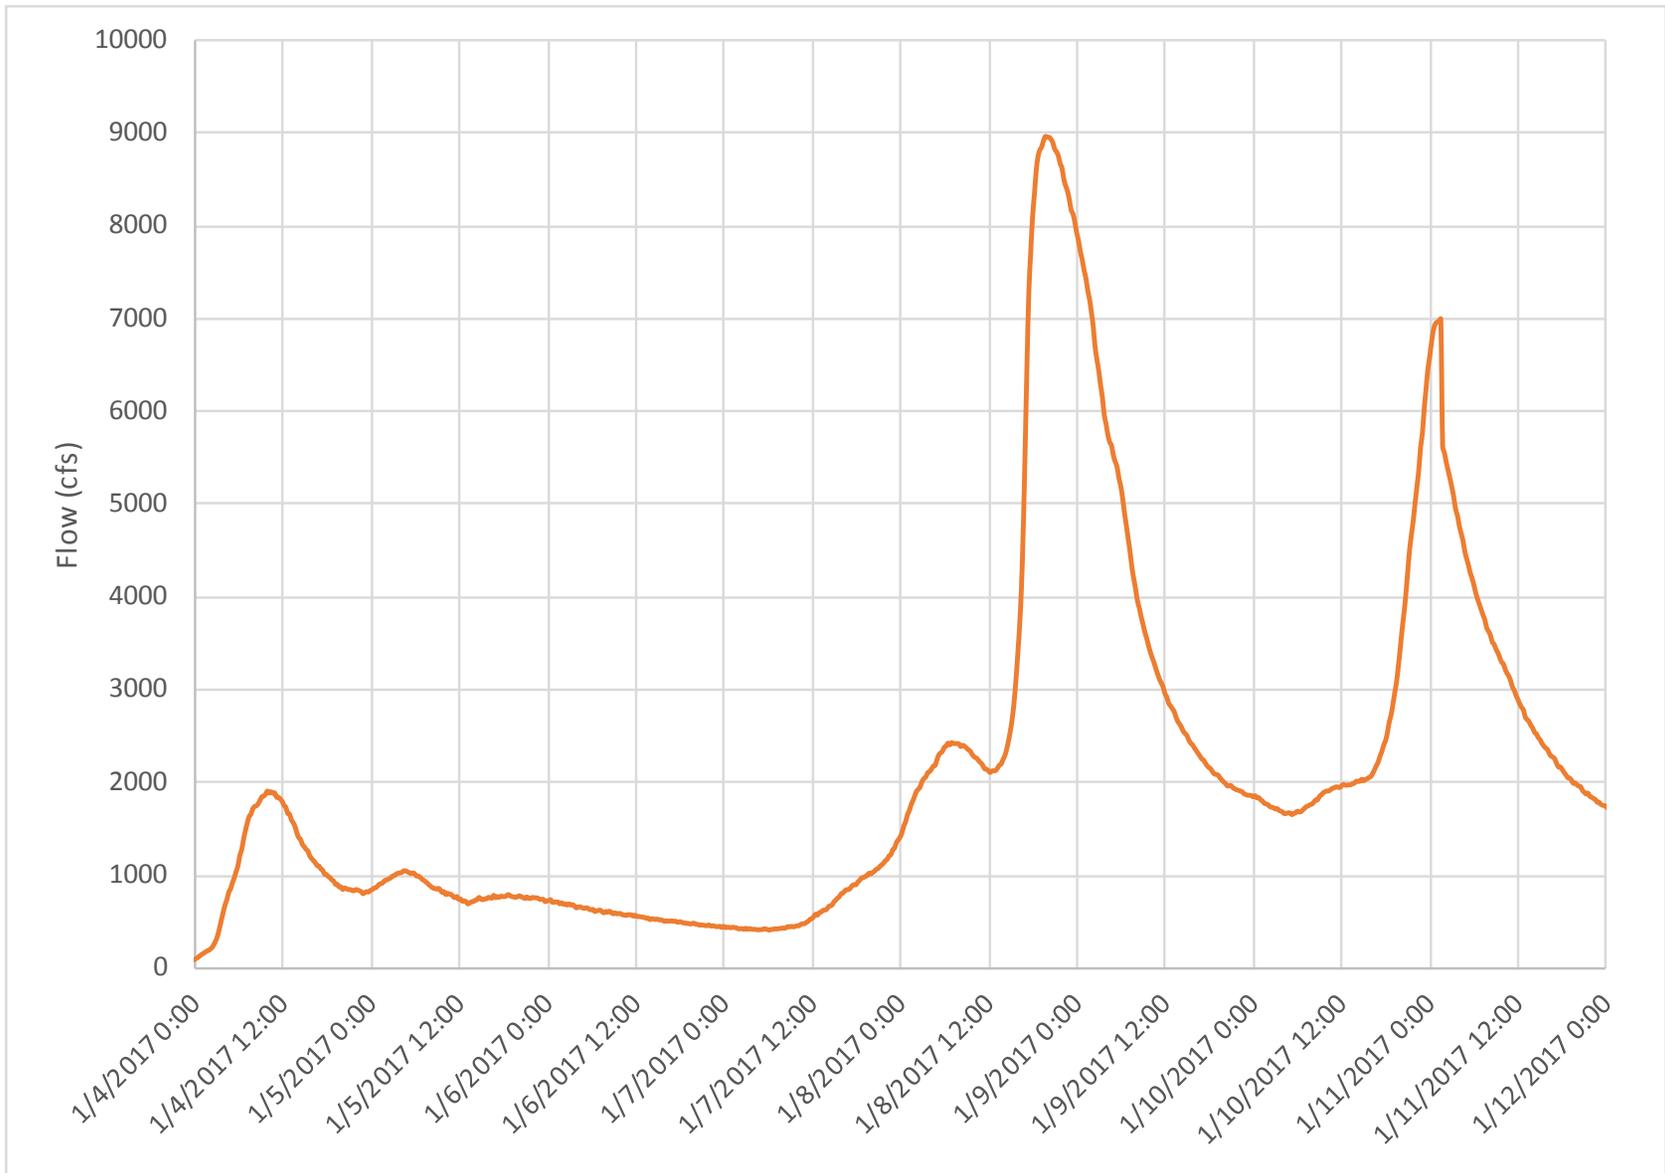
Gauge Location	Peak Flow (Preliminary)	Estimated Return Period
Luchessa Avenue	9,000cfs	10-20 Year

Figure 5: Uvas Creek @ Luchessa Hydrograph

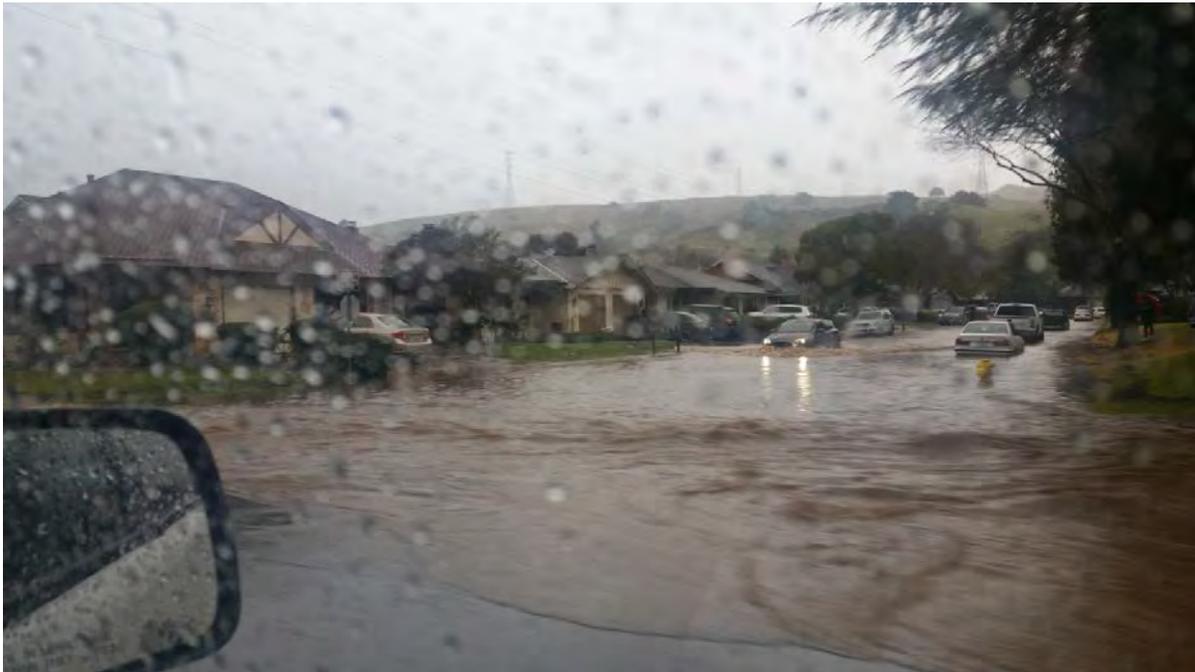
West Little Llagas began flooding upstream of the box culvert that crosses under Llagas Road. Floodwaters were observed to be traveling down Llagas Road (North bound) flooding and disconnecting Llagas Creek Drive, Christeph Drive, Carriage Drive, Shadowbrook Way, and Murphy Springs Drive. Flooding was also observed along Main Street in Morgan Hill, California, between Hale Avenue and Monterey Road. Considerable surcharging was noticed on a manhole cover on Main Street and Hale Avenue in Morgan Hill, California. Watsonville Road was also observed to be flooded at its intersection with Monterey Road on Sunday January 8th, 2017, city crews were present on Watsonville Road, closing it to all traffic due to deep water ponding on the both sides of traffic.

Figure 6: Picture - Llagas Road, looking North along Carriage Drive in Morgan Hill

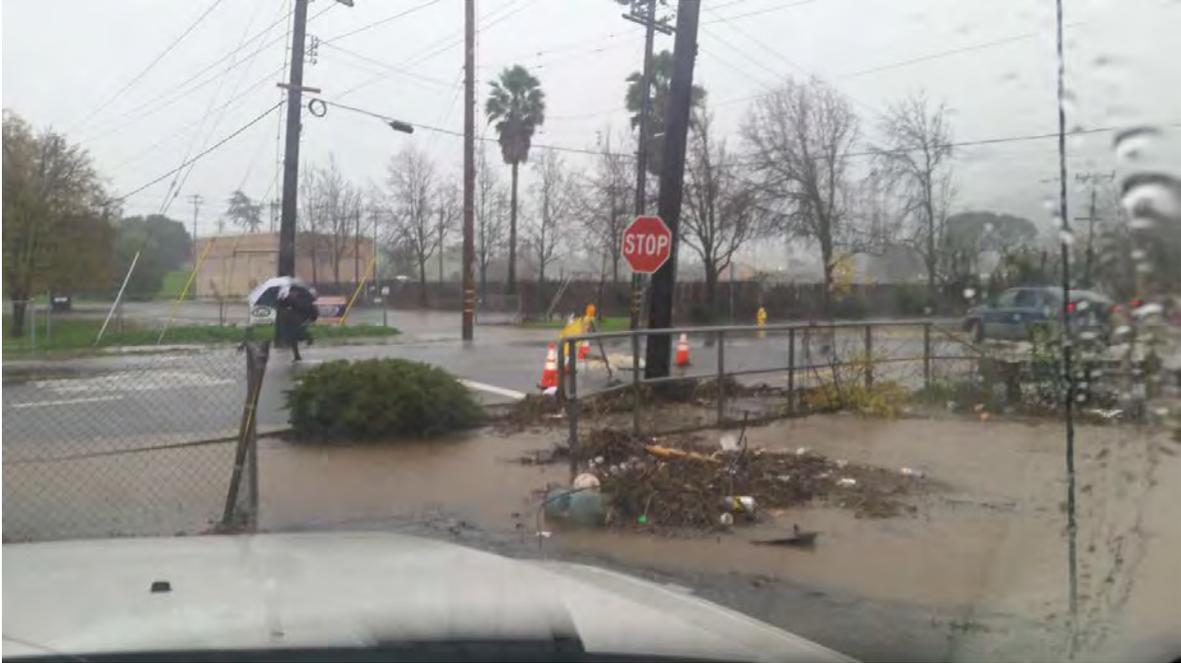
Figure 7: Picture - Main Street and Hale Avenue in Morgan Hill

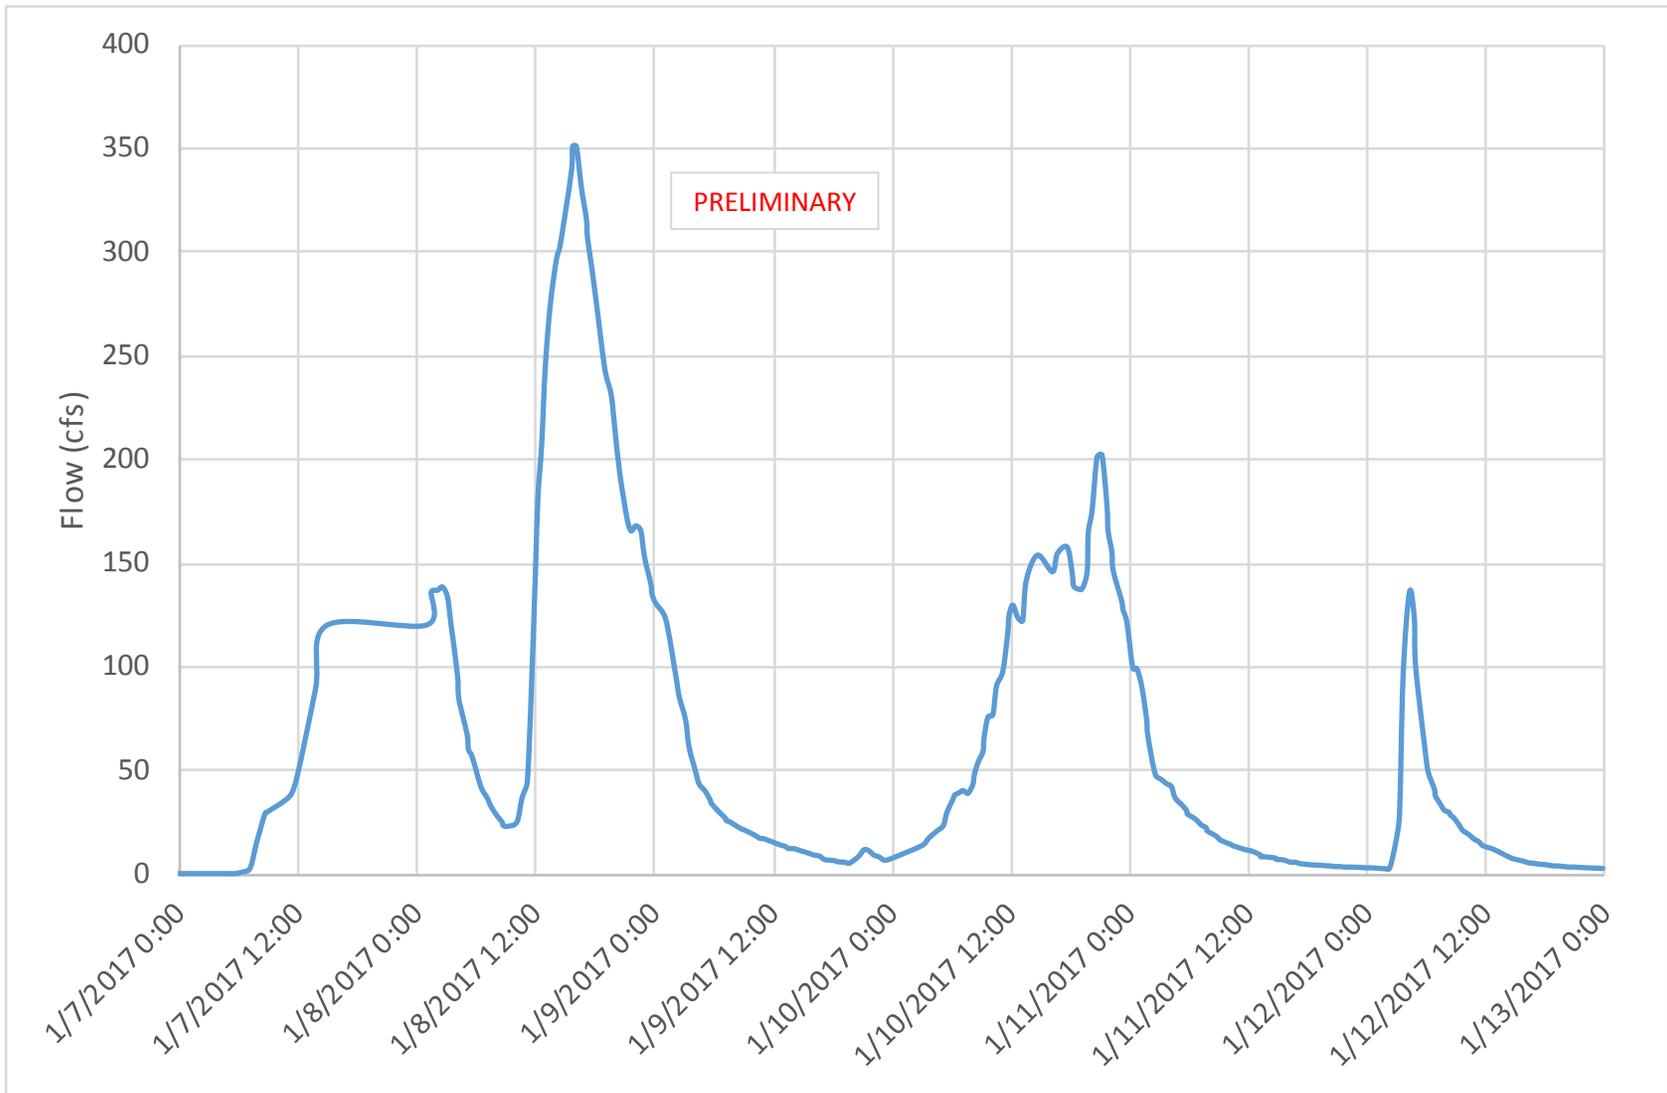
Gauge Location	Peak Flow (Preliminary)	Estimated Return Period
Edmundson Avenue	350cfs	10 Year ⁶

Figure 8: Preliminary West Little Llagas Creek @ Edmundson Avenue Hydrograph

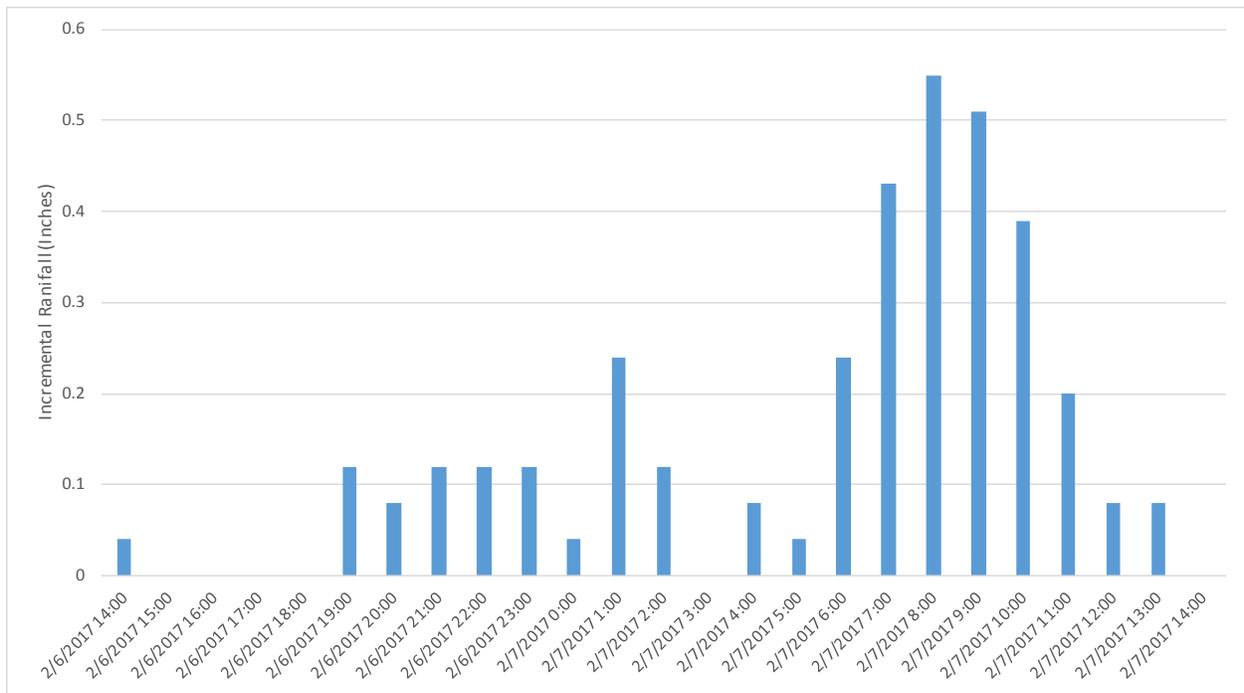
Figure 9: Wunderlich (San Francisquito) Rainfall (2/6 - 2/7)

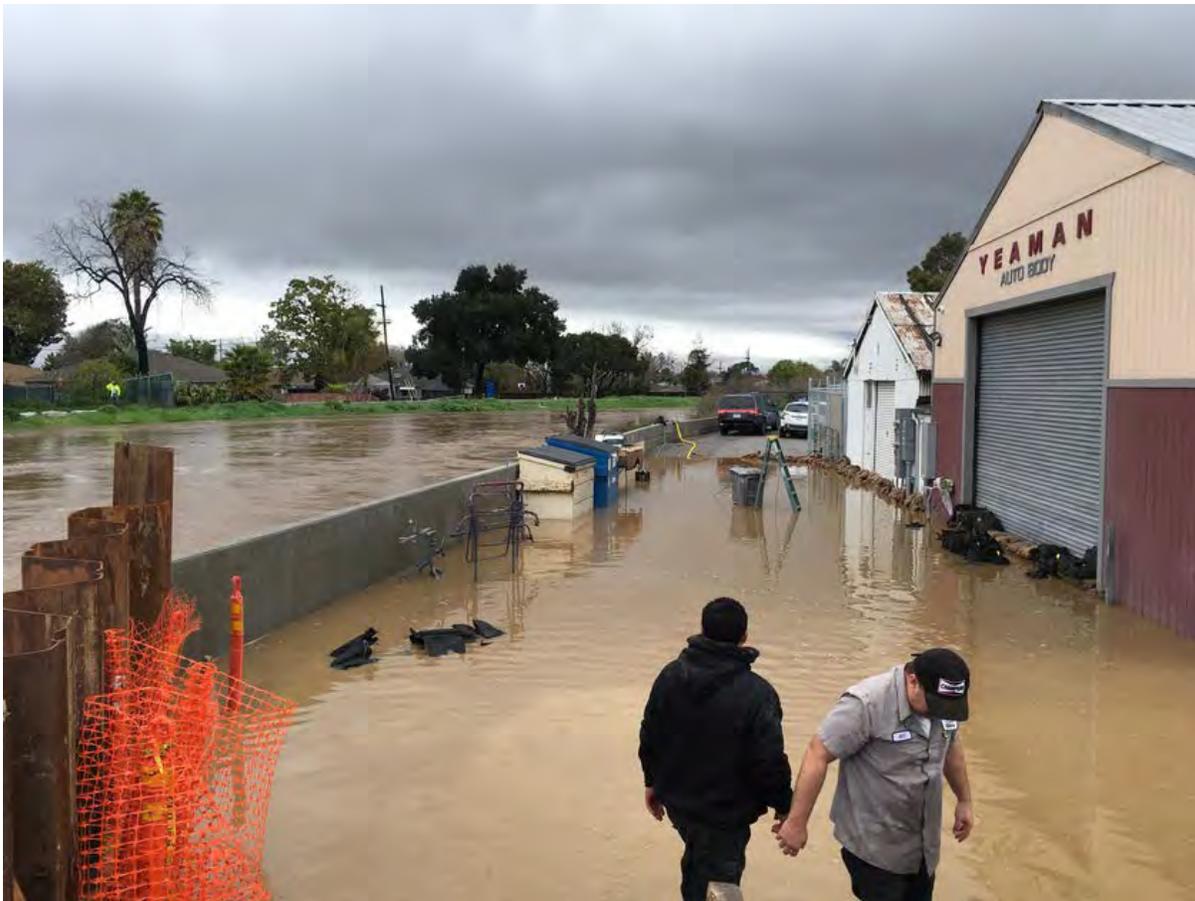
In the early afternoon on February 7th, San Francisquito Creek reached the top of levee downstream of US-101. There was flooding around some businesses on East Bayshore Road and around the US-101 bridge, but the freeway did not close. Later in the afternoon, a levee boil was detected just north of the Baylands Athletic Center. It was quickly repaired with a sandbag chimney.

Figure 10: Picture - San Francisquito Creek overflowing into Yeaman's Auto Body Shop

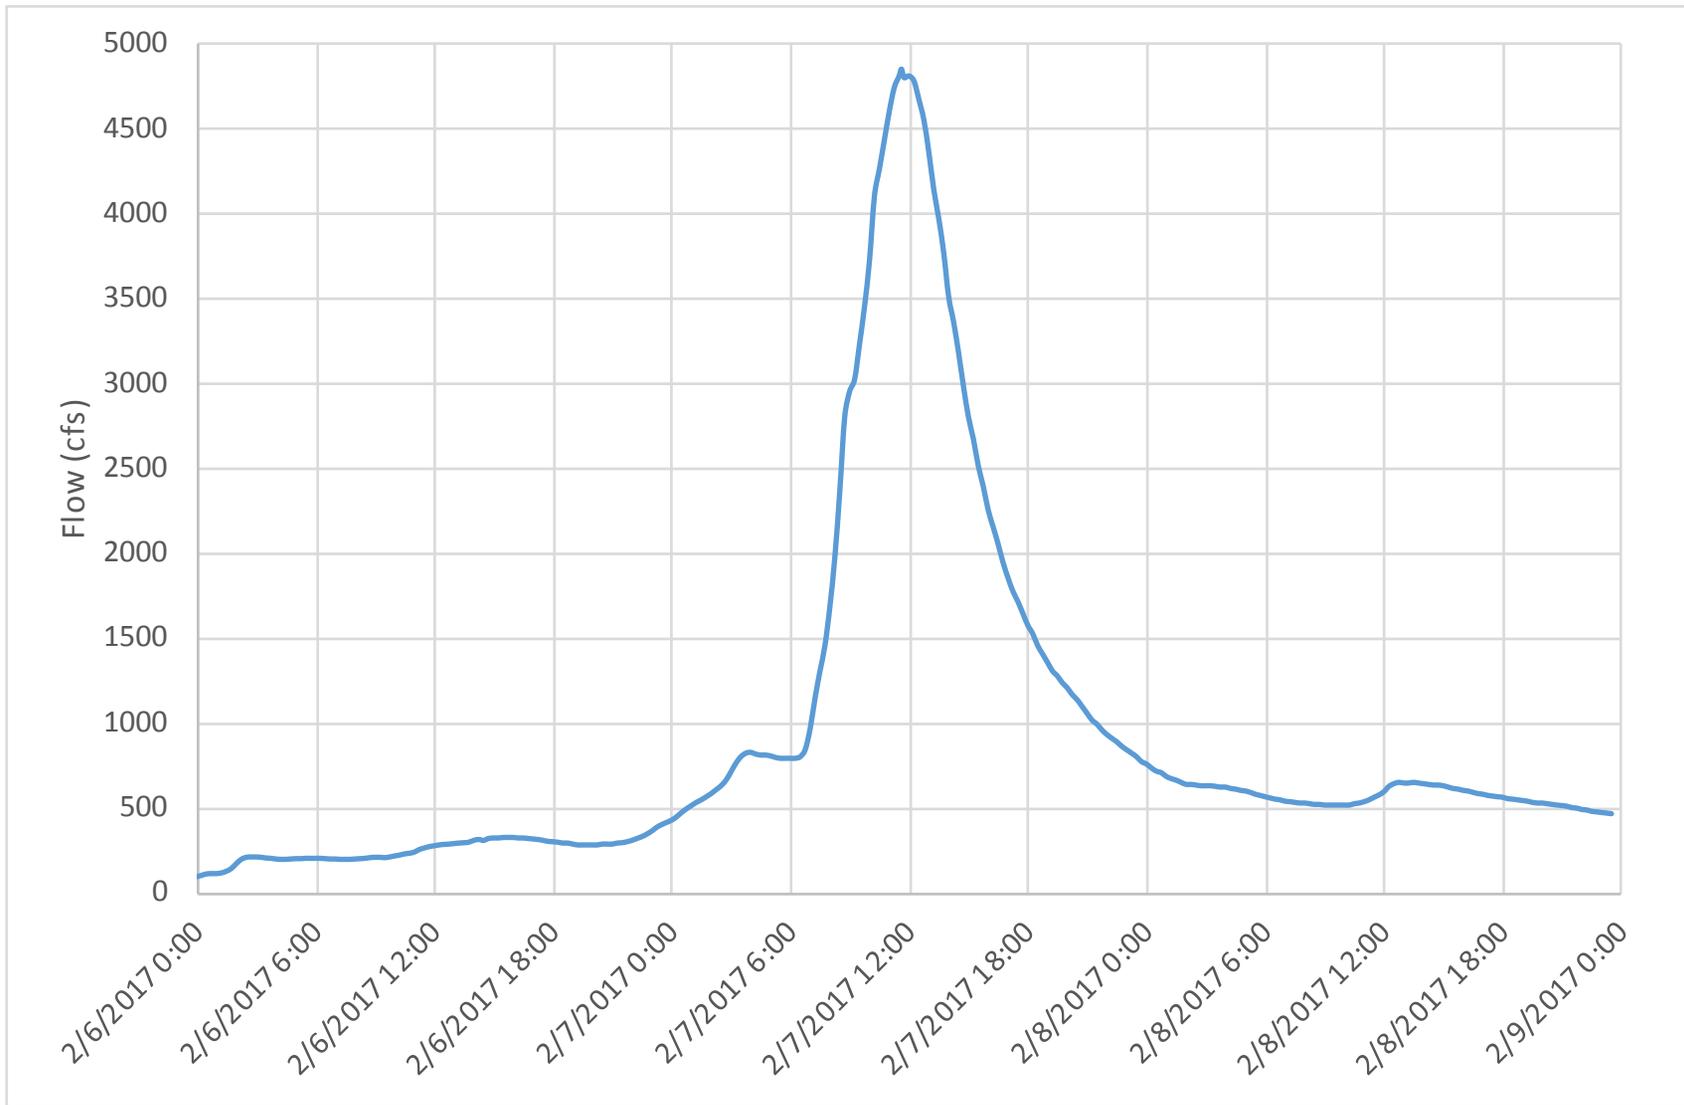
Gauge Location	Peak Flow (Preliminary)	Estimated Return Period ⁸
USGS Stanford	4,820cfs	10 Year

Figure 11: Approved San Francisquito USGS Gauge @ Stanford Hydrograph

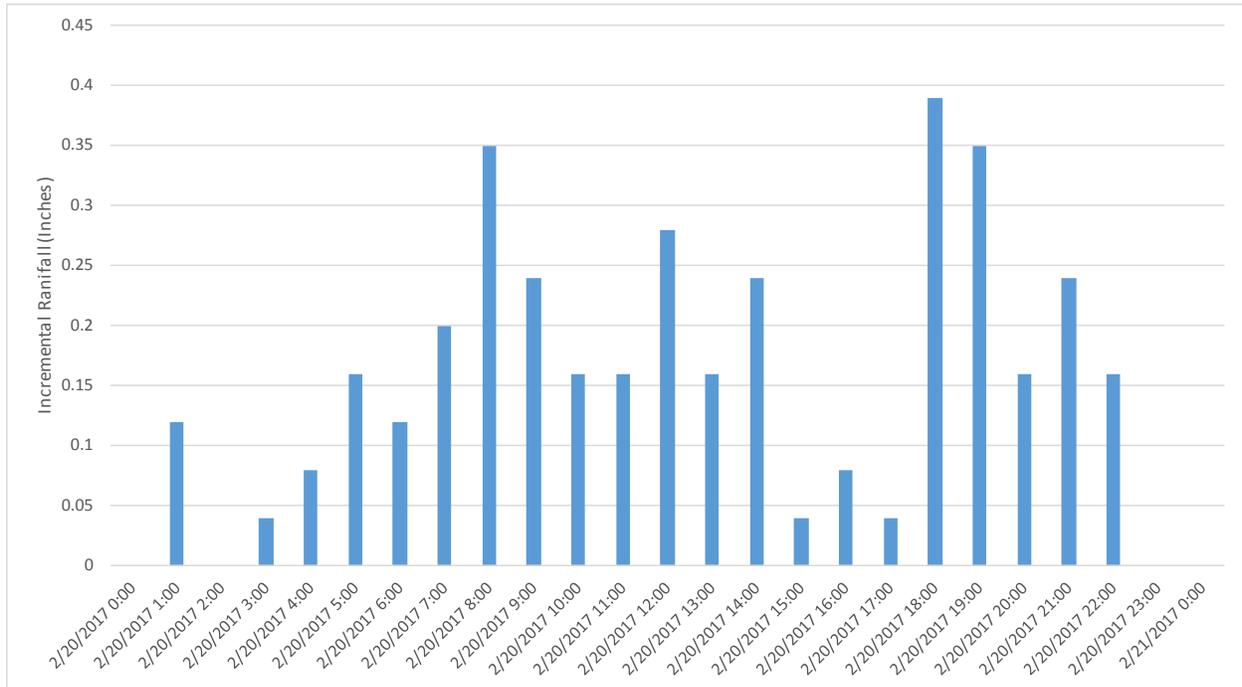
Figure 12: Coe Park (Coyote) Rainfall (2/20 - 2/21)

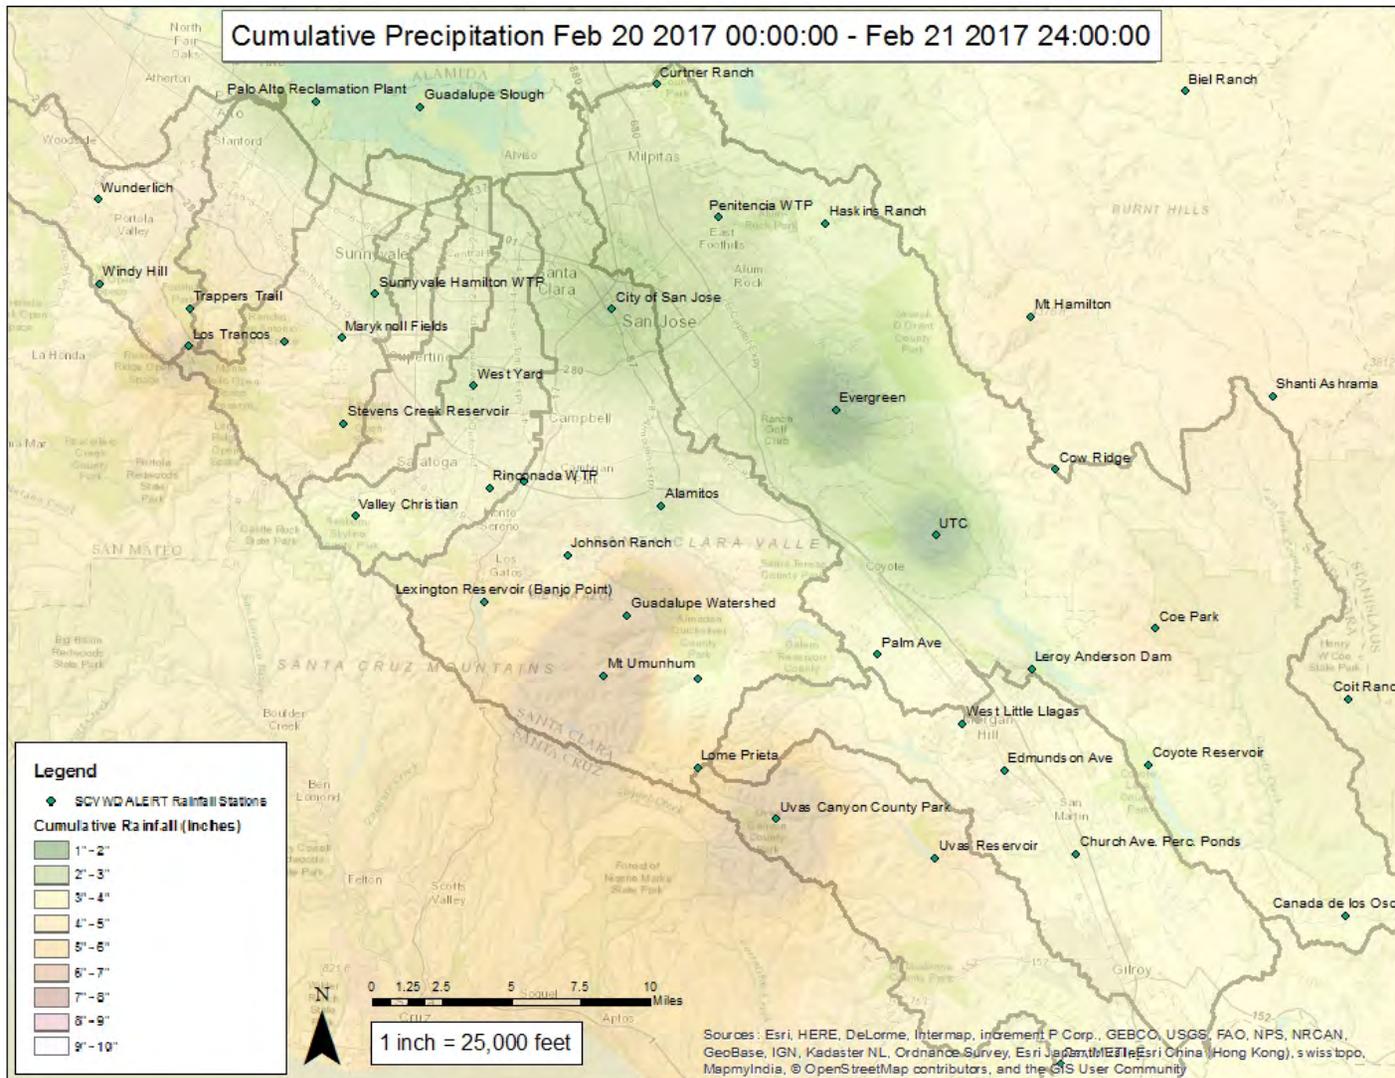
Figure 13: County Precipitation Totals (2/20 - 2/21)

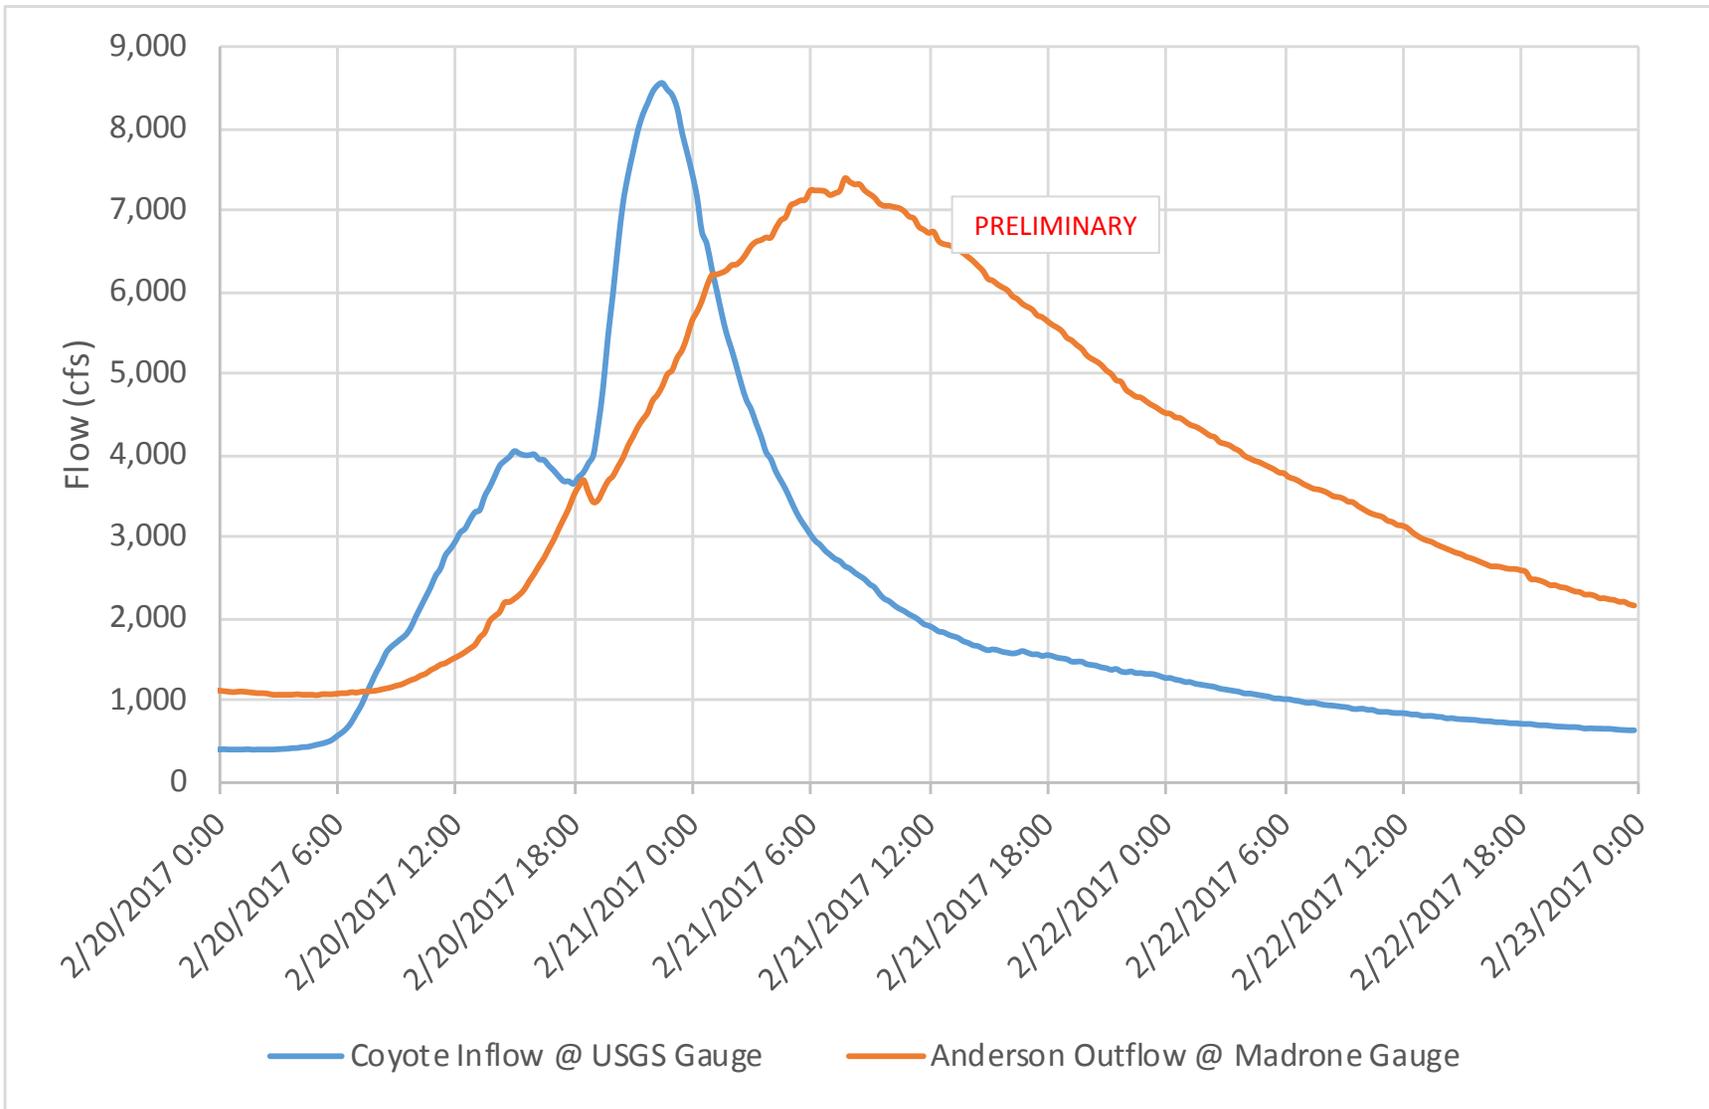
Coyote Reservoir began rising at 8am and did not peak until the following day in the early morning. Anderson Reservoir also began rising at around 8am, and did not peak until next morning. The uncontrolled spill from Anderson Reservoir was the largest ever recorded since dam construction, and caused numerous issues downstream. Information¹² recorded by the City of San Jose is also incorporated.

Figure 14: Preliminary Reservoir Inflow and Outflow Hydrographs

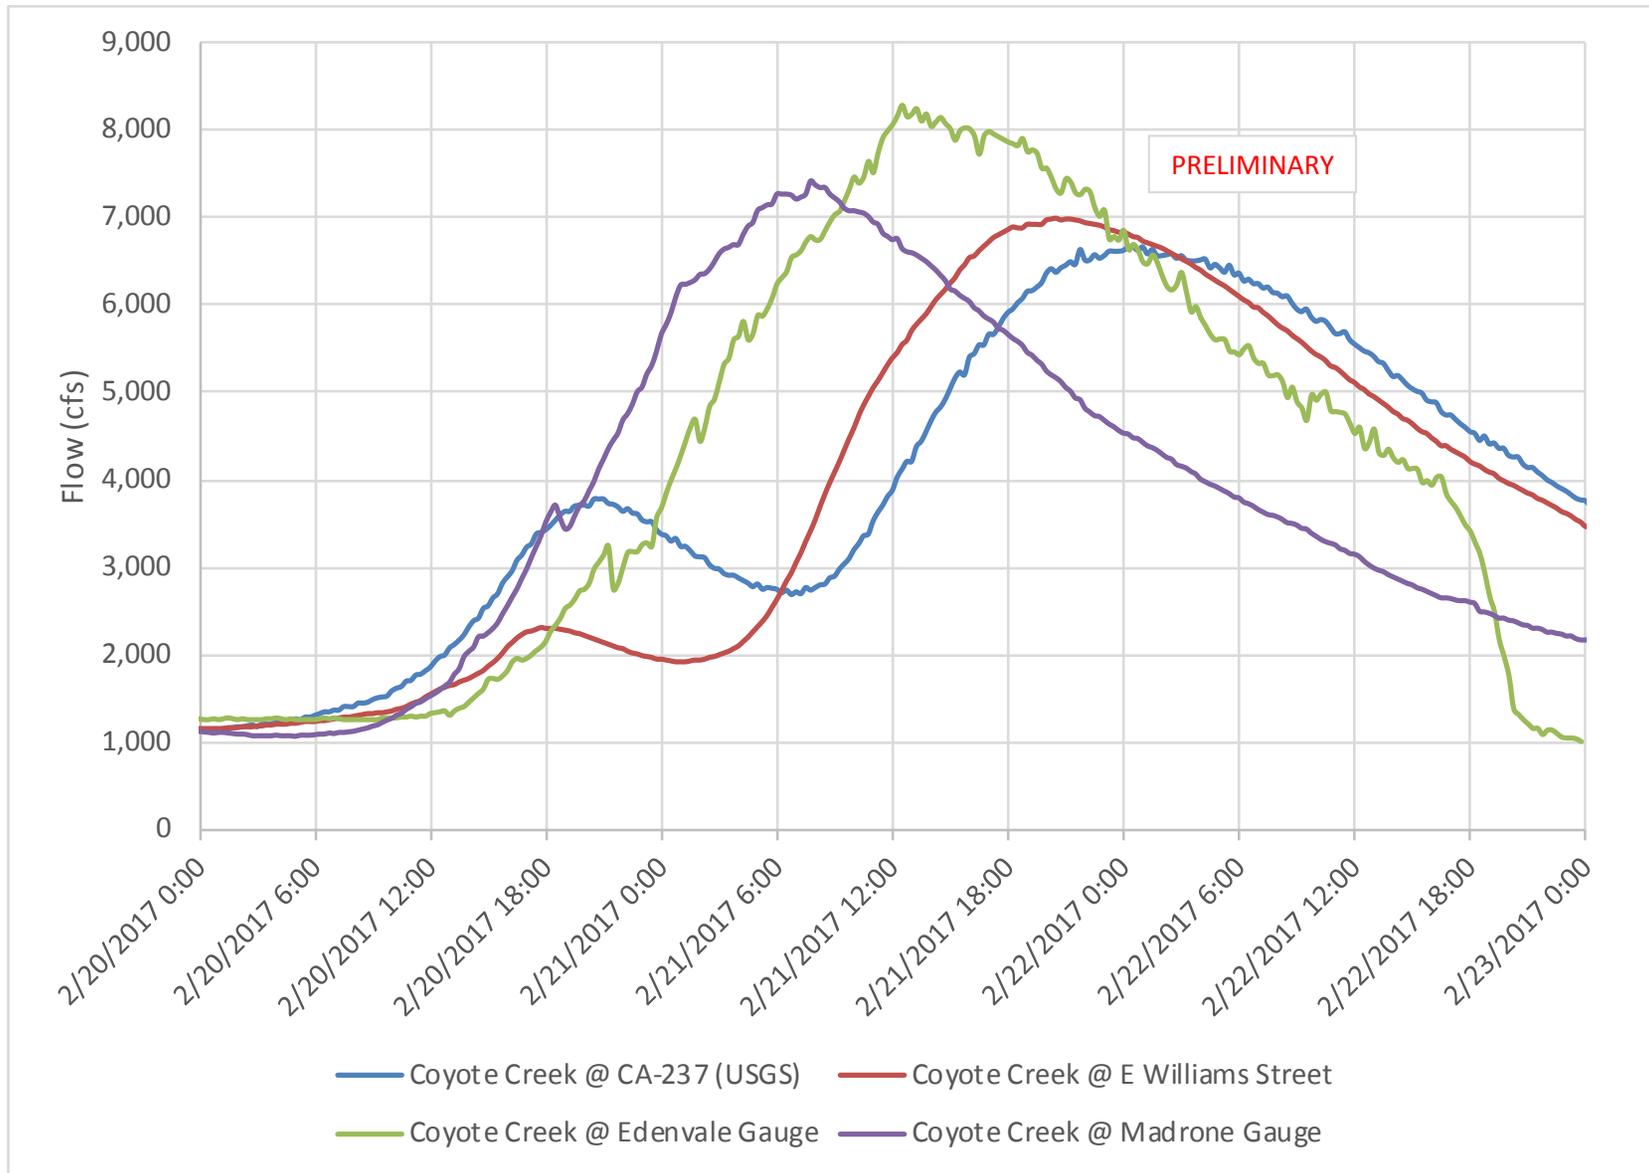
Figure 15: Preliminary Coyote Creek Hydrographs

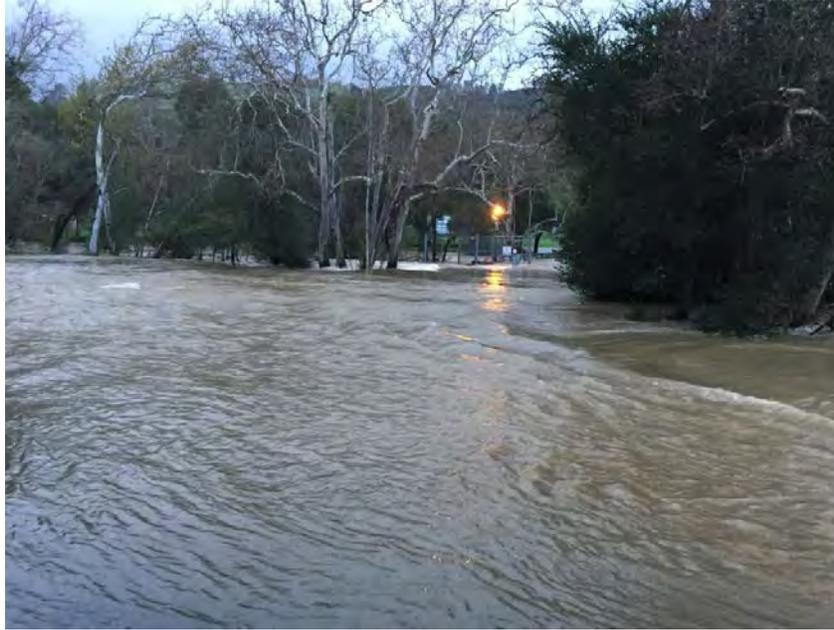
- Sycamore Avenue bridge leading towards the William F. James Boys Ranch juvenile corrections facility was overtopped. The creek overtopped and ponded the roadway along Malaguerra Avenue, inundating the Morning Star Drive and Silverwings Court intersections.

Figure 16: Picture - Coyote Creek Flooding at Malaguerra and Sycamore Avenue

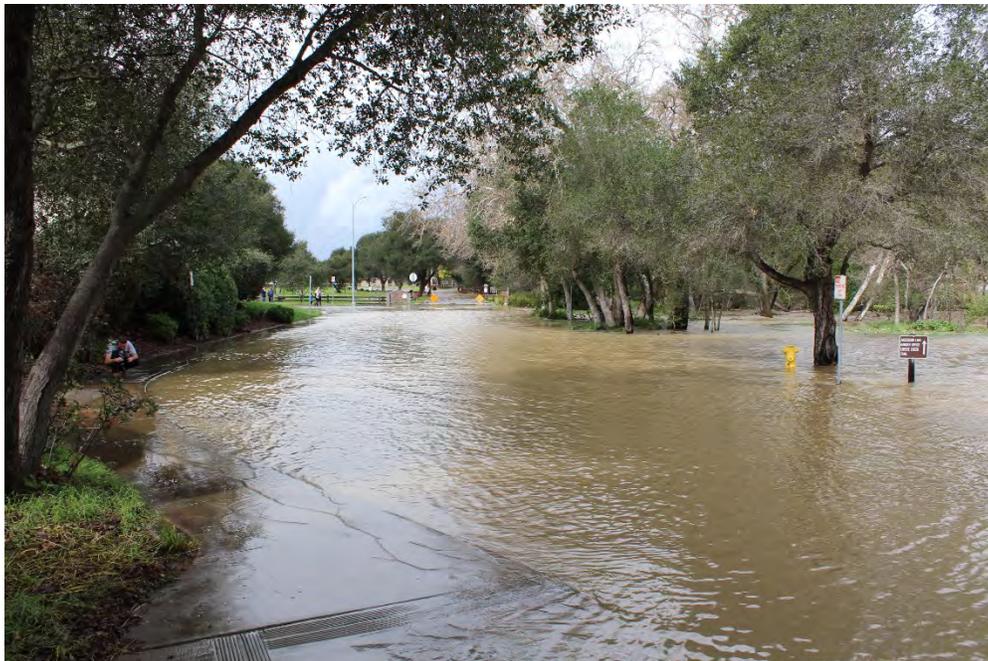
Figure 17: Picture - Coyote Creek Flooding at Malaguerra Avenue

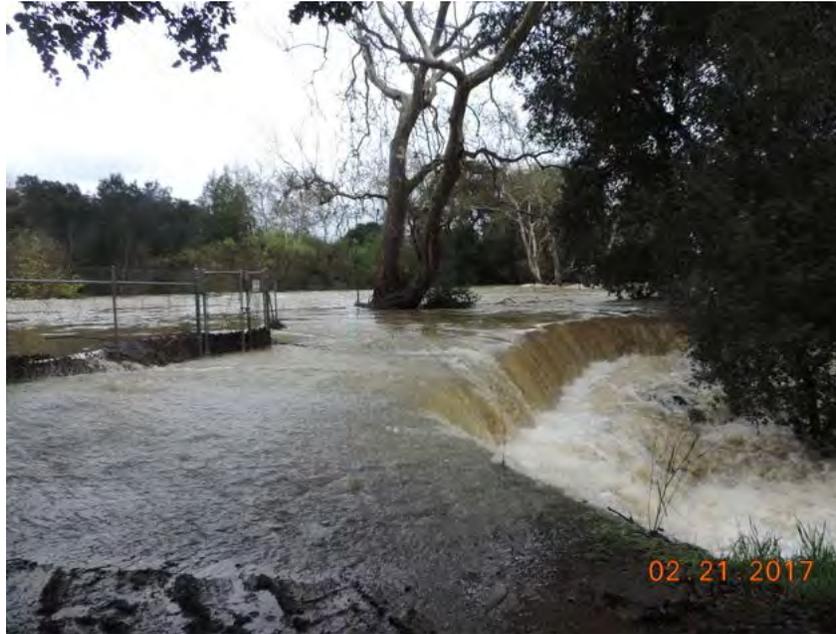
- Coyote Canal, which has been abandoned and leveed off from the main Coyote Creek channel, was breached and water flowed from the Creek into the abandoned Canal, moving downstream. Eventually, the canal overtopped US-101 about a mile south of Coyote Creek Golf Drive. District field maintenance cut breaches into the canal levees upstream to relieve high flows, and eventually built a berm approximately 2,000' south of the flooding location to divert flows through a culvert under US-101 and into Coyote Creek.

Figure 18: Picture - Coyote Creek Overflow into Abandoned Coyote Canal

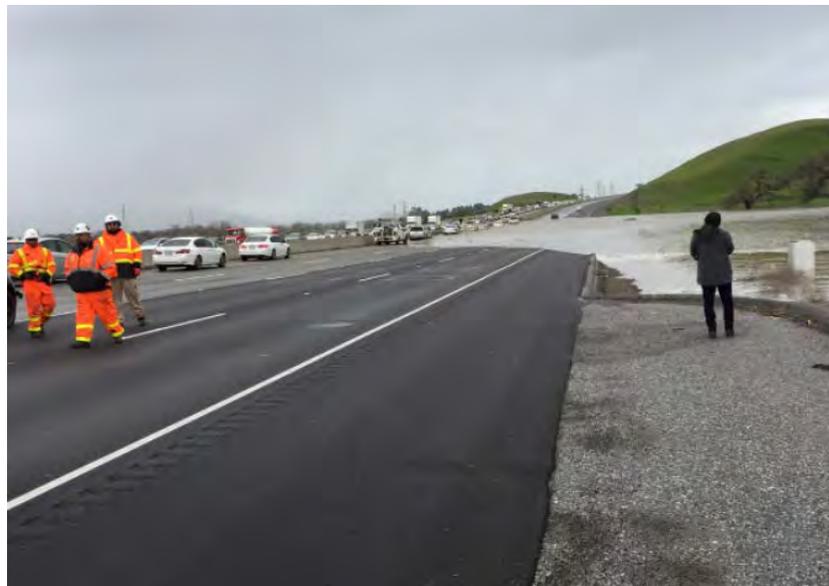
Figure 19: Coyote Canal Flooding on US-101 Northbound
