FLOODING REPORT (FINAL)

COYOTE CREEK, UVAS CREEK, SAN FRANCISQUITO CREEK,
AND WEST LITTLE LLAGAS CREEK

JANAURY AND FEBRUARY OF 2017

*Prepared by the Hydraulics, Hydrology, and Geomorphology Unit
November 2017*

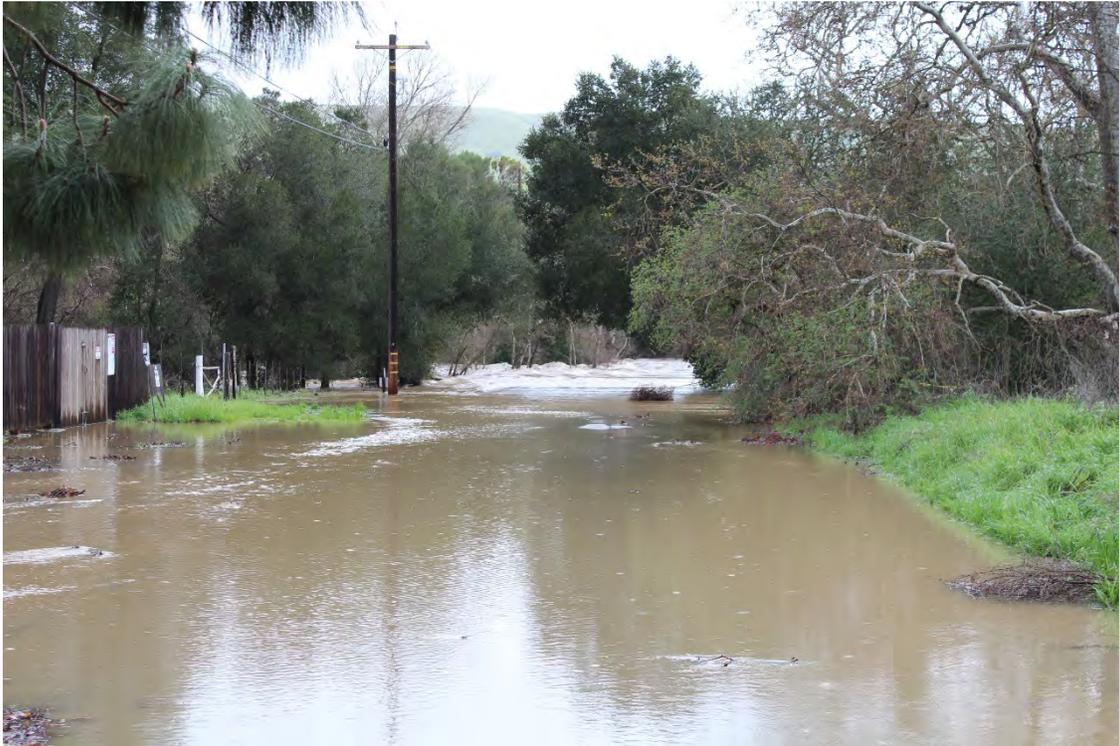
- Overtopping and breaching of levees along Olgier Ponds, along with the overtopping of Coyote Creek Golf Drive and localized flooding along the road.
- Flooding in Hellyer County Park in San Jose along the Creek, inundating most of the park except for the Velodrome.
- Flooding on the Los Lagos Golf Course in San Jose,

Figure 20: Picture - Coyote Creek overtopping Coyote Creek Drive Bridge (Looking East)

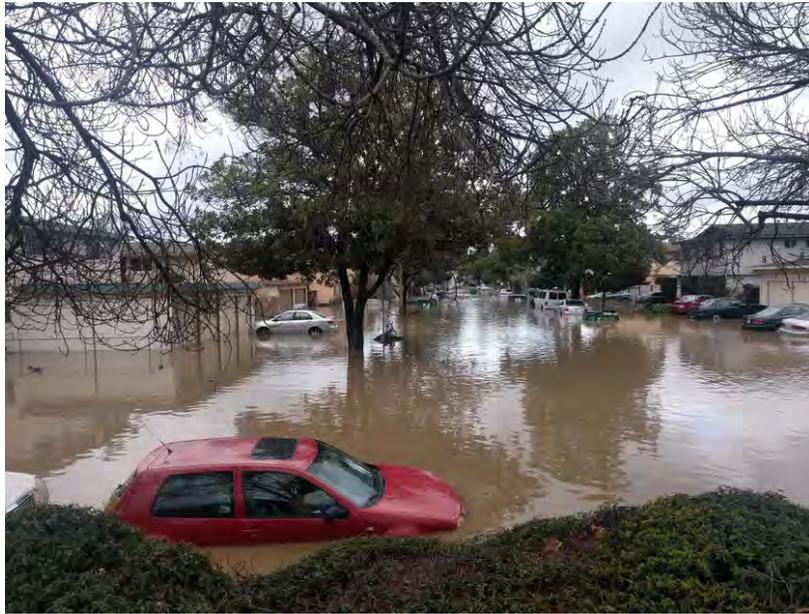
- On the morning of February 21st at about 8:30am, the neighborhood of Rock Springs was flooded as Coyote creek overtopped along Rock Springs Drive and Needles Drive, causing deep inundation. Firefighters launched rescue operations by boat and evacuated 276 residents with no fatalities or injuries. Floodwaters also rose along Bevin Brook Drive, damaging detached garages but sparing most residential buildings. Downstream of Story Rd, apartment buildings along South 12th street experienced flooding. Sections of Happy Hollow Zoo and the Japanese Friendship Garden were also flooded.

Figure 21: Picture - Flooding @ Needles Drive and Welch Avenue in the Rock Springs Neighborhood

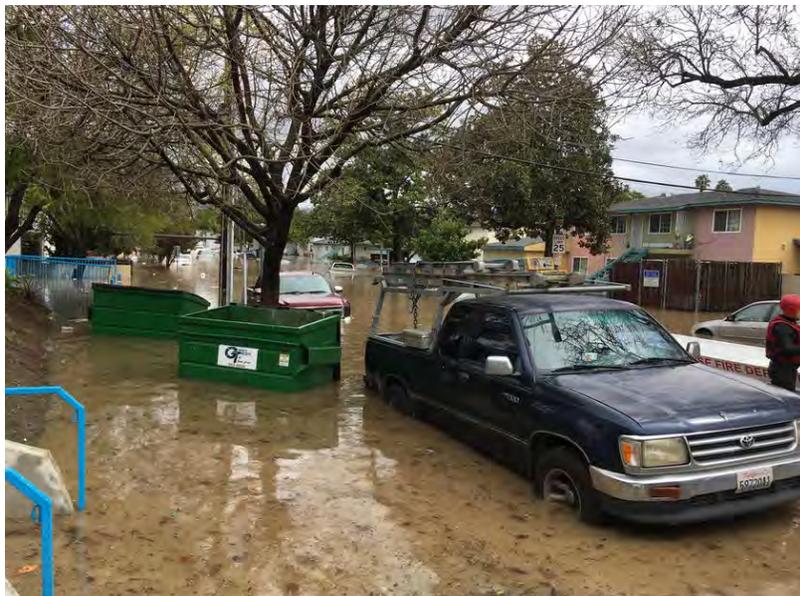
Figure 22: Picture - Flooding @ Senter Road and Nordale Avenue in the Rock Springs Neighborhood

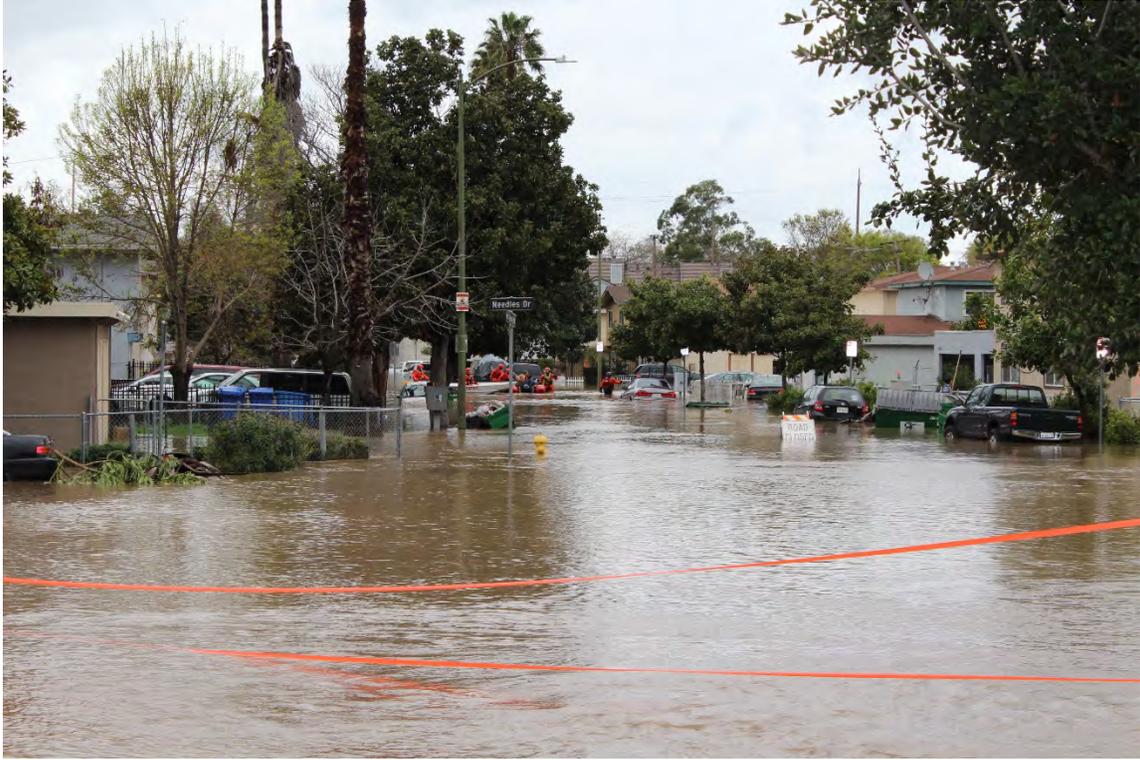
Figure 23: Picture - Intersection of Rock Springs Drive and Needles - Firefighters Evacuating Residents

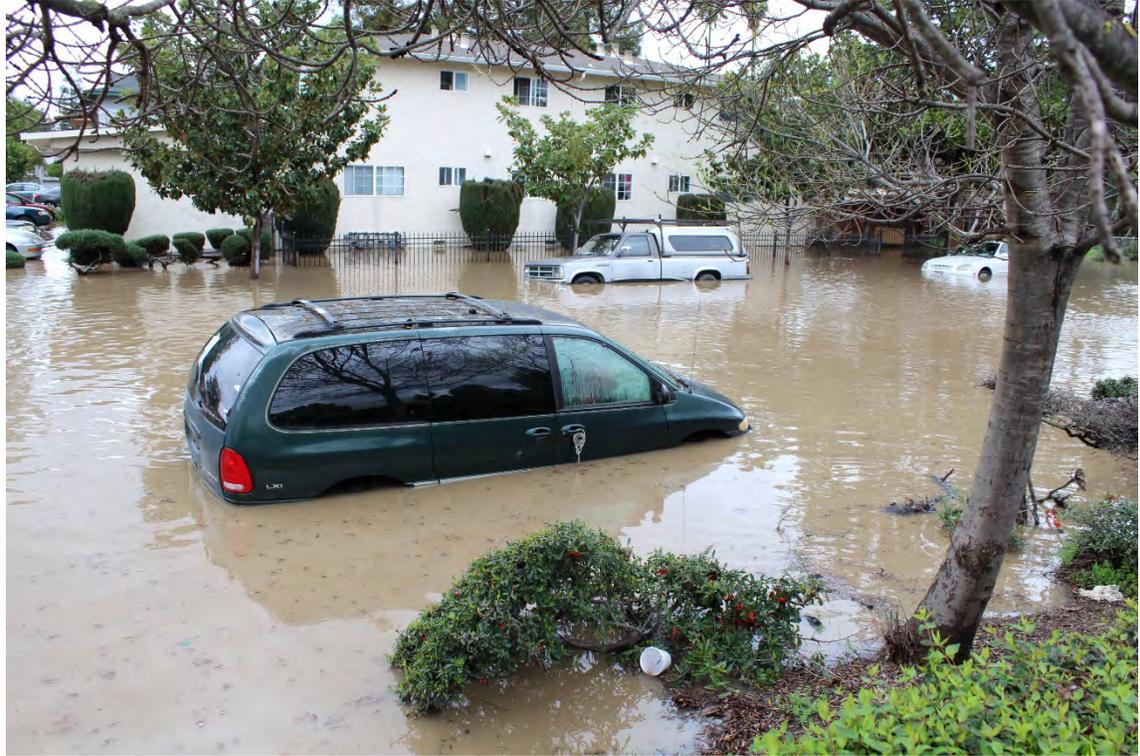
Figure 24: Picture - Flooding on Needles Drive

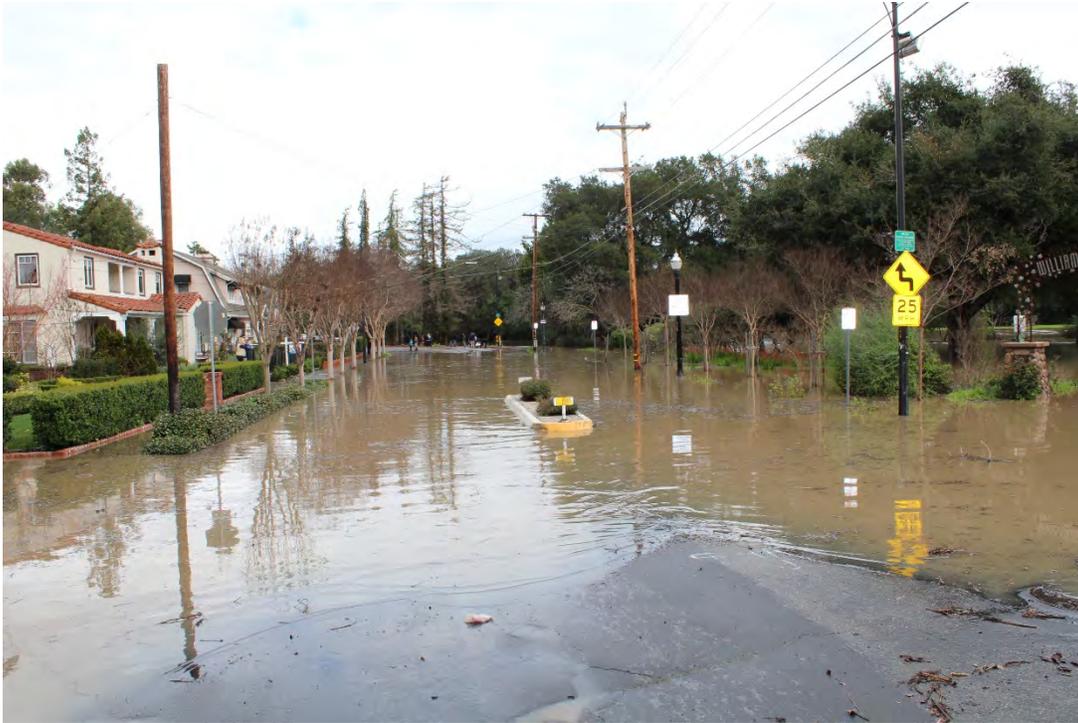
- Downstream of I-280 and upstream of East Williams Street, the Creek spread into Selma Olinder Park and Williams Street Park. On the west side, floodwaters stopped on East 16th Street and inundated several homes north of Williams. To the east, floodwaters swept through Olinder Elementary school, and headed in the north to north easterly direction over roads and flooding neighborhoods. Floodwaters stopped along Woodborough Drive south of Williams. In addition, a large eucalyptus tree fell across the channel on Friday February 17th adjacent to San Jose High School, increasing creek elevations as well.

Figure 25: Picture - Flooding @ the Intersection of East Williams and South 16th Street

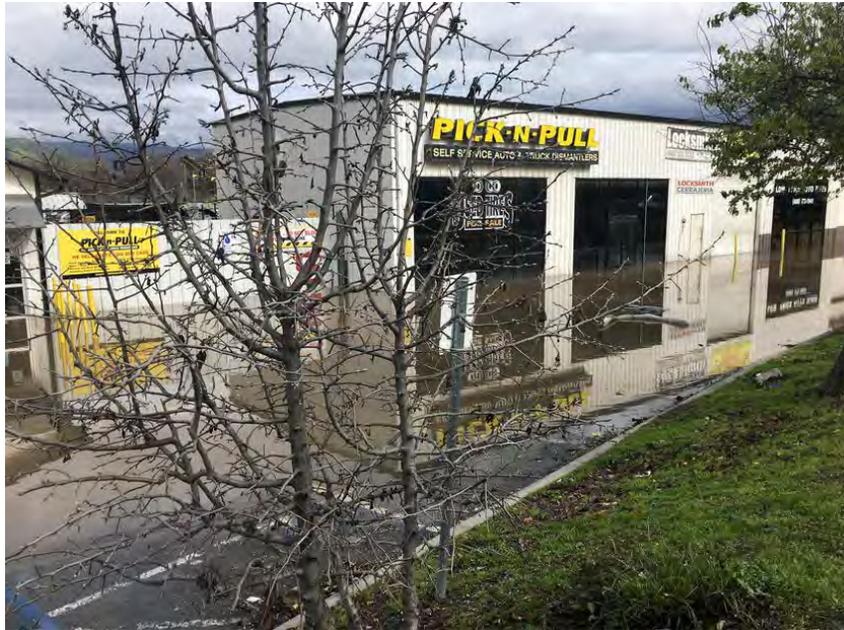
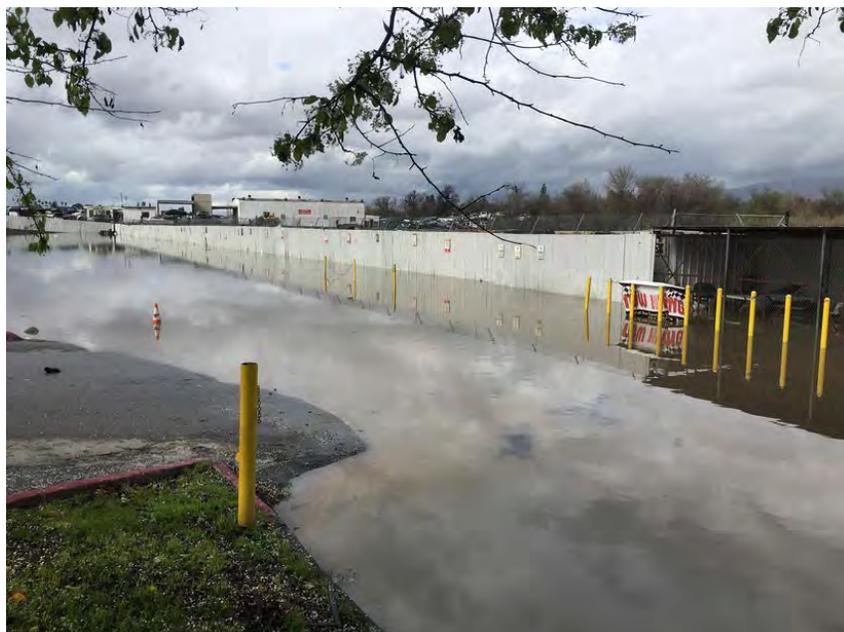
- Flooding along Watson Park in San Jose, with floodwaters inundating Monferino Drive and Jackson Street.
- Between Mabury Road and US-101, flooding on both sides of the Creek.
- Upstream of Berryessa Road, businesses on the west bank experienced flooding.
- Downstream of Berryessa Road, businesses experienced significant flooding on the west bank. Storm sewer surcharging along Berryessa Road and Commercial Street, as well as Commercial Street and Oakland Road.

Figure 28: Commercial Buildings Flooded downstream Berryessa Road

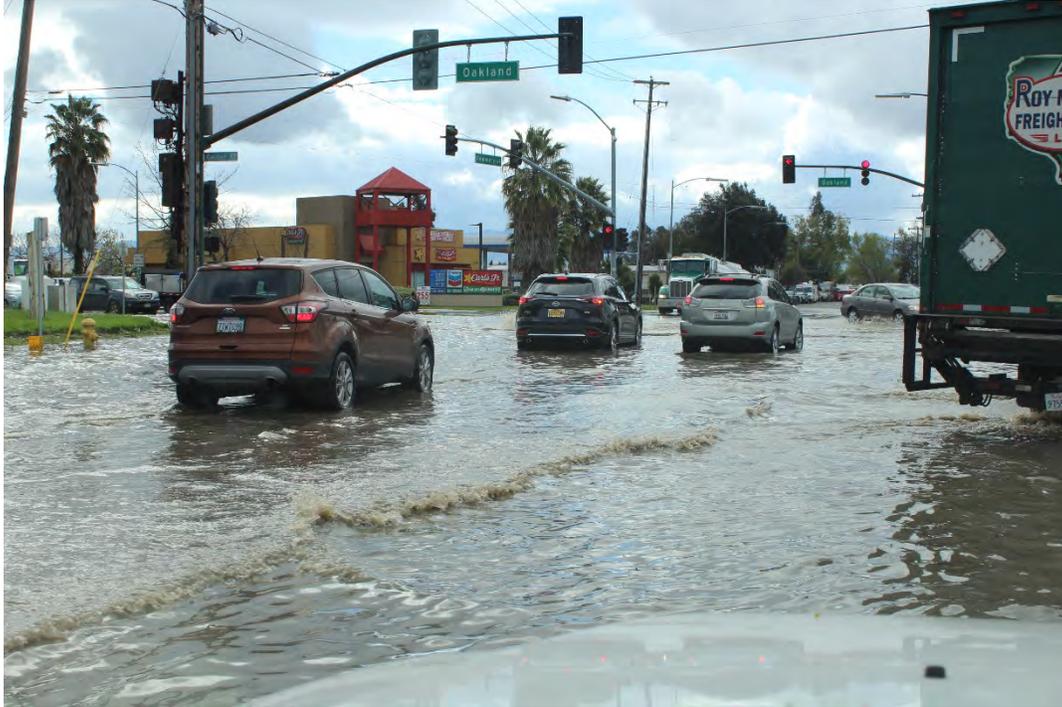
Figure 29: Picture - Street Flooding @ Oakland and Commercial Road

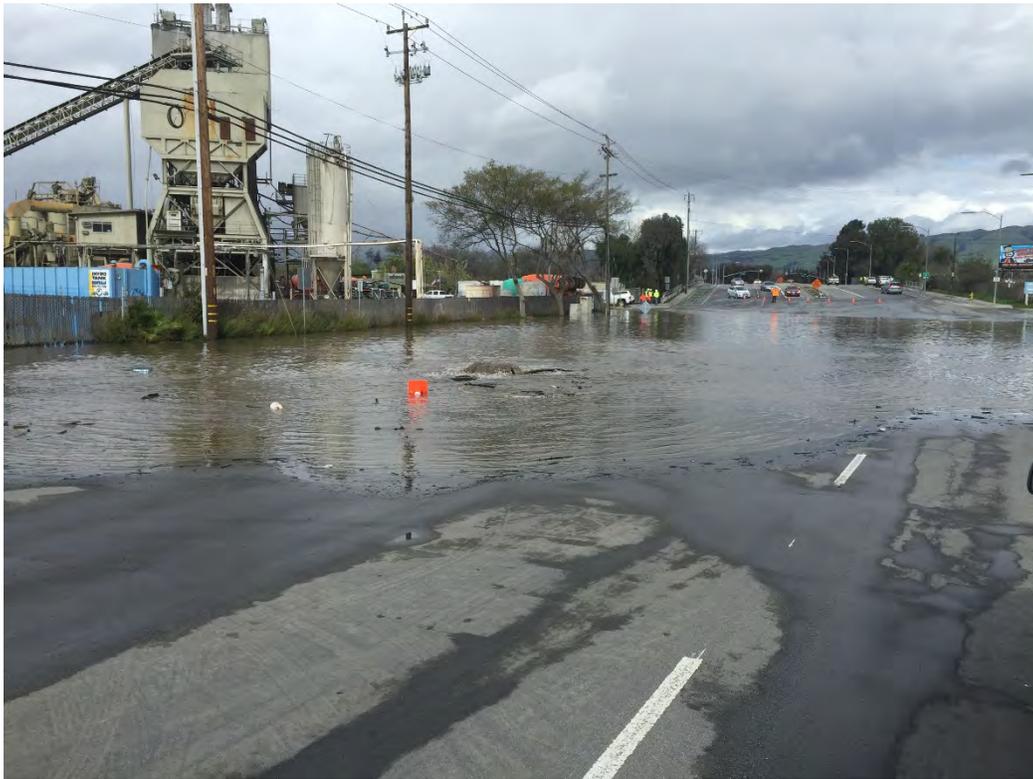
Figure 30: Picture - Street Flooding @ Berryessa Road

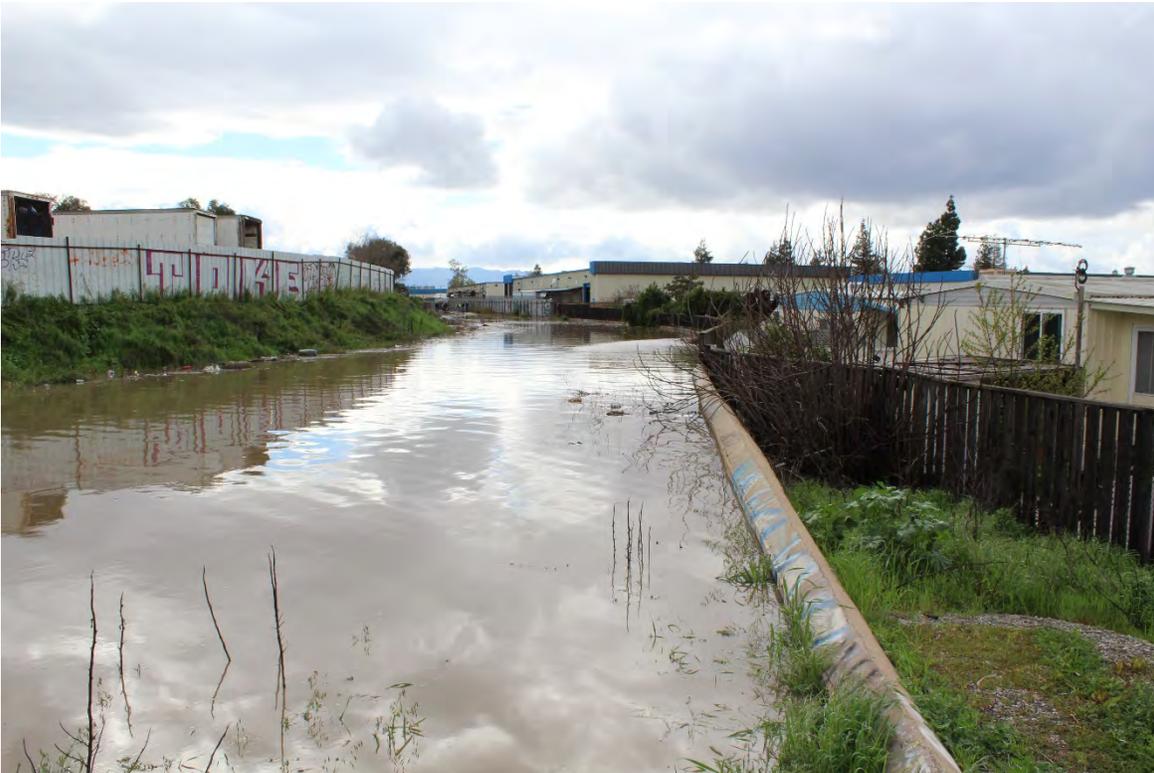
- Late during the day on Tuesday, the South Bay Mobile Home Park and adjacent mobile home parks flooded as Coyote Creek overtopped the floodwall and earthen levee on the south end near the railroad tracks. In addition, an electrical malfunction disabled a City of San Jose pump station, causing Coyote Creek backwater to flow into Faulstich Court and Old Oakland Road.
- The San Jose Municipal Golf Course parking lot and practice green was flooded.
- Coyote Creek reached the top chord at Charcot Bridge, slightly inundating the roadway in addition to storm sewer backups.

Figure 31: Picture: South Bay Mobile Home Park Floodwall - Early Afternoon

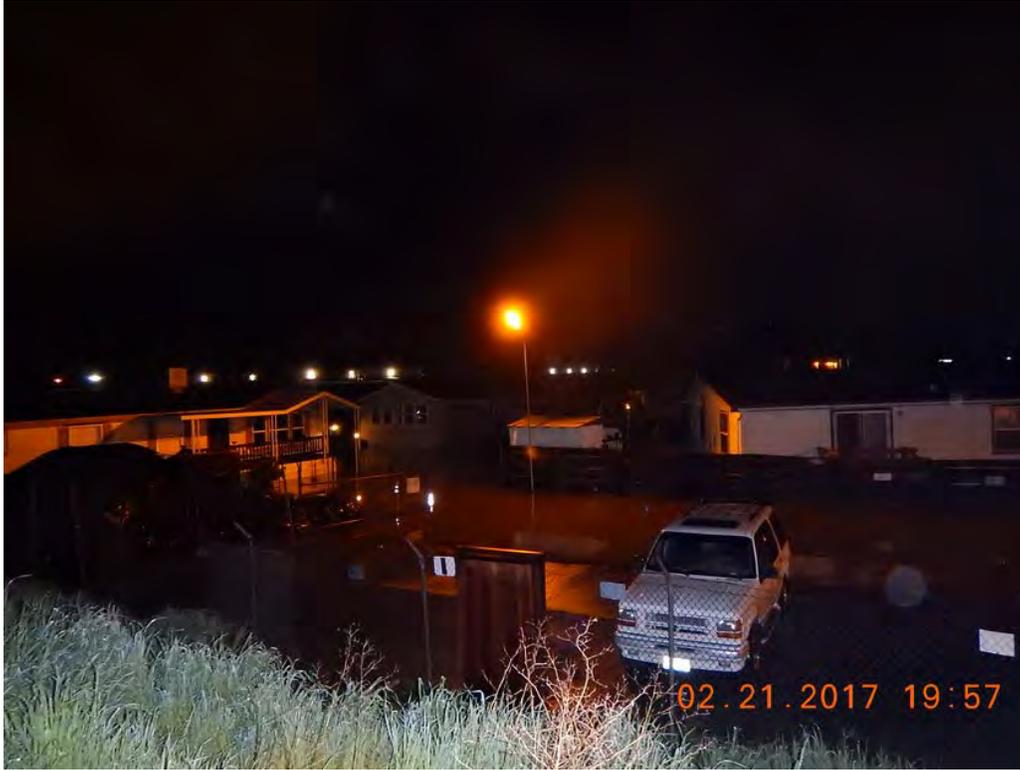
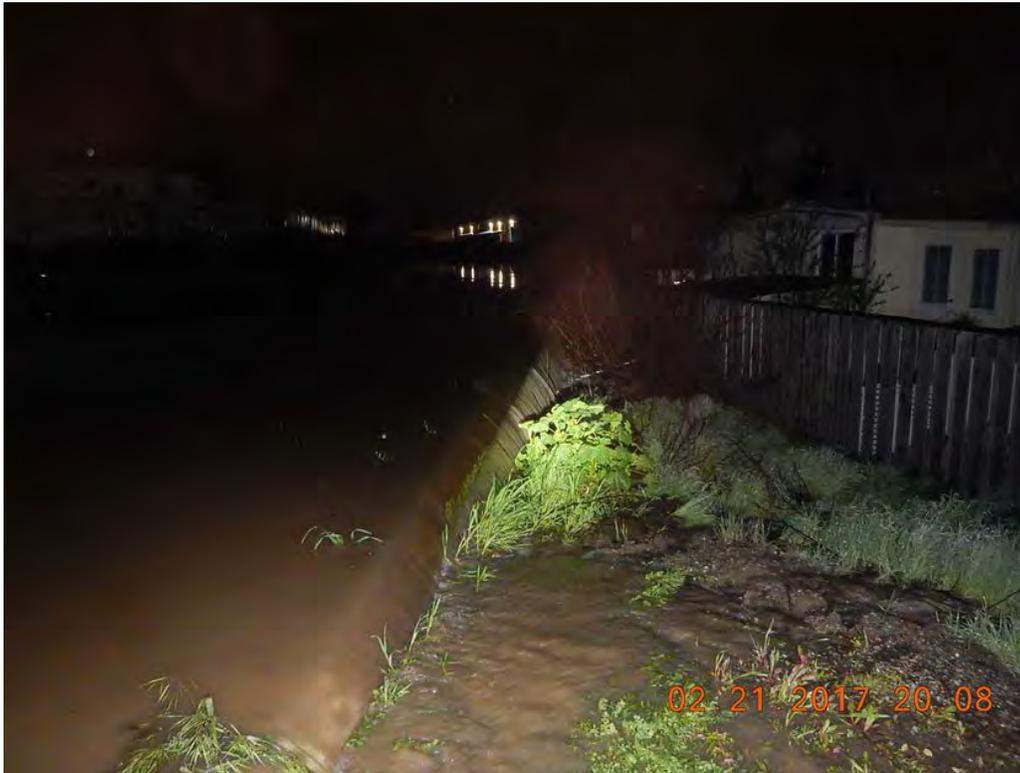
Figure 32: Coyote Creek spilling into South Bay Mobile Home Park – Evening/Night

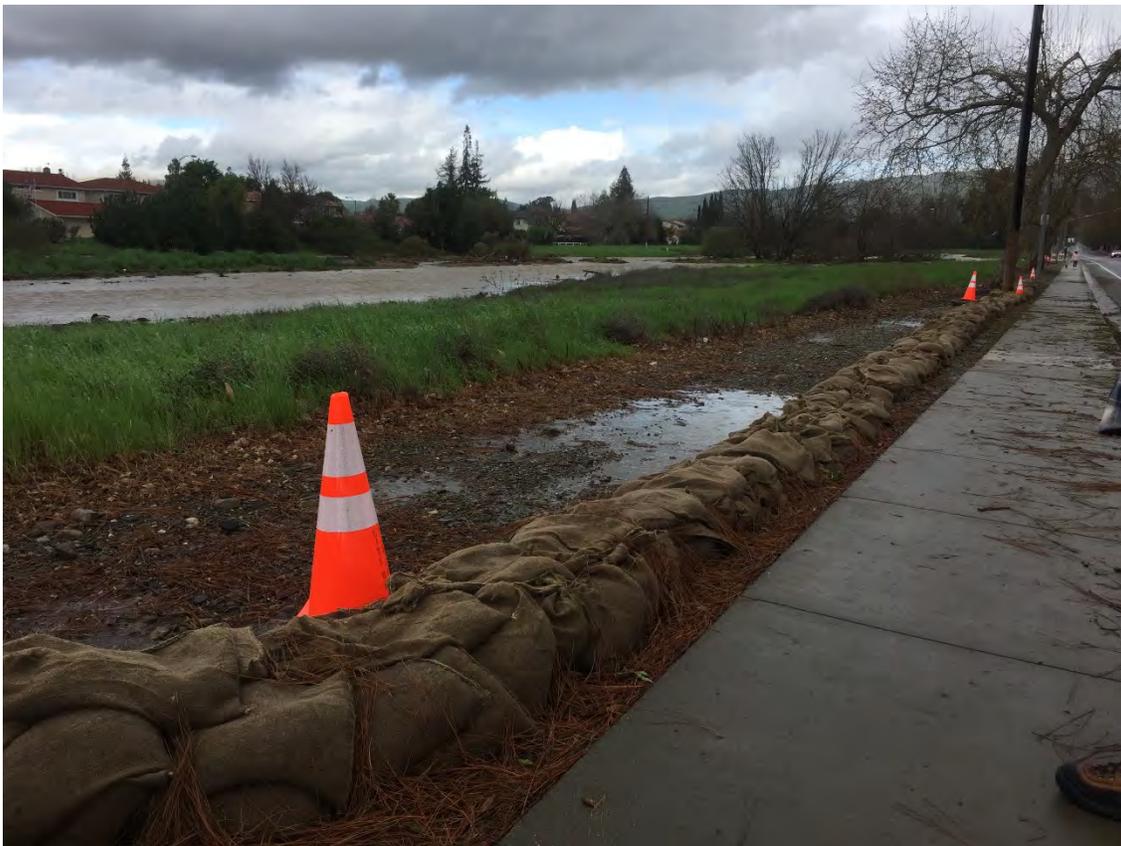
Upper Penitencia Creek experienced a few minor spills during the storm event. Spills were mainly experienced along the Mabury bypass, bounded along the east and west by Jackson Avenue and King Road respectively. Overtopping occurred along both the left and right banks, immediately downstream of the Jackson Avenue culvert.

Spills over the left bank resulted in sheet flow draining into the County Parks pond. There was also a downed tree along the left bank, obstructing the trail through the park and not the creek itself. Greater amounts of spill took place further downstream over the two concrete lateral weirs situated along the right bank, activating the Mabury bypass. The city of San Jose sandbagged areas along Mabury Road to prevent street flooding. Despite these measures, some ponding occurred at a low spot along Mabury Road. Minor flooding may have occurred along Cape Horn Drive (residential street north of the Mabury bypass). Ponding was not seen at this location, but there were some debris, indicating that the lip of the street curb may have been overtopped.

Figure 33: Upper Penitencia Bypass Channel - Educational Park Drive

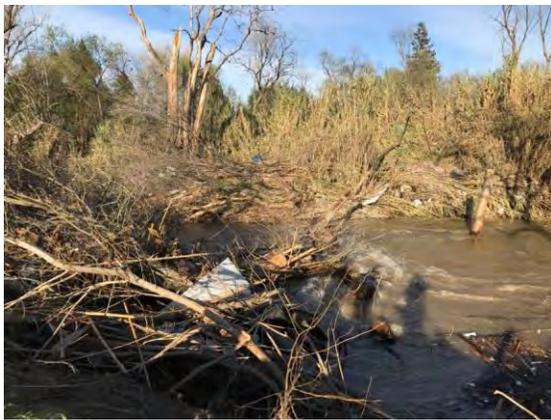
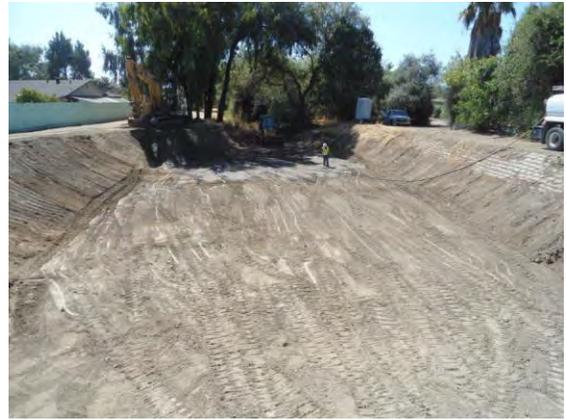
The Water District has ongoing programs to remove trash and debris from Water District property along Coyote Creek through its good neighbor, homeless encampment clean up and Adopt-A-Creek programs. The Water District removes invasive vegetation species and will be undertaking that activity at some locations along Coyote Creek this summer. Removal of vegetation for flow conveyance, including fallen trees, must also meet environmental goals and regulations that protect stream habitat. Vegetation management alone will not prevent future flooding because Coyote Creek has not been improved to convey flood flows.

Pictured: Images of a natural (left) and engineered (right) channel.
