Palo Alto Flood Basin Tide Gate Structure Replacement

June 24th, 2020 Virtual Public Meeting Project website: <u>www.valleywater.org/pafbtidegates</u>

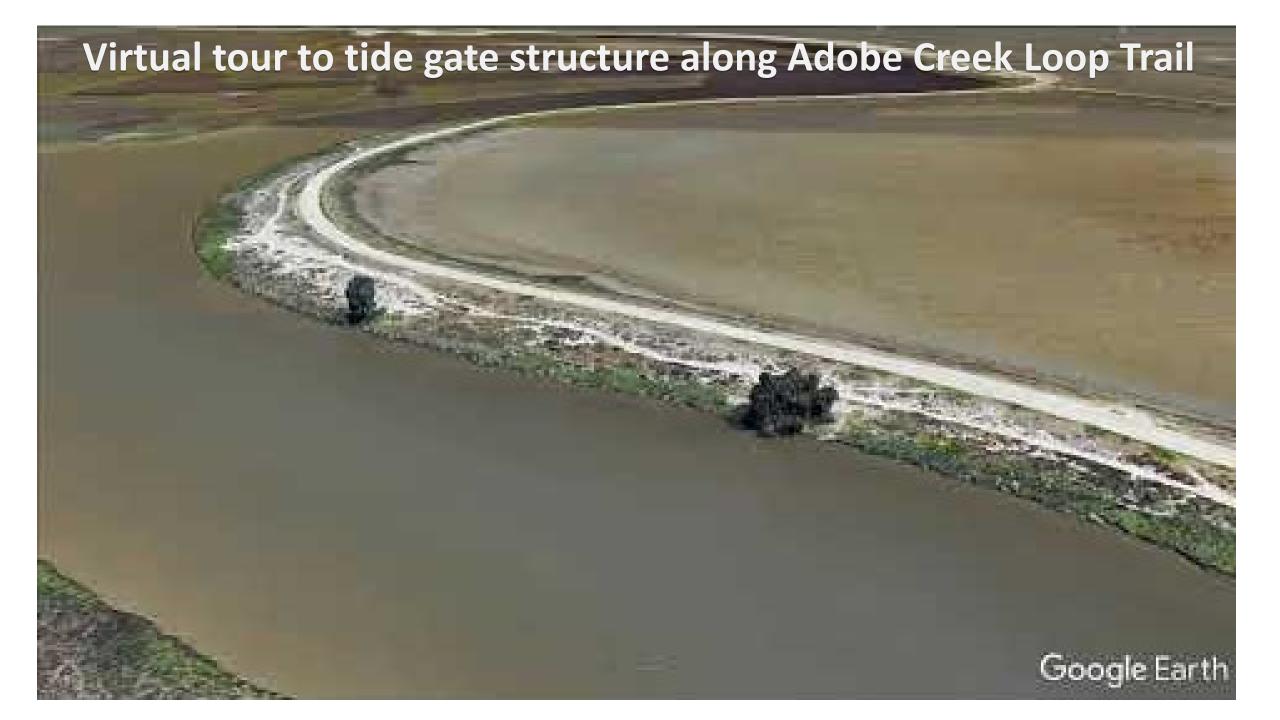
Tide Gate Structure During High Tide

Tide Gate Structure During Low Tide

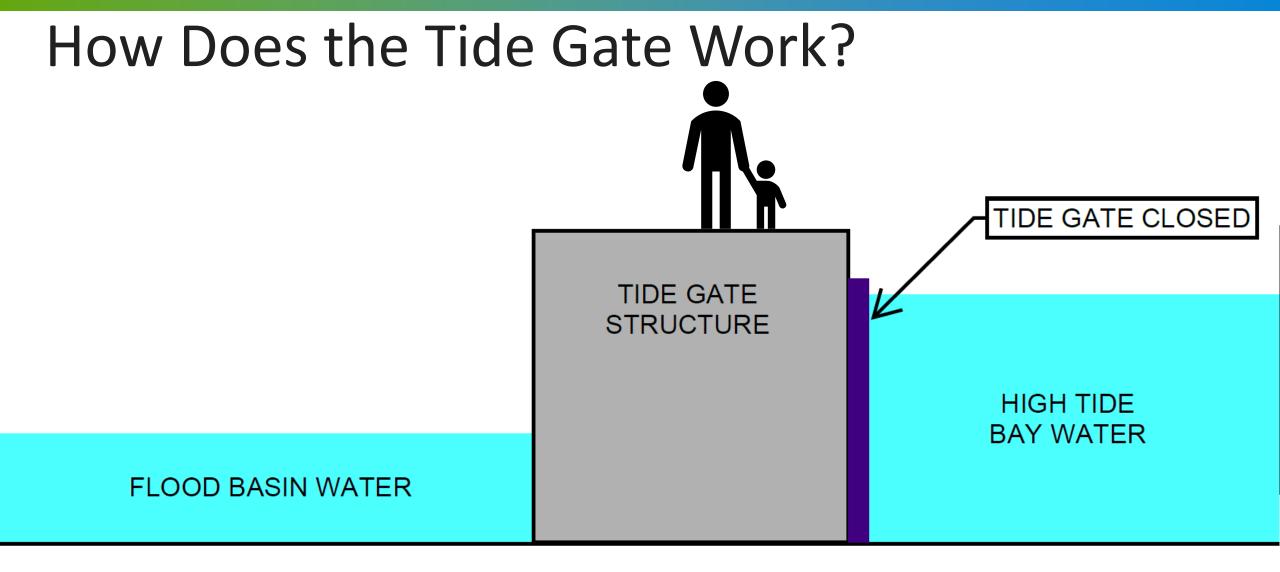
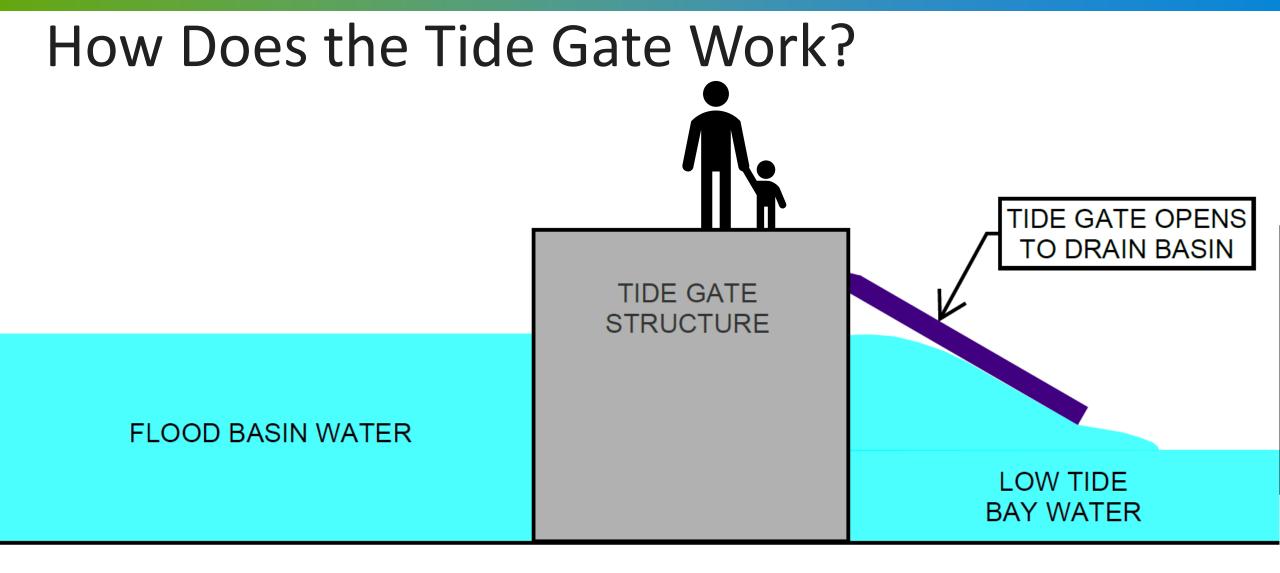
Existing Tide Gate Structure – Basin Water Level & Bay Water Level

Palo Alto Flood Basin (displaying typical summer water level)

San Francisco Bay (displaying a moderate-high tide)

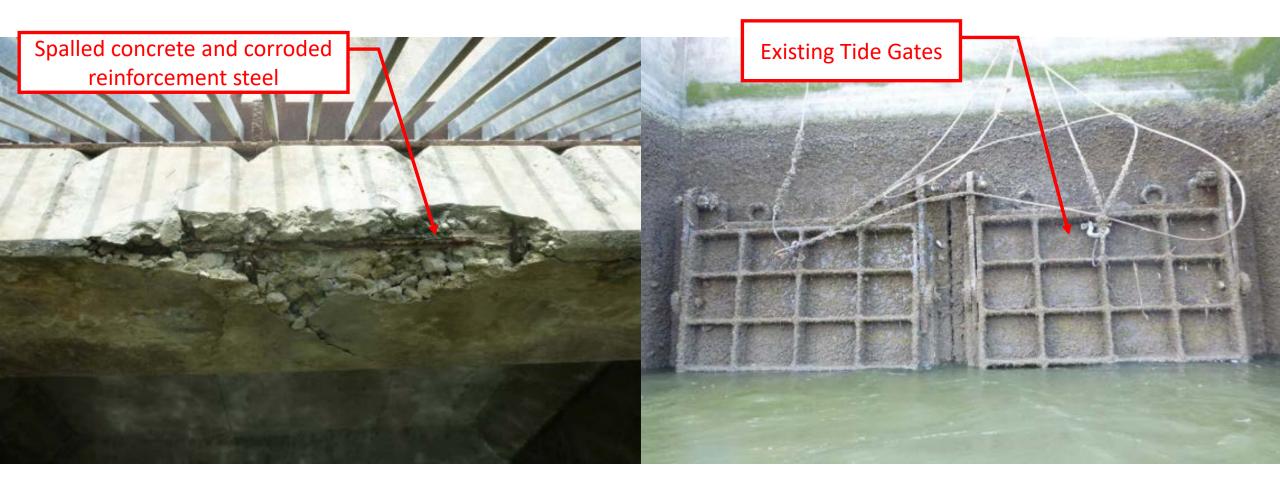
Tide Gate Structure Current Condition

2012 Seepage Photo

Vortex at Bay Side

- Water bubbling up in the Basin

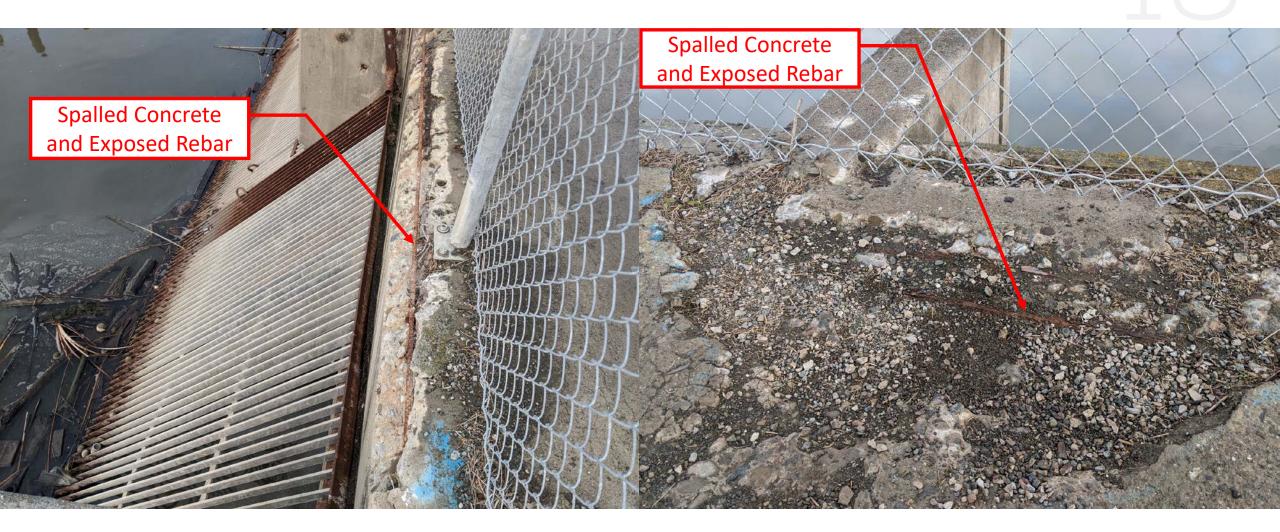
Tide Gate Structure Current Condition

- 63-year old structure: structural & hydraulic deficiencies
- Maintenance is problematic and costly
- Seismic vulnerabilities
- Leaking tide gates
- Spalled concrete and corroded steel reinforcement
- No adaptation for future Sea Level Rise
- Regular coastal flooding from a failed tide gate structure could flood approximately 400 to 700 parcels and Highway 101
- A failed tide gate structure would close the trail indefinitely

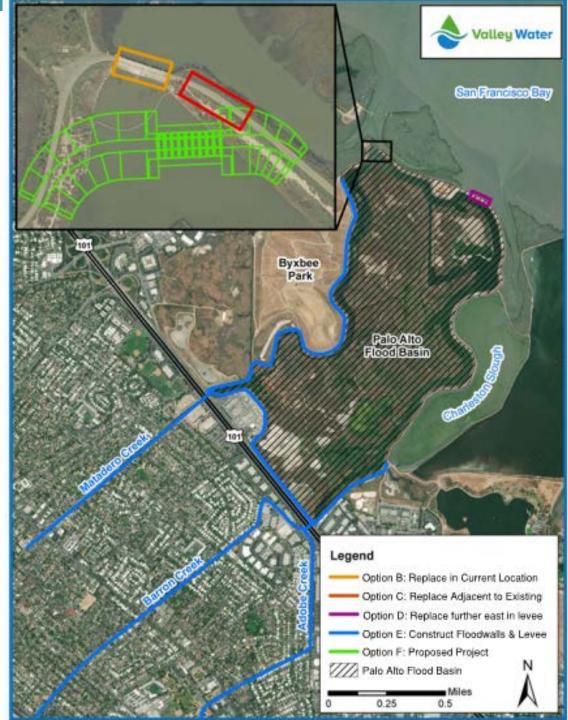
- A. No action
- B. Replace tide gate structure in existing location (SAFER Bay Option 1)
- C. Replace tide gate structure adjacent to existing tide gate on levee (SAFER Bay Option 1)
- D. Replace tide gate structure in new location further east along levee (SAFER Bay Option 1)
- E. Remove tide gate structure and build up inner levees & flood walls along Matadero, Barron, and Adobe Creeks (SAFER Bay Option 2)
- F. Replace tide gate structure nearby on new alignment (SAFER Bay Option 1)

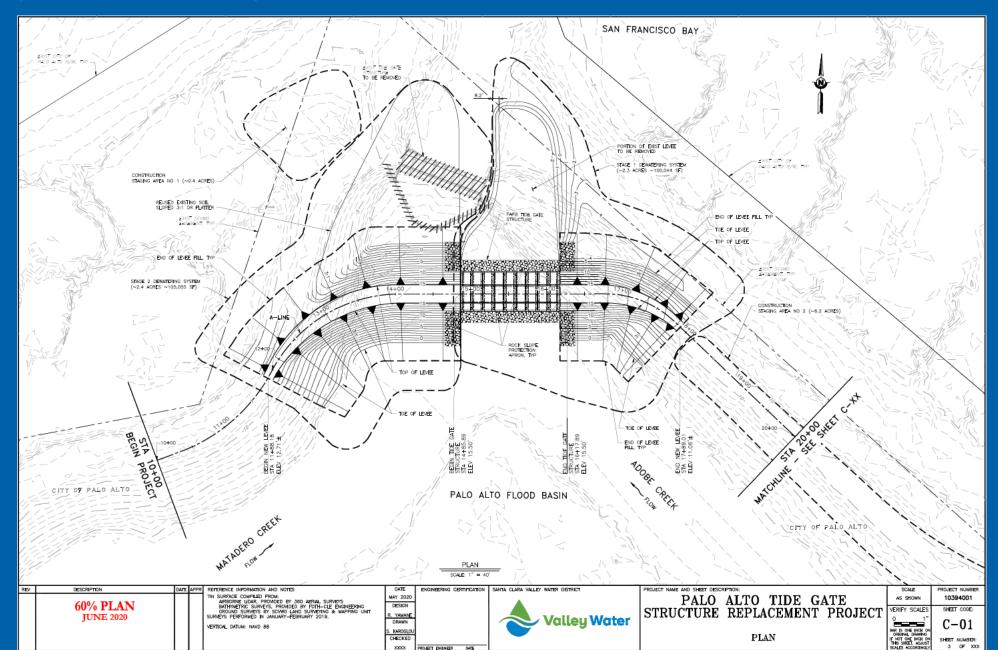
Proposed Project – Plan View

- Continued coastal and creek flood protection
- Continued protection of existing basin habitat
- Construction: 4 Years (Sept. 1st Jan. 31st)
- Accommodate 2' of future Sea Level Rise
- Temporary trail closure for 41 months
- New tide gate structure 5 feet higher than existing structure
- New tide gates and sluice gate will be more efficient than existing gates for improved operations & maintenance
- Reduced frequency of maintenance
- Project preliminary cost estimate \$33 Million

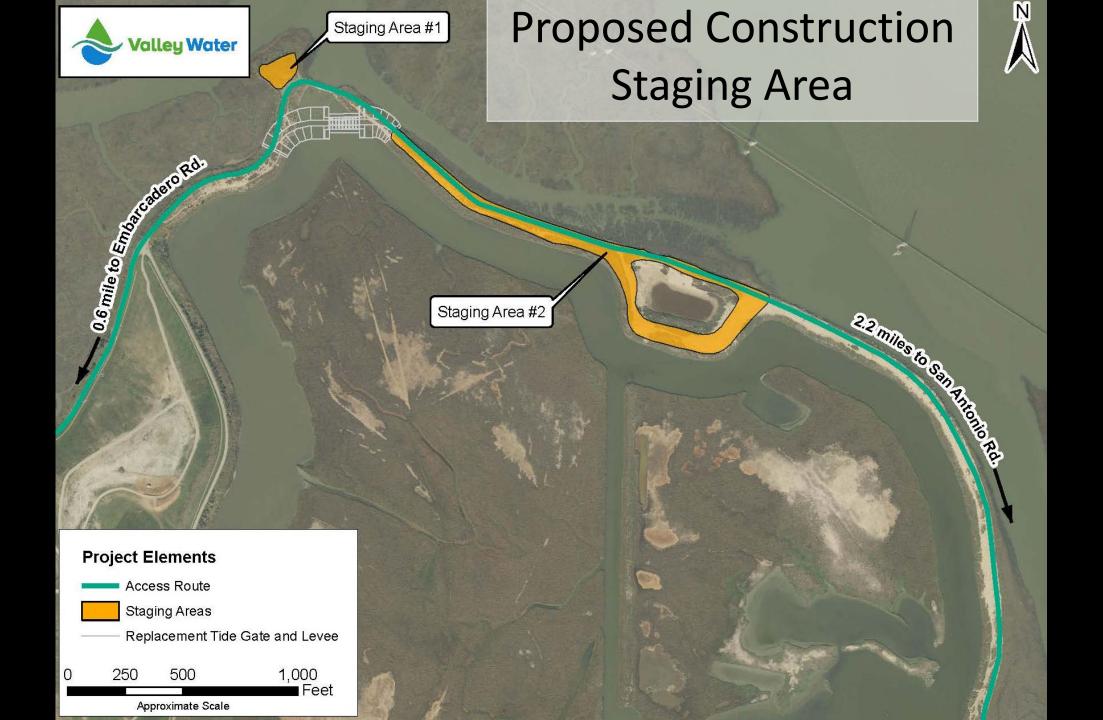
Potential Construction Traffic Routes

Construction Traffic via San Antonio Rd Exit For Years 1 & 2

Construction Traffic via Embarcadero Rd Exit For Years 3 & 4
