Coyote Creek at Rock Springs Flood Protection Project Problem Definition Report

Coyote Creek at Rock Springs Flood Protection Project

PROBLEM DEFINITION and CONCEPTUAL ALTERNATIVES REPORT

October 2016

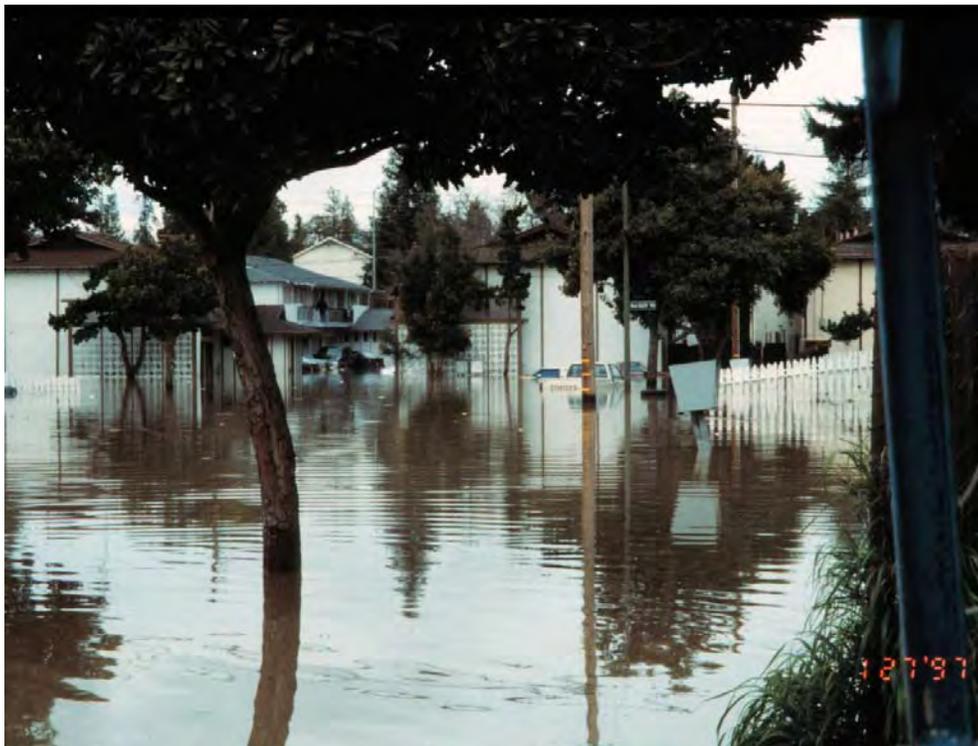
Figure 3.1. Flooding in the Rockspring Neighborhood

According to District records, there has been substantial flooding in the neighborhood one time since the neighborhood was constructed. The flooding occurred during the January 26, 1997 flood event, which had an estimated recurrence interval of 15 years. Figure 3.1 below shows a photo of the flooding that occurred. The District 1997 flood report claims that 20 apartment buildings were damaged with flooding of about 1 ft inside of the buildings. Similarly, the Section 205 Corps' report(2) notes that 25 buildings were flooded up to a depth of about 5 ft. Figure 3.1 suggests that flooding reached a depth greater than 1 ft, given the partially submerged vehicles. The creek flow peaked again in February 1997, when the waters rose to 1' below the top of bank (4).

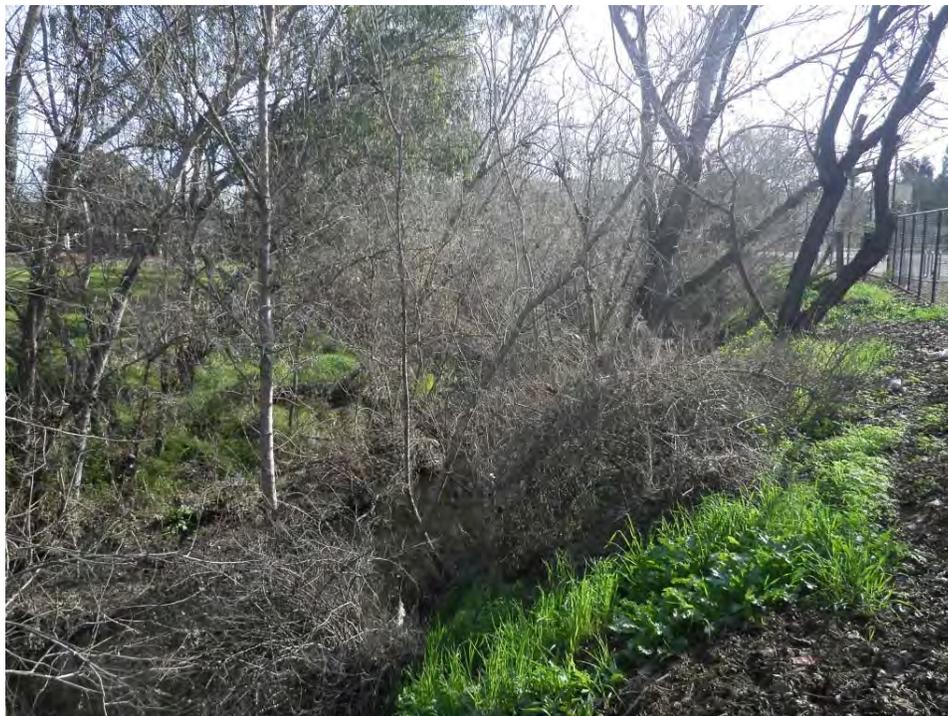
**Figure 3.7 Coyote Creek Looking Upstream from Needles Drive, West Bank.
Photo taken 2/5/2016.**

The channel cross section can be described as a bankfull channel with heavy vegetation (trees and bushes) on the channel banks. Figure 3.7 shows a picture taken on February 5, 2016 of the channel in the Rockspring area, at Needles Dr, looking upstream; the photo shows mainly the west bank, and the low flow channel is not visible. Figure 3.8, also taken on February 5, 2016, shows a photo of the channel cross section a distance of 1.3 miles upstream of the neighborhood, looking upstream from Tully Rd. Figure 3.8 establishes that the channel characteristics are similar to those near the neighborhood, and the low flow channel can be seen. As you move further downstream towards Kelley Park, the channel has a wider floodplain; Figure 3.9 shows the view, looking upstream from Bent Bridge at Happy Hollow Zoo, photo taken February 5, 2016.
