Upper Llagas Creek Flood Protection Project Site Characterization Report

Site Characterization Report

June 2012

Cardno ENTRIX
2300 Clayton Road, Suite 200, Concord, CA 94520
Tel 925 935 9920 Fax 925 935 5368 Toll-free 800 368 7511
www.cardnoentrix.com

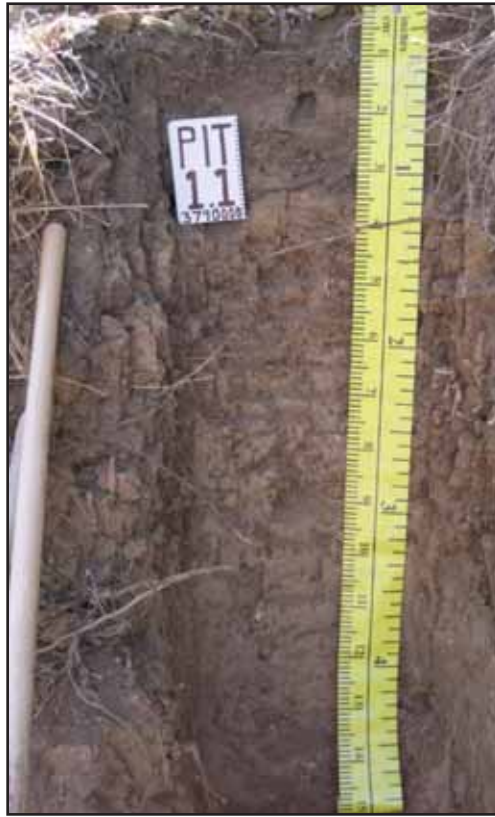
Figure 1: Soil Profile Description Location 1.1 in Reach 4 – A picture depicting the soil profile of a Coarse-loamy, mixed, thermic Typic Haploxeralf. The soil profile was located north of Buena Vista Avenue at the southern boundary of the Project Area. *(The soil profile was positioned to examine the material that forms the terrace embankment down to the bottom of the channel invert. The soil profile was located on the right side of the creek, looking downstream.)*

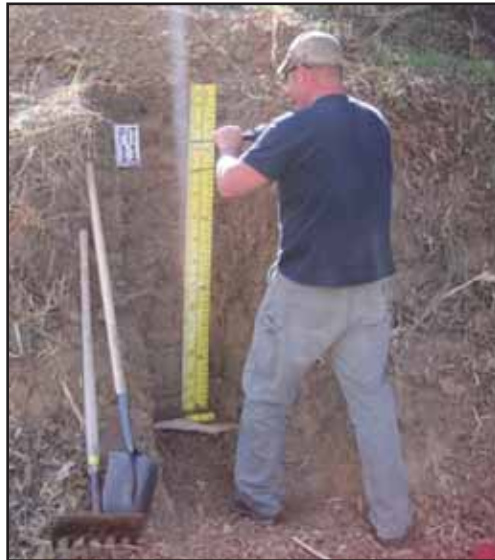
Figure 2: Soil Profile Description Location 1.1 in Reach 4 - A picture depicting the use of a static cone penetrometer (and a hand-held geotester) to quantifiably assess the topsoil's strength and the depth to densic materials.

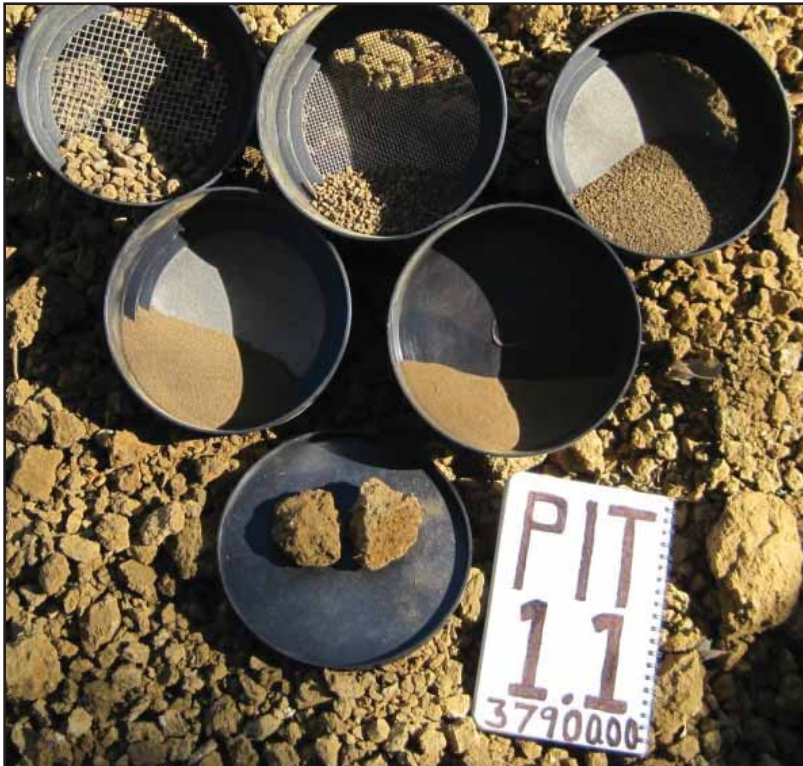
Figure 3: Soil Profile Description Location 1.1 in Reach 4 - A picture depicting the proportional soil textural separates and ped structure and color.

The soil was sampled from the top 20 inches of a profile that forms the right terrace embankment.

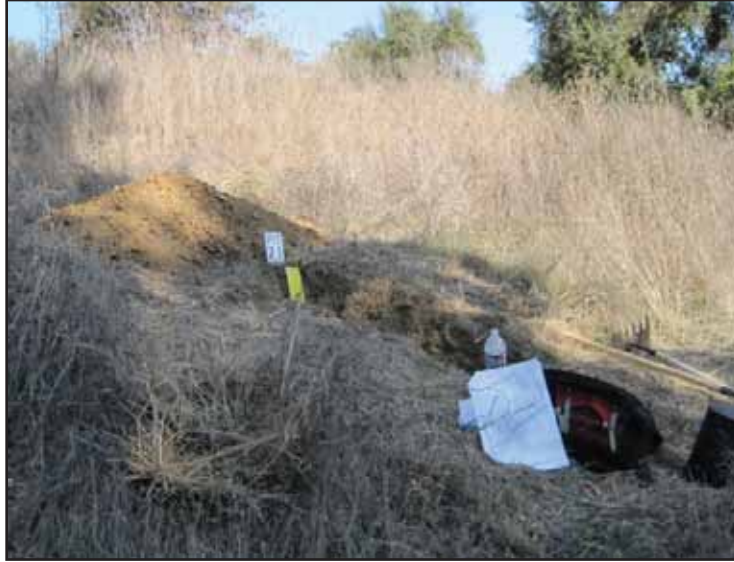
Figure 5: Soil Description Location 2.1 in Reach 4. - A picture depicting the soil profile's location.
(The soil profile was positioned on a mid-terrace flank located on the left side of the creek, looking downstream)

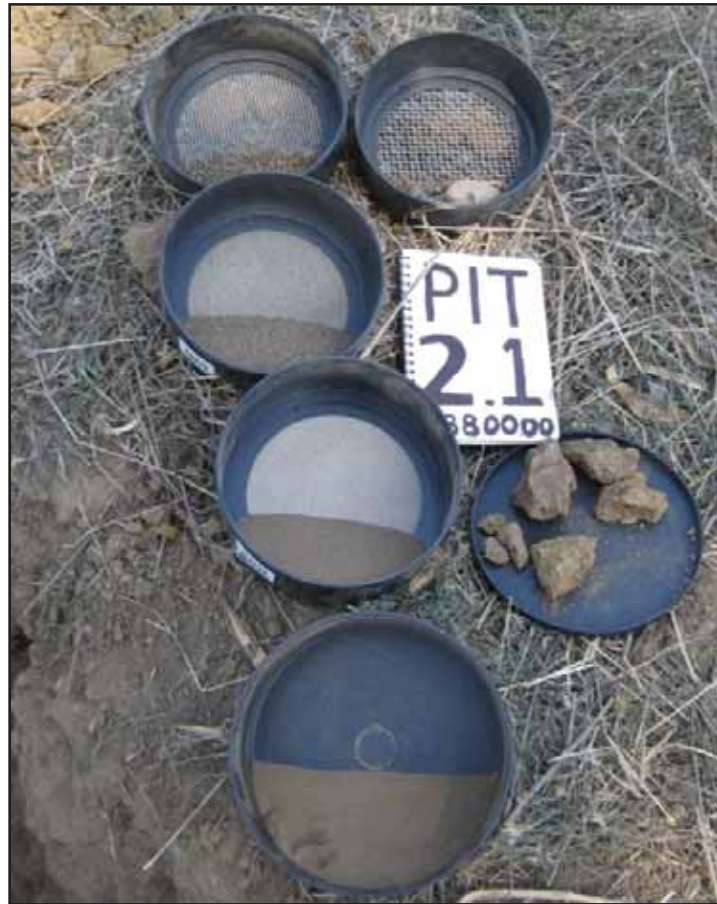
Figure 6: Soil Profile Description and Sampling Location 2.1 in Reach 4 - A picture depicting the proportional soil textural separates and ped structure.
(The soil was sampled from the top 20 inches of a profile located on the left mid-terrace flank of the creek, looking downstream)

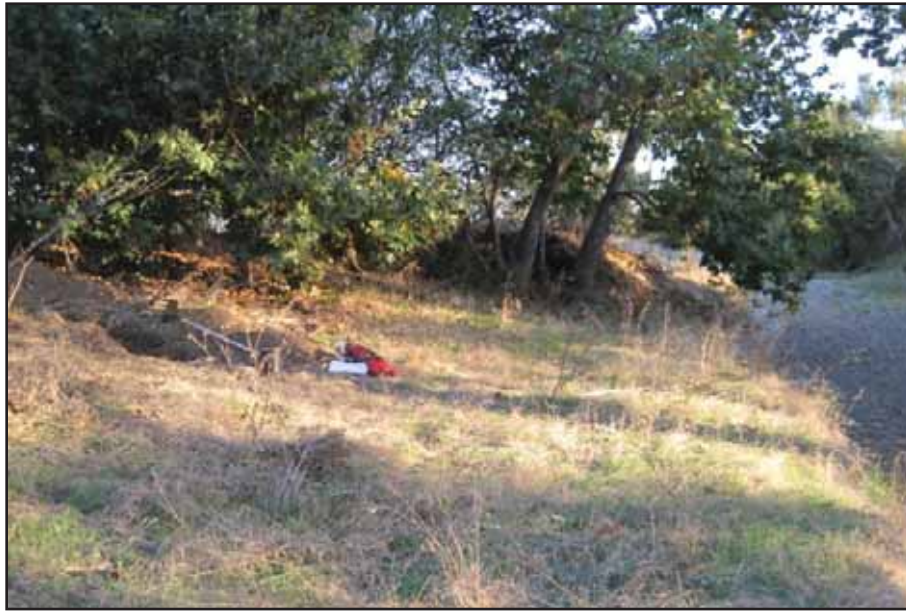
Figure 7: Soil Profile Description Location 3.1 in Reach 4 - A picture depicting the soil profile's location.
(The soil profile was positioned on a mid-terrace flank located on the left side of the creek, looking downstream)

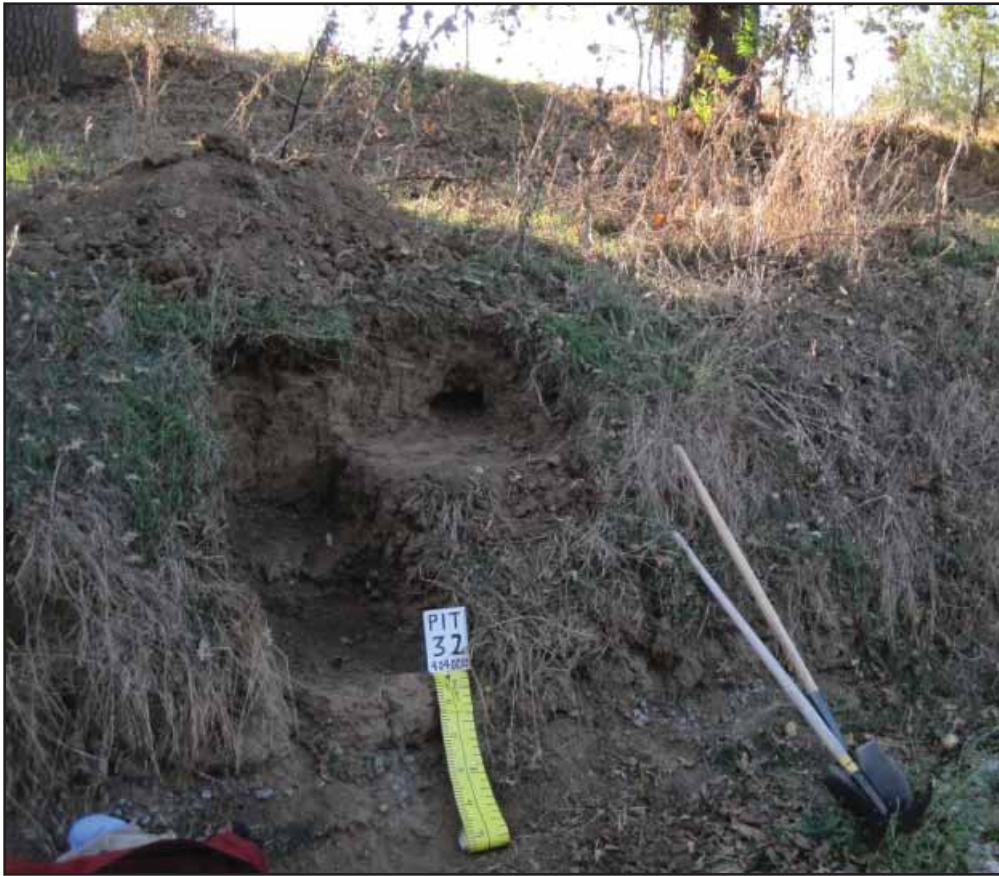
Figure 9: Soil Profile Description Location 3.2 in Reach 4 - A picture depicting the soil profile's location.
(The soil profile was positioned to examine the material that forms the terrace embankment down to the bottom of the channel invert. The soil profile was located on the right side of the creek, looking downstream)

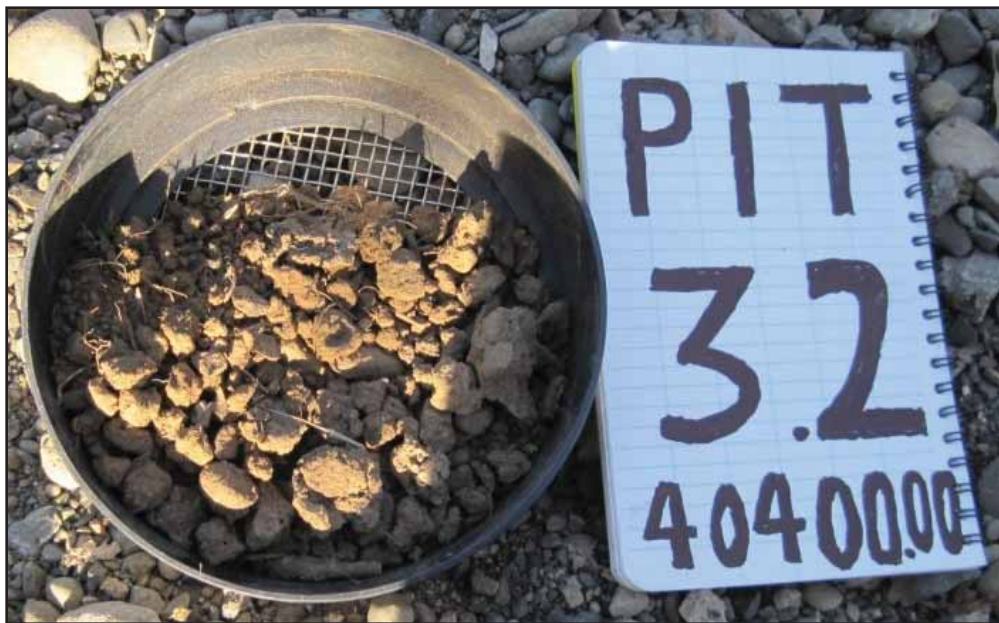
Figure 10: Soil Profile and Sampling Description Location 3.2 - A picture depicting size, shape, and type of ped structure.
(The soil was sampled from the top 20 inches of a profile that forms the right terrace embankment)

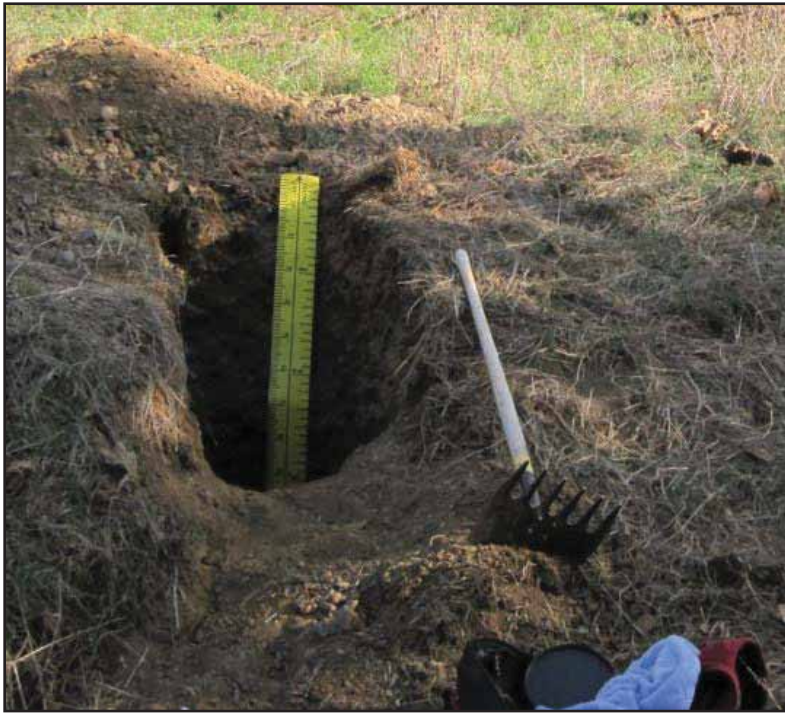
Figure 11: Soil Profile Description Location 4.1 in Reach 4. - A picture depicting the soil profile's location.
(The soil profile was positioned on a mid-terrace flank located on the left side of the creek, looking downstream)

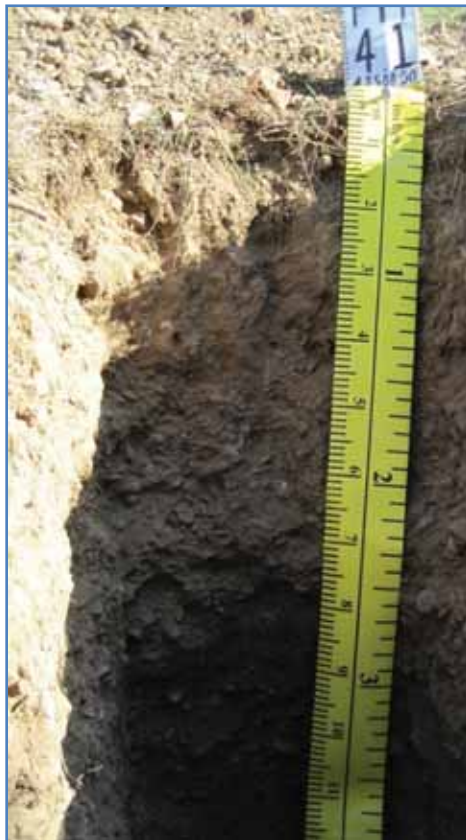
Figure 12: Soil Profile Description Location 4.1 in Reach 4 - A picture depicting the soil profile of a Loamy-skeletal, mixed, thermic Typic Xerorthent.
(The soil profile was positioned on a mid-terrace flank located on the left side of the creek, looking downstream)

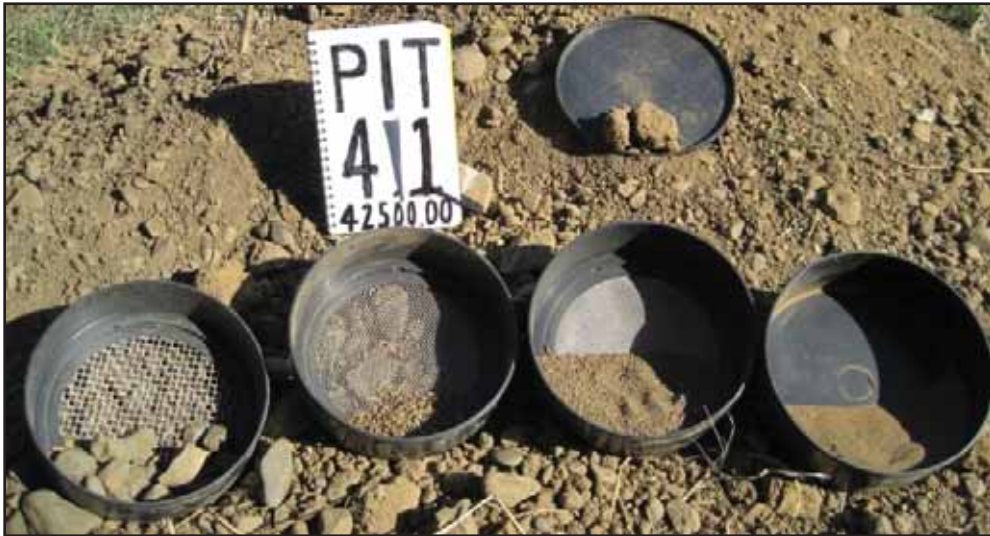
Figure 13: Soil Profile Description and Sampling Location 4.1 in Reach 4 - A picture depicting the proportional soil textural separates and ped structure. The soil was sampled from the top 20 inches of a profile located on the left mid-terrace flank of the creek, looking downstream.

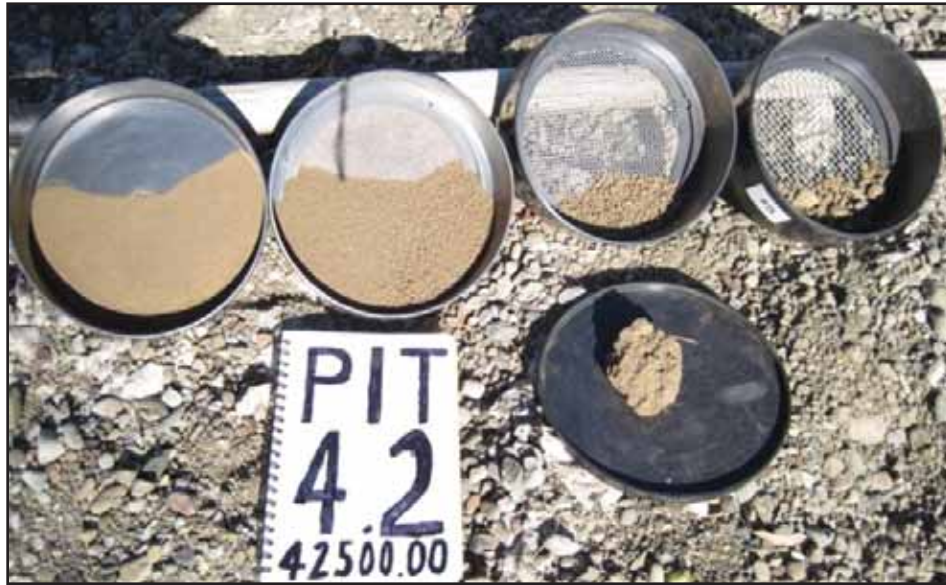
Figure 15: Soil Description and Sampling Location 4.2 in Reach 4 - A picture depicting the proportional soil textural separates and ped structure. The soil was sampled from the top 20 inches of a profile located on the left mid-terrace flank of the creek, looking downstream.

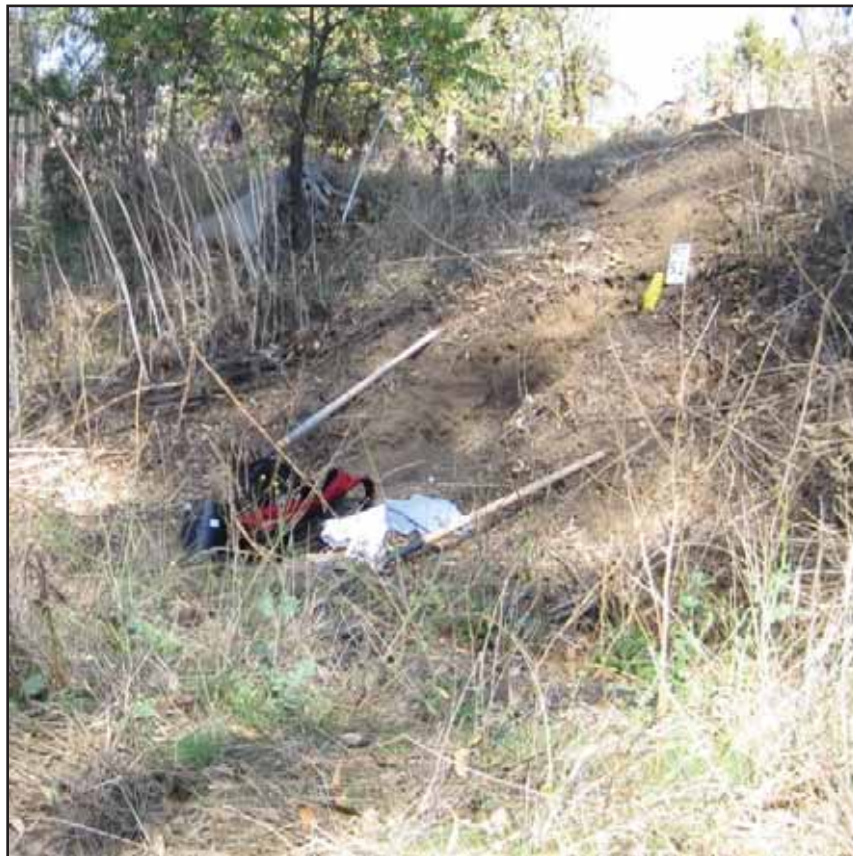
Figure 16: Soil Profile Description Location 5.1 in Reach 4. - A picture depicting the soil profile's location.
(The soil profile was positioned on a mid-terrace flank located on the left side of the creek, looking downstream)

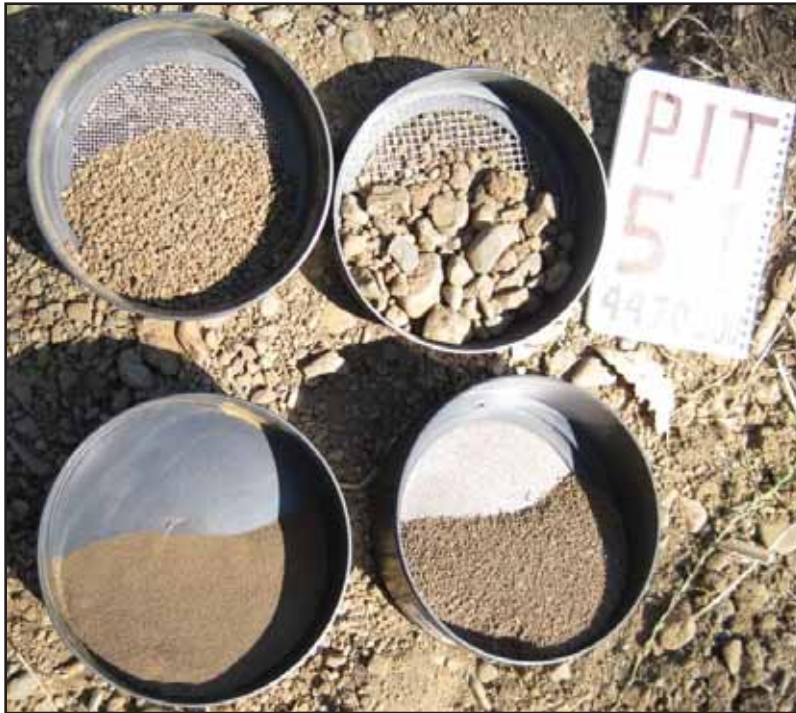
Figure 17: Soil Profile Description and Sampling Location 5.1 in Reach 4 - A picture depicting the proportional soil textural separates.
(The soil was sampled from the top 20 inches of a profile located on the left mid-terrace flank of the creek, looking downstream)

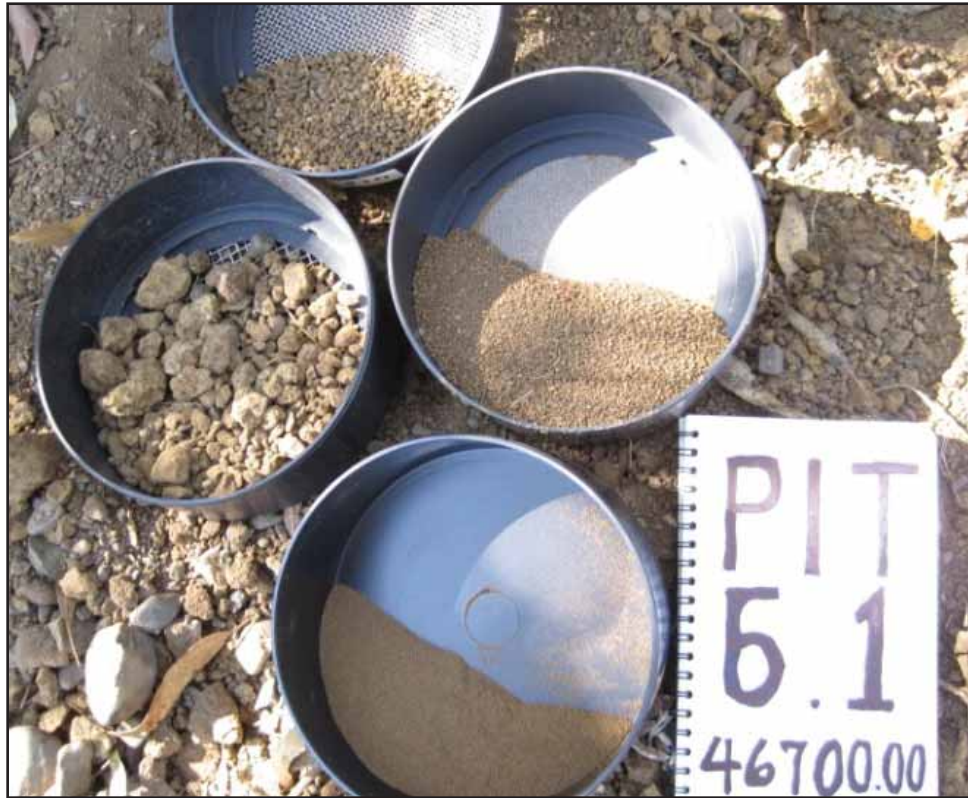
Figure 19: Soil Profile Description and Sampling Location 6.1 in Reach 4 - A picture depicting the proportional soil textural separates.
(The soil was sampled from the top 20 inches of a profile that forms the right terrace embankment, looking downstream)

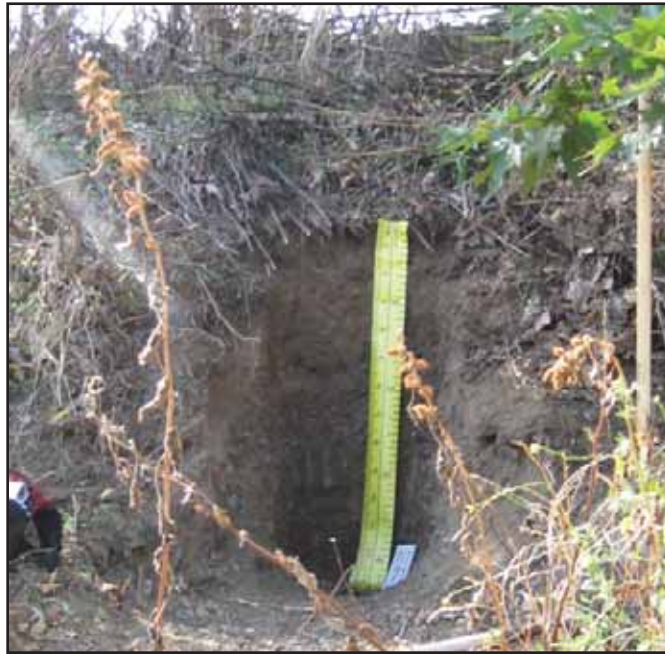
Figure 21: Soil Profile Description Location 7.1 in Reach 4. - A picture depicting the soil profile's location.
The soil profile was positioned to examine the material that forms the terrace embankment down to the bottom of the channel invert. The soil profile was located on the right side of the creek, looking downstream.

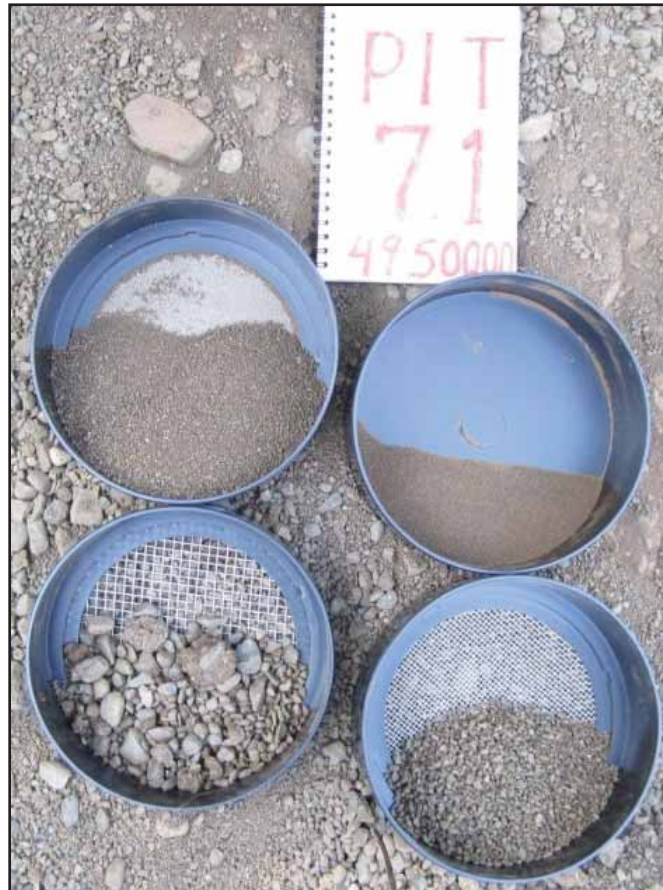
Figure 22: Soil Profile Description Location 7.1 in Reach 4 - A picture depicting the proportional soil textural separates.
The soil was sampled from the top 20 inches of a profile that forms the right terrace embankment.

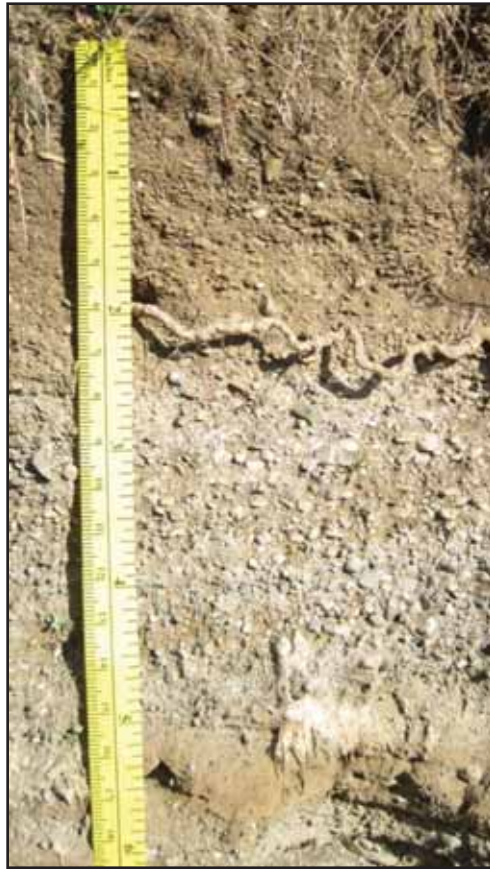
As previously mentioned, a gravelly, moderately cemented substratum and a finely textured lacustrine-deltaic deposit were observed (See Appendix D - Figures 4 and 23). When encountered as shallow contacts, these two subjacent geological units impose a strong influence on soil quality and mitigation suitability.

Both types of substratum were observed in sections of Reaches 4, 6 and 7a. Both types of substratum were observed to directly prevent the downward growth of roots, causing them to bend at 90 degrees at the point of contact (See Appendix D - Figures 4 and 23).

Figure 23: This is a picture depicting a stratigraphic column exposure located on the left side of the creek channel (looking downstream) between soil description and sampling sites 7 and 8 (the north end of Reach 4). Notice the abrupt change in particle size and the hydraulically related energetics (i.e. clast entrainment and sorting) represented at the contact boundary between the pedogenic unit and the weakly cemented subjacent fanglomerate.

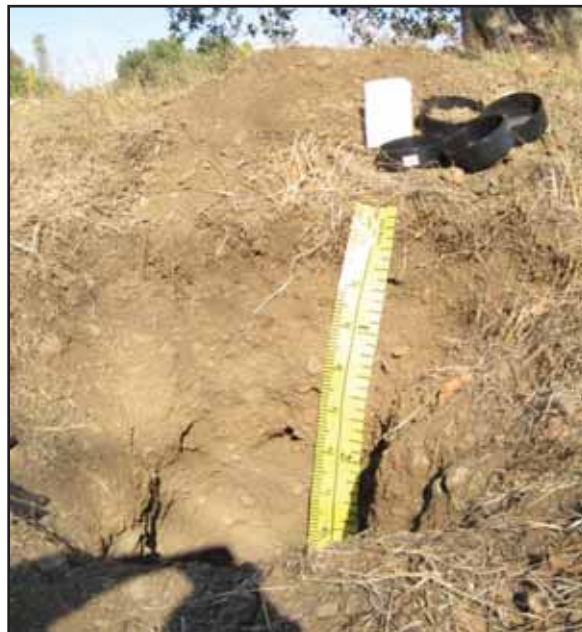
Figure 24: Soil Profile Description Location 8.1 in Reach 4. - A picture depicting the soil profile's location.
The soil profile was positioned on a mid-terrace flank located on the left side of the creek, looking downstream.

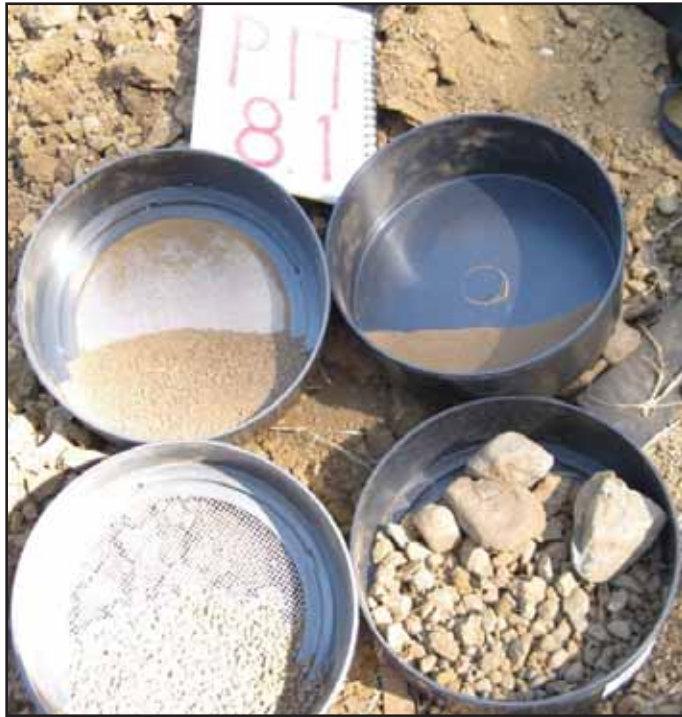
Figure 25: Soil Profile Description Location 8.1 in Reach 4 - A picture depicting the proportional soil textural separates.
The soil was sampled from the top 20 inches of a profile located on the left mid-terrace flank of the creek, looking downstream.

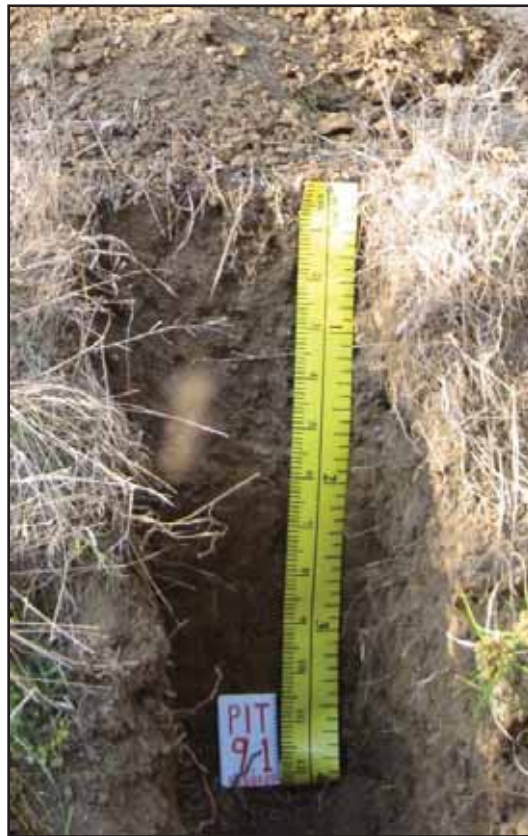
Figure 26: Soil Profile Description Location 9.1 in Reach 4. - A picture depicting the soil profile of a Loamy-skeletal, mixed, thermic Typic Xerorthent.
The soil profile was positioned on a mid-terrace flank located on the left side of the creek, looking downstream.

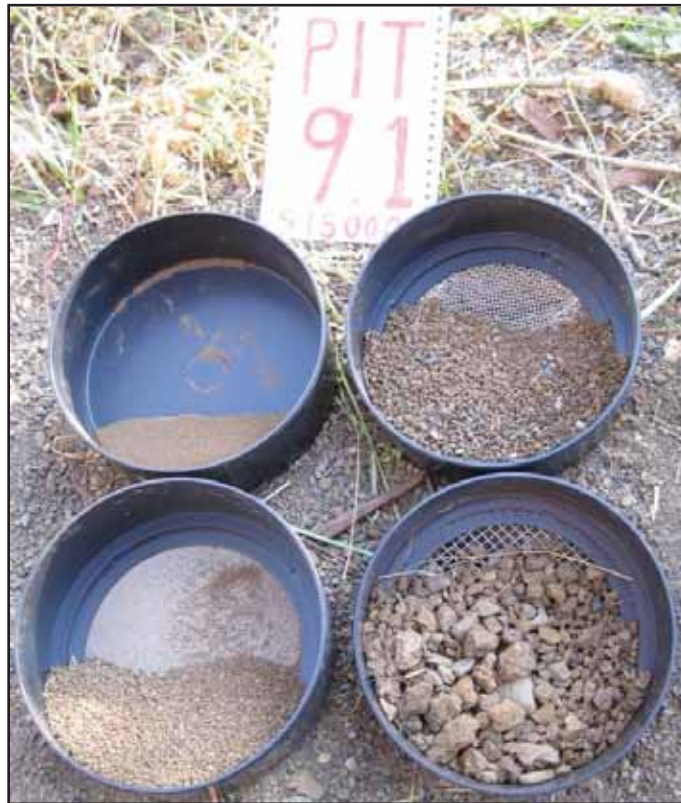
Figure 28: Soil Profile and Sampling Description Location 9.1 in Reach 4 - A picture depicting the proportional soil textural separates associated with the AC horizon. The soil was sampled from the top 20 inches of a profile located on the left mid-terrace flank of the creek, looking downstream.

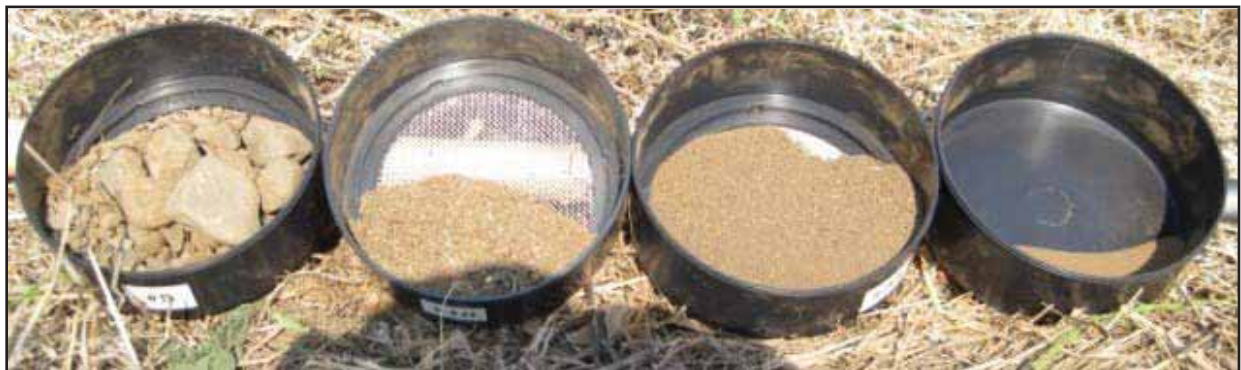
Figure 30: Soil Profile Description and Sampling Location 10.1 in Reach 5 - A picture depicting the proportional soil textural separates.
(The soil was sampled from the top 20 inches of a profile located on the left mid-terrace flank of the creek, looking downstream)

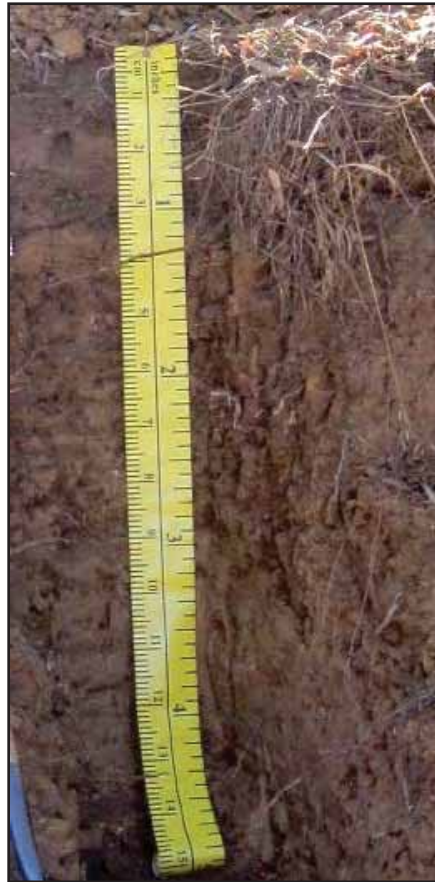
Figure 31: Soil Profile Description Location 11.1 in Reach 5 - A picture depicting the soil profile of a Loamy-skeletal, mixed, thermic Typic Xerorthent. The soil profile was positioned to examine the material that forms the terrace embankment down to the bottom of the channel invert. The soil profile was located on the left side of the creek, looking downstream.

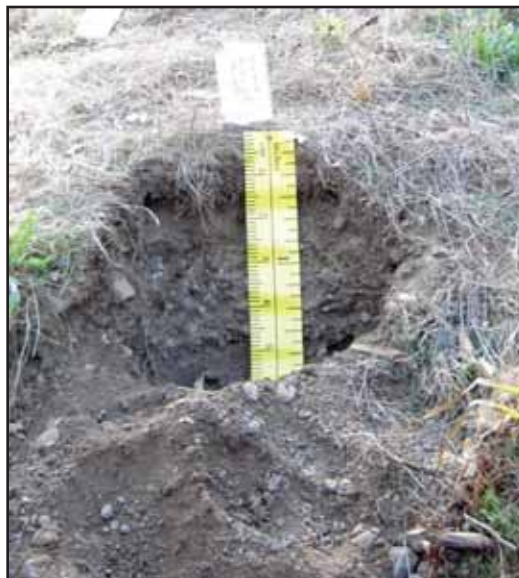
Figure 32: Soil Profile Description Location 12.1 in Reach 6b - A picture depicting the soil profile's location. *(The soil profile was positioned on the right side of the creek on the western embankment of the flood control basin)*

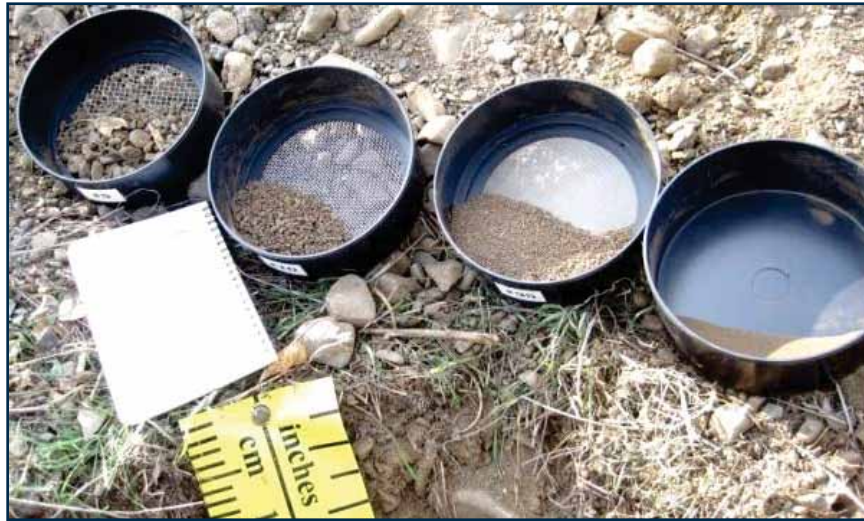
Figure 33: Soil Profile Description and Sampling Location 12.1 in Reach 6b - A picture depicting the proportional soil textural separates. The soil was sampled from the top 20 inches of a profile located on the left mid-terrace flank of the creek, looking downstream.

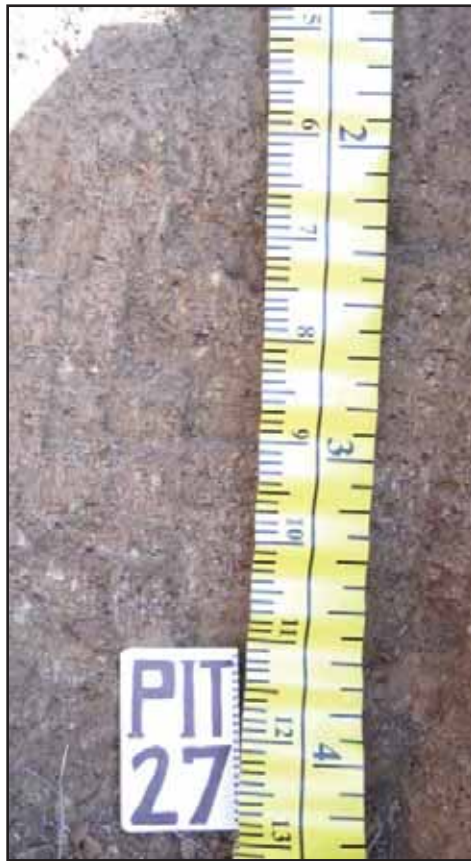
Figure 77: Soil Profile Description Location 27.1 in Reach 7b - A picture depicting the massive embankment fill that keyed out as a man-modified Loamy-skeletal, mixed, thermic Typic Xerorthent.

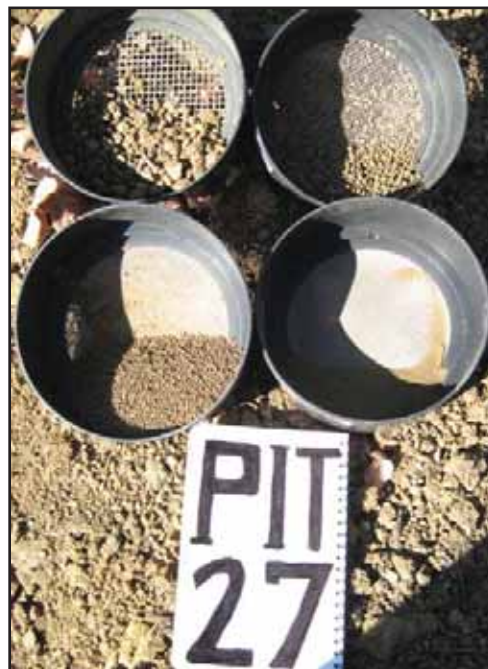
Figure 78: Soil Profile Description and Sampling Location 27.1 in Reach 7b - A picture depicting the proportional soil textural separates. The soil was sampled from the top 20 inches of the profile.

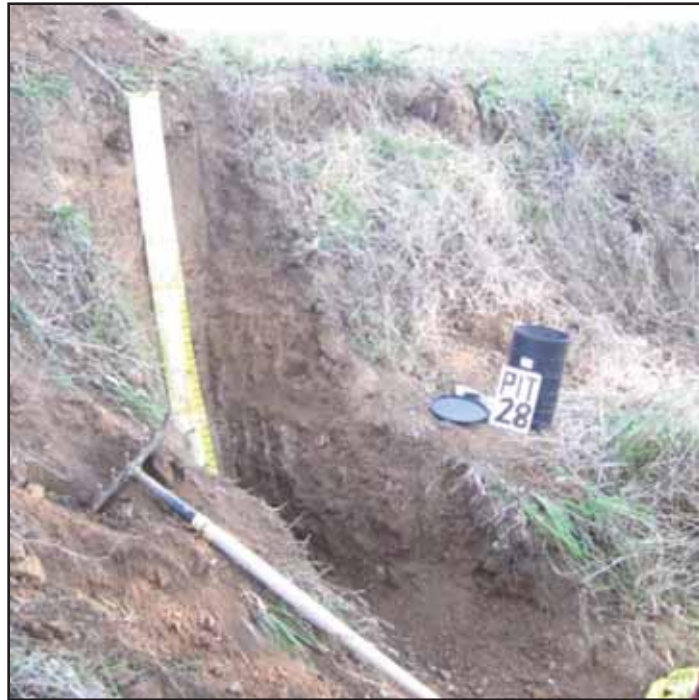
Figure 79: Soil Profile Description Location 28.1 in Reach 7b - A picture depicting the location of the soil profile.
The soil profile examined the soil material from the top of the embankment down to the bottom of engineered channel invert on the right side of the West Little Llagas Creek channel (looking southwest). The soil Profile was located in middle of the channel section south of Cosmos Drive and north of Edmundsen Road.

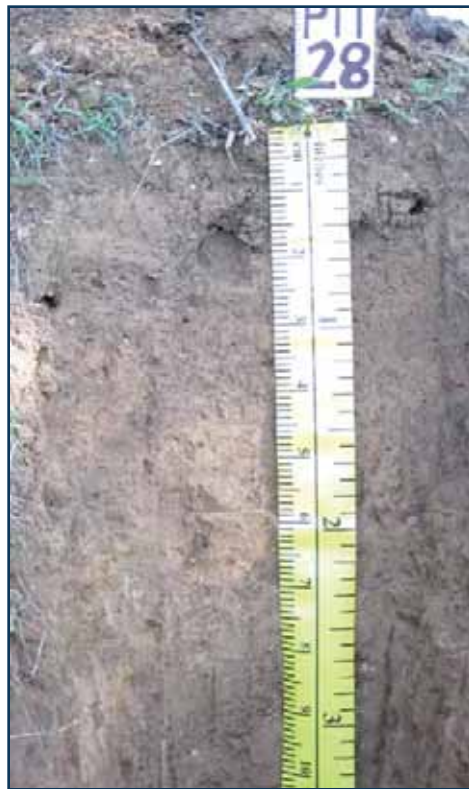
Figure 80: Soil Profile Description Location 28.1 in Reach 7b - A picture depicting an embankment fill with an incipient A horizon that keys out as a man-modified Loamy-skeletal, mixed, thermic Typic Xerorthent.

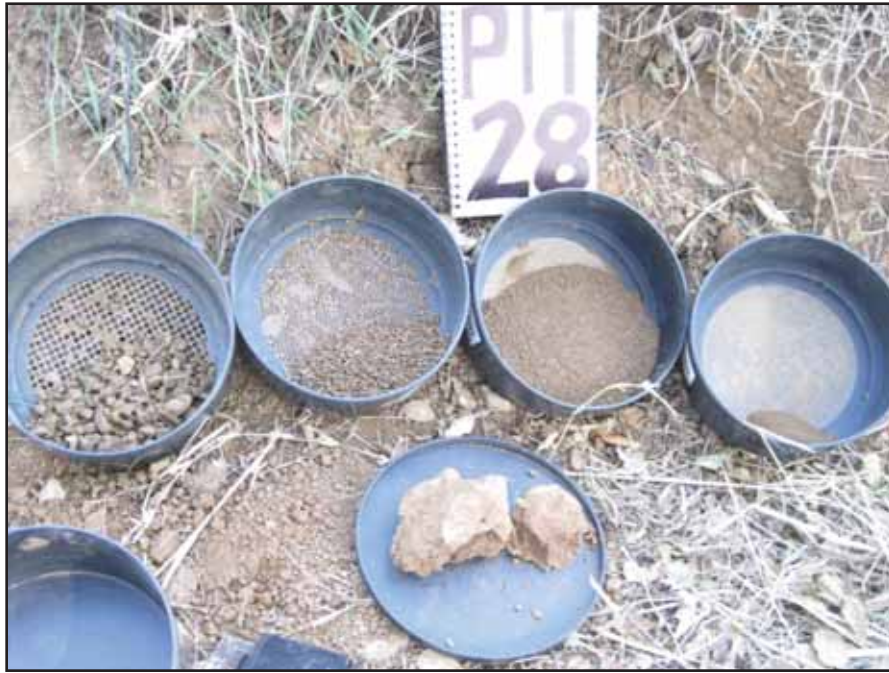
Figure 81: Soil Profile Description and Sampling Location 28.1 in Reach 7b - A picture depicting the proportional soil textural separates and “clod-like” ped structure. The soil was sampled from the top 20 inches of the profile.

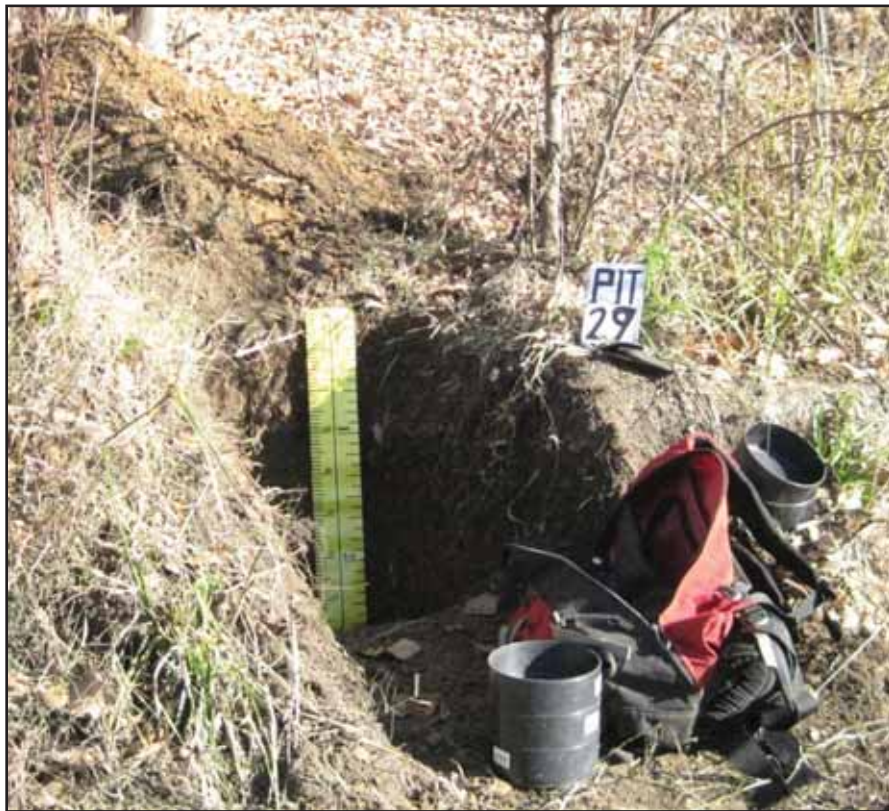
Figure 82: Soil Profile Description Location 29.1 in Reach 7b- A picture depicting the location of the soil profile.
The soil profile examined the soil material from the top of the embankment down to the bottom of engineered channel invert on the left side of the West Little Llagas Creek channel (looking southwest). The soil profile location was located just south of Cosmos Drive.

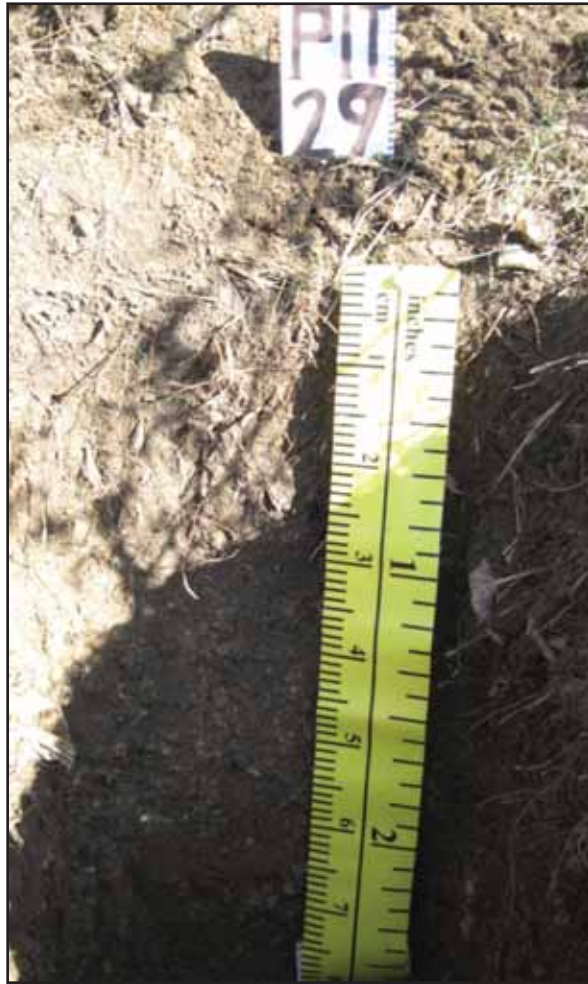
Figure 83: Soil Profile Description Location 29.1 in Reach 7b - A picture depicting the upper part of the soil profile that keys out as a man-modified Coarse-skeletal, mixed, thermic Typic Xerorthent.

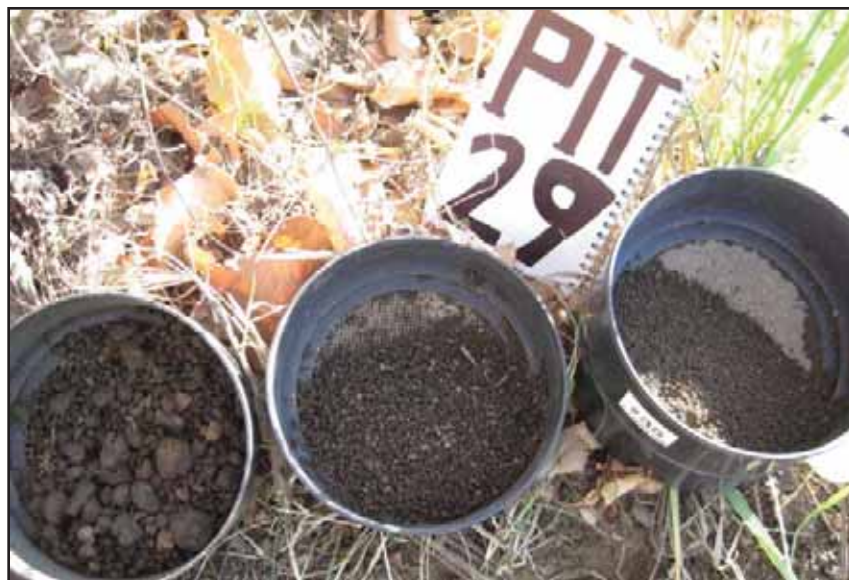
Figure 84: Soil Profile Description and Sampling Location 29.1 in Reach 7b - A picture depicting the differing ped sizes, structure and color. The soil was sampled from the top 20 inches of the profile.

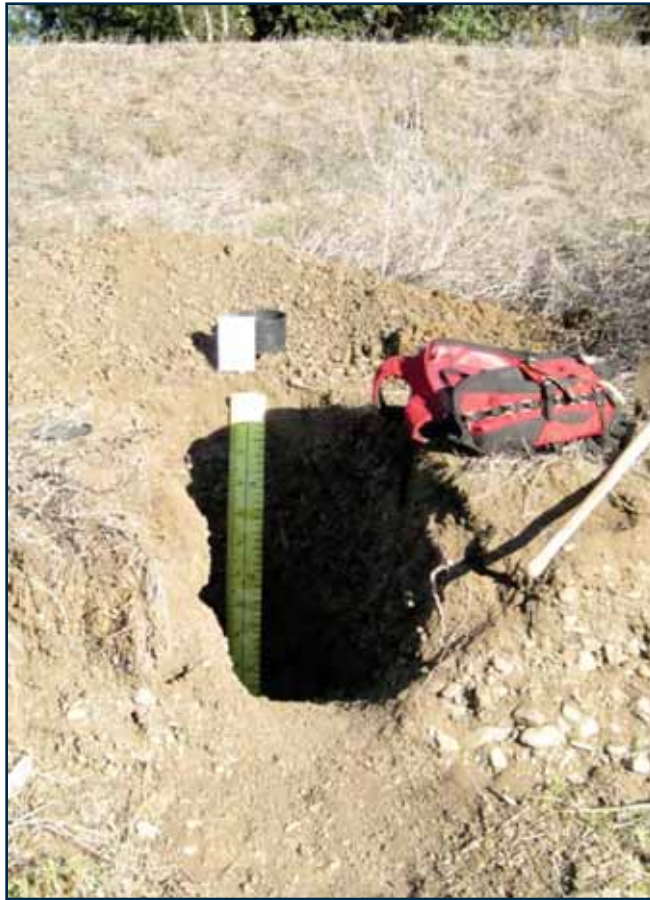
Figure 85: Soil Profile Description Location 30.1 in Reach 14 - A picture depicting the location of the soil profile.
The soil profile examined the soil material from the top of the embankment down to the bottom of engineered channel invert on the left side of East Little Llagas Creek channel (looking southwest). The soil profile location was located just north of San Martin Avenue.

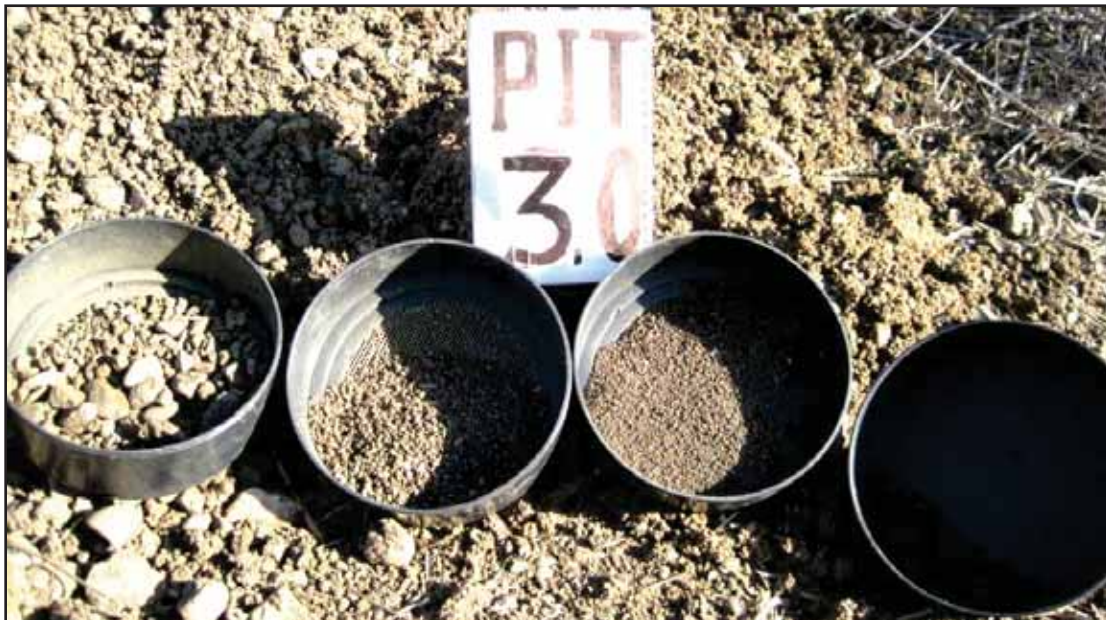
Figure 86: Soil Description Location 30.1 in Reach 14 - A picture depicting the proportional soil textural separates. The soil was sampled from the top 20 inches of the profile.

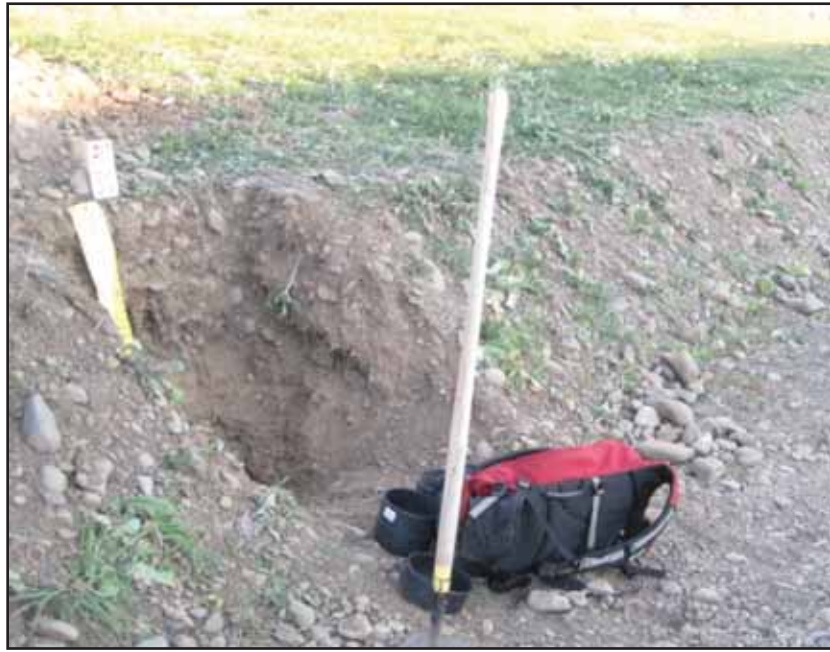
Figure 87: Soil Profile Description Location 31.1 in reach 14 - A picture depicting the location of the soil profile.
The soil profile examined the soil material from the top of the embankment down to the bottom of engineered channel invert on the left side of East Little Llagas Creek channel (looking southwest). The soil profile location was located south of Church Avenue.

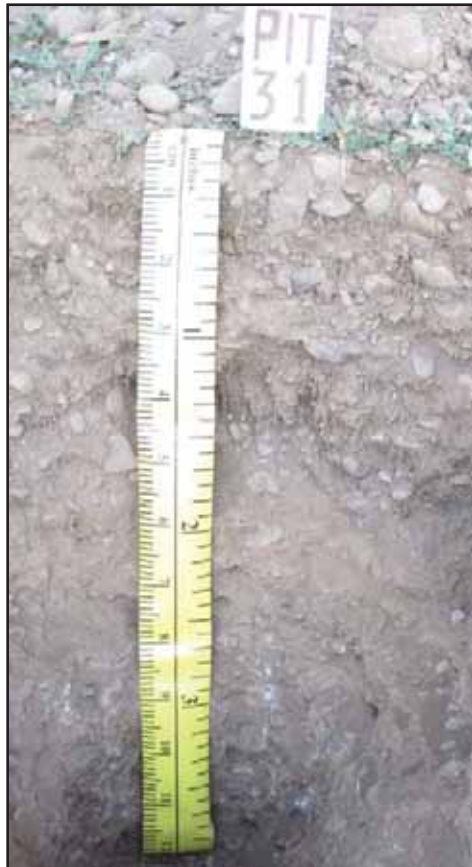
Figure 88: Soil Profile Description Location 31.1 in Reach 14 - A picture depicting the soil profile that keyed out as a Loamy-skeletal, mixed, Typic Xerofluvent.
