Upper Llagas Creek Flood Protection Project Site Characterization Report

Site Characterization Report

June 2012

Cardno ENTRIX
2300 Clayton Road, Suite 200, Concord, CA 94520
Tel 925 935 9920 Fax 925 935 5368 Toll-free 800 368 7511
www.cardnoentrix.com

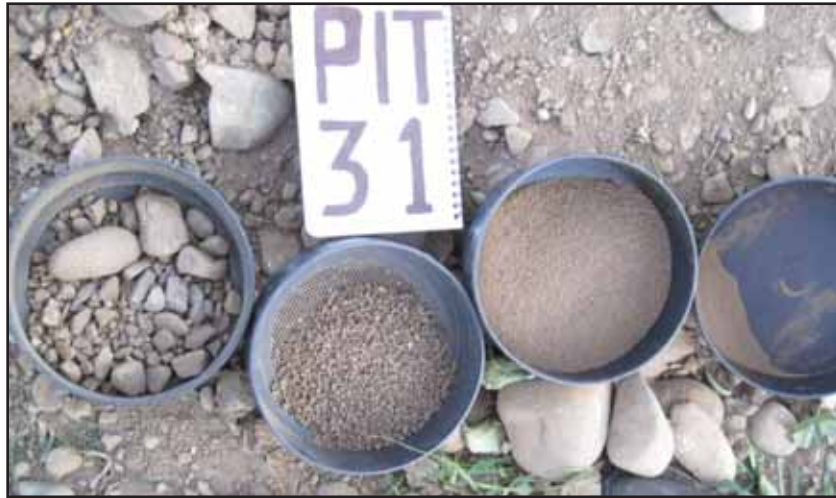
Figure 89: Soil Description Location 31.1 in Reach 14 - A picture depicting the proportional soil textural separates. The soil was sampled from the top 20 inches of the profile.
