# STEVENS CREEK FISH PASSAGE ANALYSIS

*Prepared for*

Valley Water  
5750 Almaden Expressway  
San Jose, CA 95118

June 2020

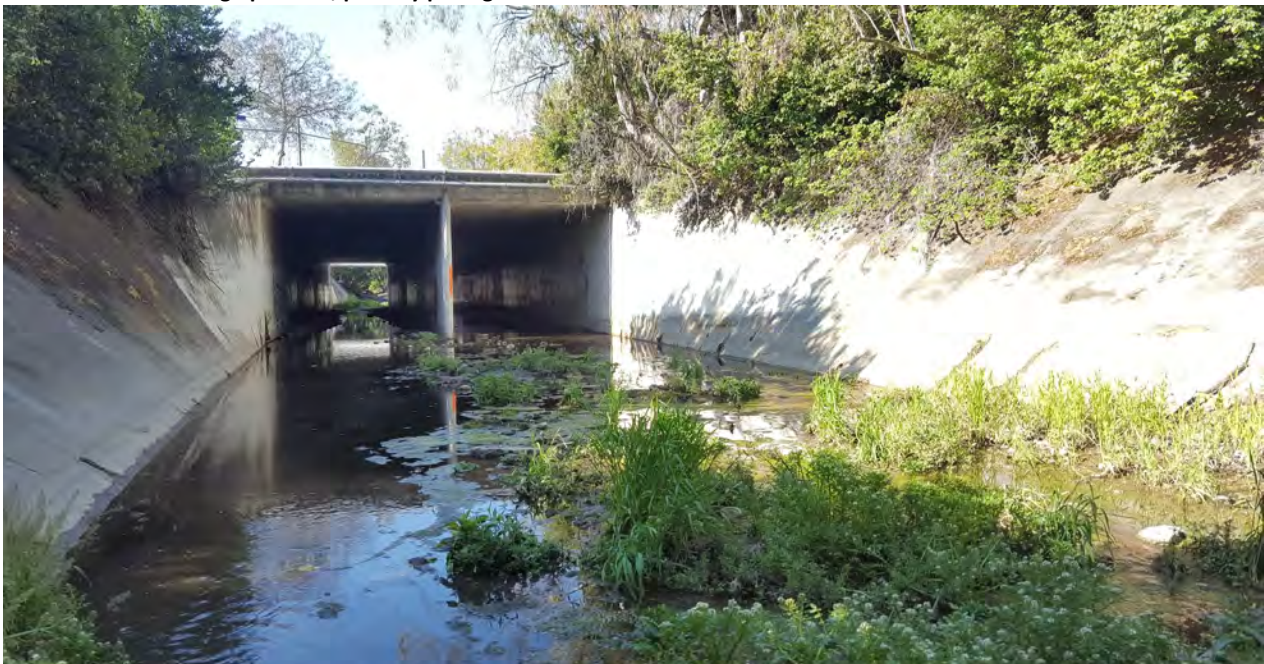
- Site 4 (Moffett Boulevard crossing) received a score of 23 and is in the yellow score category. The crossing is passable by juveniles and adults at most flows, with insufficient depth at lower flows being the only substantial passage issue. Deposition observed throughout the primary culvert (Attachment E) likely further improves passage conditions. Considering the relatively favorable passage conditions observed at the time of the field survey and evaluated in the Study, the site may not warrant remediation for fish passage; note that its score and placement into the yellow score category were heavily influenced by its position low in the watershed.

**Culvert outlets looking upstream, primary passage culvert on left**

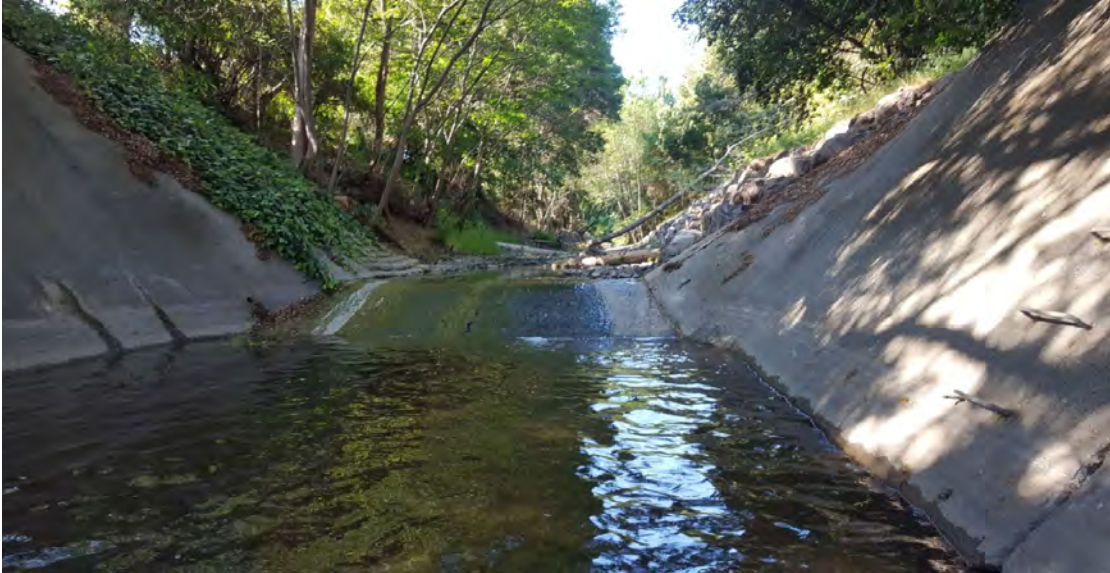
**Site:** 5  
**River Mile:** 3.21  
**Reach:** Reach 3  
**Site Name:** Drop structure upstream of Moffett Boulevard  
**Latitude:** 37.402569    **Longitude:** -122.069111    **PAD ID:** 713642

**Looking upstream to drop structure**

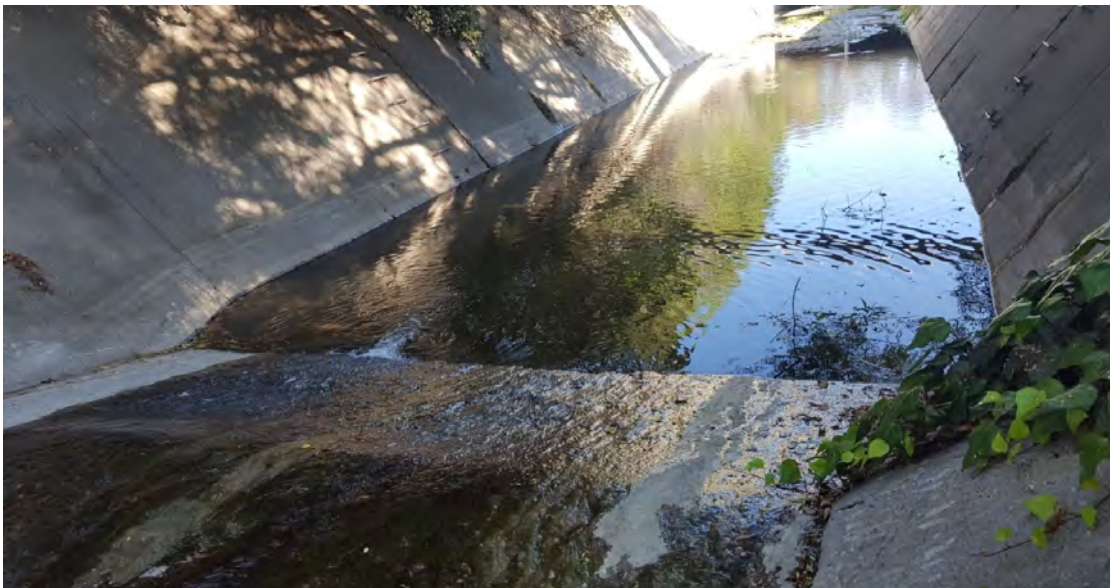
**Looking downstream from top of drop structure**

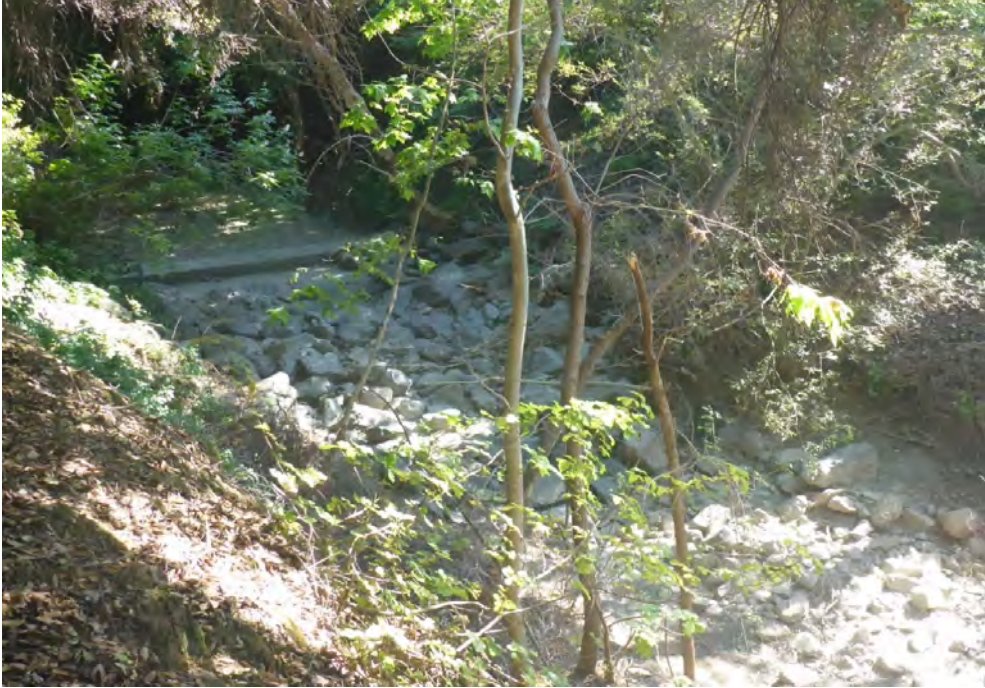
**Concrete grade control with boulder chute below, looking upstream**

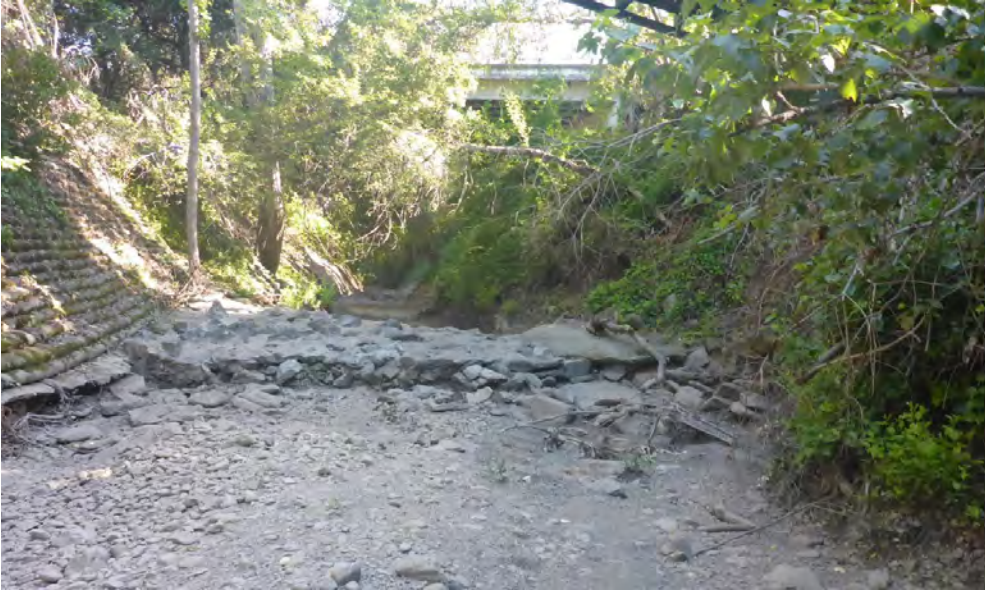
Site: 14.1  
River Mile: 4.21  
Reach: 4  
Site Name: Drop structure at pedestrian bridge  
Latitude: 37.388637 Longitude: -122.069288 PAD ID:

Grouted boulder drop structure looking upstream

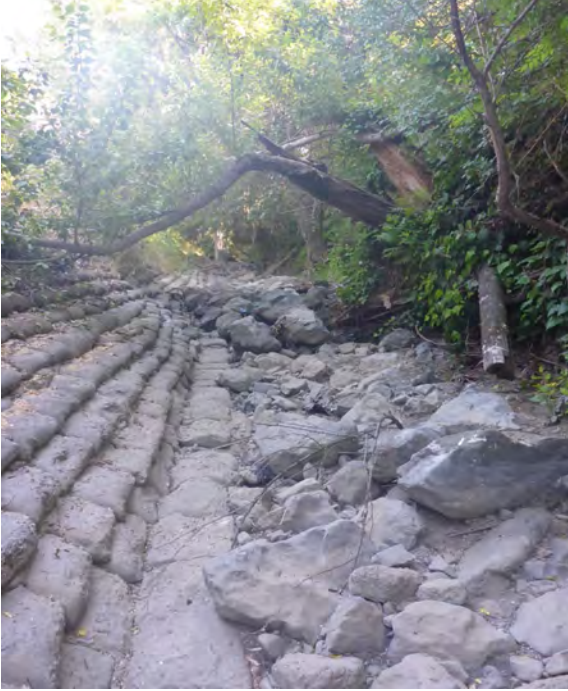
Looking upstream at boulder jam

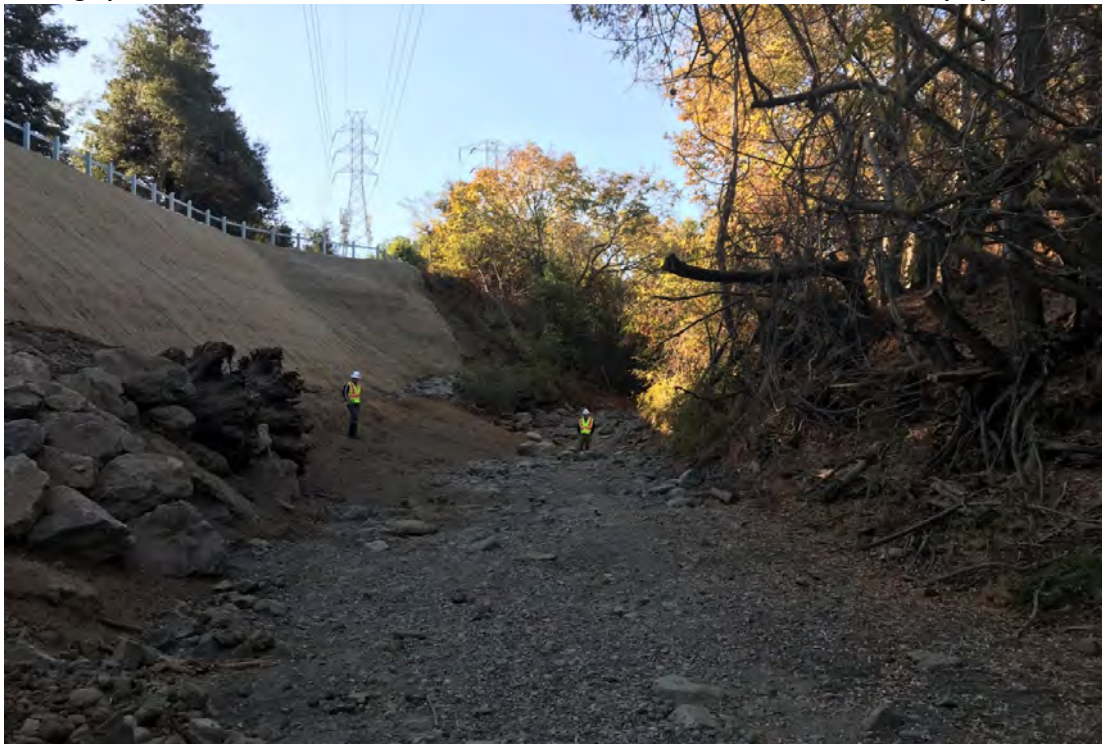
Looking upstream at downstream end of boulder channel and 2018 bank stabilization project

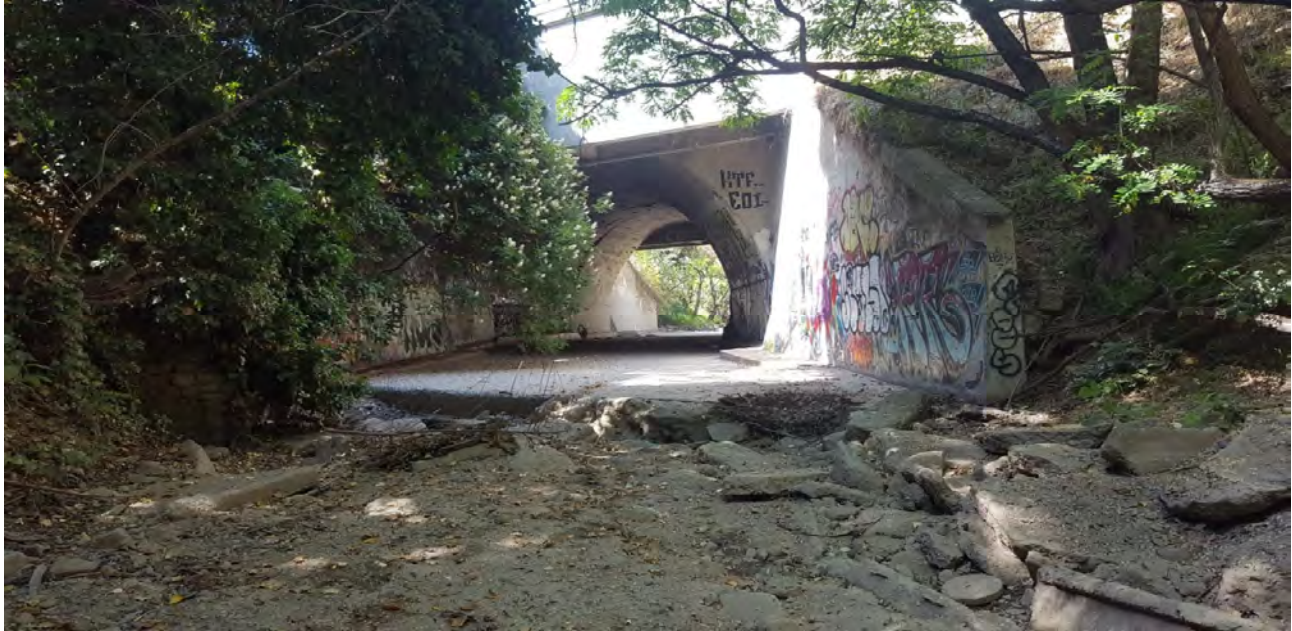
Looking downstream at culvert inlet

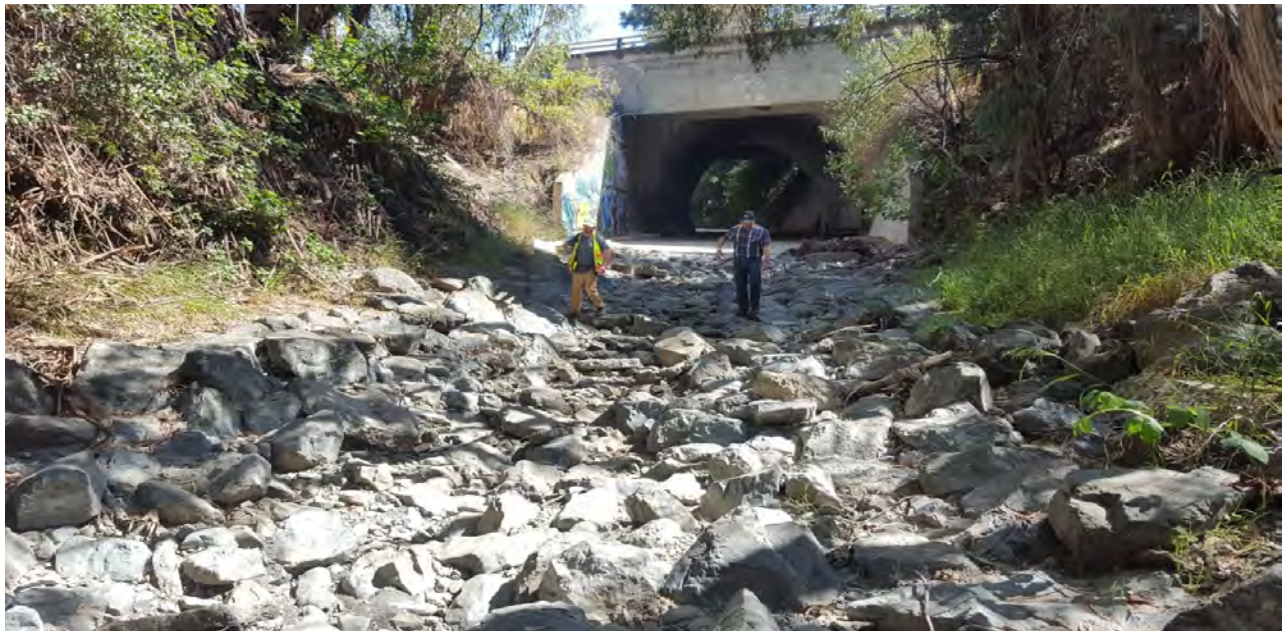
Looking upstream at culvert outlet with boulder channel (site 16) downstream of apron

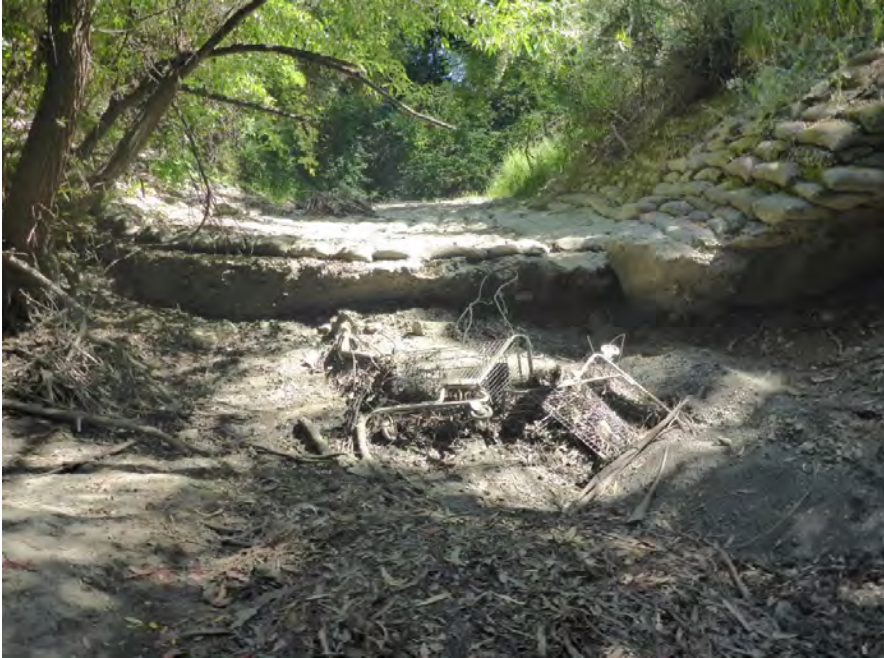
Looking upstream at drop structure/drainage outfall protection

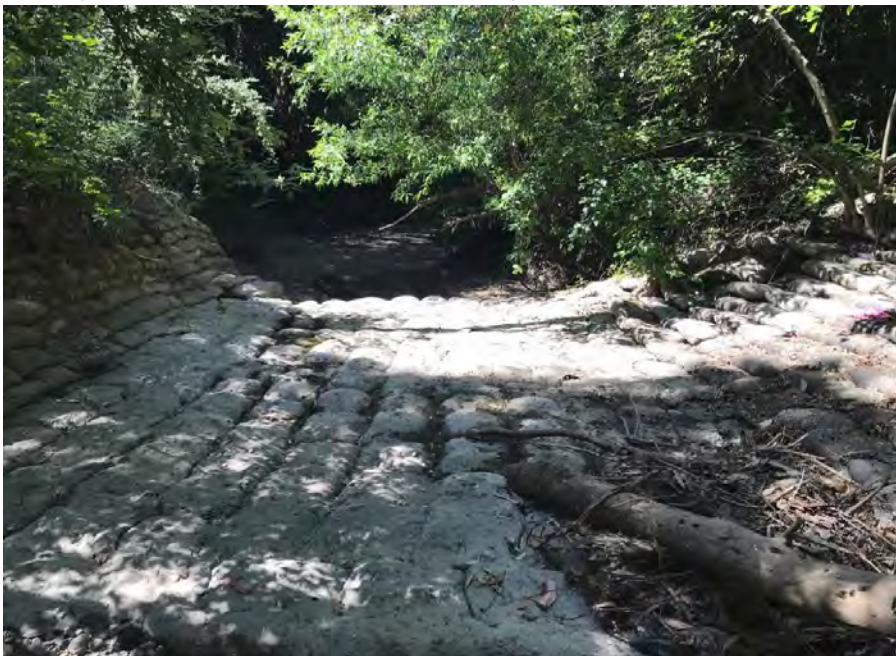
Looking downstream at drop structure/drainage outfall protection

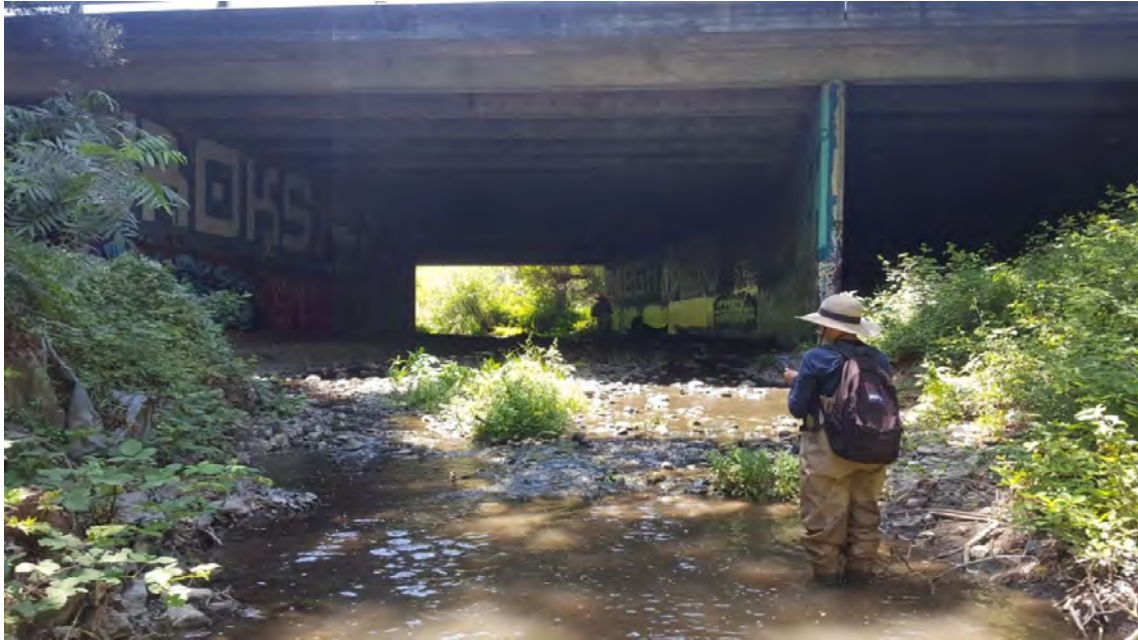
The channel is over-widened under the bridge, resulting in a depth barrier for adults and juveniles up to moderate flows. The analysis found velocity barriers for juveniles within the riffle near the outlet due to lack of roughness.

**Bridge outlet looking upstream**

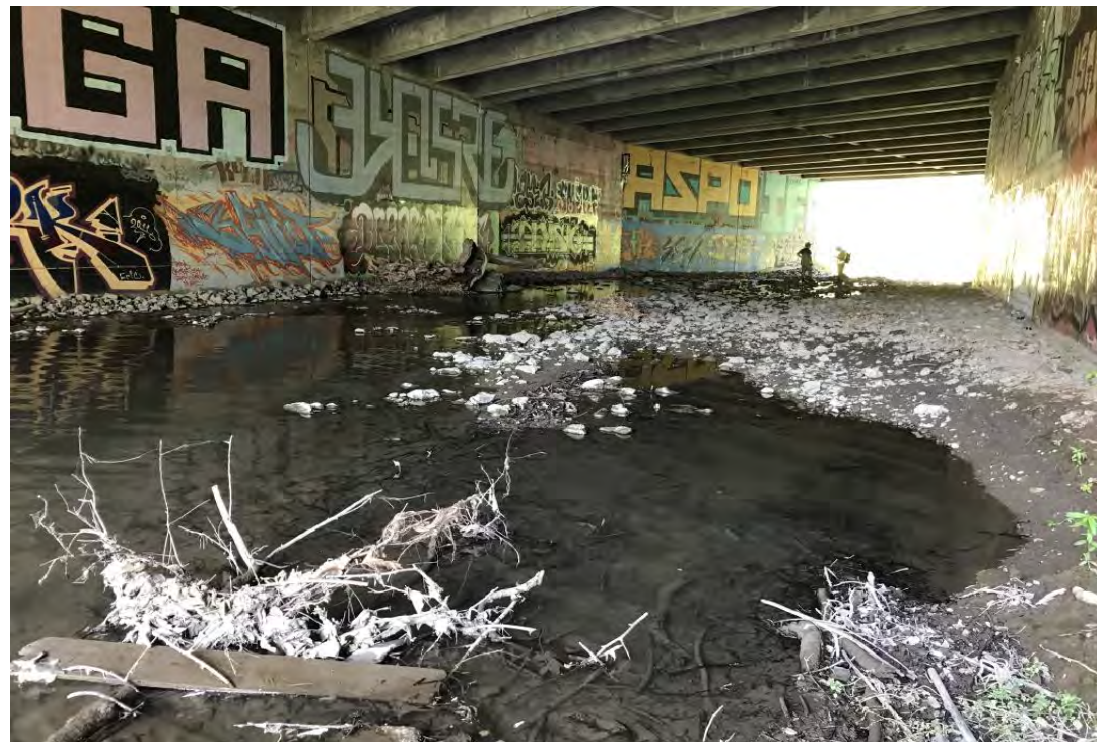
**Inside bridge, looking downstream.**

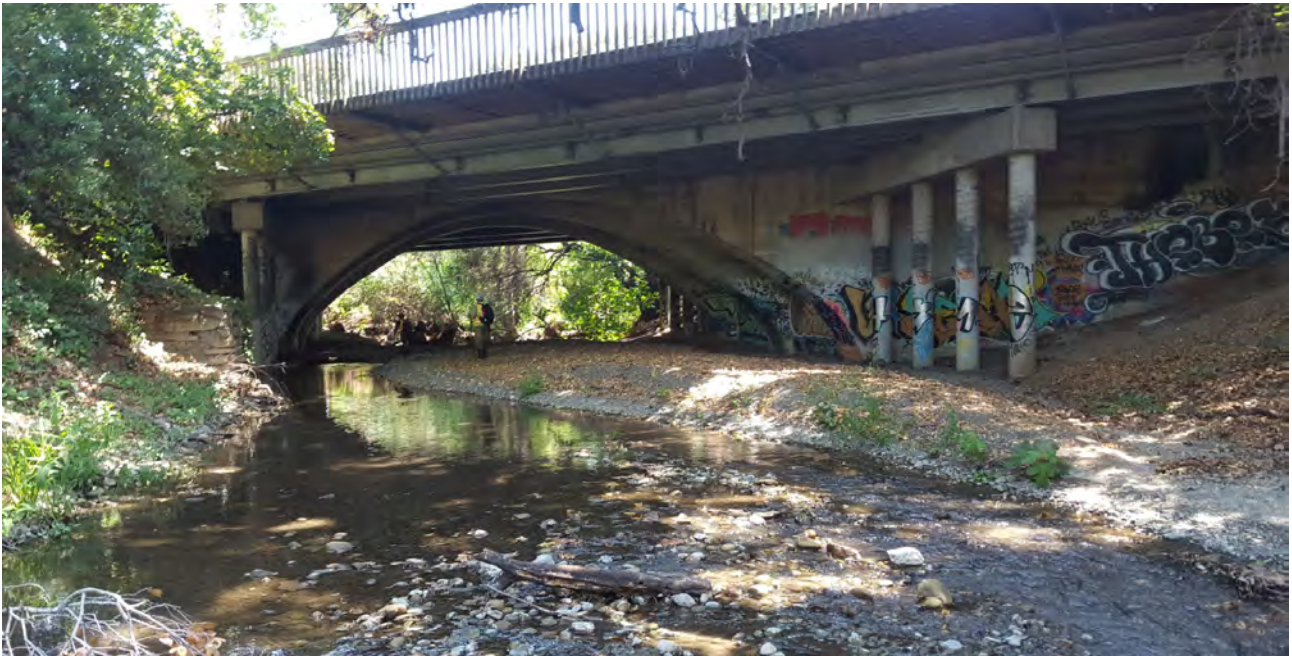
Culvert outlet facing upstream

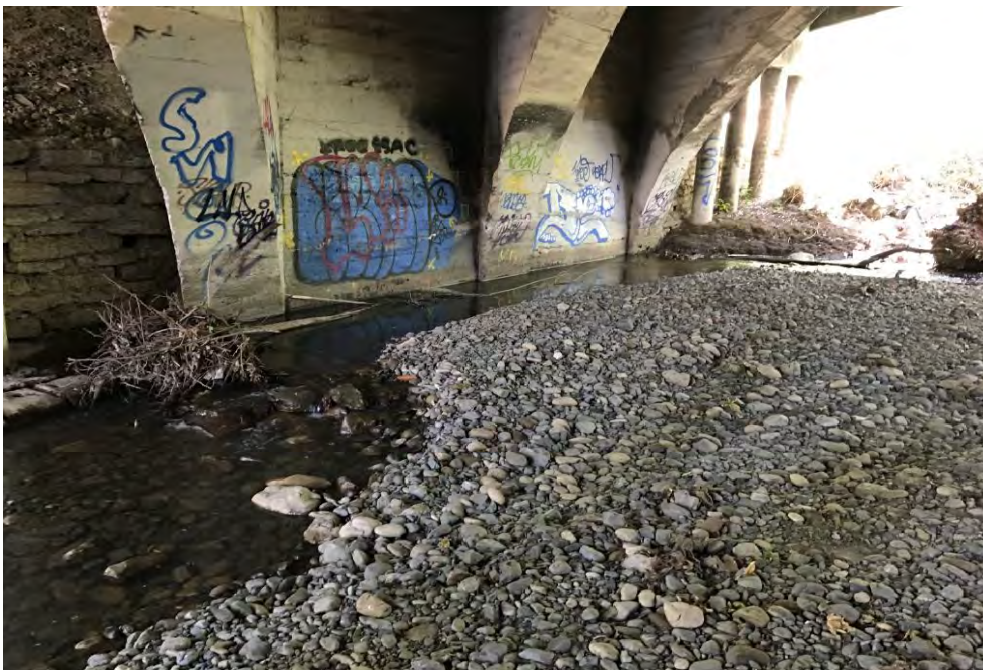
Inside culvert, facing upstream

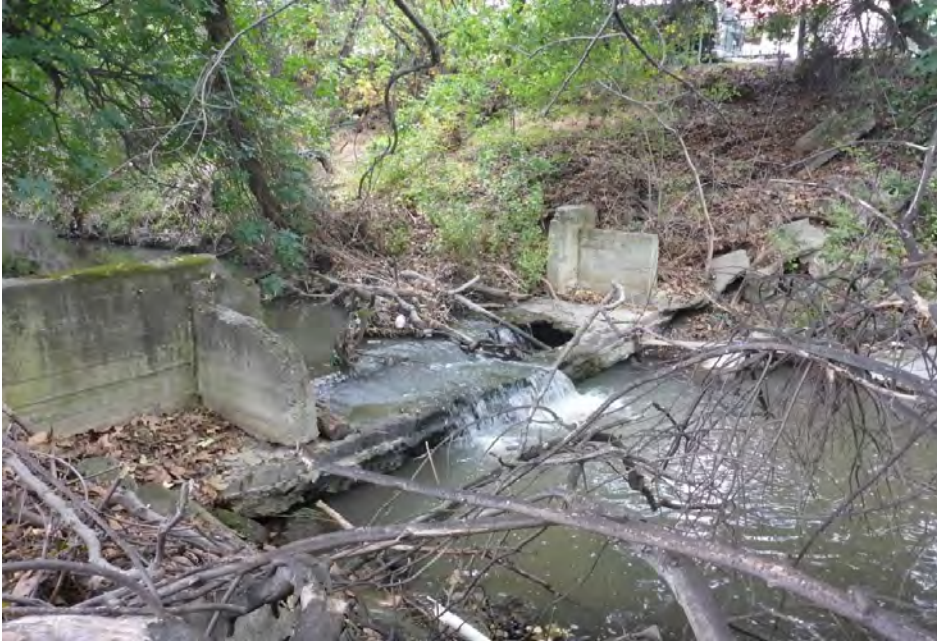
Abandoned flashboard dam. Structure partially failed and sagging in center. Hole in concrete apron with exposed rebar. Debris deposited upstream of hole.

Structure has already partially failed and currently serves no purpose. Hole in concrete apron and exposed rebar further exacerbates passage conditions due to fallback potential and risk of fish injury. Removal of this structure will likely increase drop at downstream end of concrete channel at next site upstream.

Drop structure looking upstream from right bank

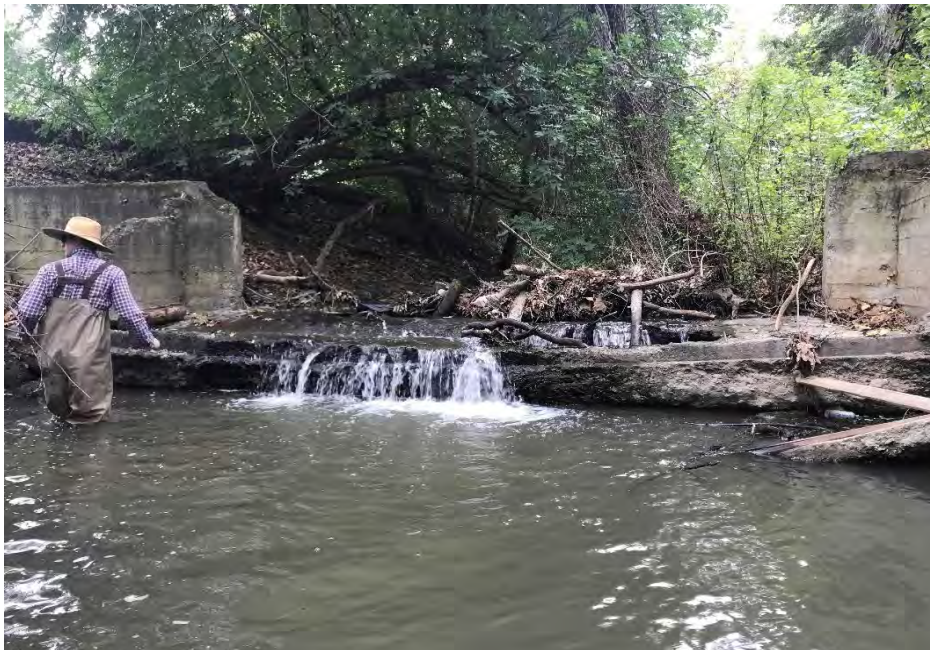
Drop structure looking upstream from scour pool
