SECTION 2 - CAUSES OF STREAM BANK EROSION

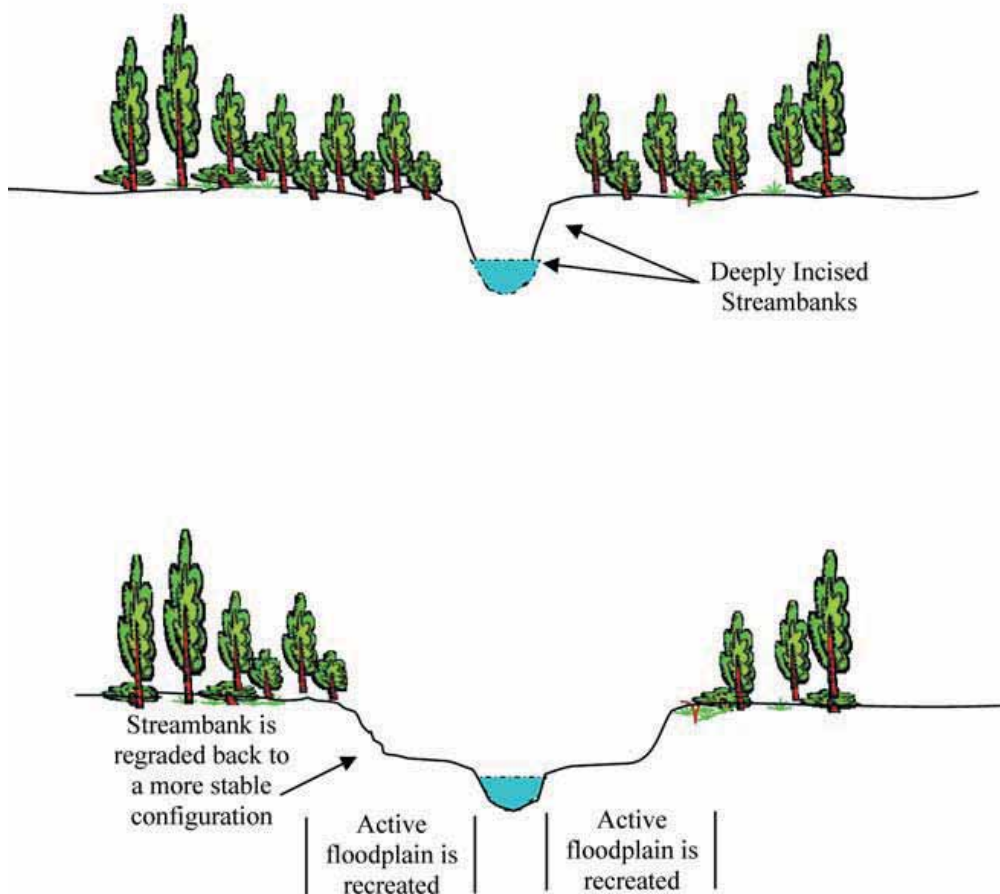
Associates in Collaboration with H. T. Harvey and Associates for the San Francisquito Creek Joint Powers Authority. They write, “The higher a bank is, the flatter the angle must be to prevent slumping. For example, most soils will support a three-foot high vertical bank, but if the river cuts a deeper channel (say five feet) the bank will collapse under its own weight. A five-foot tall bank would need to be graded to a lower gradient to be as stable as a three-foot vertical bank, and a ten-foot high bank would have to be excavated to an even lower gradient to be stable. The higher the bank, the lower the stable gradient becomes.” The best remedy for this problem—the problem of an over-steepened bank experiencing both hydraulic and geotechnical failures—combines several steps. The first step involves regrading the slope to a more stable angle, which is why it is called “laying it back.” The second step involves reinforcing the toe, where necessary, with biotechnical methods such as logs and rocks. The third step involves reducing erosive energy on the bank by planting the bank, so that it does not become over-steepened again. For an illustration, see figure 3 below.

Figure 3: Laying Back a Streambank to Increase Stability
