FLOODING AND FLOOD-RELATED DAMAGES REPORT

SAN FRANCISQUITO CREEK SANTA CLARA COUNTY DECEMBER 21-23, 2012

# FLOODING AND FLOOD RELATED DAMAGES REPORT IN SANTA CLARA COUNTY SAN FRANCISQUITO CREEK DECEMBER 21-23, 2012

# SAN FRANCISQUITO CREEK EVENT INSPECTION 12/27/2012

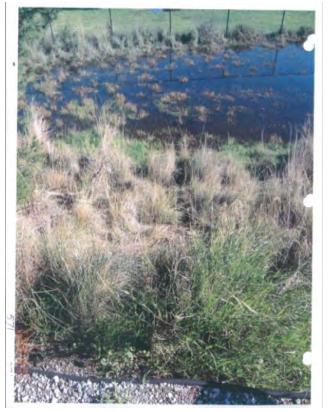
Standing water (SCVWD 570) – 12/27/2012

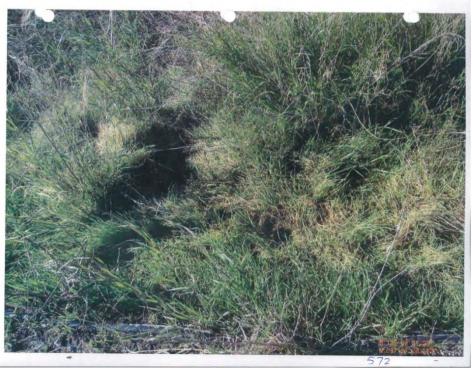
Standing Water (SCVWD 571) – 12/27/2012

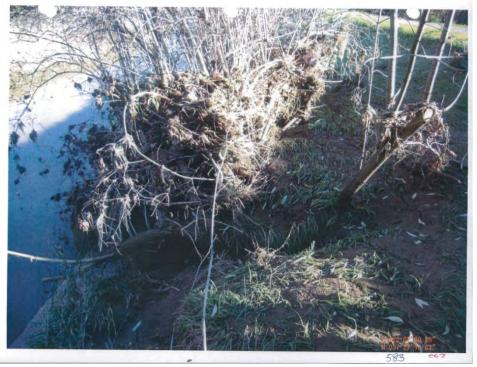
New sloughing located on the opposite bank (SCVWD 582) – 12/27/2012

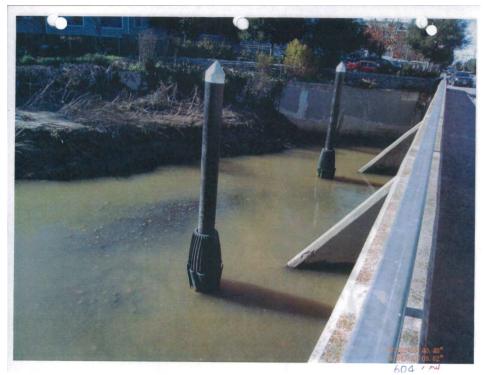
Bridge Shark (SCVWD 604) – 12/31/2012

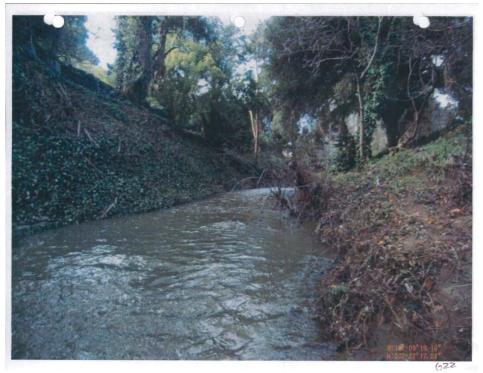
(SCVWD 622) - 12/31/2012
