# STEVENS CREEK FISH PASSAGE ANALYSIS

*Prepared for*

Valley Water  
5750 Almaden Expressway  
San Jose, CA 95118

June 2020

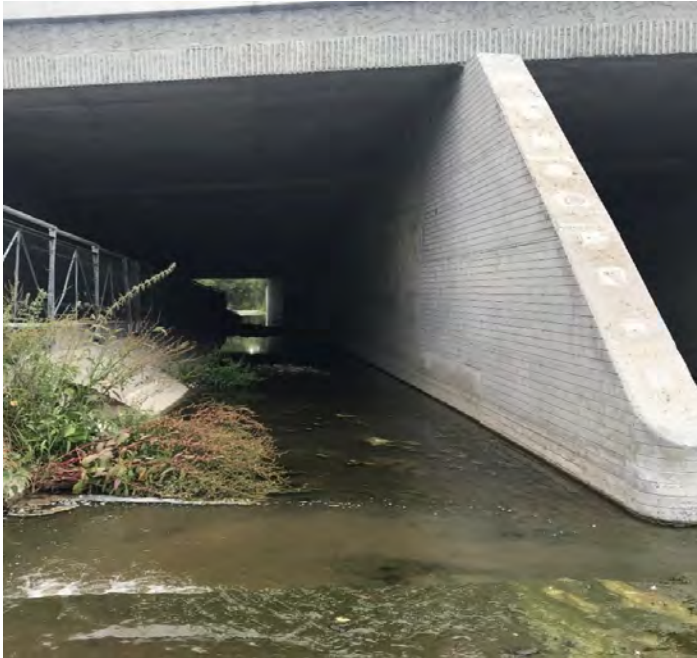
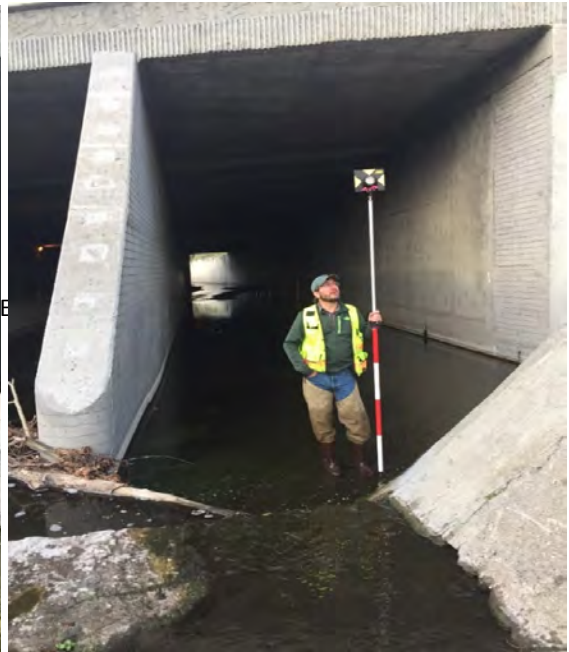
Looking downstream at Highway 101 inlet (a) west culvert and (b) east culvert, with inlet drop in foreground

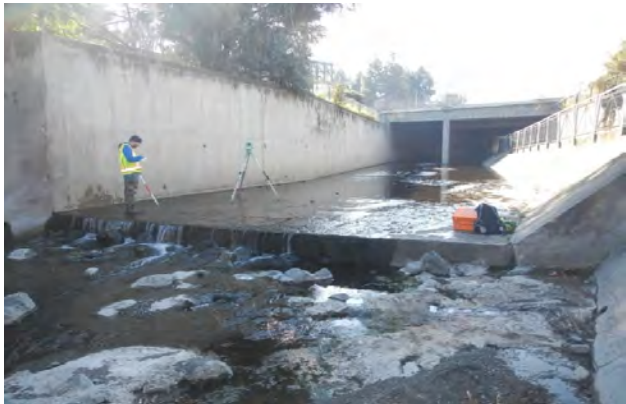
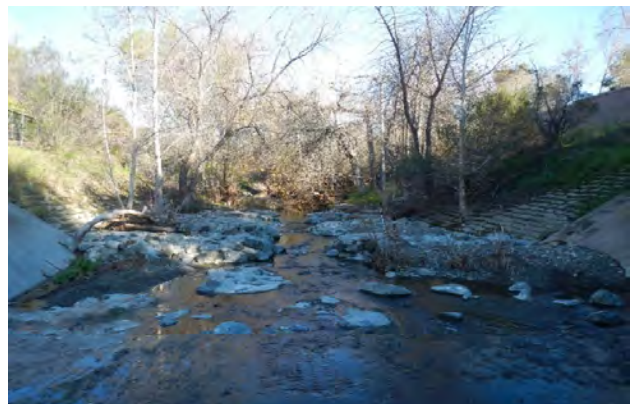
Highway 101 (a) culvert outlet looking upstream and (b) grouted rock veins looking downstream

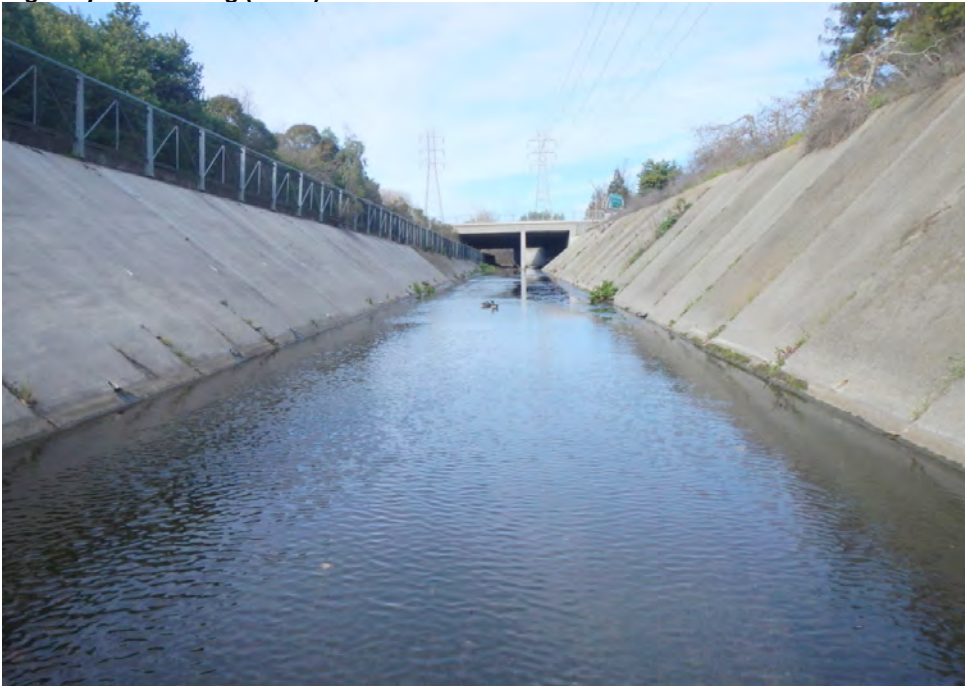
Concrete channel downstream of Moffett Drop Structure, looking downstream to Highway 101 crossing (Site 2)

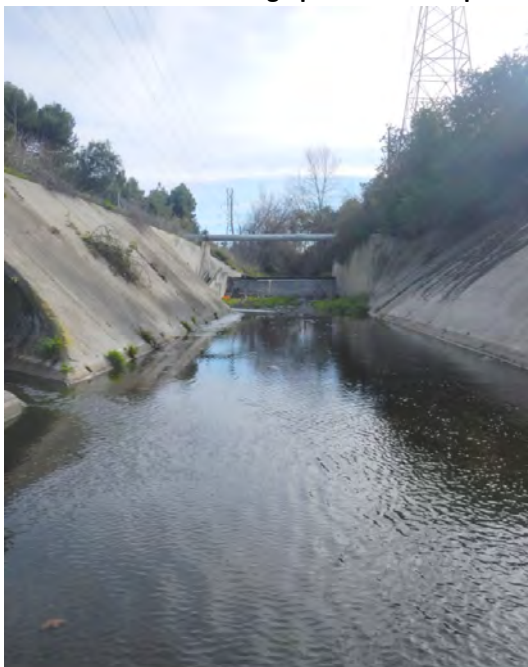
Concrete channel looking upstream to drop structure

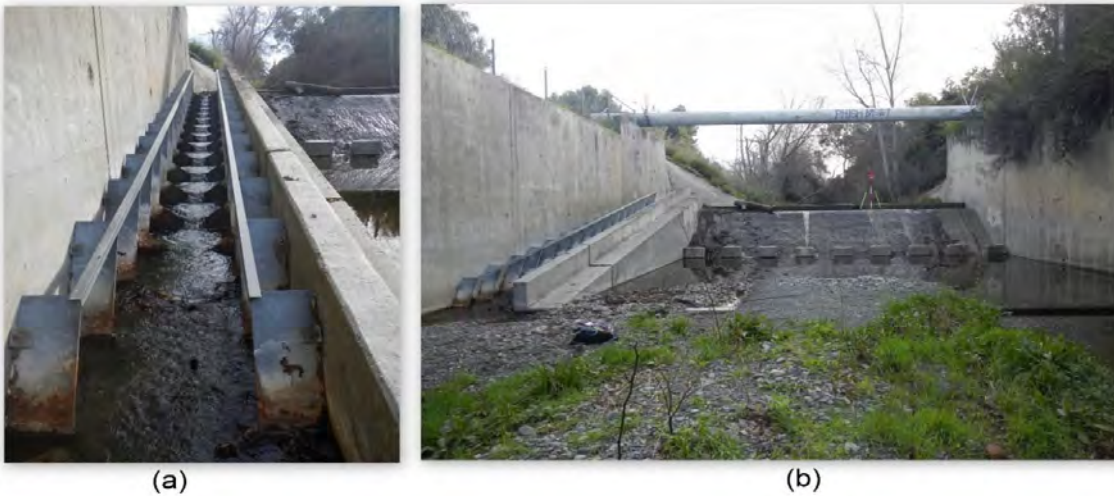
**Site:** 3  
**River Mile:** 2.93  
**Reach:** 2  
**Site Name:** Moffett fish ladder  
**Latitude:** 37.406618    **Longitude:** -122.069042    **PAD ID:** 707059

- Site 3 (Moffett fish ladder) received a score of 14 and is in the red score category. However, observed frequent clogging of the fish ladder with small debris, which makes it impassable much of the migration season, is not captured by the model results. Denil fish ladders (Site 3 and Site 21) have a propensity to clog with sediment and small debris. Maintenance during the migration season is restricted to manual debris removal, which is not always effective or possible during high flows, so these sites may be impassable during substantial portions of the migration season when steelhead are most likely attempting to migrate upstream. Adult passage at this site is likely much lower than the 72 percent suggested by the quantitative analysis.

**Moffett drop structure and denil fishway, looking upstream.**

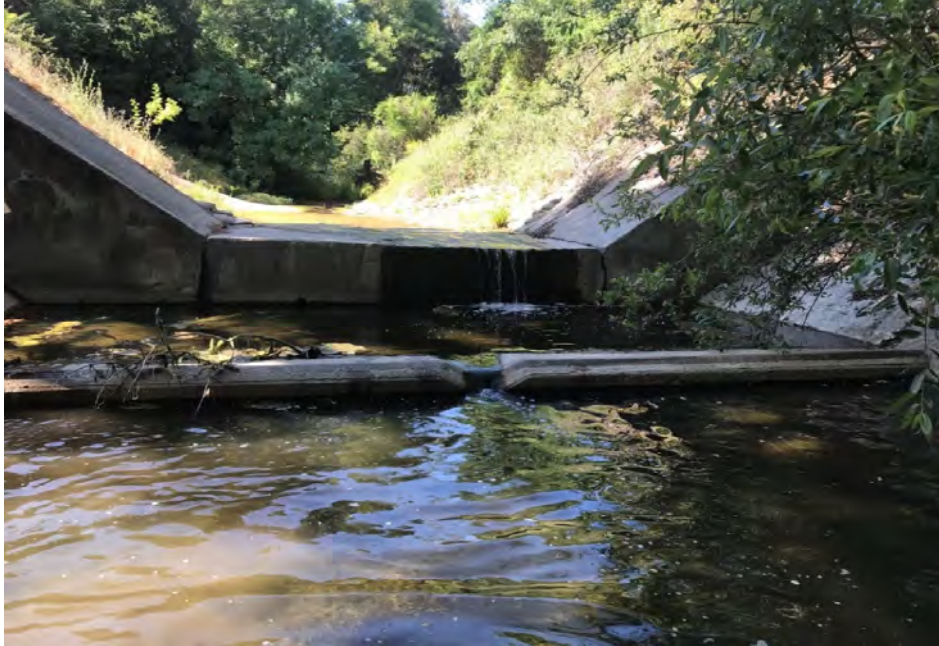
Looking upstream at the drop structure with pool and weir

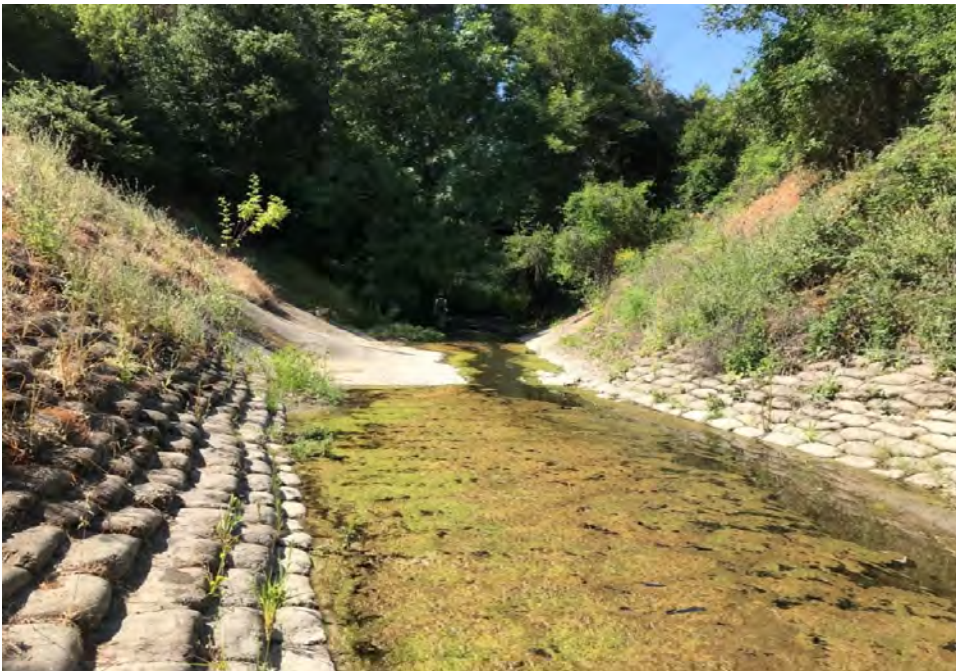
Looking upstream and concrete and sacrete channel above drop structure

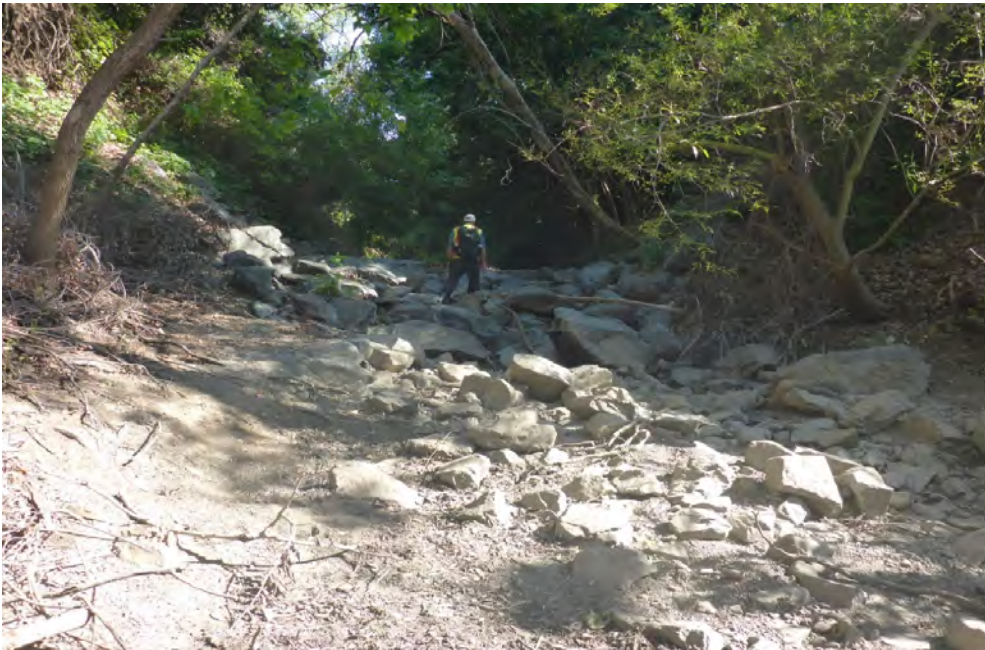
**Boulder chute looking upstream**

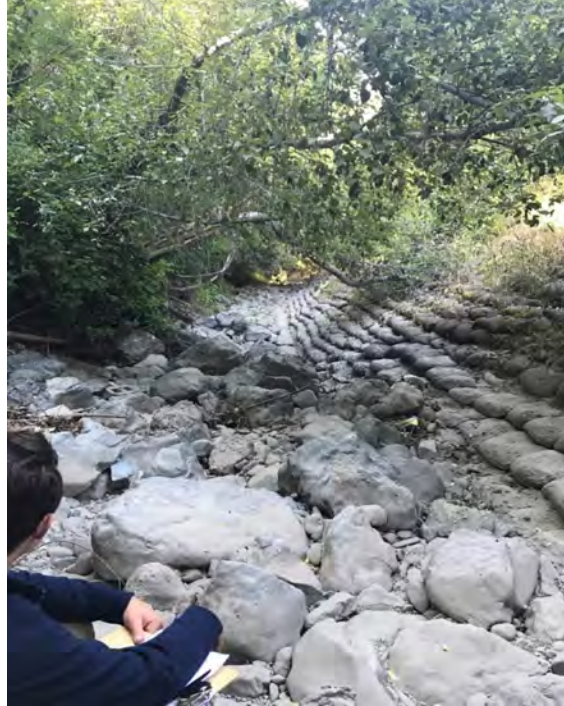
Looking downstream from top of boulder jam

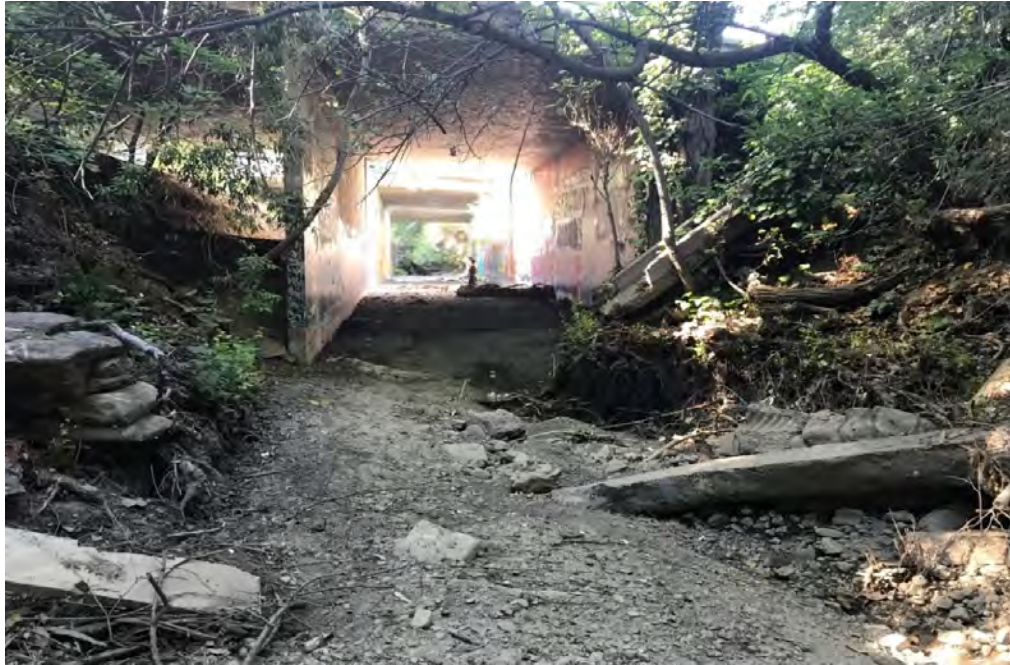
**Culvert inlet looking downstream**

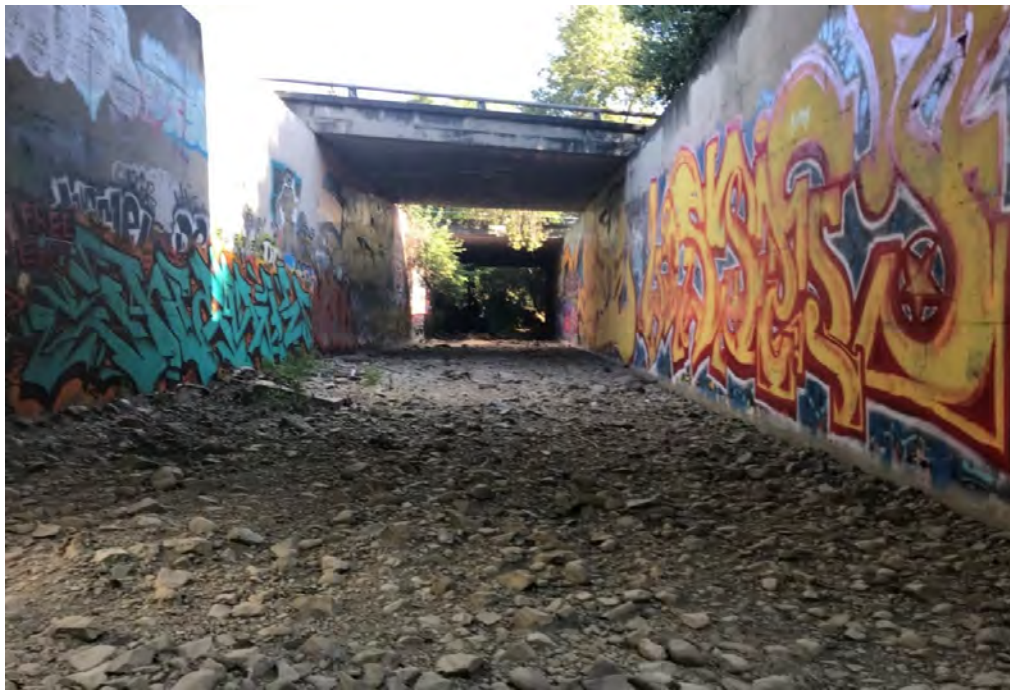
**Mid culvert looking upstream**

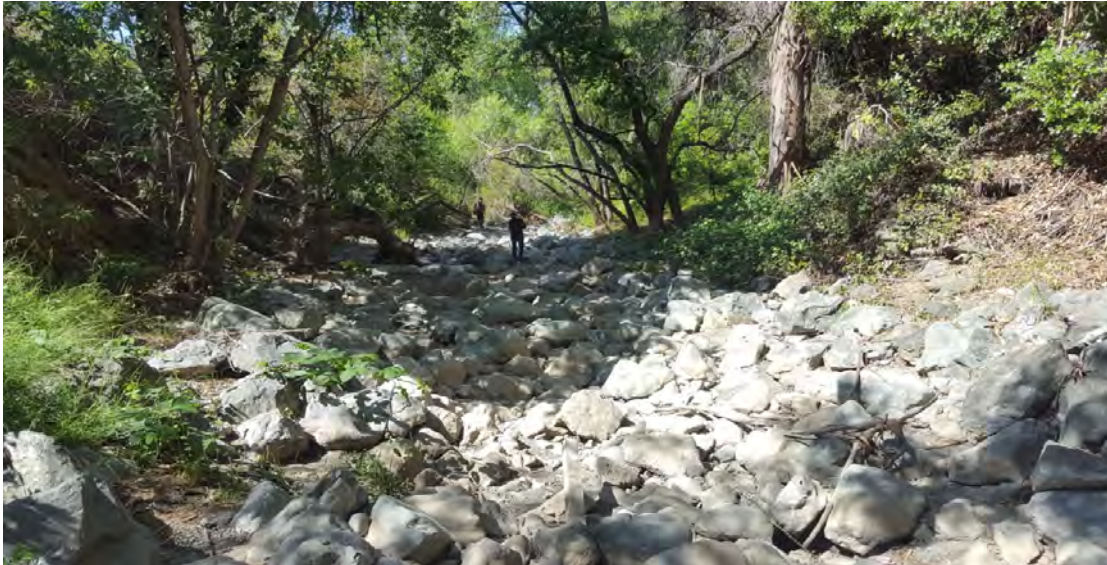
Looking downstream at boulder lined channel

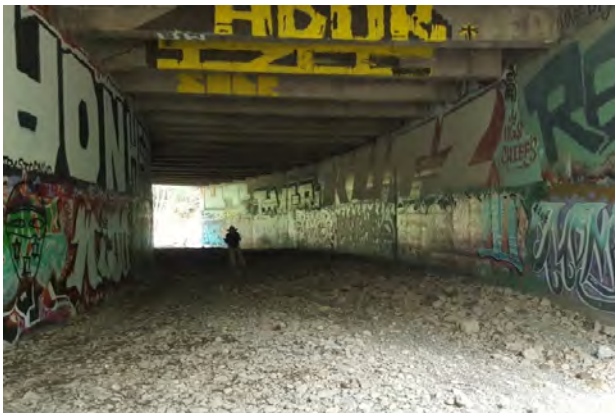
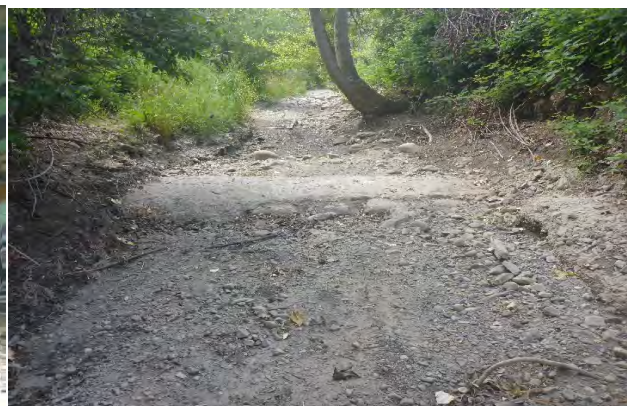
**Looking (a) downstream within culvert and (b) at exposed concrete spanning channel upstream of culvert**

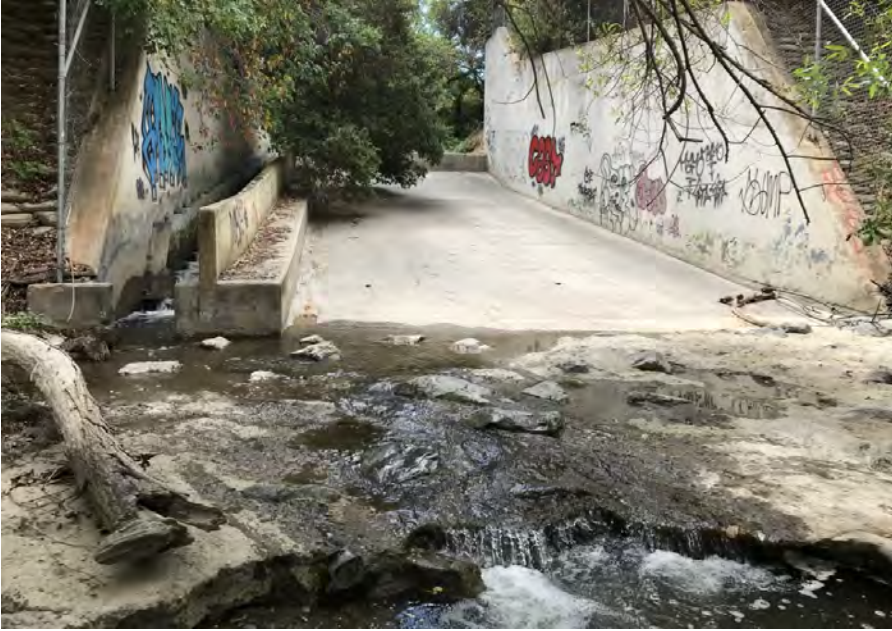
Grouted rock apron and fishway both create juvenile velocity barriers at all flows. Grouted rock apron creates depth barrier and poor entrance conditions at low to moderate flows for adults.

Looking upstream at Denil fish ladder entrance on left and grouted rock apron

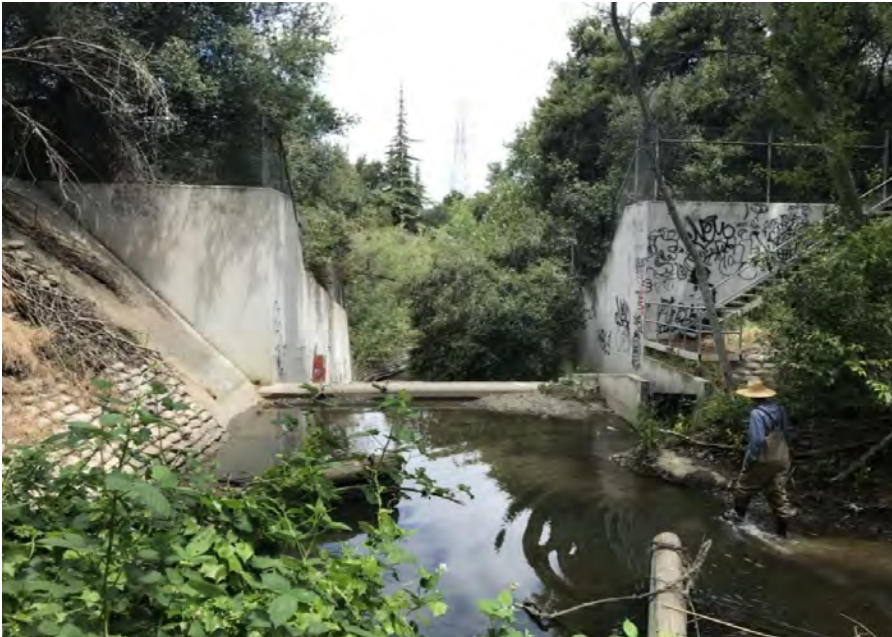
Looking downstream at top of drop structure with Denil fish ladder exit on right

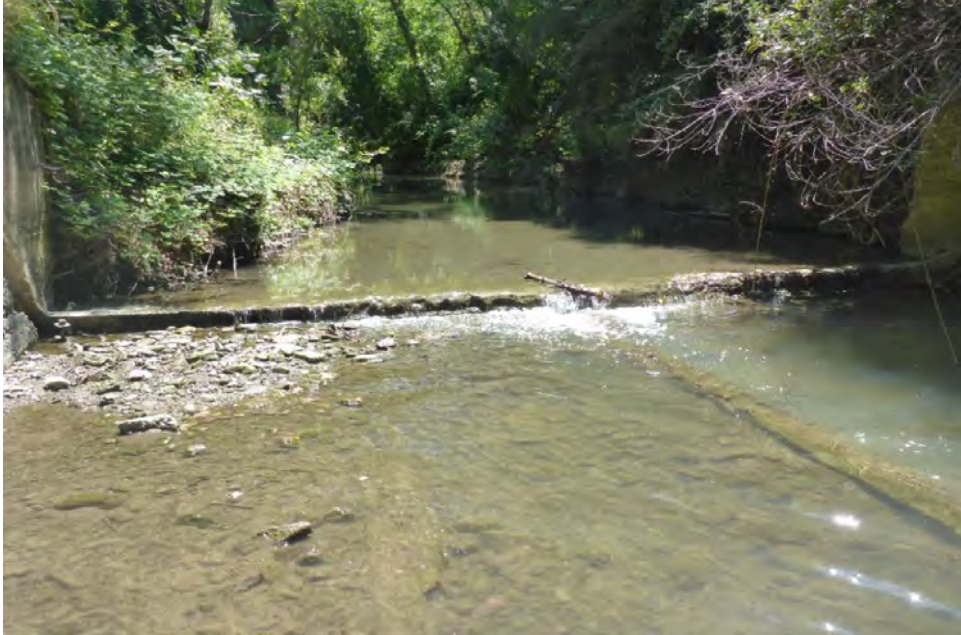
Drop structure looking upstream.

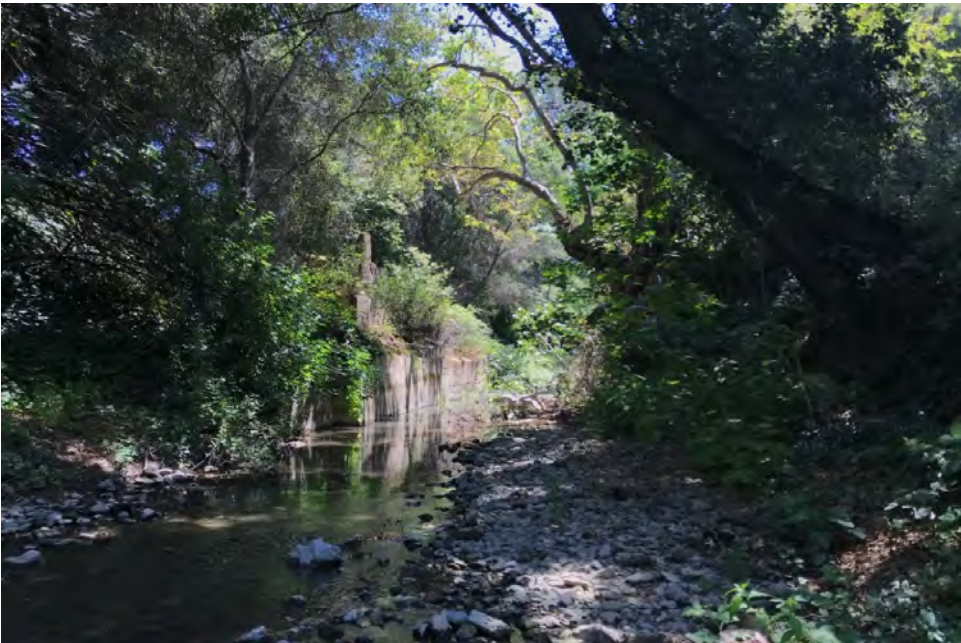
Tailwater control and drop structure pool, looking upstream.

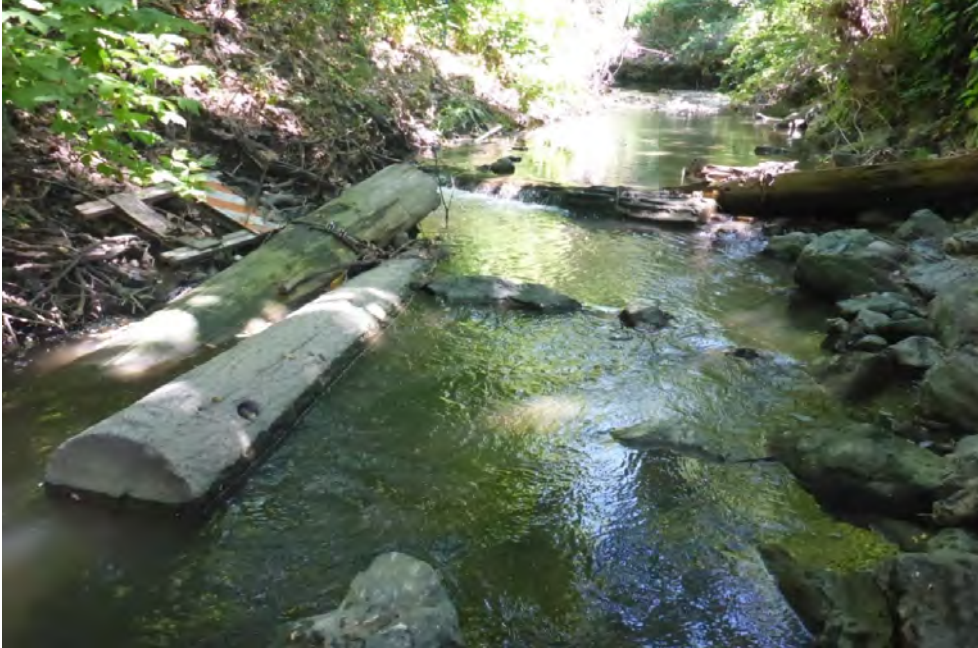
Concrete and wooden log structures, looking upstream.

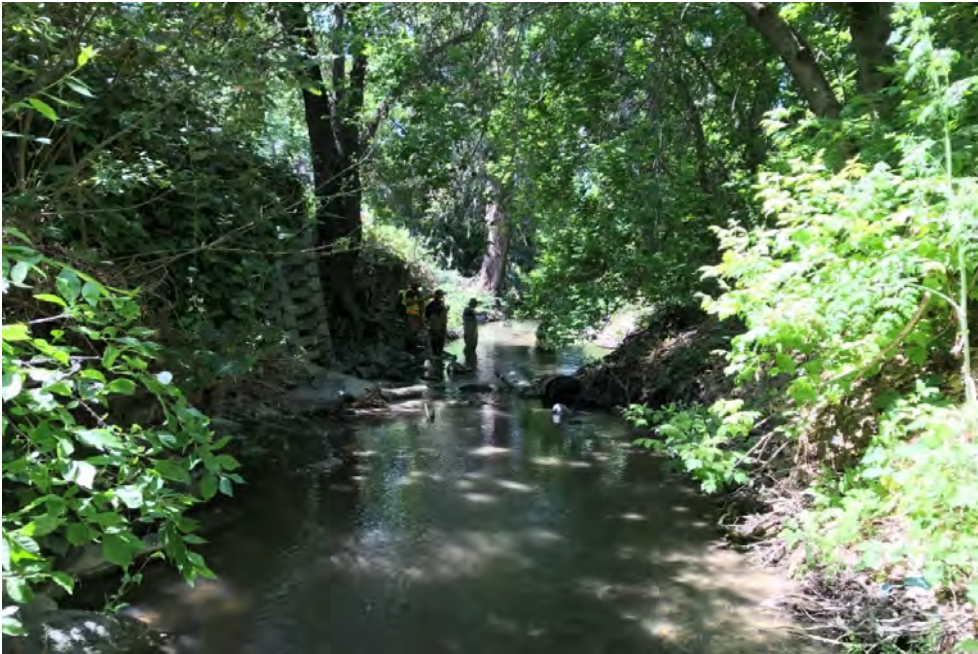
Looking downstream with concrete and wooden log structures in center

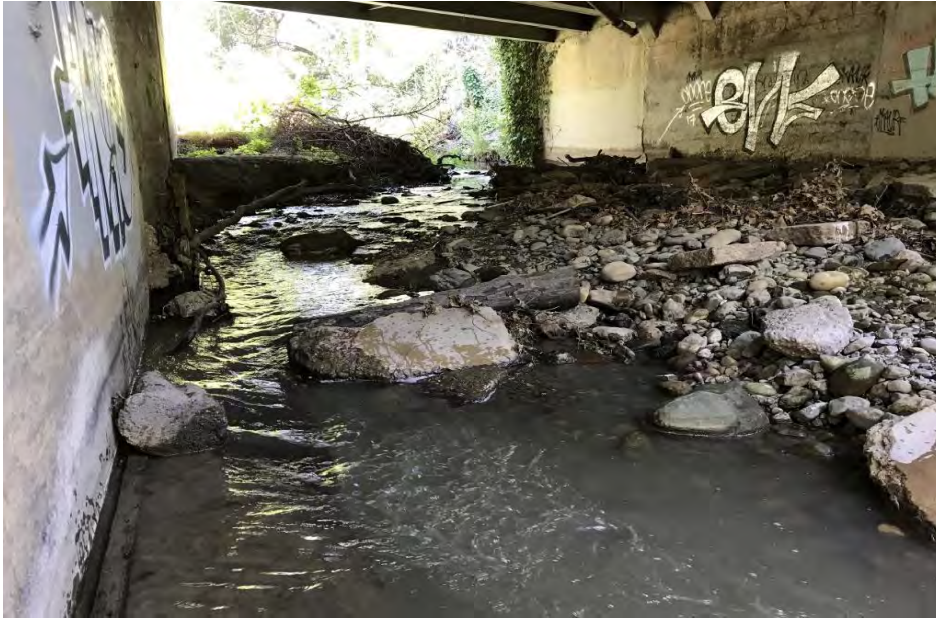
**Looking upstream from crossing outlet**

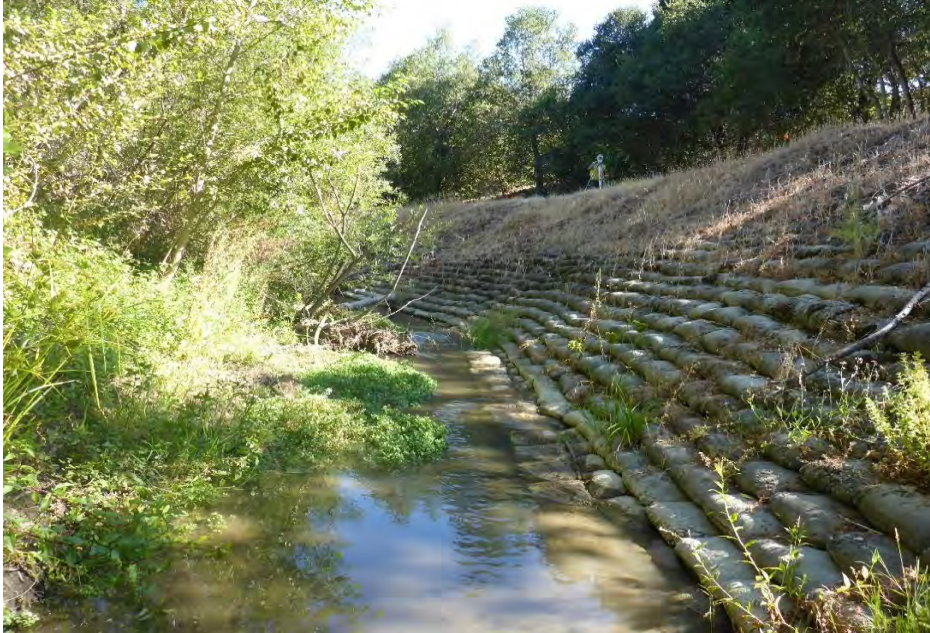
Mid-channel reach looking upstream

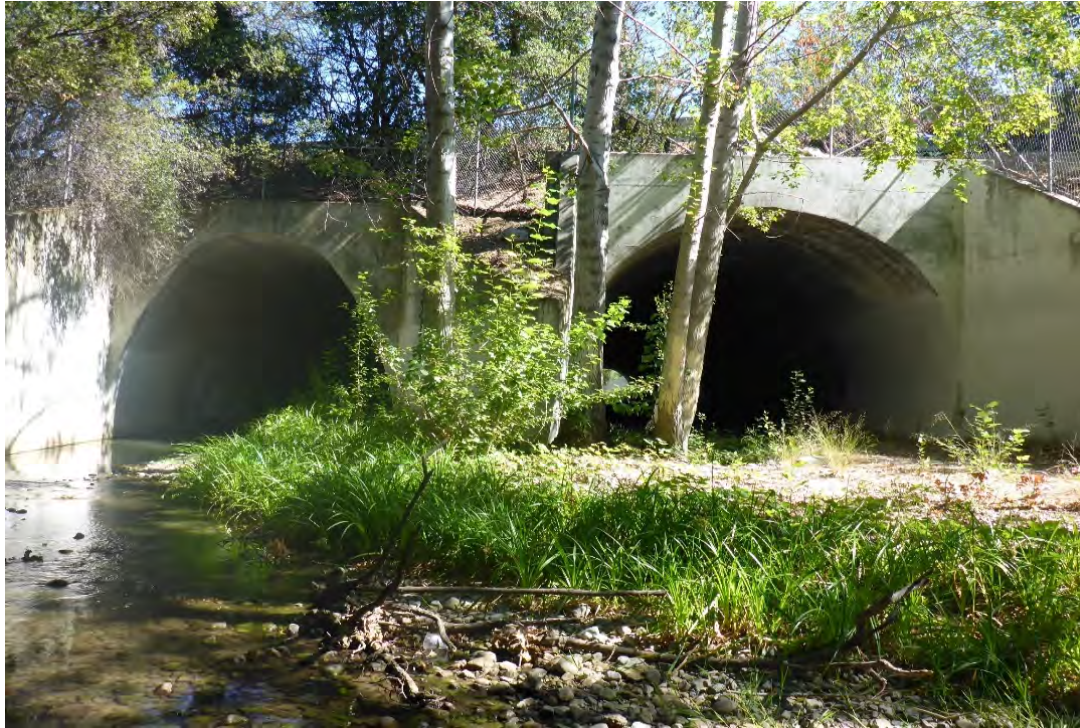
Juvenile fish likely able to pass this culvert at nearly all fish passage flows due to velocity diversity. A low flow channel along the right side of the culvert helps concentrate flows to provide adequate depth. This passage analysis fails to account for the areas of low velocity close to the bed of the channel.

**Culvert inlets looking downstream, primary passage culvert on left**

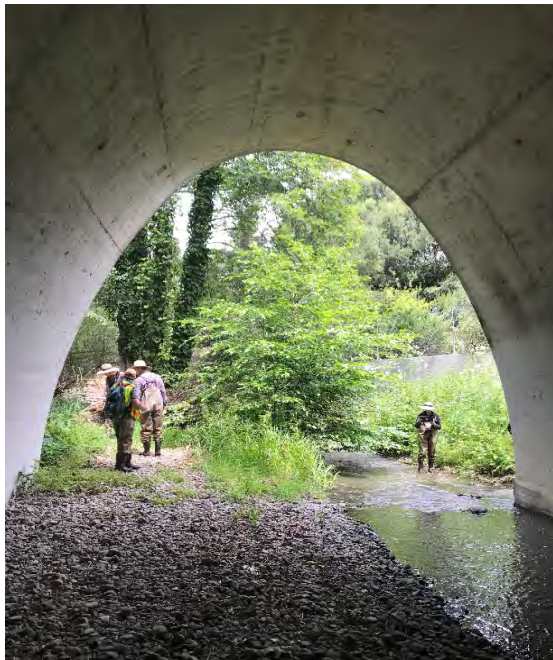
**Primary passage culvert's outlet, looking downstream. Note low-flow channel shape provides suitable depth.**

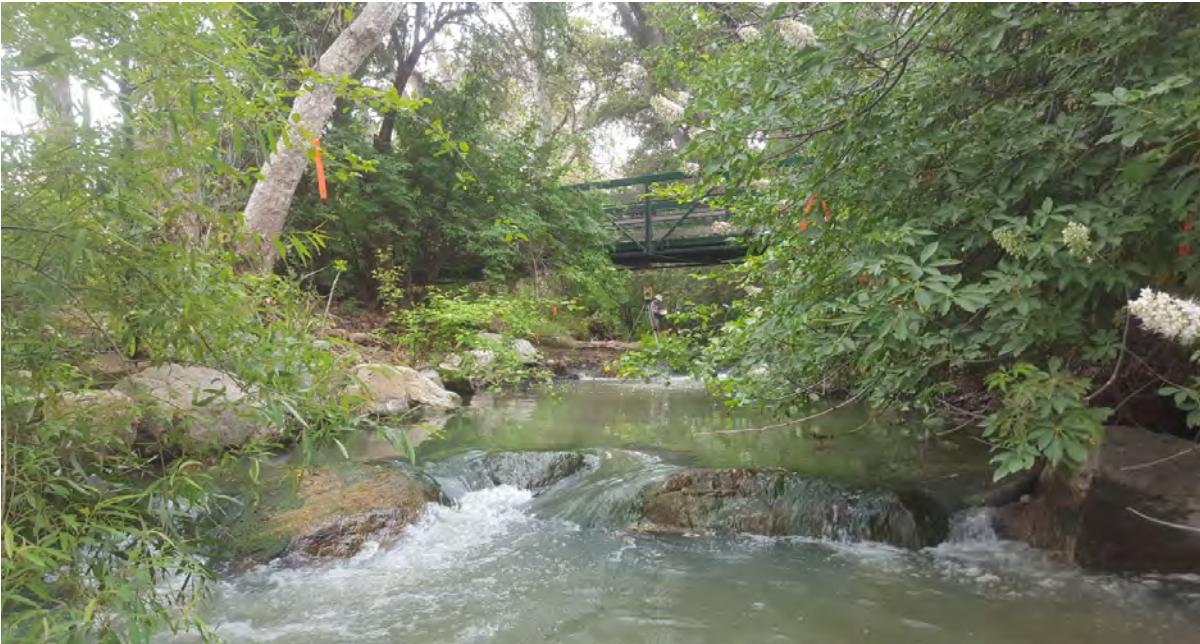
**Looking upstream from downstream of lower weir**

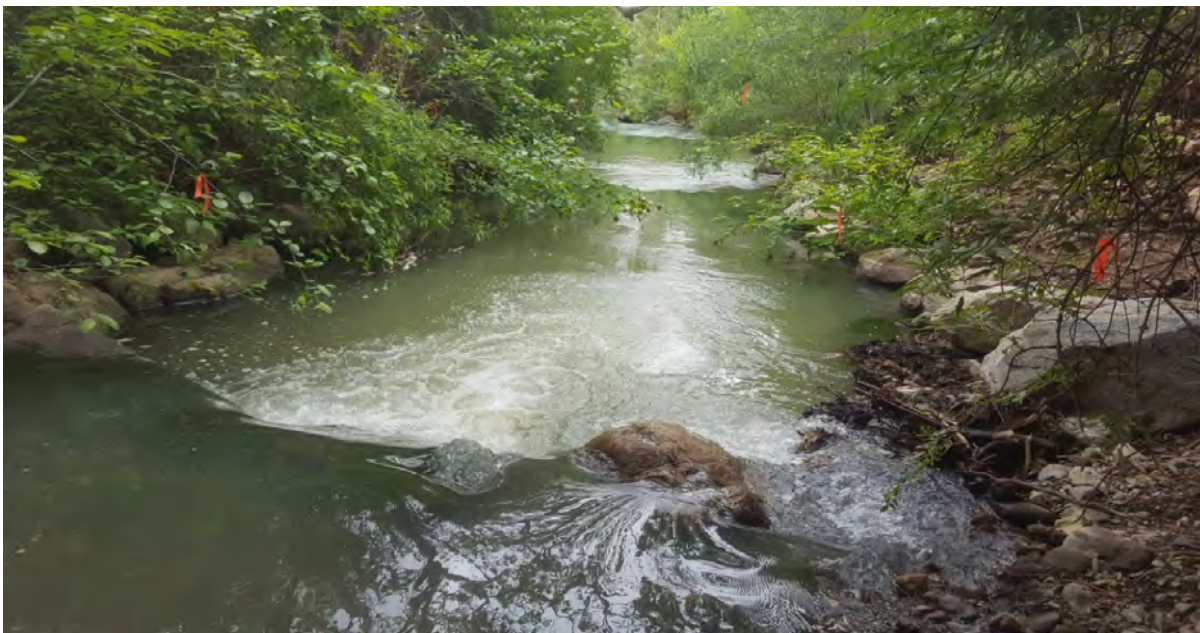
**Looking downstream from upstream of upper weir**

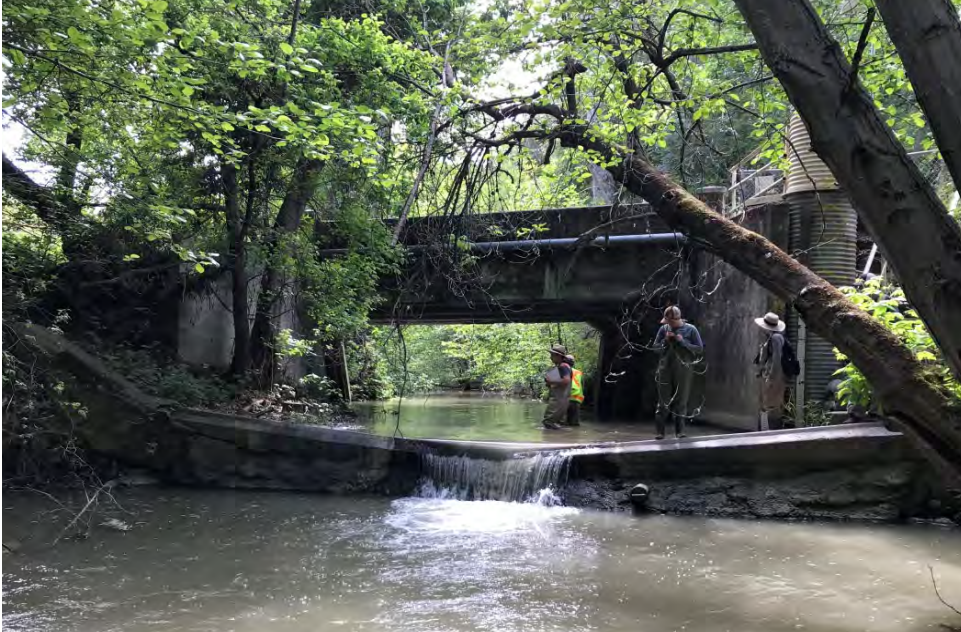
**Looking upstream to gaging weir**

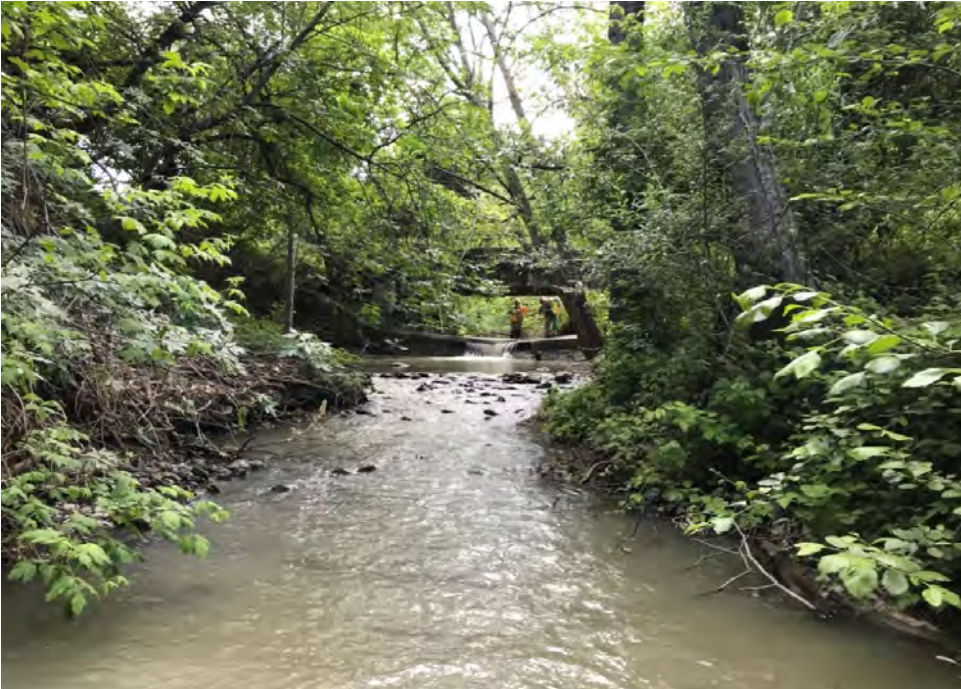
**Looking upstream at riffle control of pool below gaging weir**
